REPORT NO. FHWA/CA/TL-80/17

ROADWAY DAMAGE DURING THE SAN FERNANDO, CALIFORNIA EARTHQUAKE OF FEB. 9, 1971

FEB., 1981

6. PERFORMING ORGANIZATION CODE		
7. AUTHOR(S) R. H. Prysock and J. P. Egan, Jr.			8. PERFORMING ORGANIZATION REPORT NO. 19305-632119		
9. PERFORMING ORGANIZATION NAME AND ADDRESS Office of Transportation Laboratory California Department of Transportation Sacramento, California 95819			10. WORK UNIT NO.

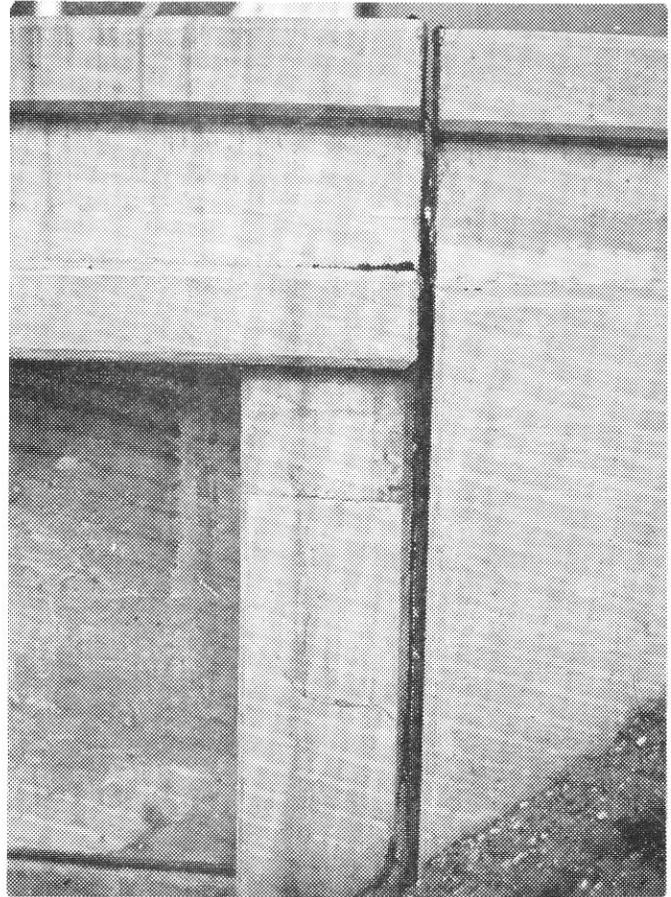
Damage to the Rinaldi Street Undercrossing consisted of abutment settlement, shattering of the abutment corners, and wingwall movement. Settlement and separation of the south abutment wingwall are shown in Photo No. 1.

Photo 1. Looking easterly at south abutment of Rinaldi Street Undercrossing. Note settlement of wingwall, separation at construction joint, and crack in diaphragm.

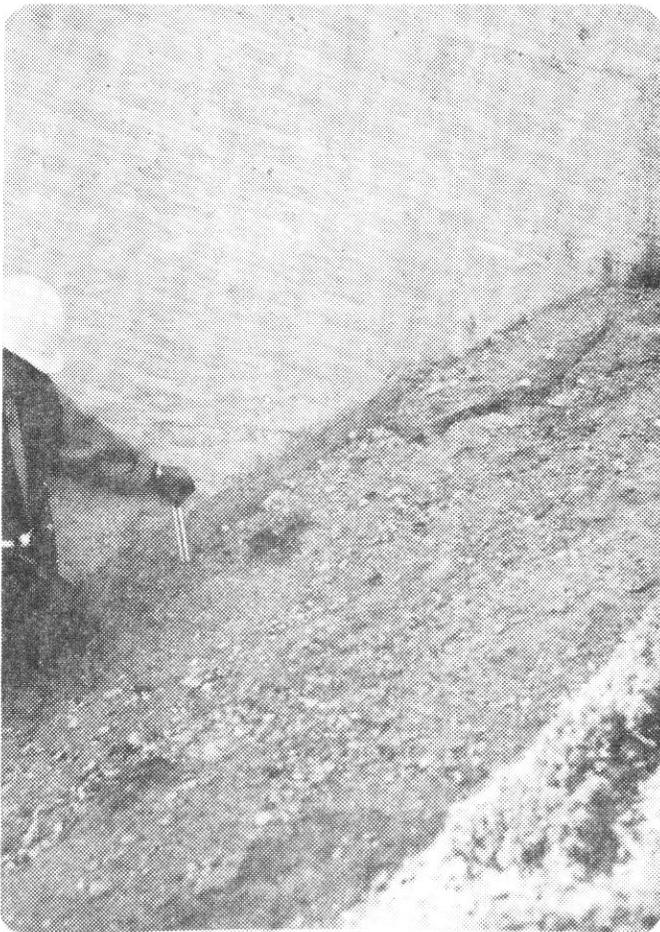
Photo 5. Looking westerly at northeast wingwall of San Fernando Mission Boulevard Undercrossing. Note fill settlement relative to wingwall.

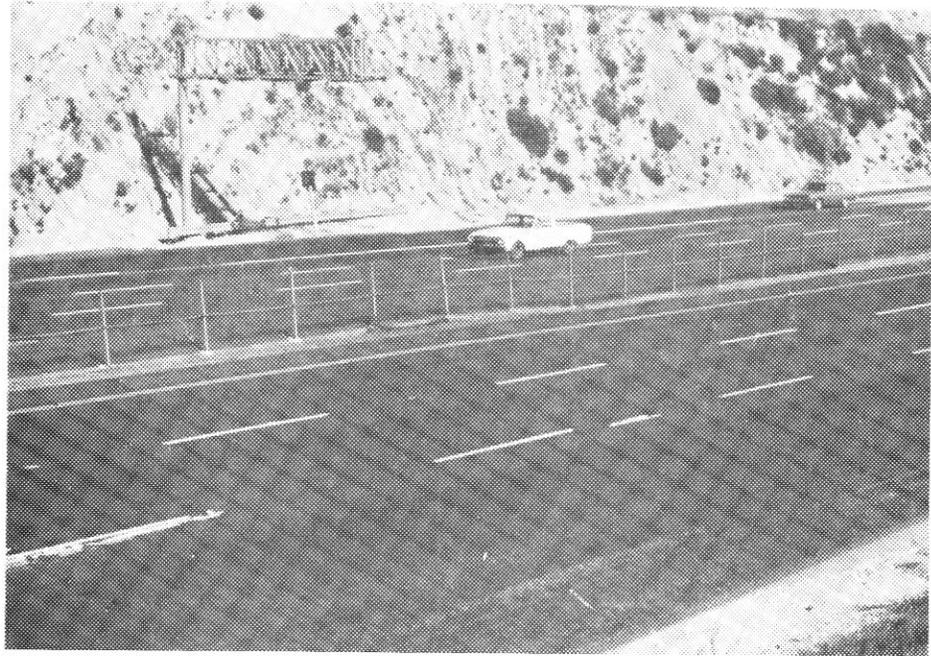
Photo 10. Looking westerly across truck lane pavement. Fault trace extended up cut slope in background.

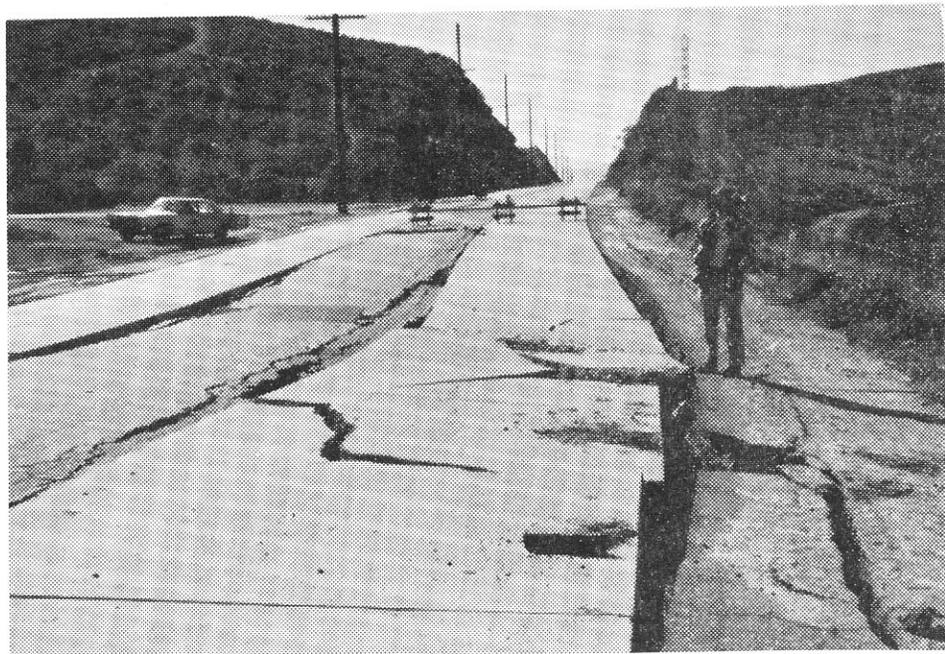
At this location, a Blucher Avenue fill slid toward the reservoir, as shown in the lower right center of Photo 6. Lateral movement of the fill and pavement damage are shown in Photo 15. Failure of the fill was possibly due to liquefaction of the saturated foundation material, although no supporting evidence to that effect was found.

Photo 15. Looking southerly along Blucher Avenue at results of fill movement to the west.

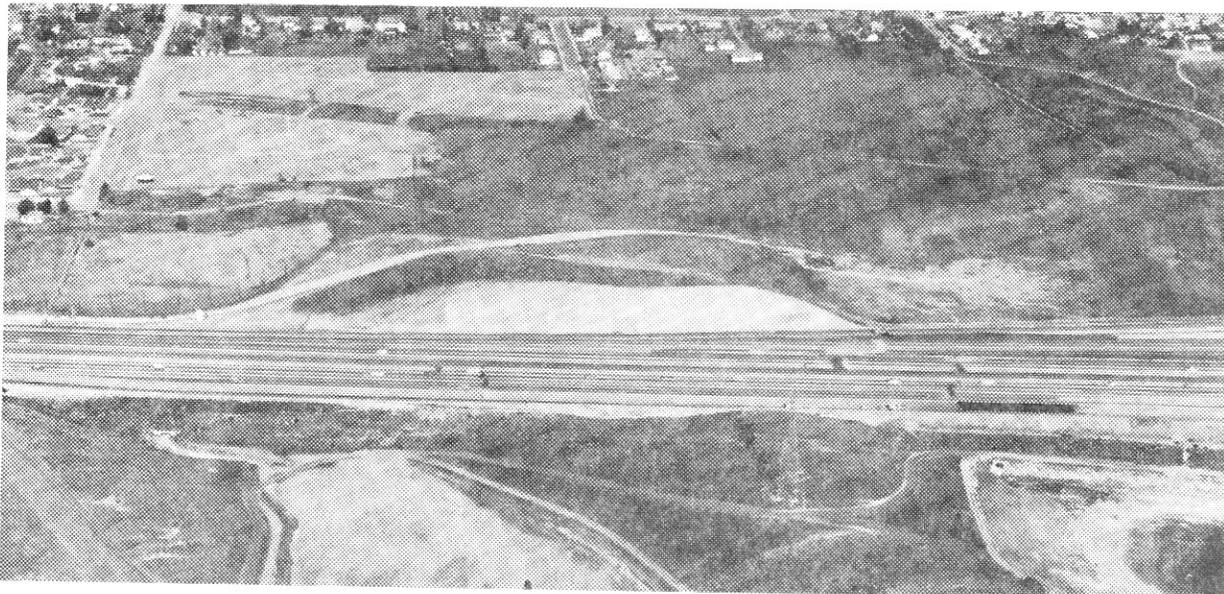
The top of the cut slope (Photo 25) was distressed by slope-shattering and transverse cracks, shown in detail in Photo 26.

Photo 25. Looking northeasterly at Route 5. Cut slope in top center sustained cracking. Note patches in pavement.

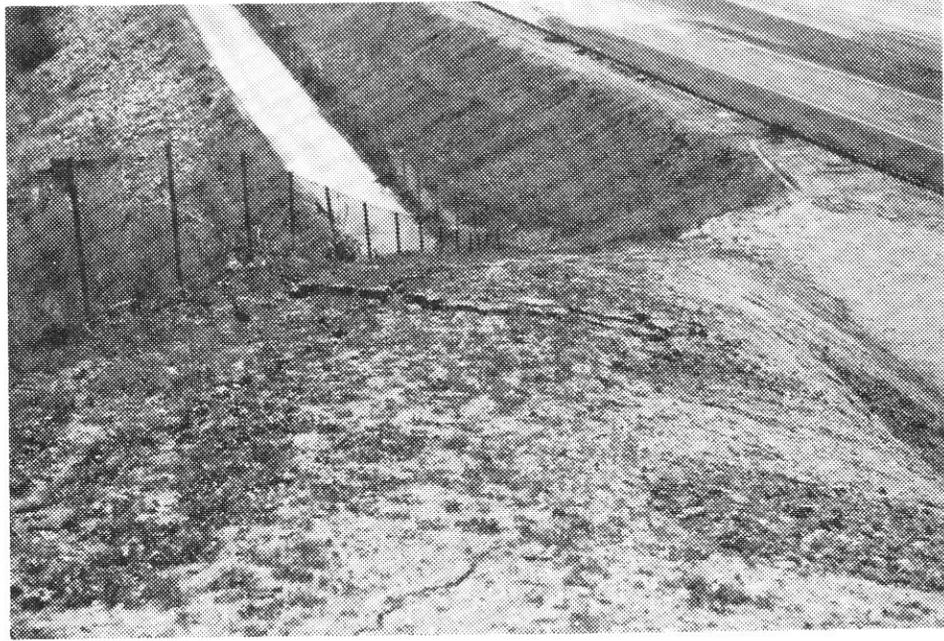
Photo 26. Typical cracks in cut slope shown in Photo 25.

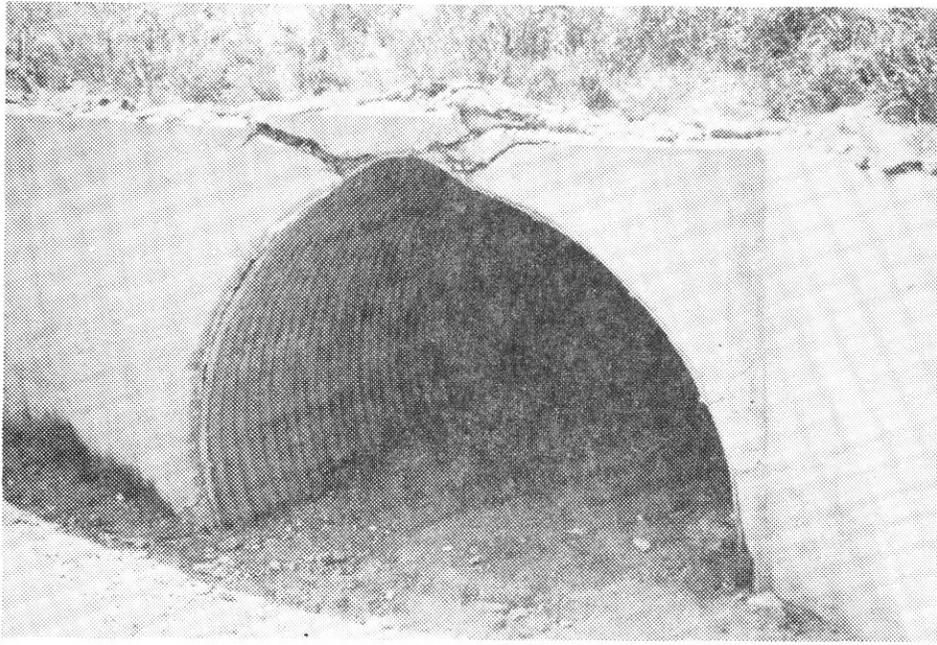
Photo 27. Cracking and distortion in drainage structure headwall.

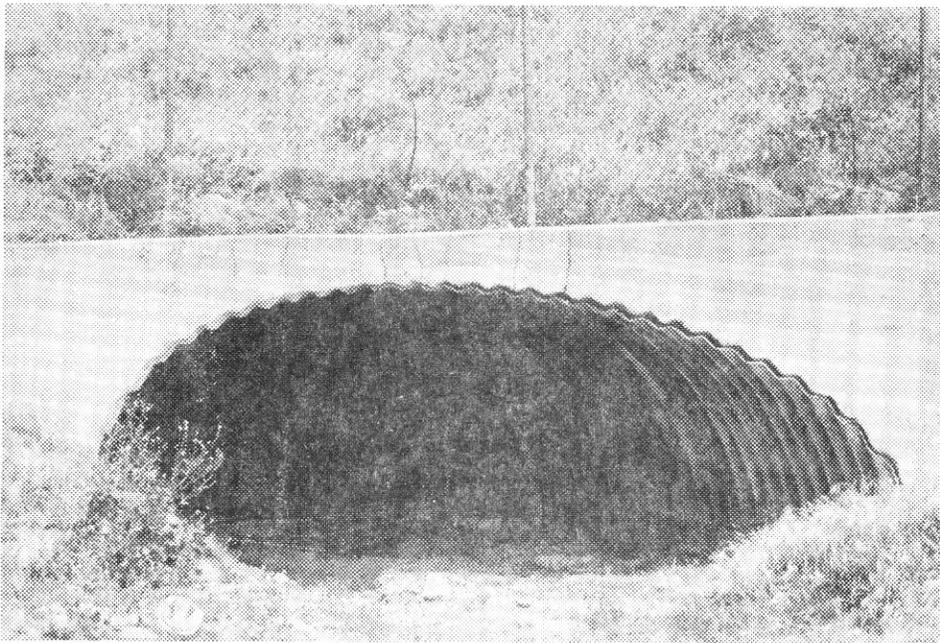
Photo 28. Cracking in drainage structure endwall. Note separation of concrete and metal at top of structure.

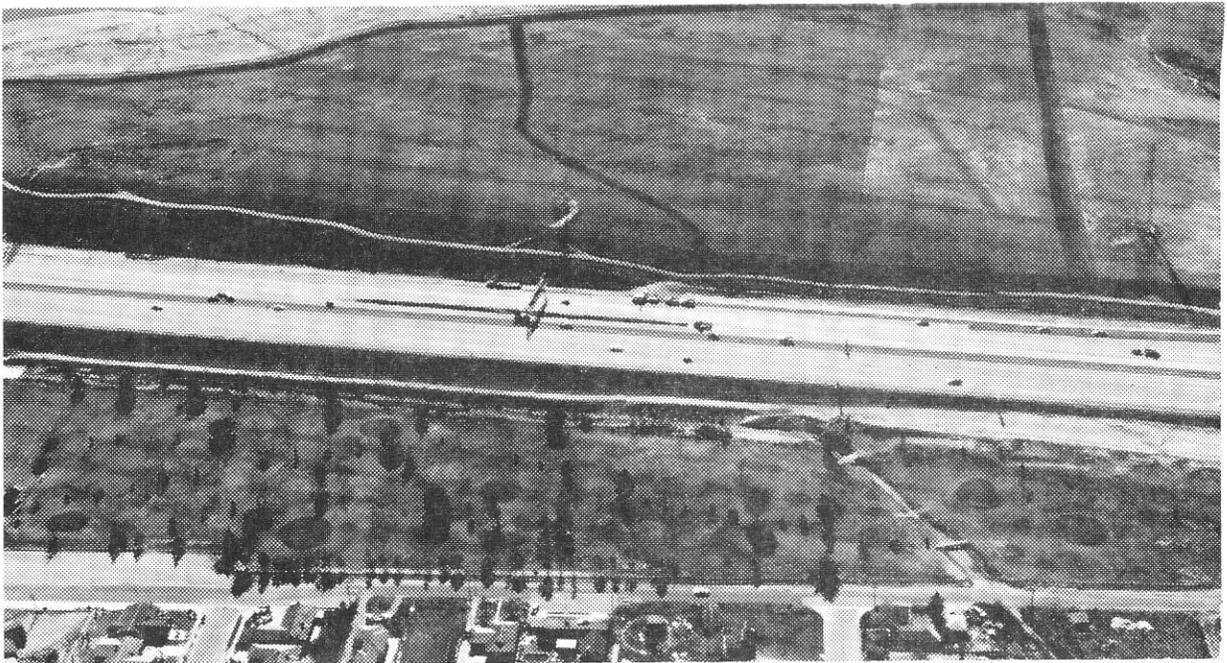
Rotational movement occurred in the cut slope on the west side of the freeway shown in Photo 29. The movement, although small, was sufficient to develop cracks behind the top of cut (Photos 30 and 31) and to upthrust the south-bound roadway surface and cause slab separation, which required patching. Four hundred feet to the south, another upthrust bulge occurred in the roadway but it did not require immediate repairs. It was not obvious upon first observation that slope movements of this nature were the cause of the roadway riding surface damage.

Photo 29. Looking westerly at Route 5.

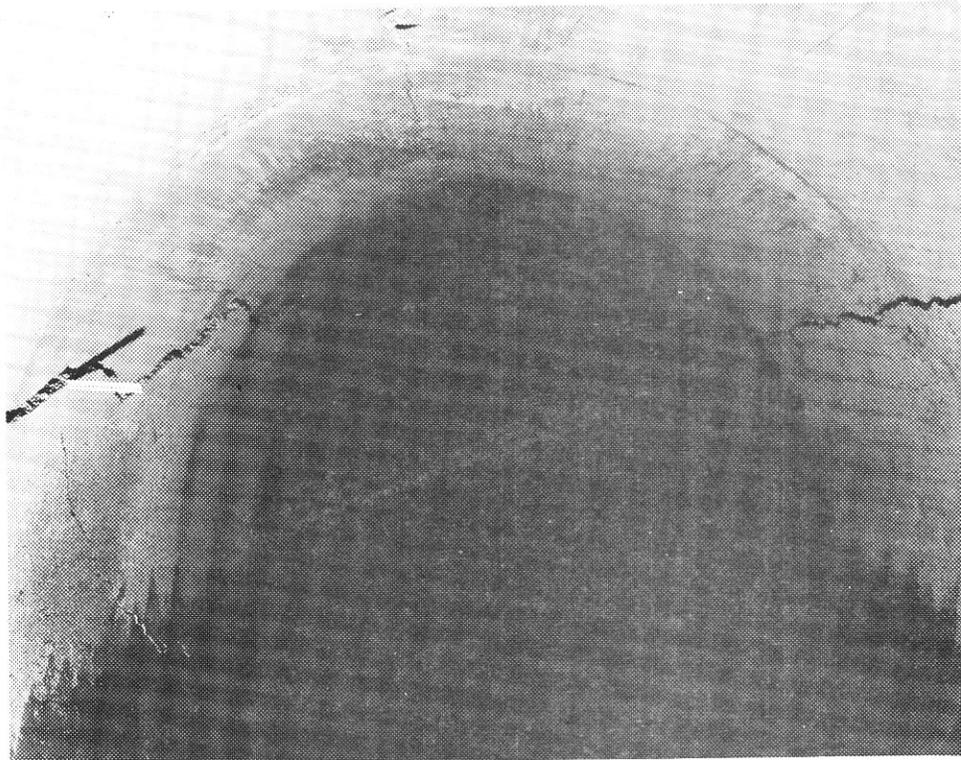
Between the cut described for Location 4 and Roxford Street, Route 5 is carried on fill. An 84-inch concrete drainage pipe was located under most of the fill length, beginning at Roxford Street and outletting near the cut of Location 4. The outlet may be seen in Photo 29, right of center, at the bend in the open channel. This pipe was cracked badly from the headwall on the east side of the fill for a distance of about 600 feet to the south and west. Longitudinal cracking was practically continuous, mainly between the 8 and 11 o'clock and 2 and 4 o'clock positions when viewed looking westerly. Cracks up to one inch wide with lateral offsets up to one inch were noted. Also, peripheral cracks at joints had opened about 1/4-inch at several locations. The longitudinal crack pattern is shown in Photo 32.

Photo 32. Typical longitudinal cracks in 84-inch concrete pipe.

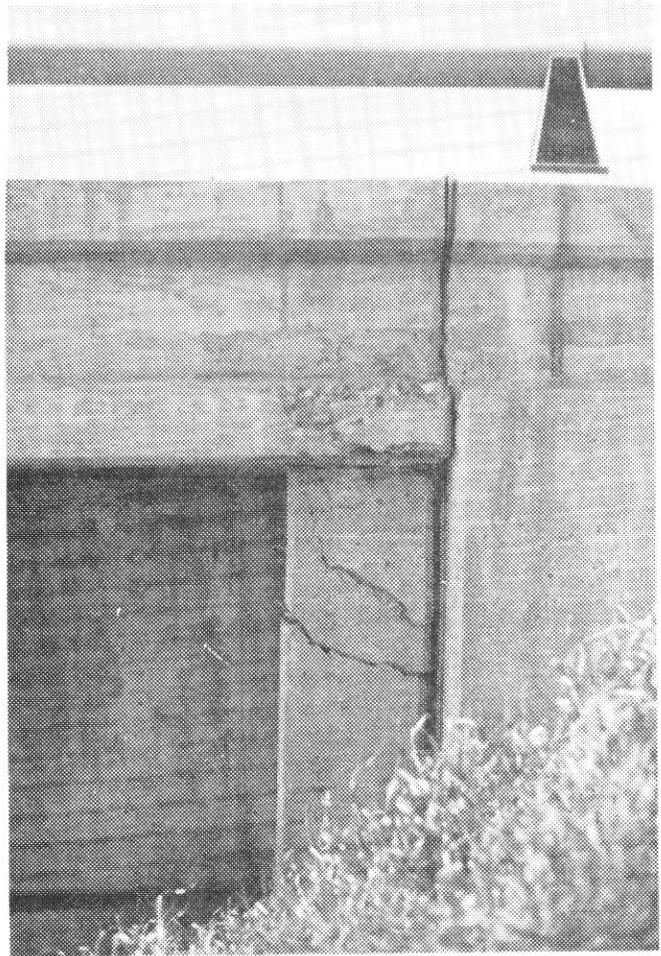
Photo 34. Separation and settlement of wing wall, cracking of abutment diaphragm, Roxford Street Undercrossing.

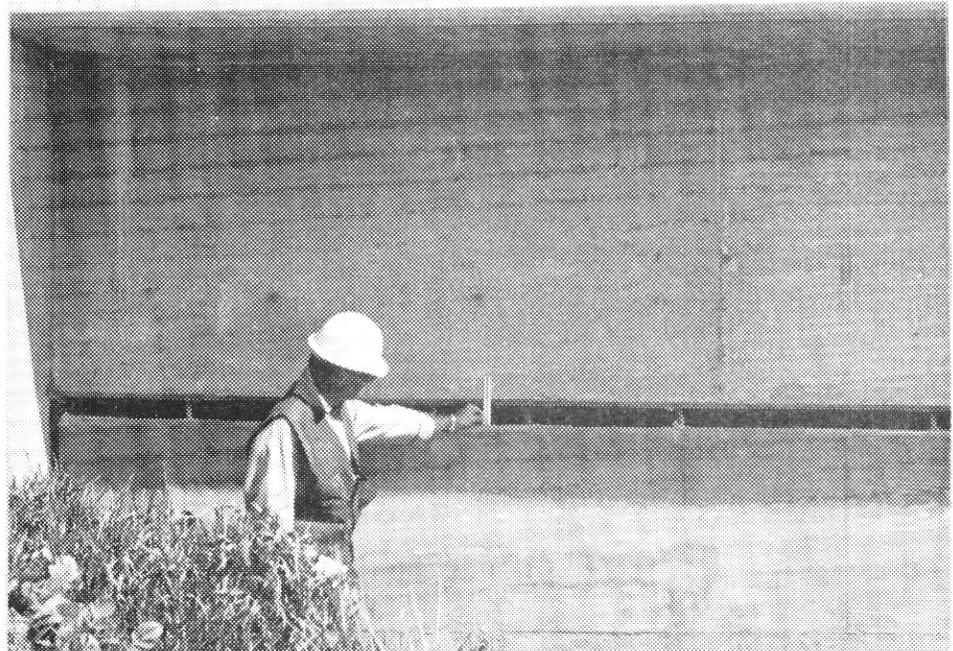
Photo 35. Settlement of concrete curtain wall from bridge girder. Note exposed rebars along separation.

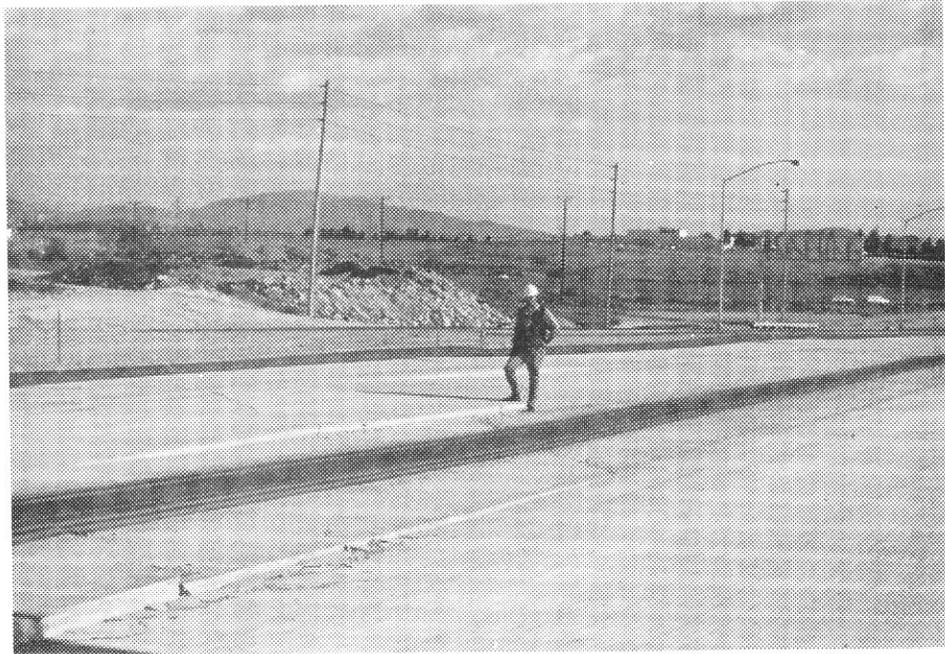
Lateral movement of the roadway along the northern flank of the slide resulted in separation, rotation, and differential heaving of pavement slabs as illustrated in Photo 40. Photos 41-43 show other features of the slide, detailed analyses of which may be found in References 7 and 9.

Photo 40. Looking southeasterly at Route 5. Northern flank of Juvenile Hall slide crossed pavement here, resulting in pavement slab movement.

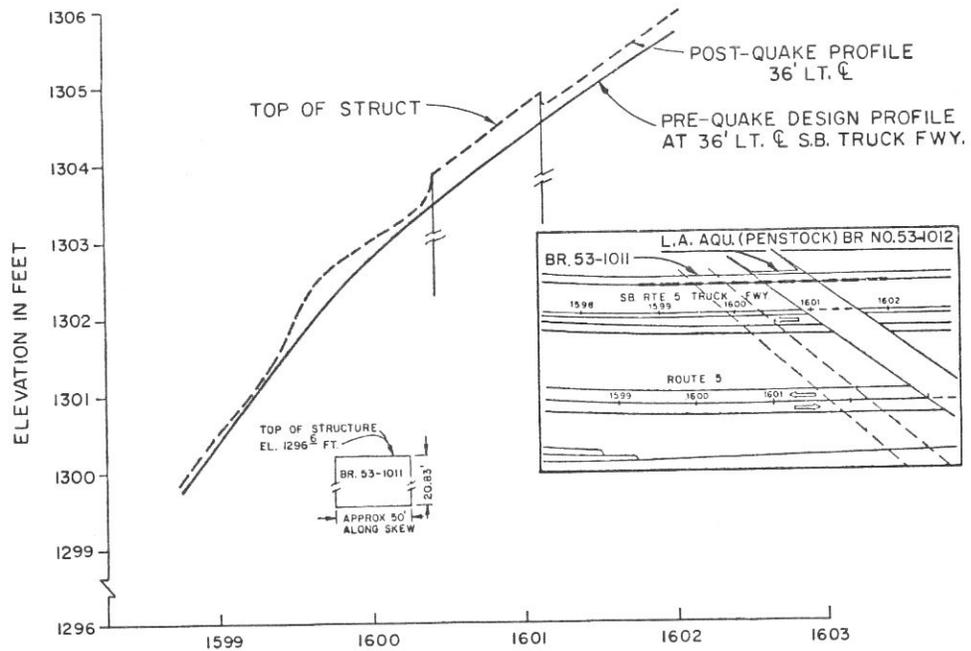
BEFORE AND AFTER QUAKE PROFILES OF PAVEMENT SHOWN IN PHOTO 50.

Photo 50. Looking northerly at undulating pavement of Route 5 caused by differential settlement. Balboa Boulevard Overcrossing structure is in background.

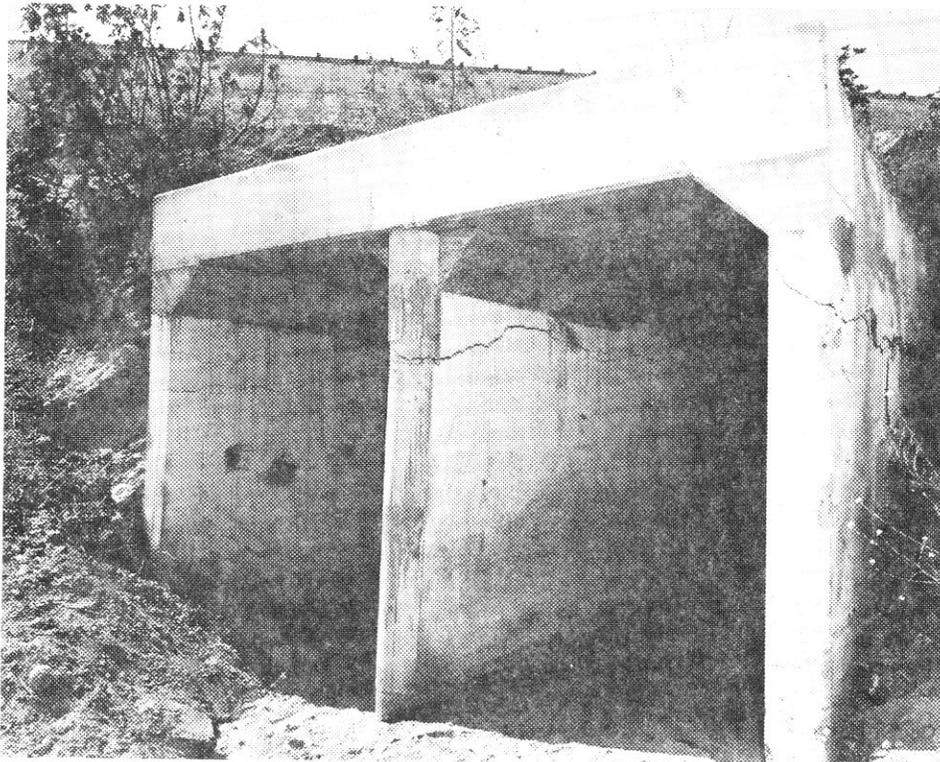
The conduit at this location is a double reinforced concrete box 6 feet wide by 11 feet high at the outlet (south end). Fill height over the southerly portion of the box was about 65 feet. Vertical members of the box experienced cracking as shown in Photo 68 that extended into the box for a distance of about 200 feet.

Photo 68. Cracking in reinforced concrete double box culvert. Note vertical members are out of plumb.

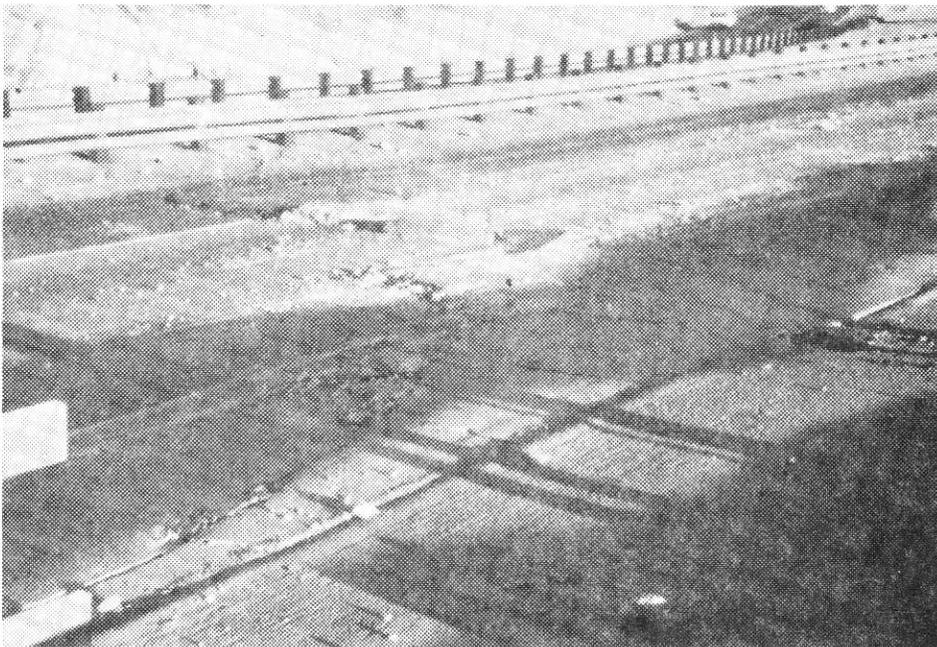
Photo 75. Closer view of pavement damage shown in Photo 74.

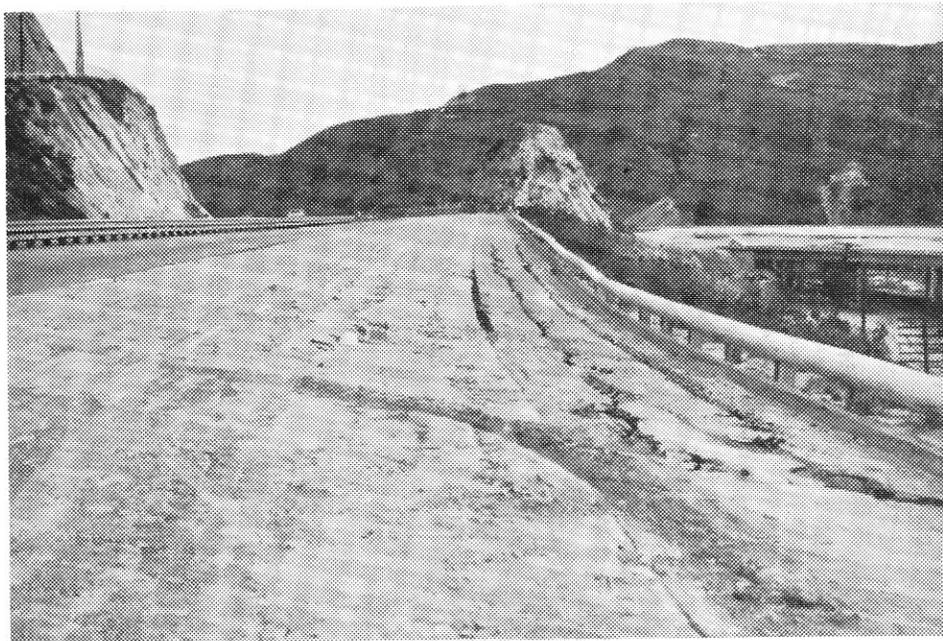
Minor compression spalling occurred at the construction joints in a retaining wall that separates the railroad from highway embankment. The fill supported by the wall slumped and longitudinal cracking occurred in the roadway, as shown in Photo 76.

Photo 76. Longitudinal cracking in pavement due to lateral movement at top of cantilever retaining wall. Pavement has been broken mechanically for removal.

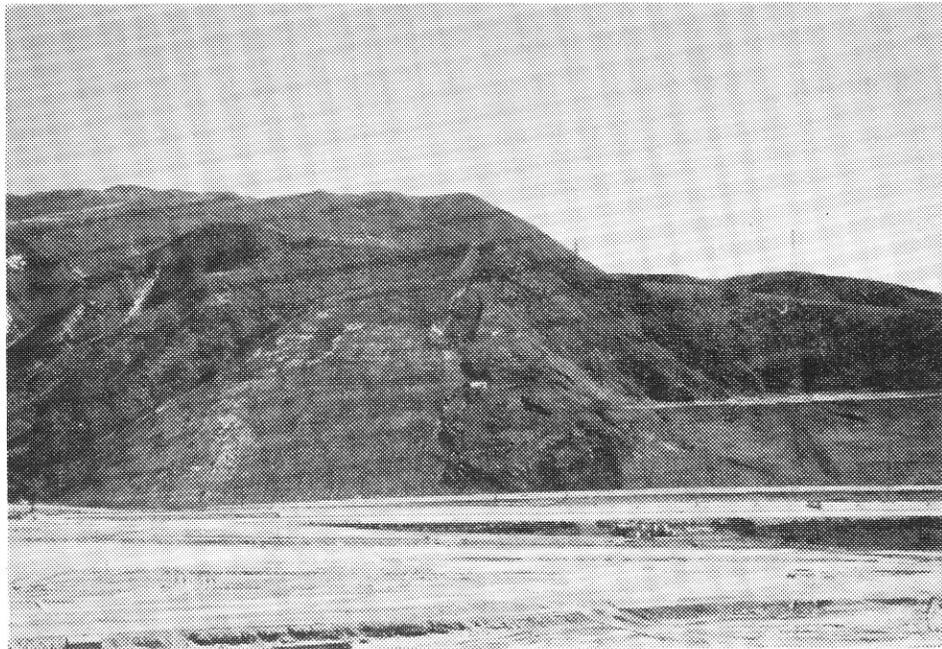
A slump landslide that occurred in a cut slope is shown in Photos 69 (upper right) and 79. The slide, which did not encroach upon the roadway, occurred in a clayey silt with a high moisture content.

Photo 79. Looking easterly at a slide in a cut slope, immediately south of the Route 5/14 Interchange.

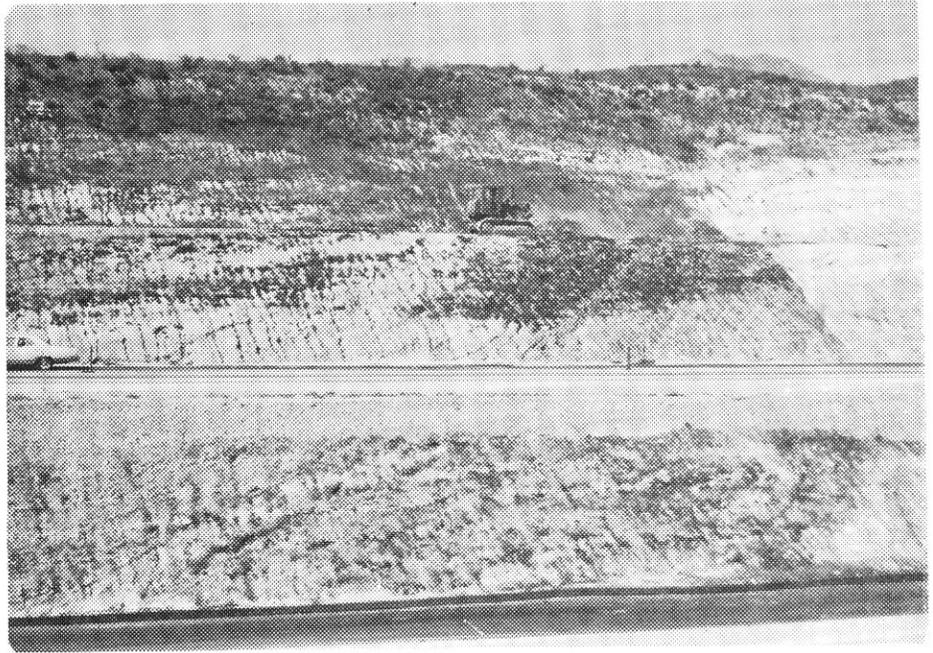
Photo 80. Looking easterly at quake-activated ancient slide in cut slope.

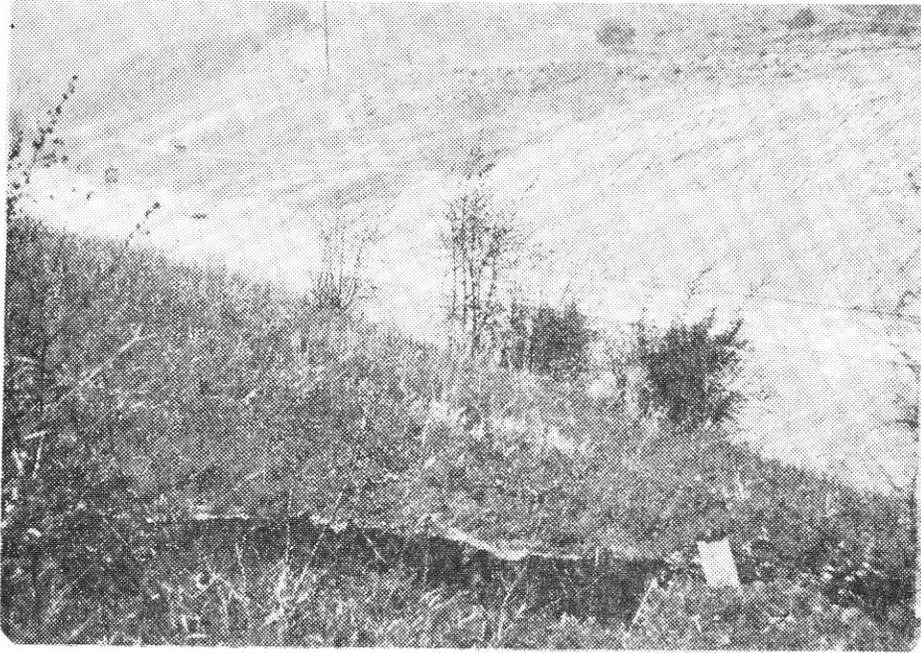
Further north, a cut slope on the east side of the highway had ground breakage behind the top of cut as shown in Photos 82 and 83.

Photo 82. Ground breakage at top of cut slope on east side of Route 5.

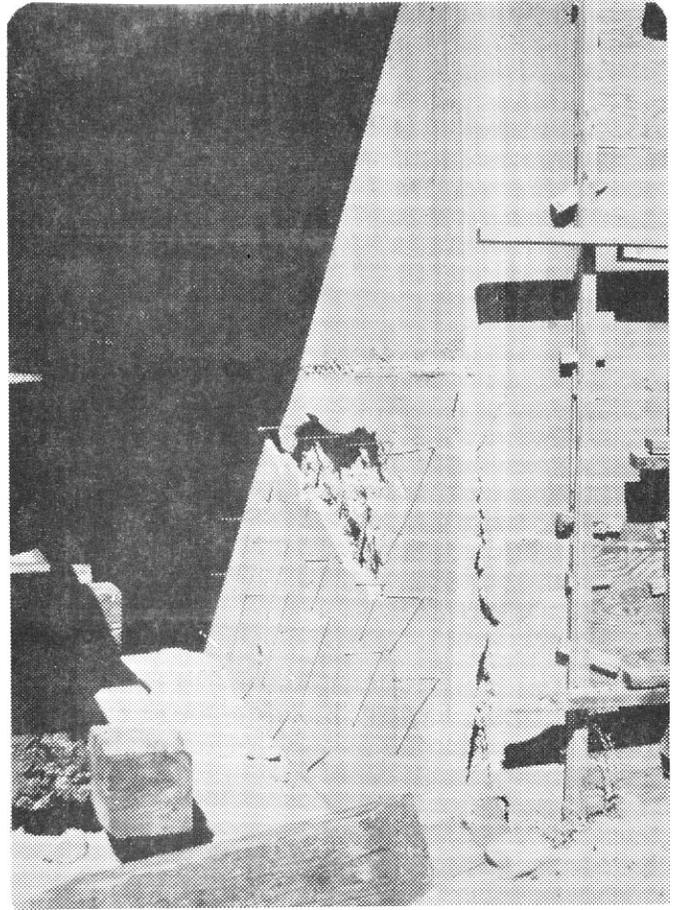
Photo 88. Typical abutment damage through the eastern portion of Route 14.

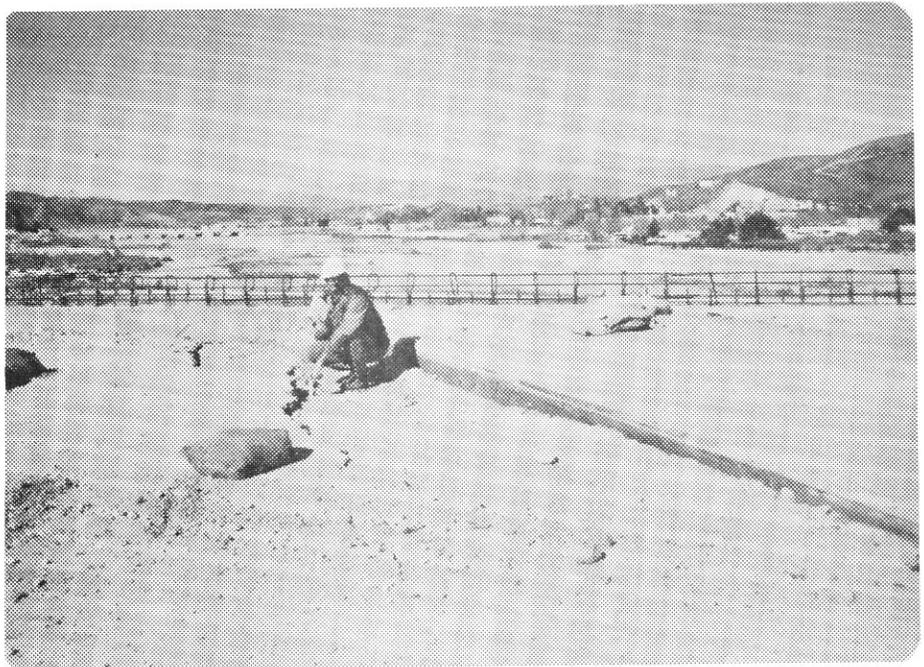
photo 89. Abutment backfill settlement at the Santa Clara River Bridge (west abutment, west-bound structure).

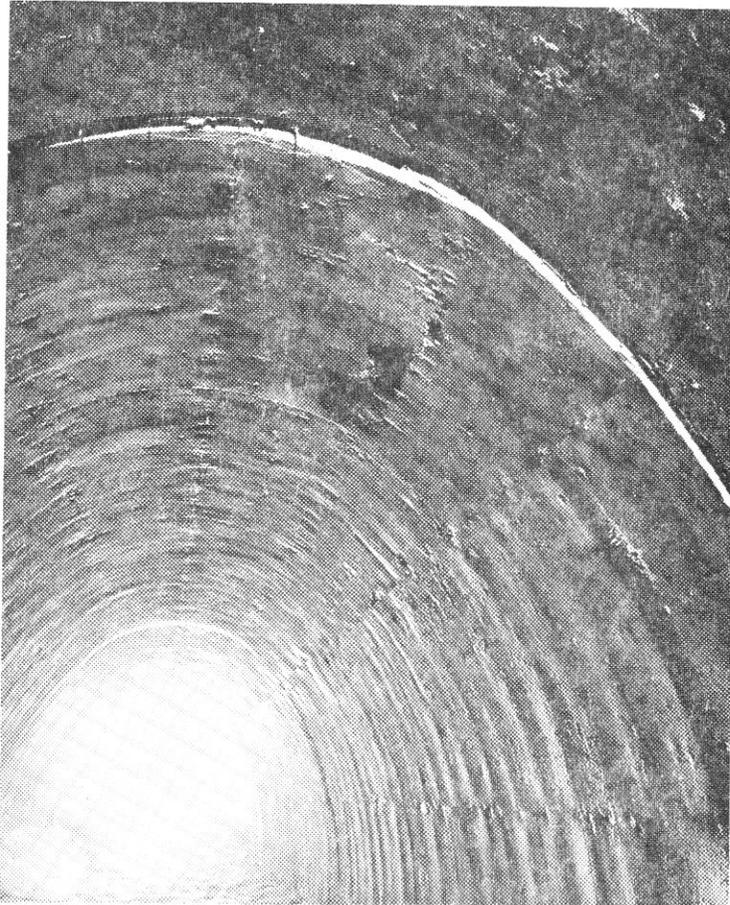
Photo 91. Minor spalling and joint separation in an 11-foot concrete arch culvert.

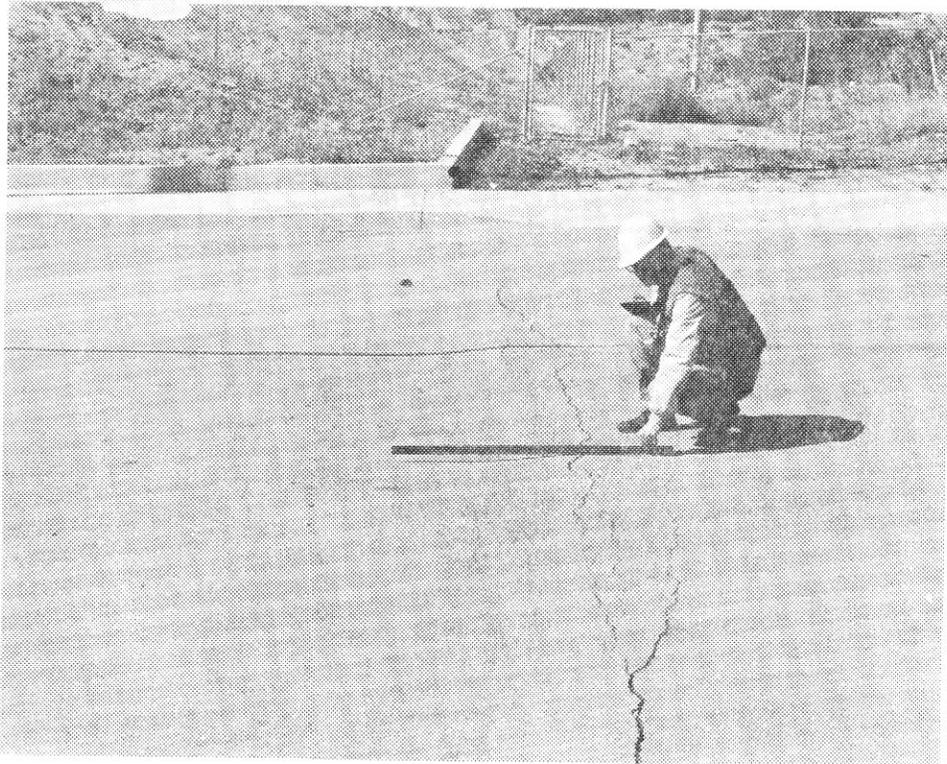
Photo 101. Looking west across Glenoaks Boulevard at tension cracks in AC pavement caused by differential settlement.

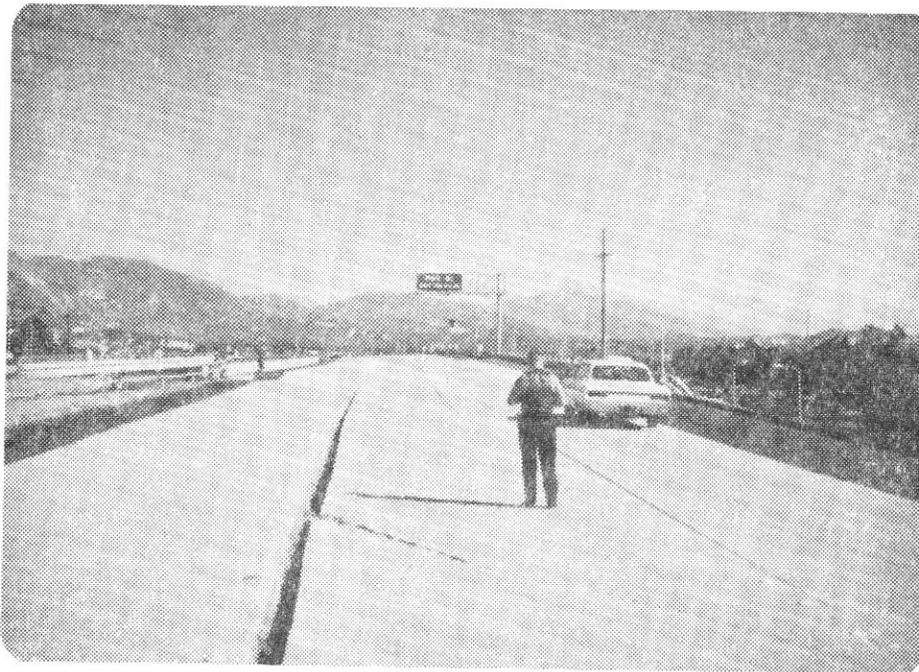
Photo 106. Looking east at Roxford Street Undercrossing. Note pavement separation at longitudinal joint and diagonal crack caused by fill slippage and differential settlement.

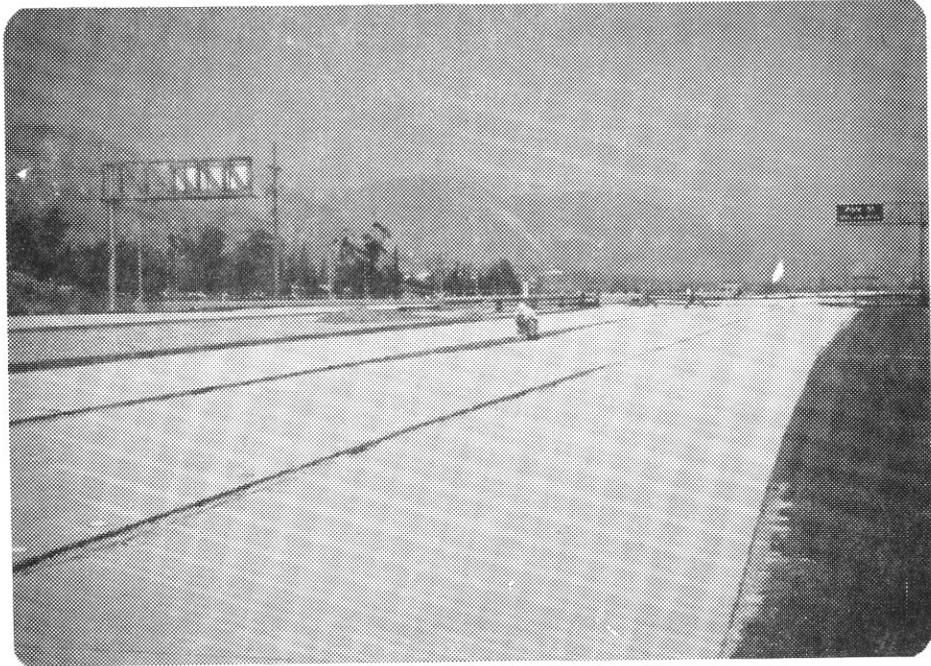
Photo 107. Same location as Photo 106. Note faulting of pavement at longitudinal joint.

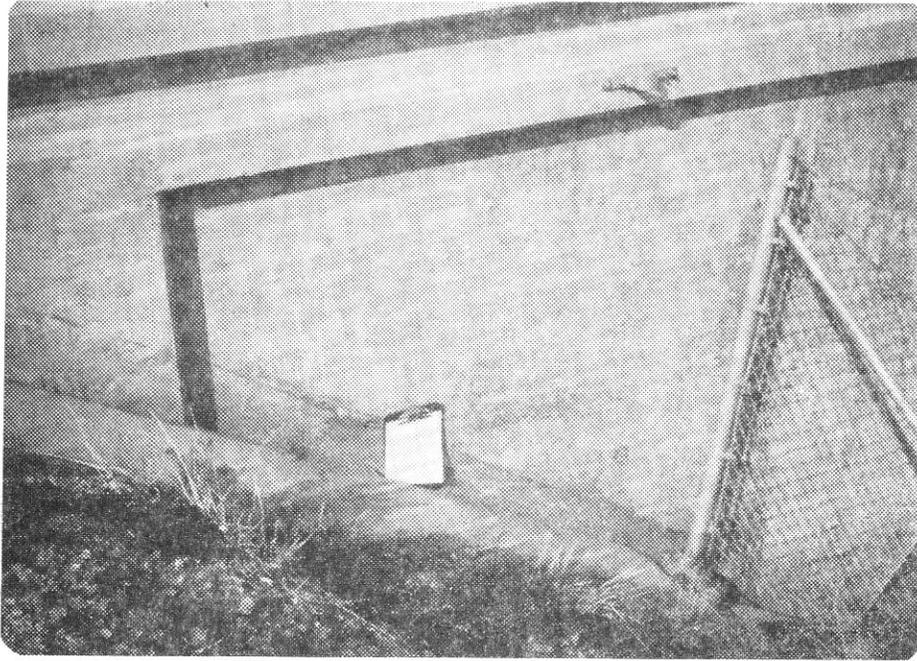
Photo 109. Wingwall at Roxford Street Undercrossing. Note fill settlement relative to structure as delineated by staining on wall.

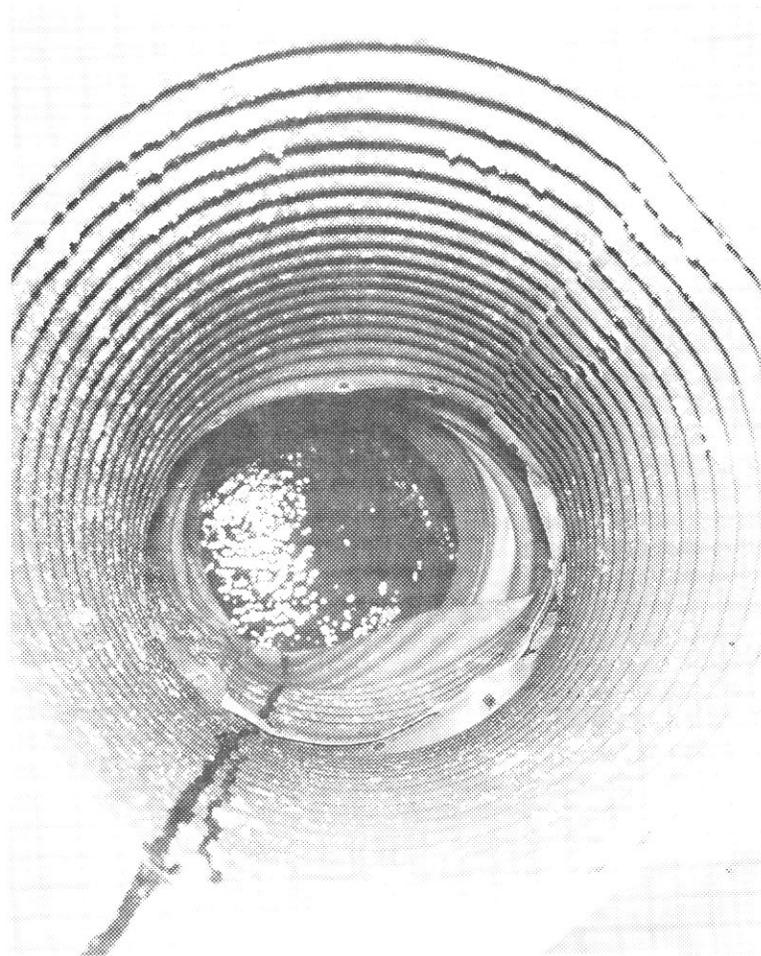
Photo 111. Compression wrinkling of vertical CMP down drain caused by shearing forces during fill settlement.

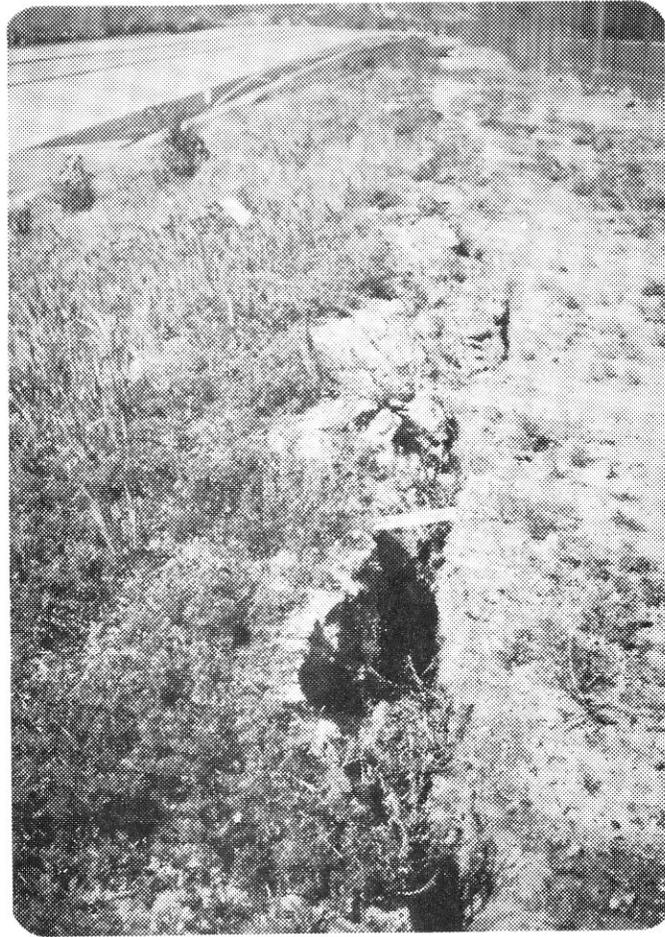
Photo 118. Looking west at cracks along top of cut slope.

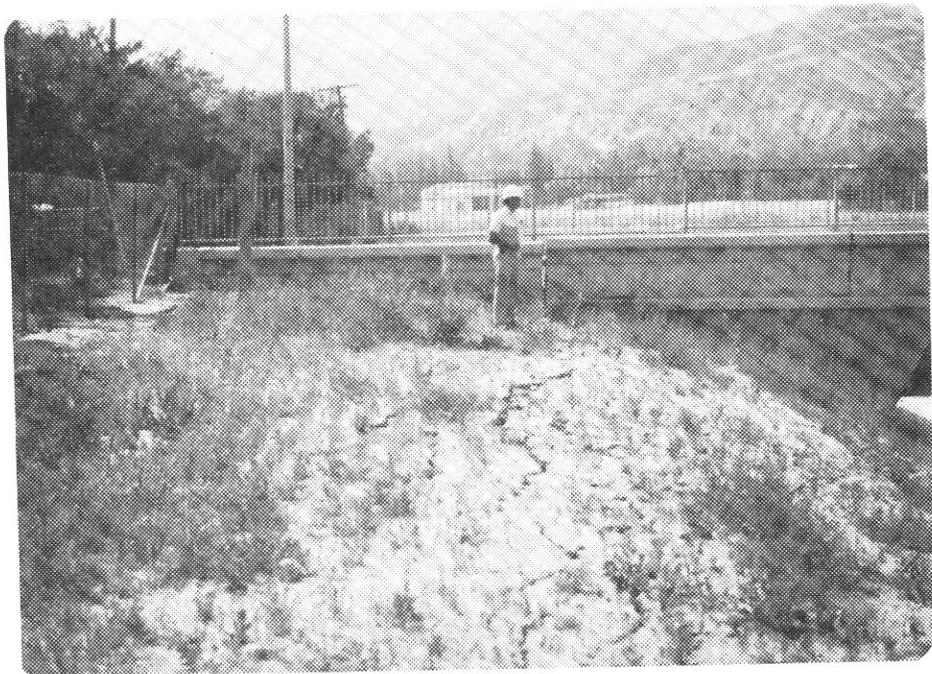
Photo 122. Looking west at southern end of Bledsoe Street Overcrossing. Note cracks in cut slope and settlement of wingwall relative to structure.

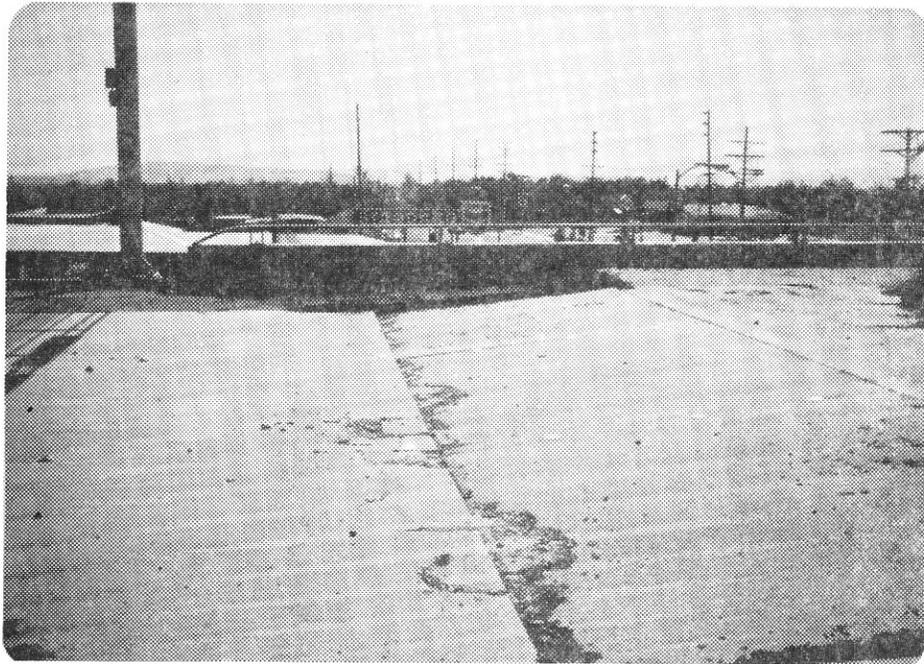
Photo 128. East approach of eastbound structure of Polk Street Undercrossing. Note approach slab spalling along transverse joint.

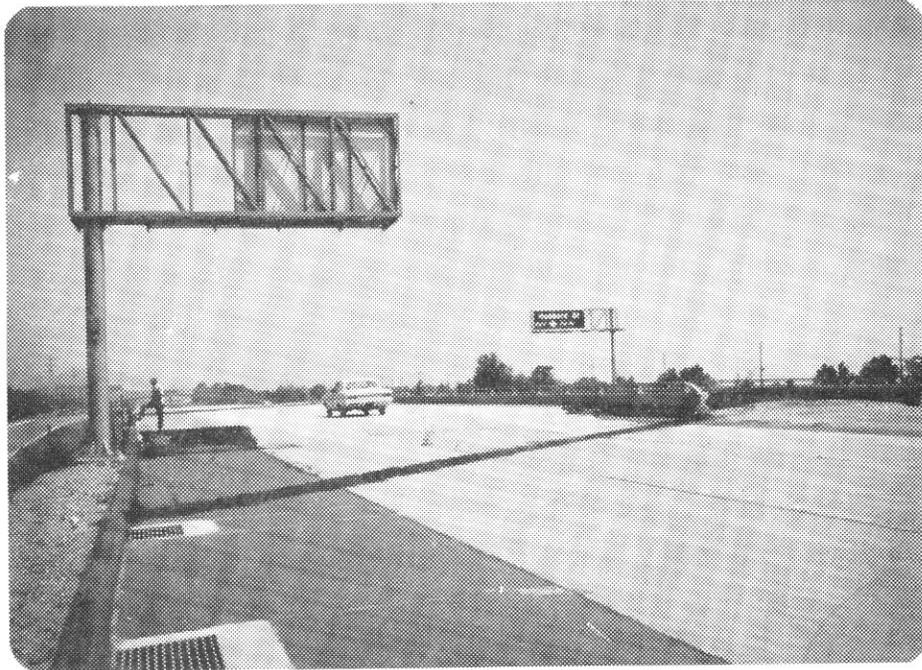
Photo 129. Westbound lanes at Polk Street Undercrossing. Note slab separation at joints.

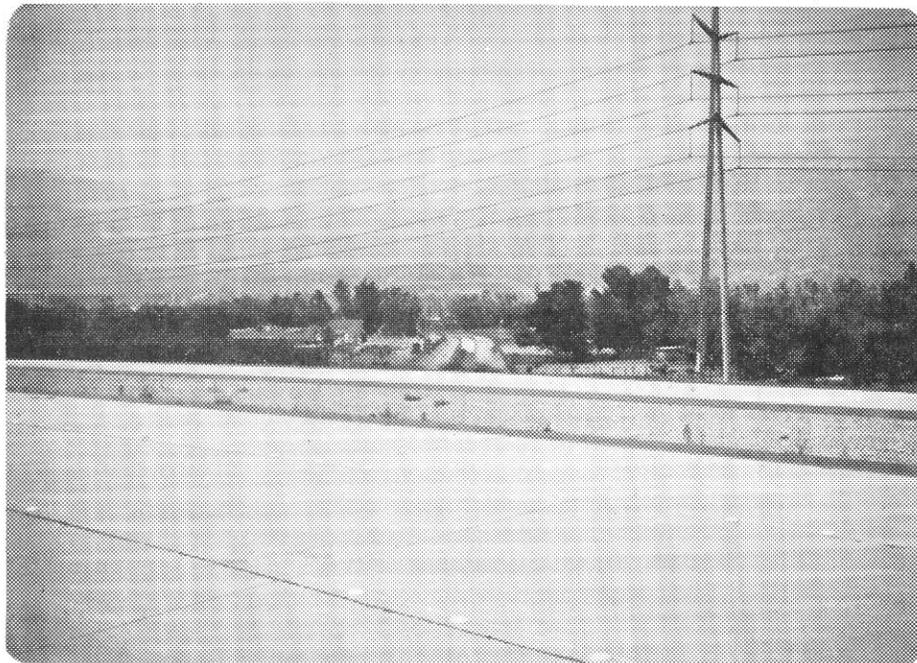
Photo 130. Eastbound lanes at Polk Street Undercrossing. Further examples of slab separation at joints.
