REPORT NO. FHWA/CA/TL-80/17

ROADWAY DAMAGE DURING THE SAN FERNANDO, CALIFORNIA EARTHQUAKE OF FEB. 9, 1971

FEB., 1981

6. PERFORMING ORGANIZATION CODE		
7. AUTHOR(S) R. H. Prysock and J. P. Egan, Jr.			8. PERFORMING ORGANIZATION REPORT NO. 19305-632119		
9. PERFORMING ORGANIZATION NAME AND ADDRESS Office of Transportation Laboratory California Department of Transportation Sacramento, California 95819			10. WORK UNIT NO.

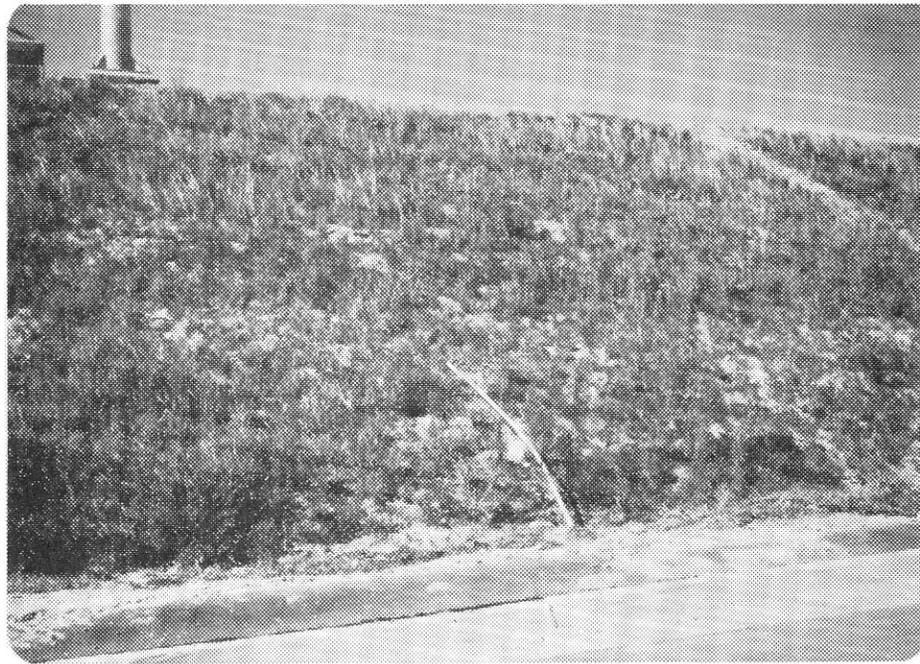
Photo 131. West approach fill to Polk Street structure. Note conduit that was forced out of slope as fill settled.

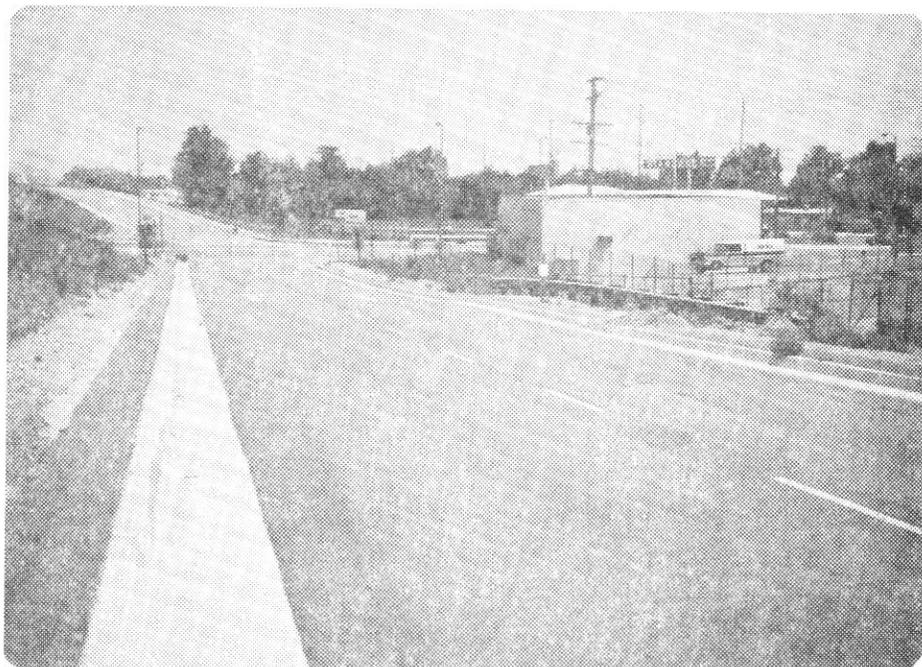
Photo 133. Eastbound off ramp to Polk Street. Note "hump" in pavement over underlying drainage structure.

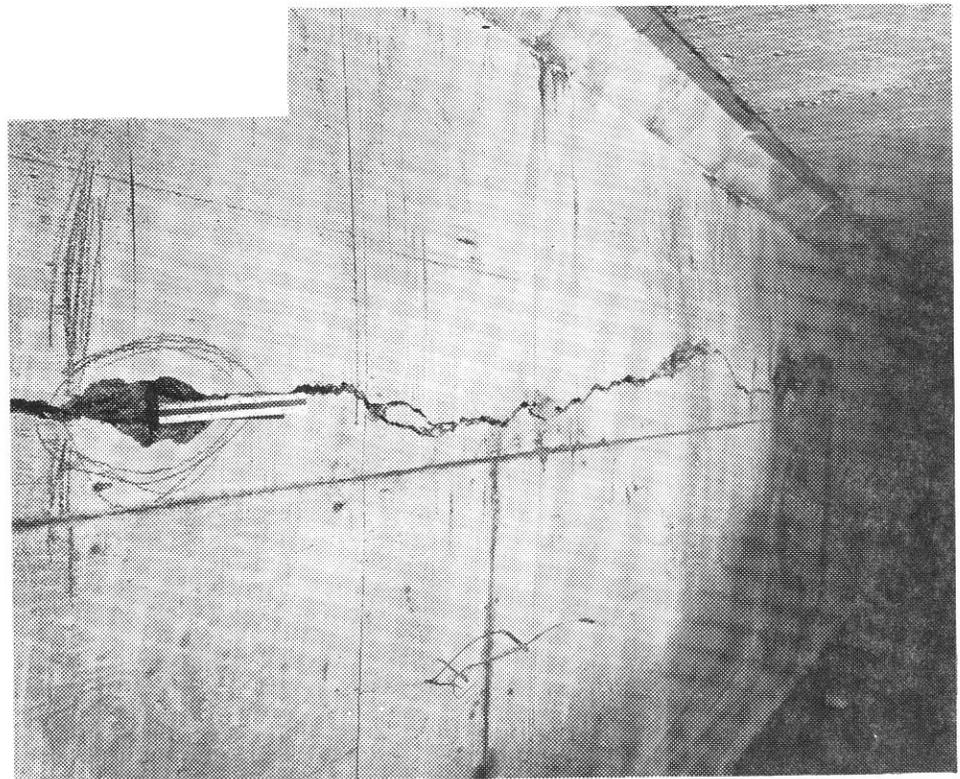
Photo 135. Crack in drainage structure of Photo 134.

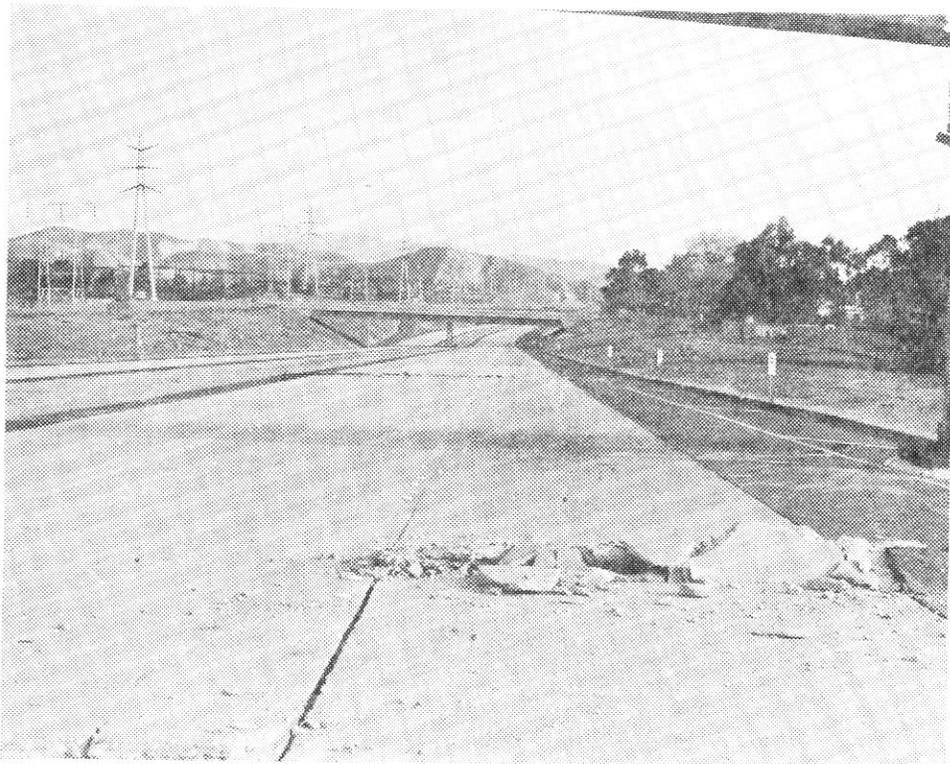
Photo 136. Looking east at compression features in pavement slabs. Note spalling occurred only in one lane.

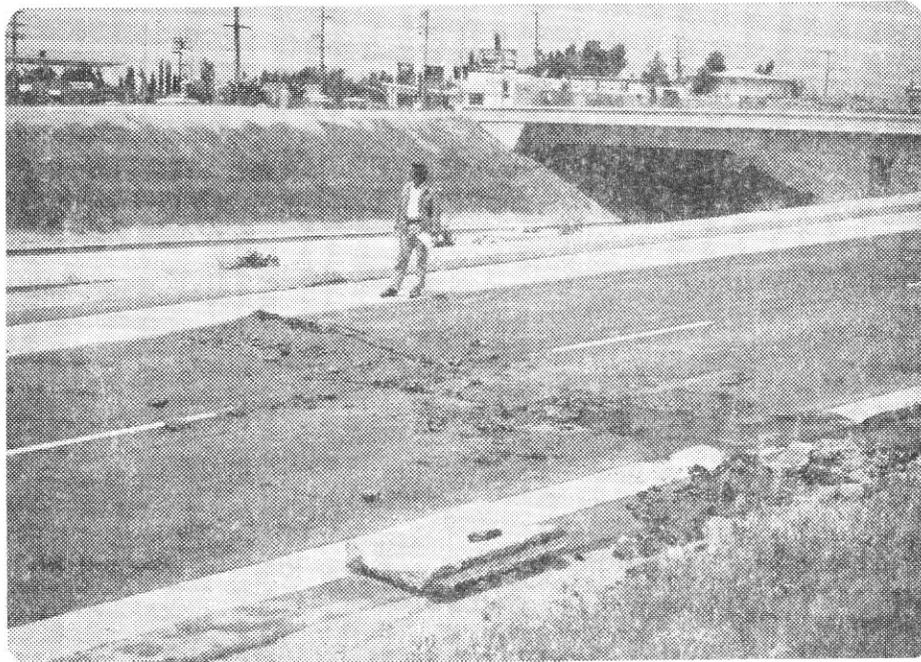
Photo 143. Compression buckle in westbound off ramp to Hubbard Street. Note PCC curb and gutter near freeway was unaffected whereas other curb and gutter section buckled.

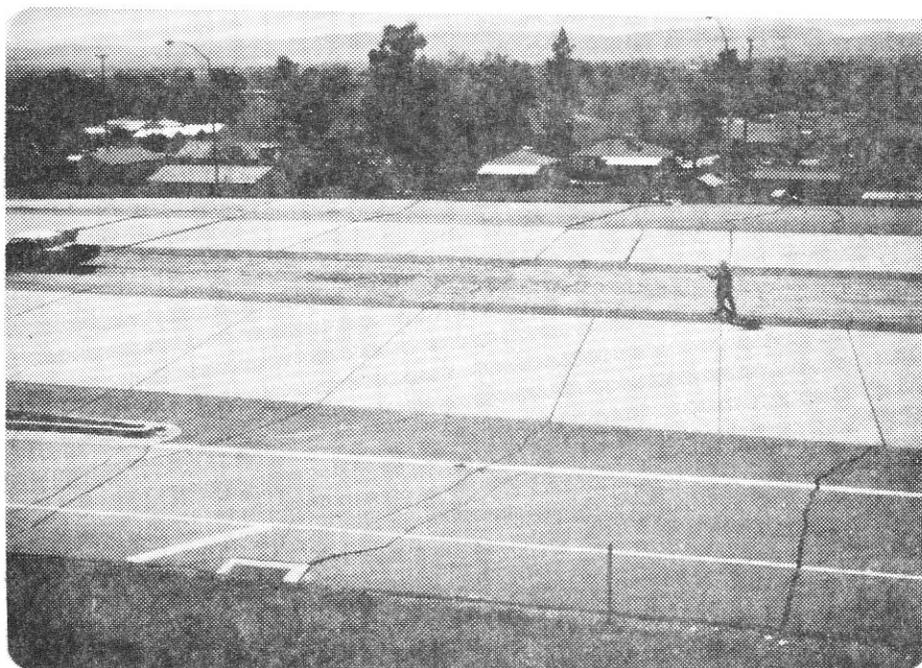
Photo 151. Looking south at cracks and slab separation through fault zone.

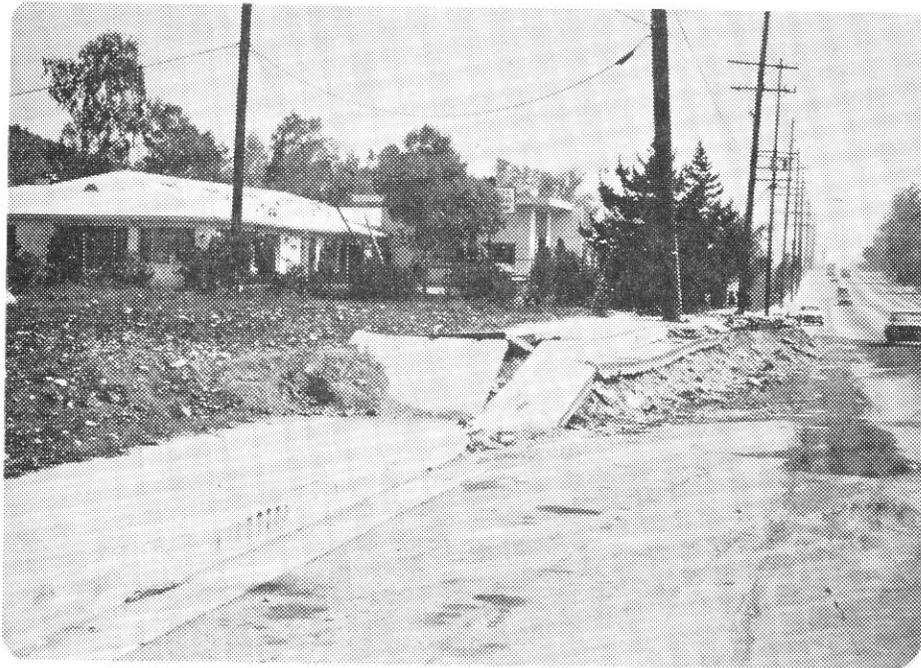
Photo 152. Faulting and ground upheaval adjacent to Foothill Boulevard. Route 210 is off photo to left.

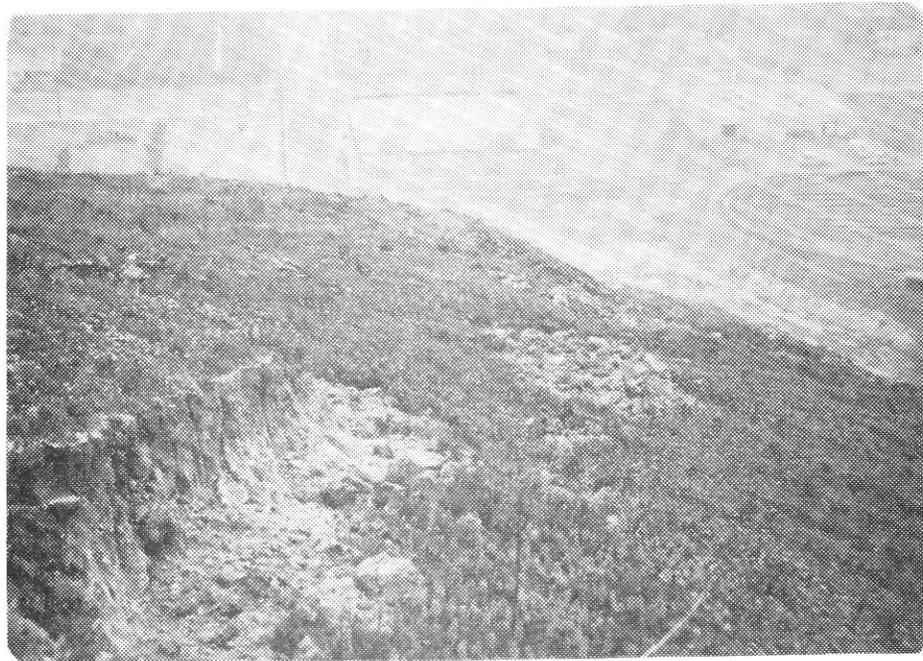
Photo 155. Cracking and displacement in slopes of hills shown in Photo 152.

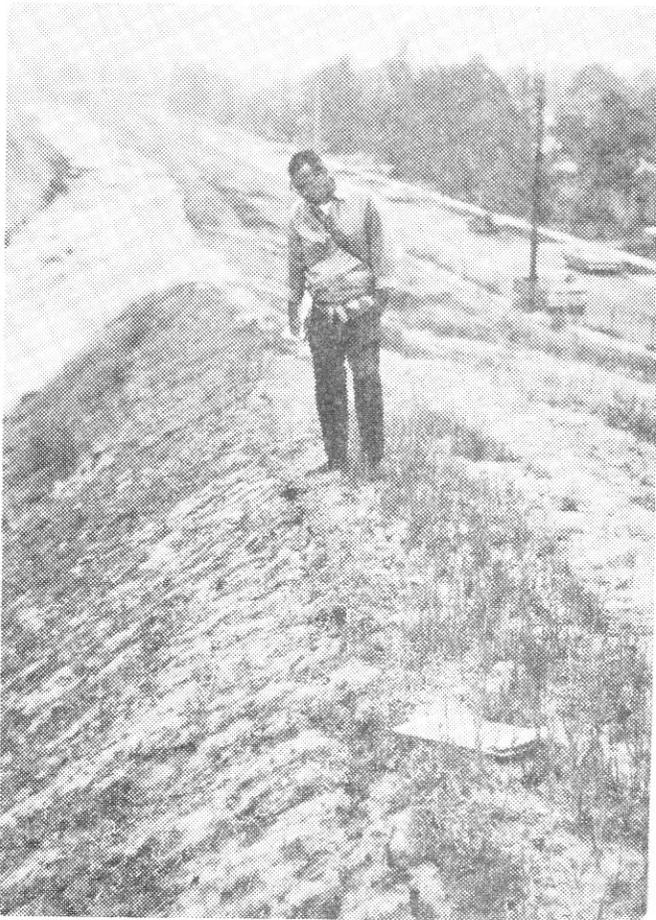
Photo 156. Cracking along hinge point of Route 118 stage construction fill.

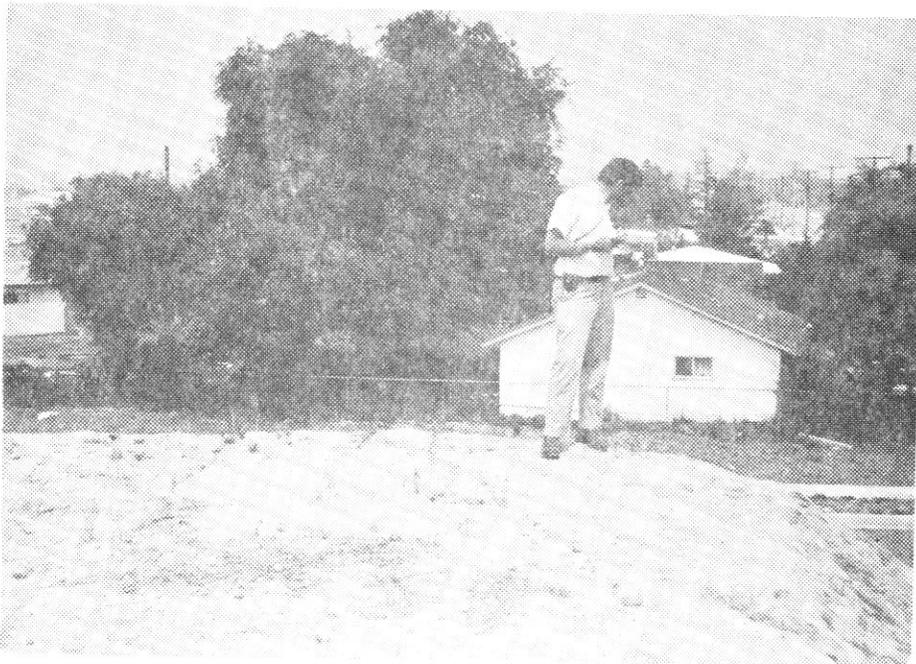
Photo 157. Typical cracking at corner of Route 118 approach fill.

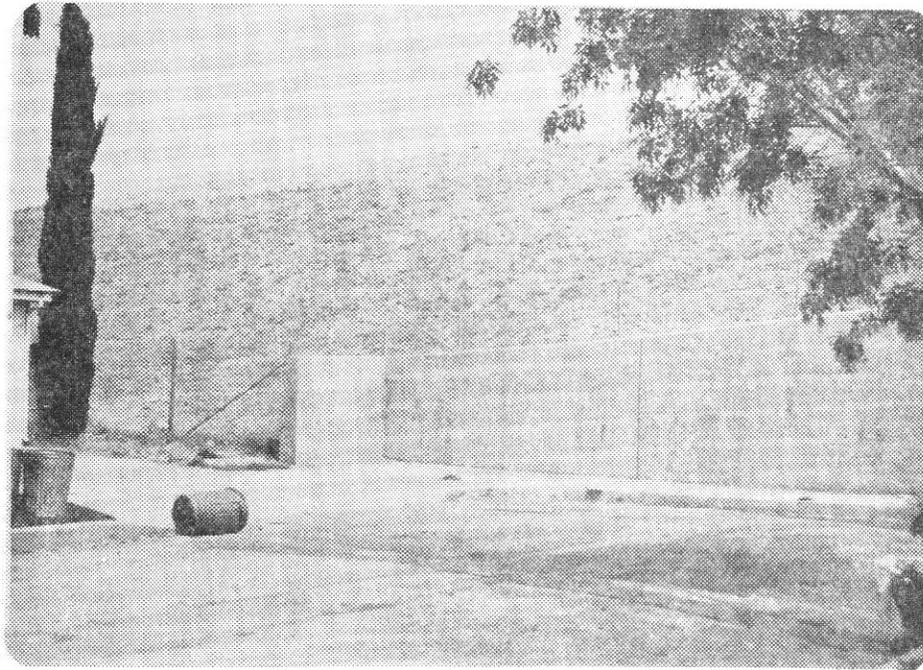
Photo 160. Retaining wall was undamaged but lateral forces transmitted through sidewalk cracked curb.
