INFORMATION HANDOUT

CALIFORNIA DEPARTMENT OF TRANSPORTATION (CALTRANS)
PLUMAS SR 70 METAL BEAM GUARDRAIL REPAIR PROJECT

Subject: Foundation Report for Wall Location 15

02-PLU-70 PM 1.67/1.68 (LOCATION 15)
Foundation Report

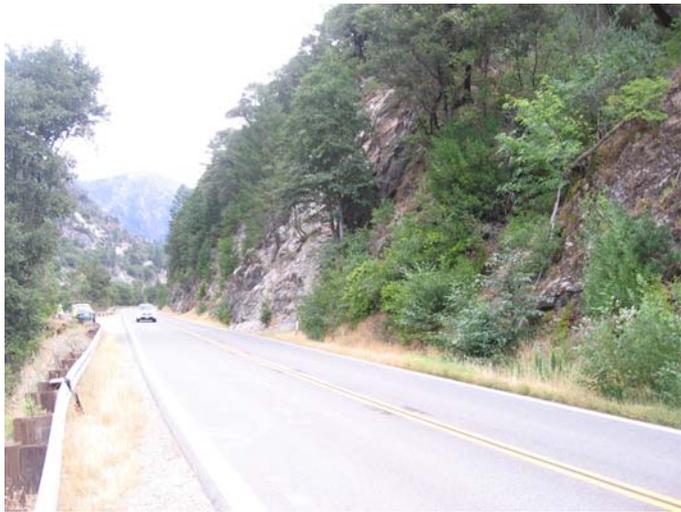
Photo No. 1. Route 70 at Location 15; looking northerly; photo date 9-9-10.

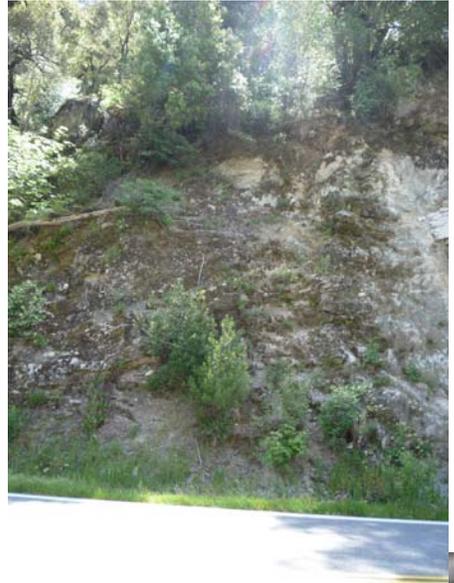
Photo No. 2. Rock cut slope, opposite of proposed Location 15 wall; right of approx. STA "A1" 88+80; photo date 5-19-09.

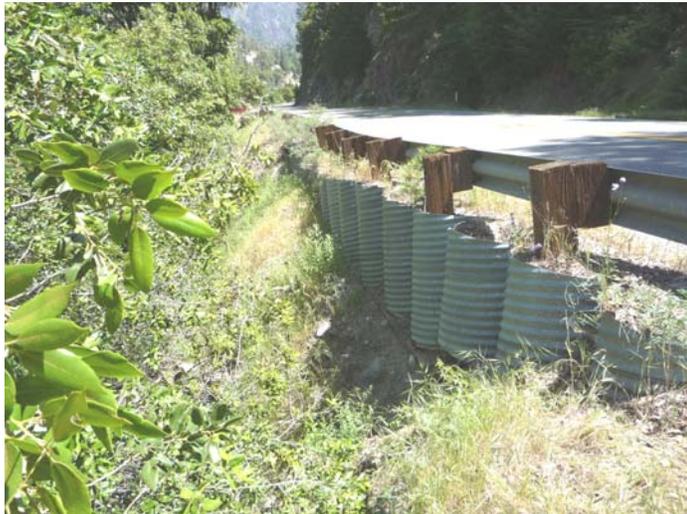
Photo No. 3. Can-wall at Location 15; viewing northerly; photo dated 5-19-09.

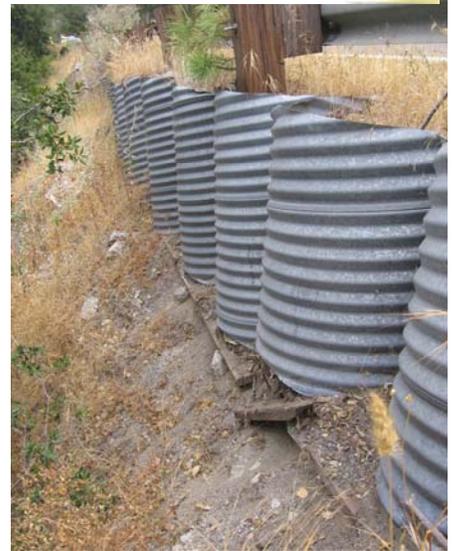
Photo No. 4. Can-wall at Location 15; viewing northerly; note deteriorating timber footings and undermining; photo dated 9-9-10.

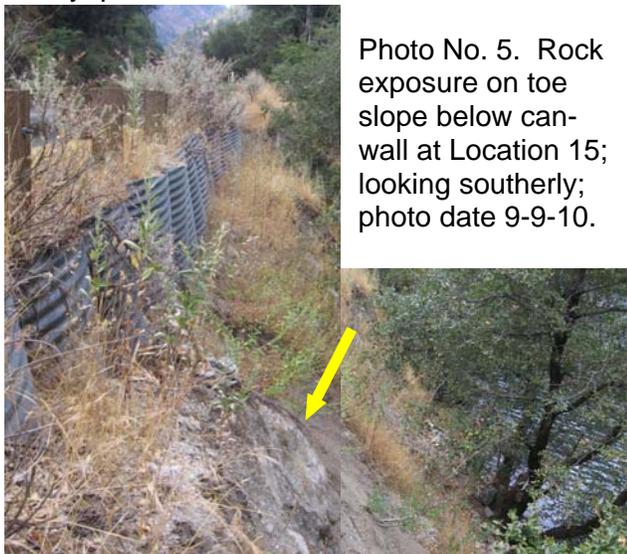
Photo No. 5. Rock exposure on toe slope below can-wall at Location 15; looking southerly; photo date 9-9-10.

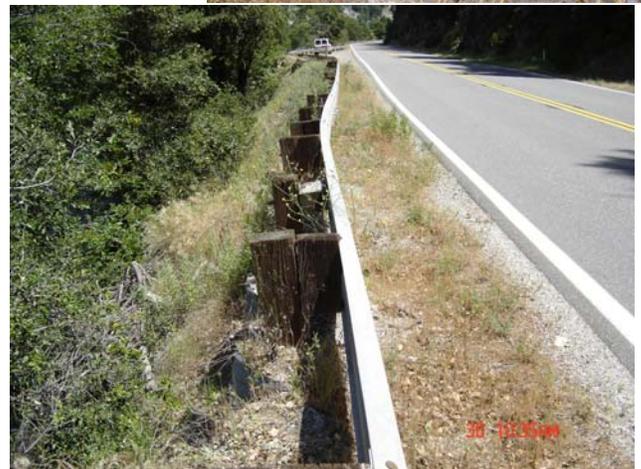
Photo No. 6. Bent MBGR and tilting posts atop can-wall at Location 15; viewing northerly; photo date 5-19-09.

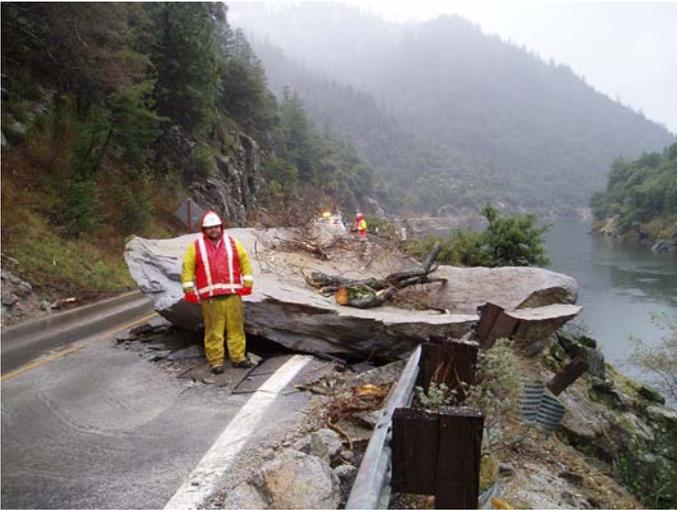
Photo No. 1. Rockfall rock flake at PM 2.73; looking south; photo date 12-7-04.

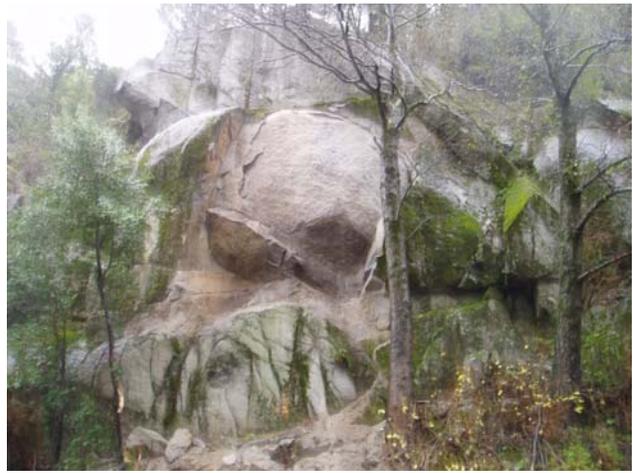
Photo No. 2. Rock flake source on rock slope above roadway (PM 2.73); photo date 12-7-04.

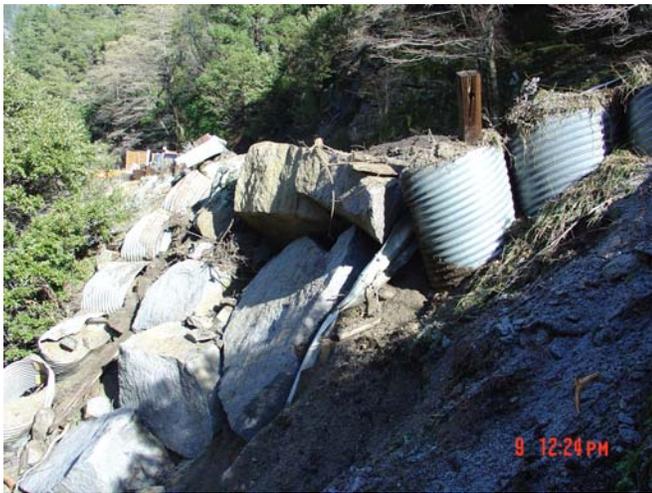
Photo No. 3. Damaged can-wall at PM 2.73 (Location 33); photo dated 12-9-04.

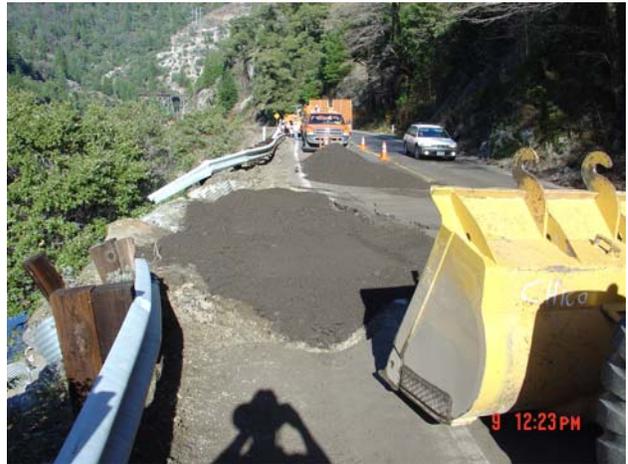
Photo No. 4. Roadway repair of crater from rock flake impact; looking north; photo date 12-9-04.

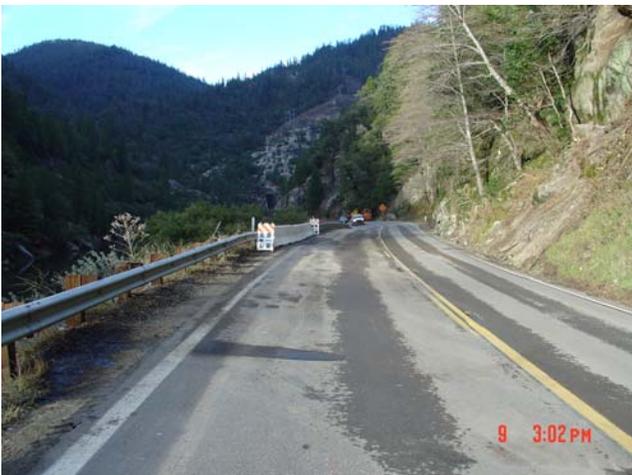
Photo No. 5. Repaired roadway and K-rail at rock flake impact location (PM 2.73); looking north; photo date 12-9-04.

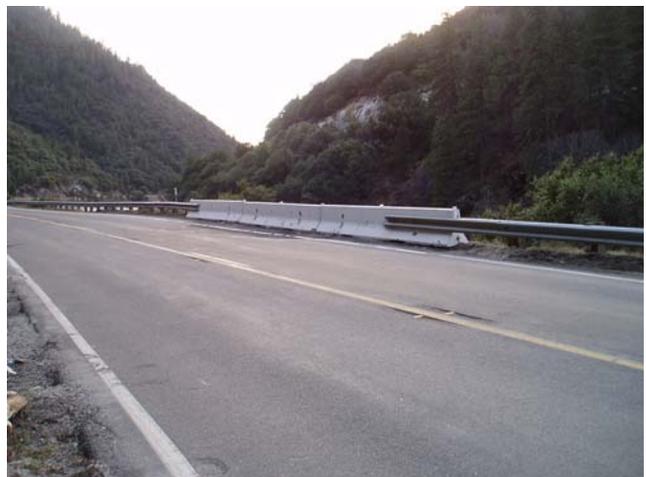
Photo No. 6. Repaired roadway and K-rail at rock flake impact location (PM 2.73); looking southwest; photo date 12-14-04.

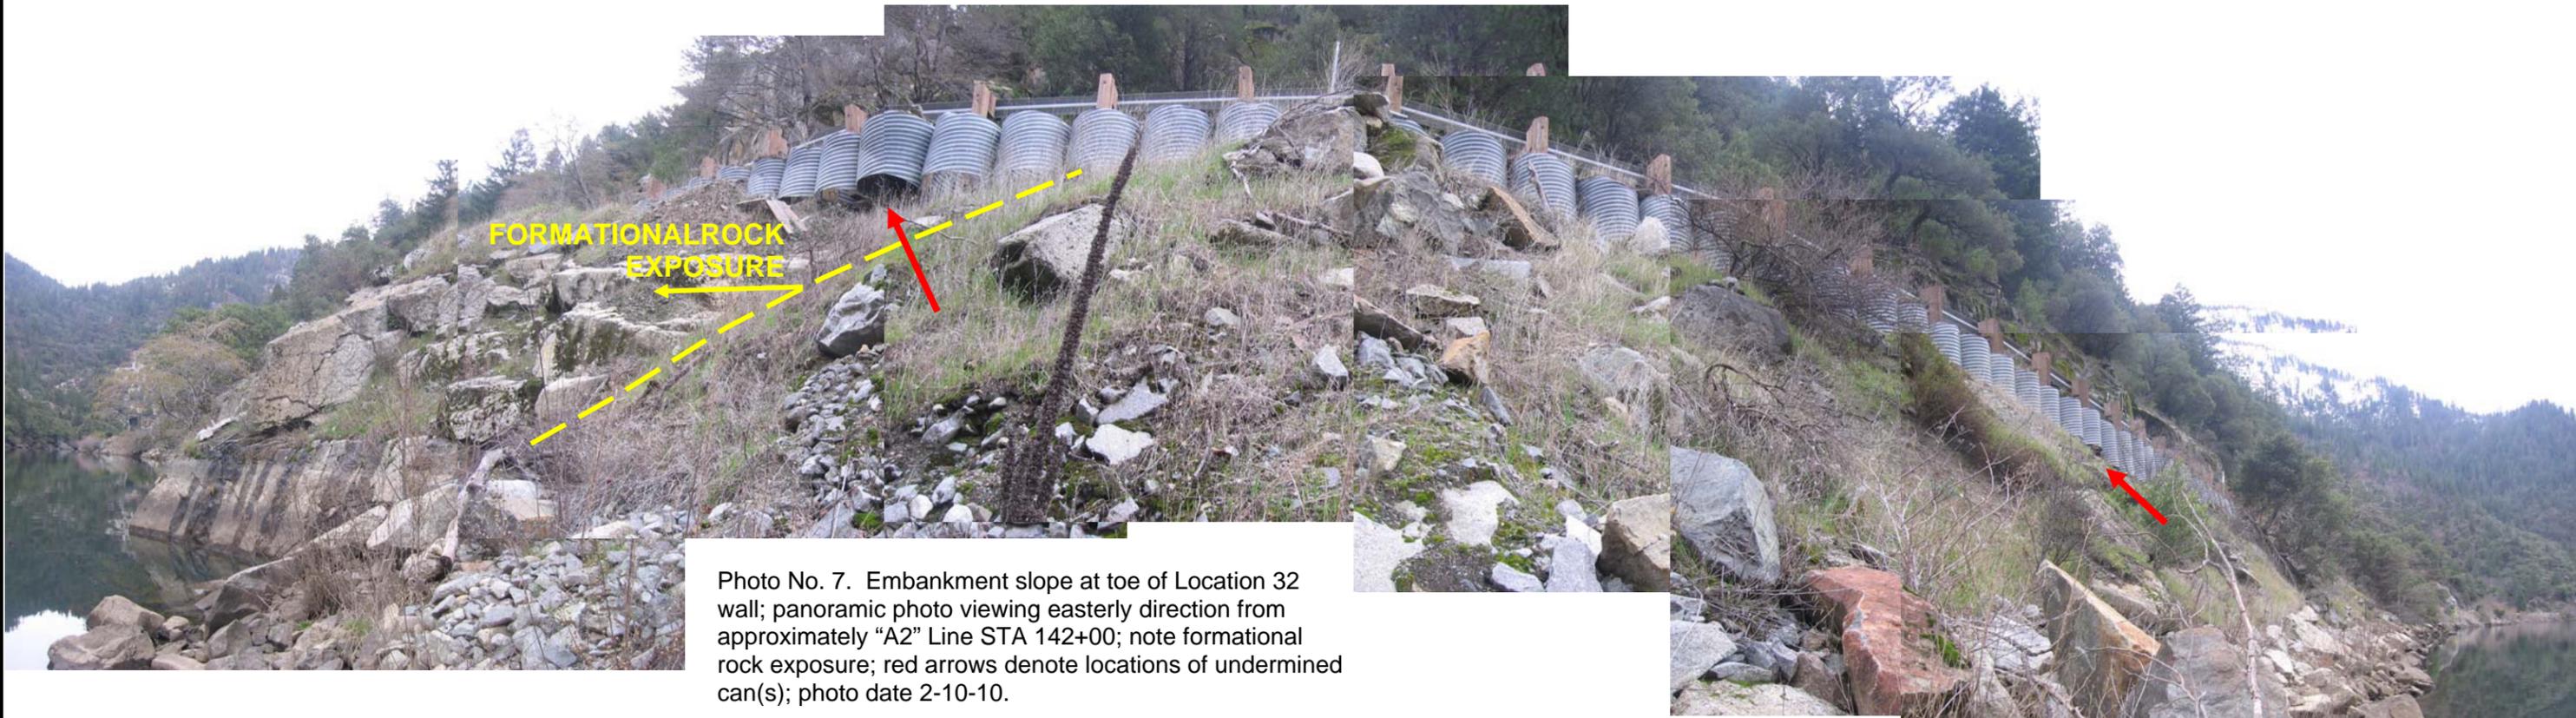
Photo No. 7. Embankment slope at toe of Location 32 wall; panoramic photo viewing easterly direction from approximately "A2" Line STA 142+00; note formational rock exposure; red arrows denote locations of undermined can(s); photo date 2-10-10.

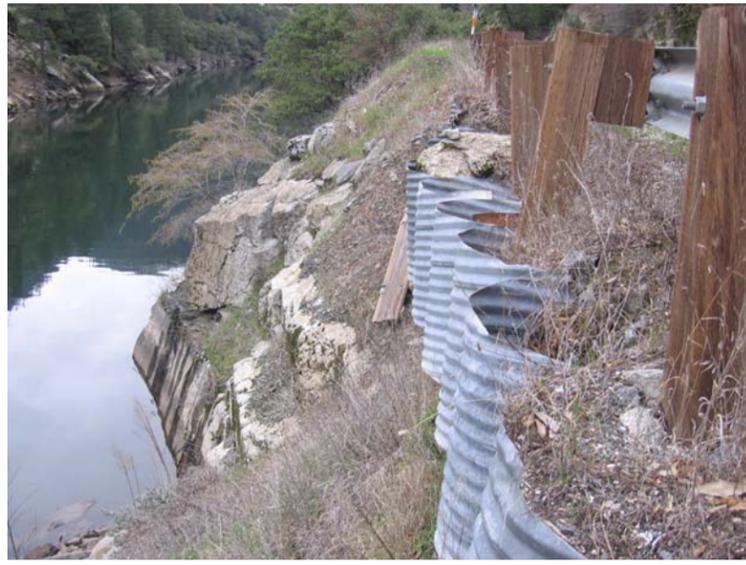
Photo No. 8. Toe Slope "A2" Line approximately STA 142+00; photo viewing northerly direction; note formational rock exposure; Photo date 2-10-10.

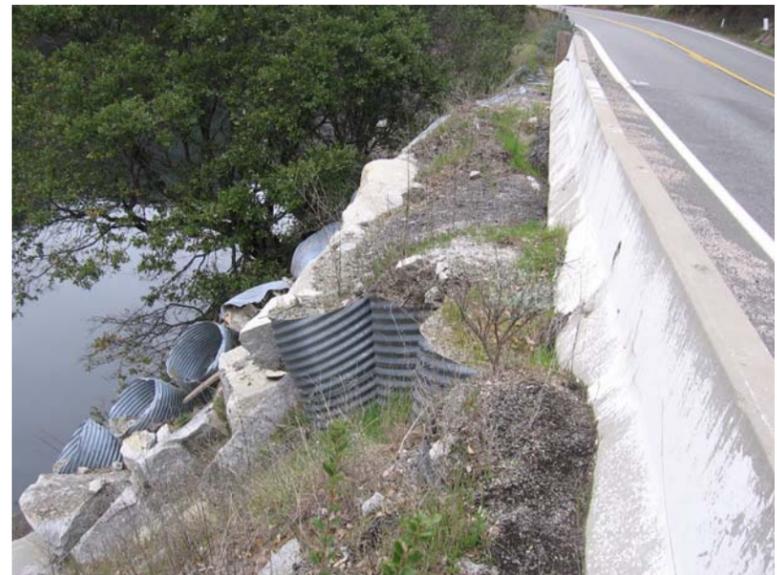
Photo No. 9. Toe slope "A2" Line approximately STA 143+00; photo viewing northerly direction; note damaged can-wall; Photo date 5-19-09.

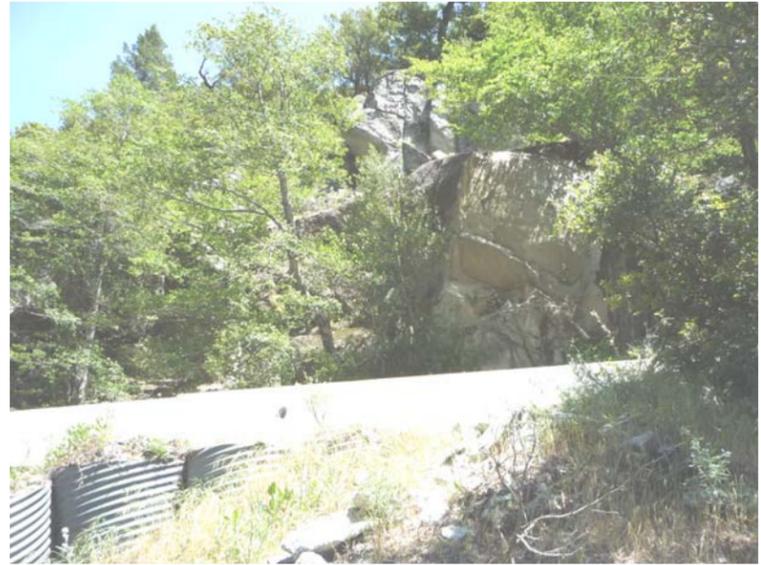
Photo No. 10. Cut slope right of "A2" Line approximately STA 143+00; photo viewing easterly direction; Photo date 5-19-09.

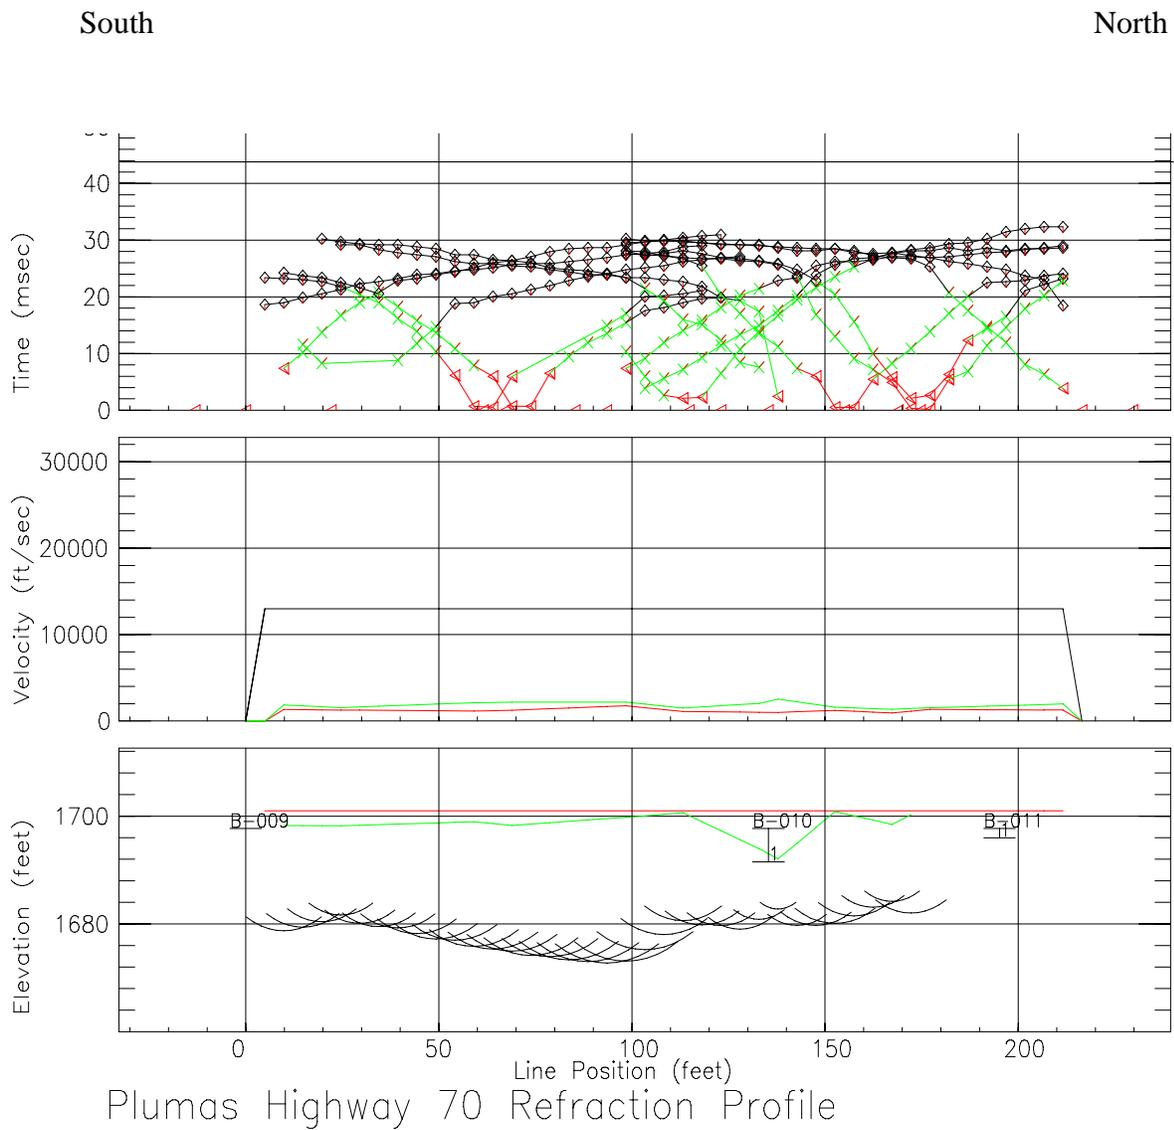
Figure 2. Travel time curve, velocity model and depth section for the seismic refraction line performed on the existing pavement from Borehole 009 through 011. Model indicates approximately 20 feet of very slow material ($V_p=200$ ft/s) above rock ($V_p=13,000$ ft/s).

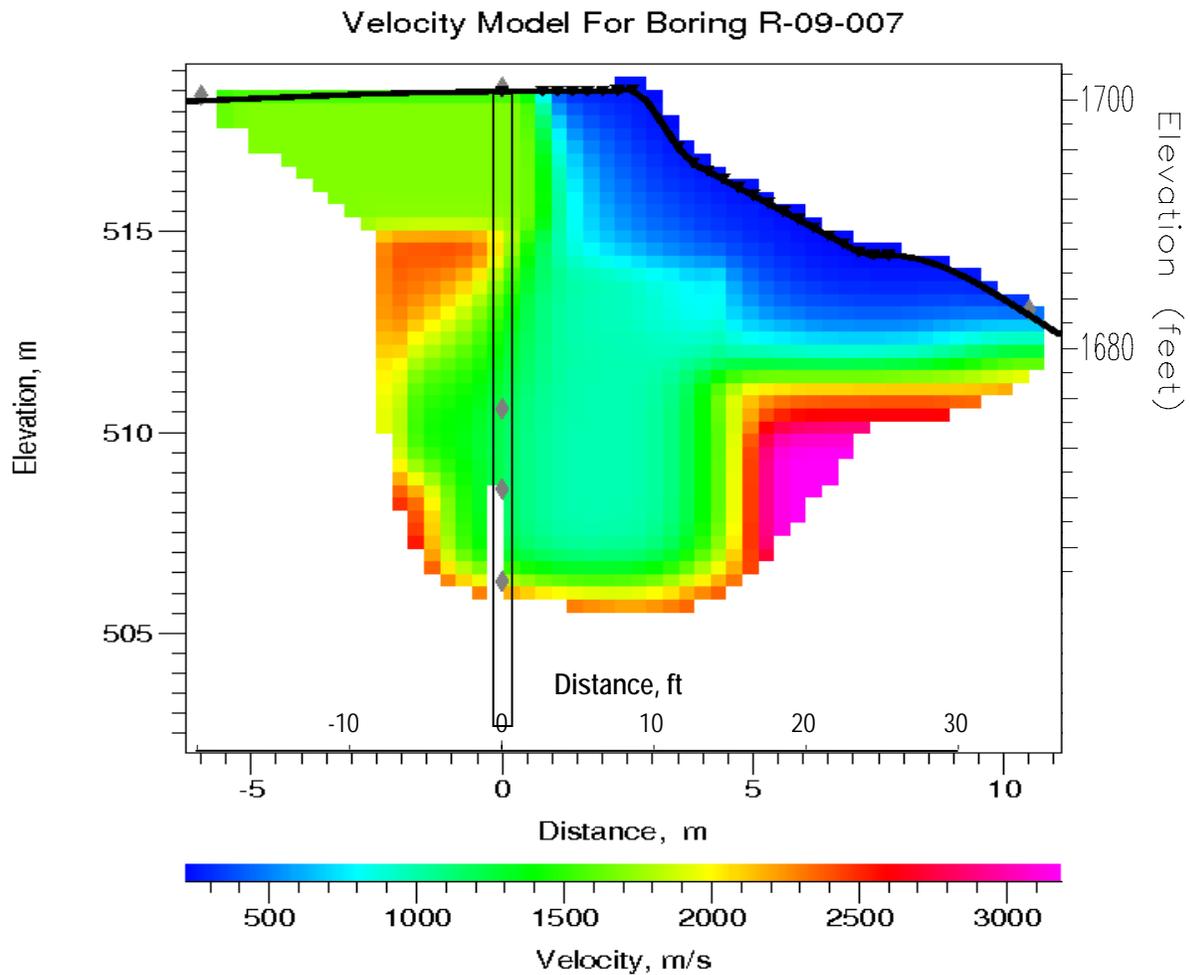
Figure 3. Velocity model for Boring R-09-007. Boring is at 0 meters as shown. Model indicates competent rock through entire borehole, and below fill, (blue color) at elevation 513.5 meters (1685 feet) at the wall location, about 3.5 m (11.5 ft) on the X axis. Shot points are shown as diamonds and the geophones are shown as small black triangles along the slope. Ground surface is the dark black line. LOTB describes hard diorite below elevation 516 m (1692.5 ft).

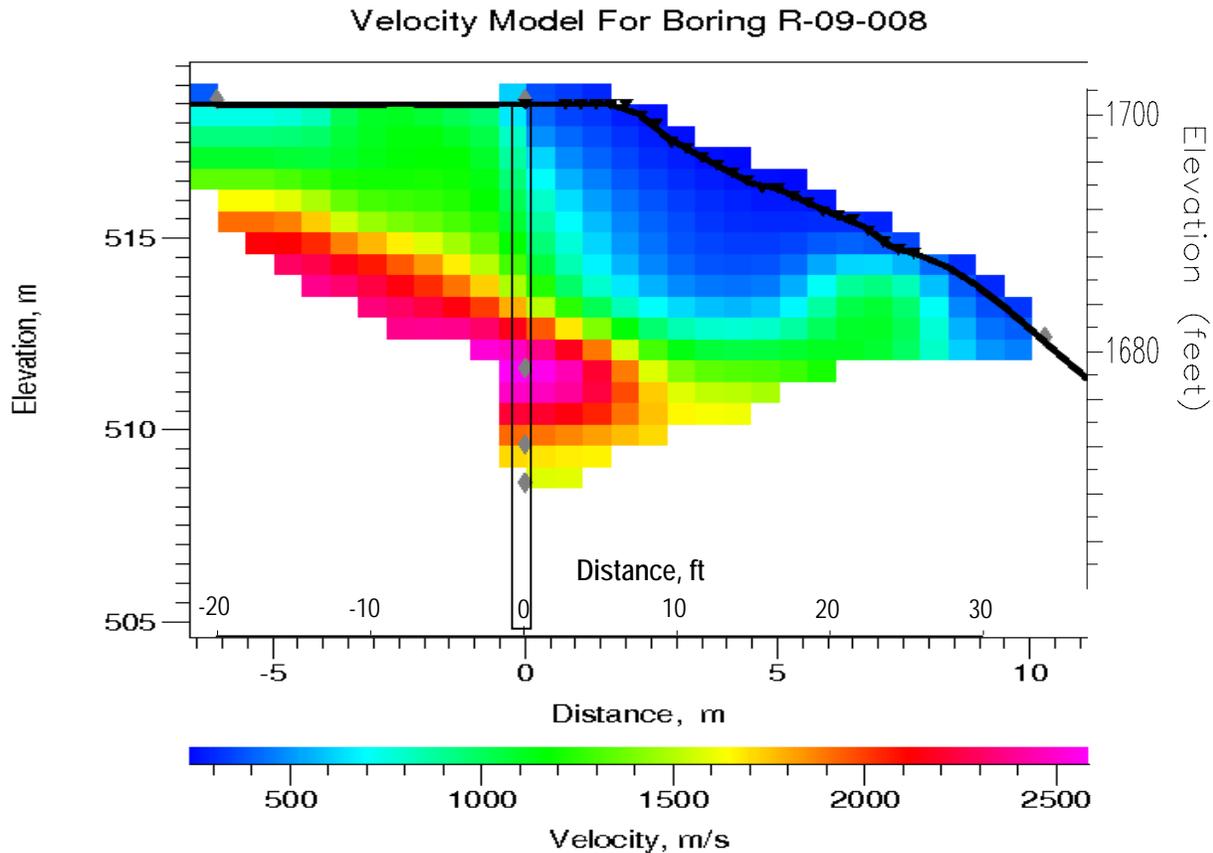
Figure 4. Velocity model of boring R09-008. Blue color is interpreted as slow boulder fill and fractured diorite. Green color interpreted as fractured diorite and red color is higher-velocity bedrock. Wall location is approximately 2.35 m (7.7 ft.) on the X axis. Shot points are shown as diamonds and geophones are shown as small black triangles. Model indicates fractured diorite at elevation 512.5 m (1681 ft) at proposed wall location. Ground surface is the black line. LOTB describes very hard, unfractured diorite below elevation 1667 ft. (508 m).

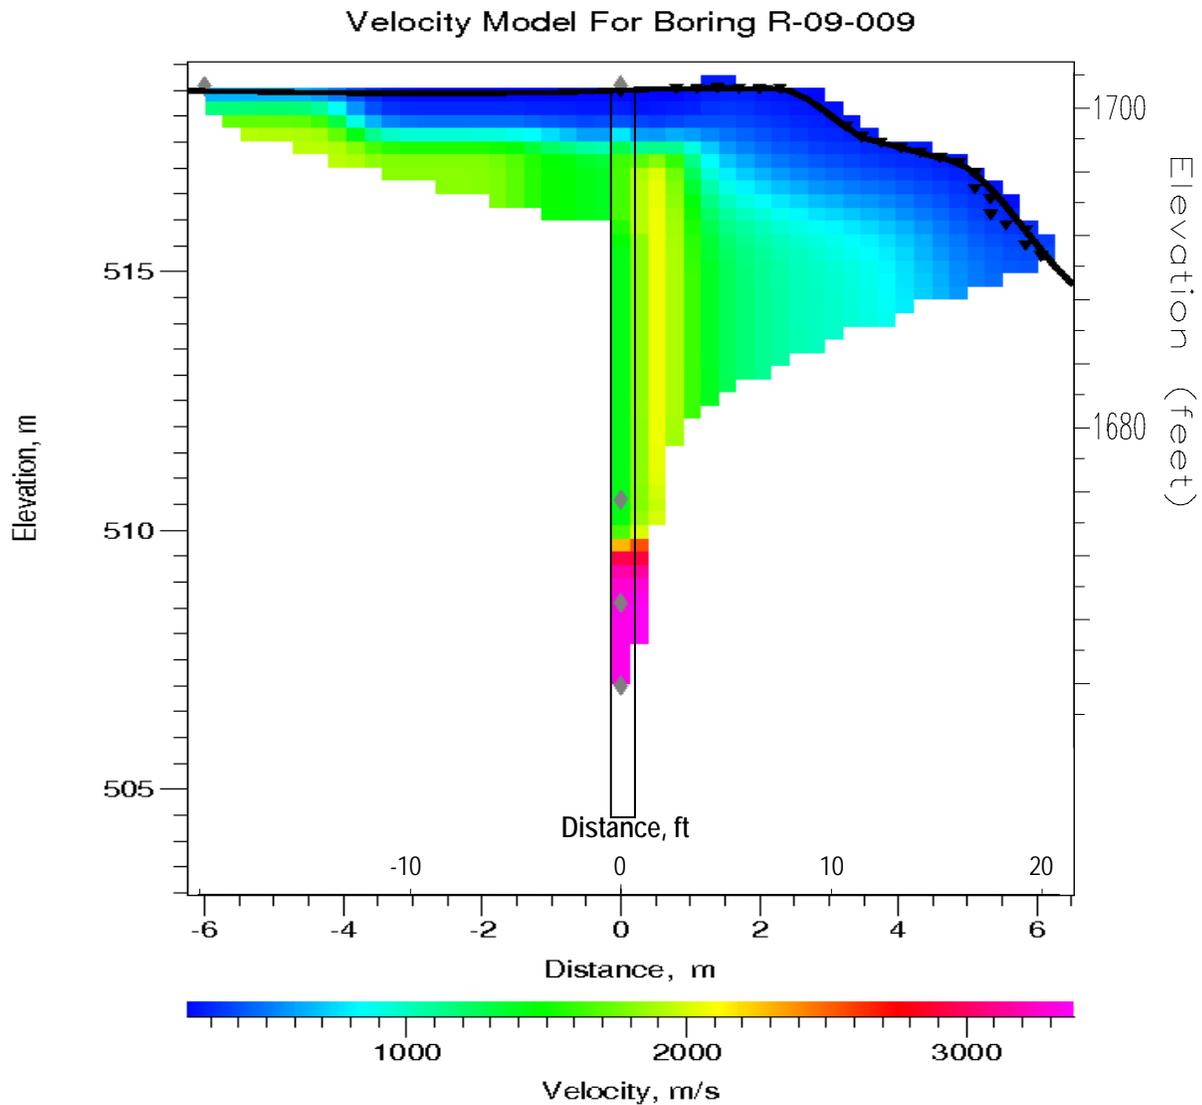
Figure 5. Velocity model for boring R-09-009. Blue color represents slow boulder fill and road base, green is interpreted as fractured diorite. Bedrock may not extend as far west (towards the river) as at other borings, but still appears to extend under the proposed wall location at about 2.81 m (9.2 ft) on the X axis. Red color indicates better-quality bedrock that correlates with LOTB descriptions of unfractured hard to very hard diorite at elevation 509 m (1671 ft). Ground surface is the black line. Shot points are shown as diamonds and geophones are shown as small black triangles.

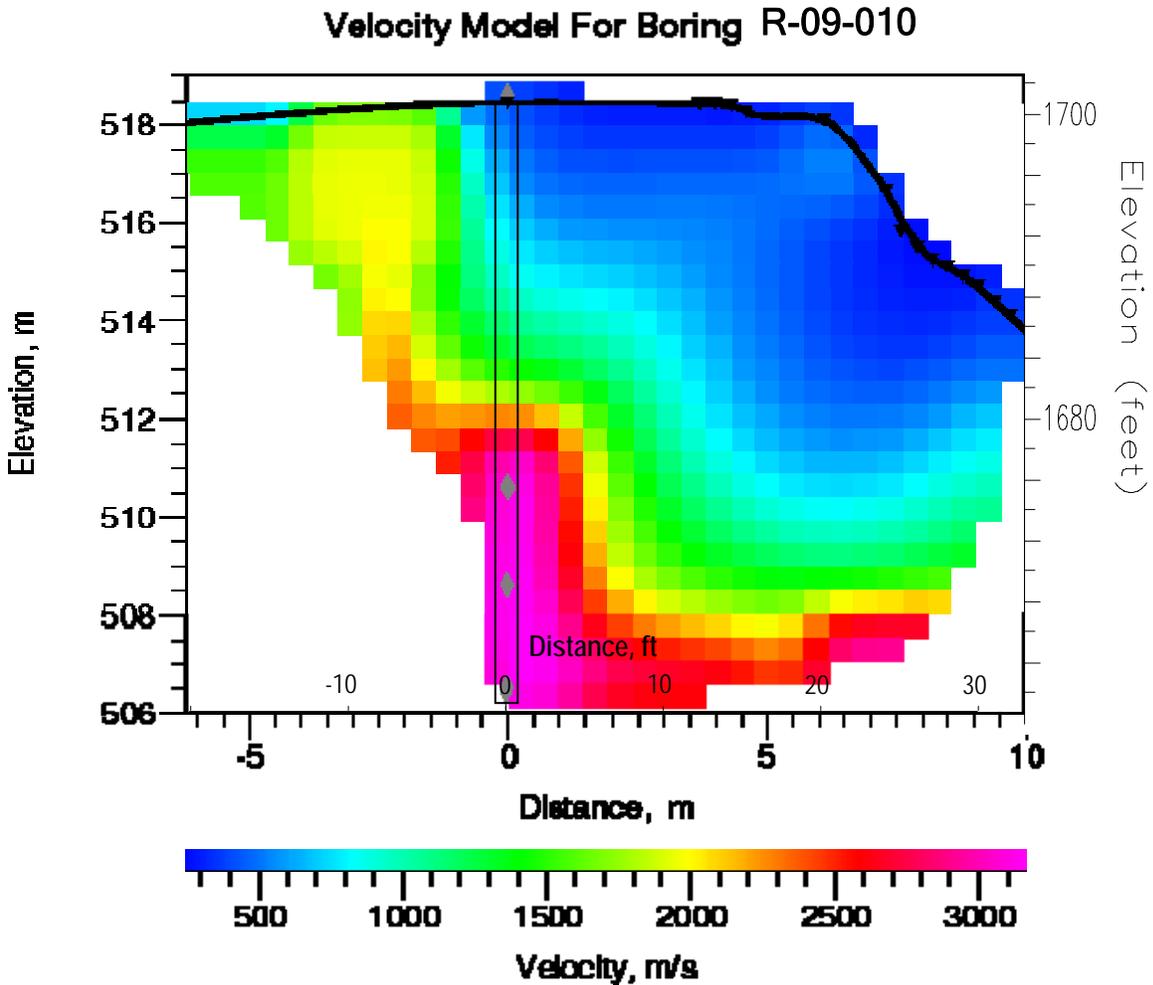
Figure 6. Velocity model for boring R-09-010. LOTB indicates a 4-foot void from 5.0 feet to 9.0 feet. Model indicates very slow material (blue color) in upper section of boring but competent rock (lime green and red) under boulder fill at the wall location and approximate elevation 509.5 meters (1672 feet).

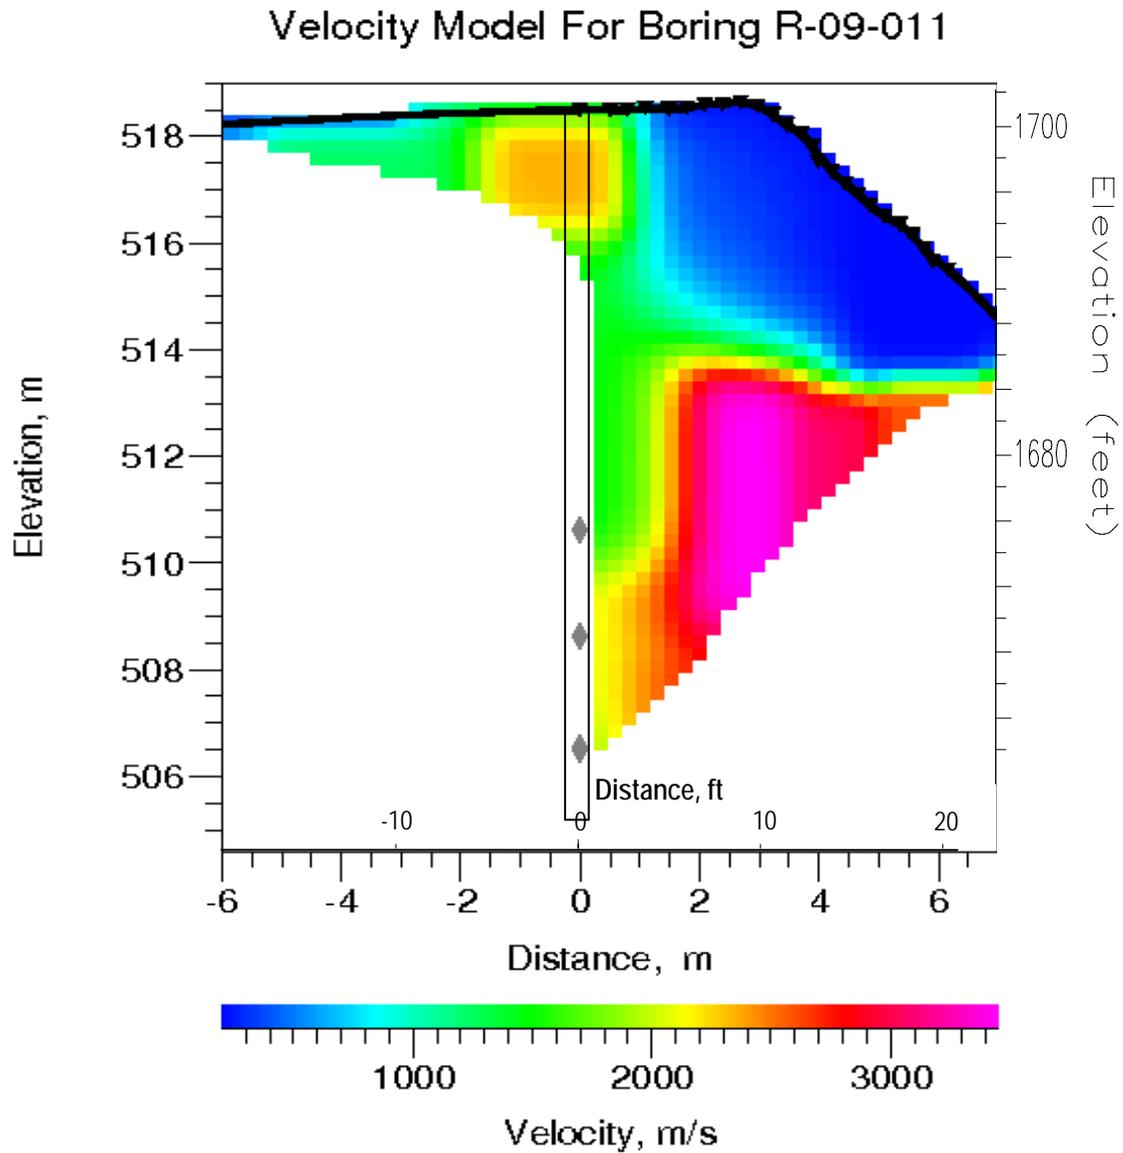
Figure 7. Velocity model for boring R-09-011. Competent rock is at elevation 513.50 meters (1685 feet) at the wall location (about 3.0 m (9.8 ft) on the X axis. Shot points are shown as diamonds and geophones are small triangles along the ground surface (black line).
