FOR CONTRACT NO.: 04-4S1604

FOUNDATION REPORT FOR SOLDIER PILE WALL DATED JULY 14, 2010

File: 04-SON-1 PM 21.7
04- 4S1601
(0400001213)
Soldier pile Wall
Storm Damage Project

Subject: Foundation Report (FR) for Soldier Pile Wall

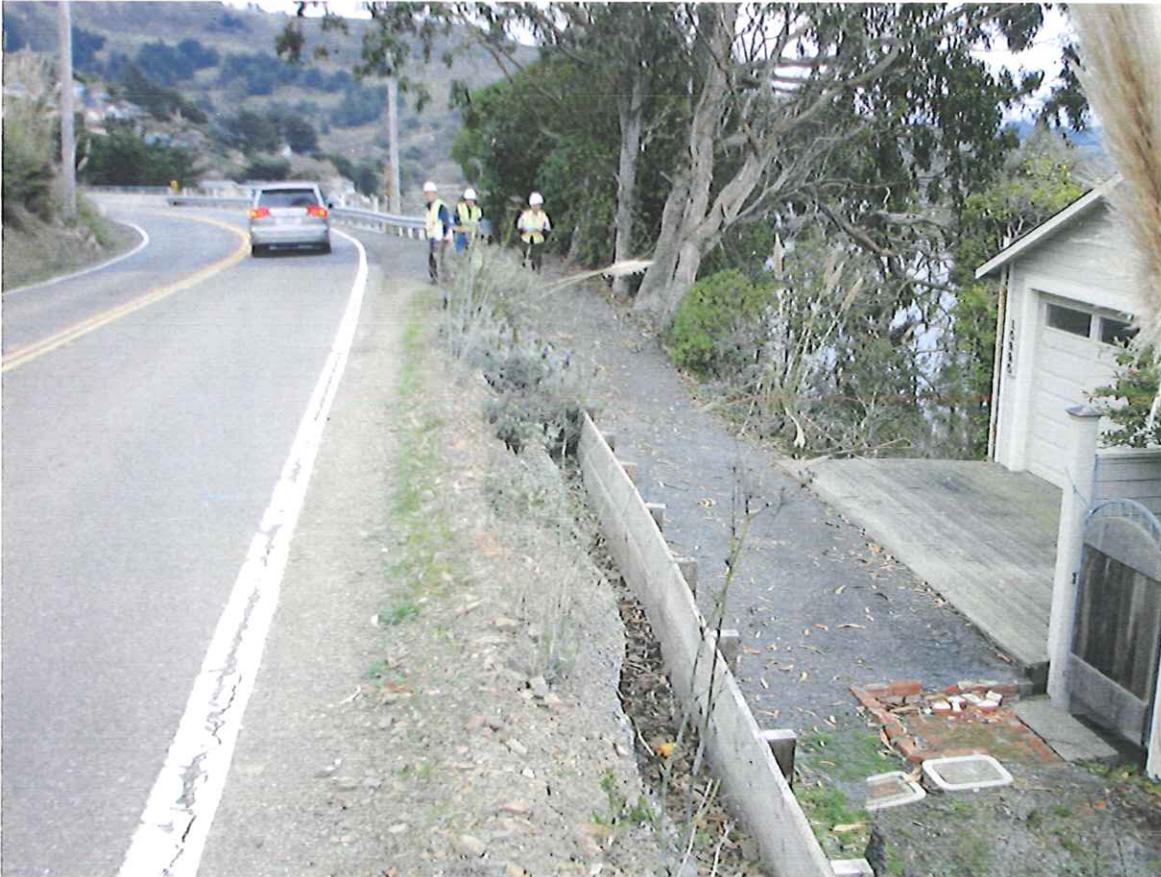
During our initial site visit on April 2009, we observed that an existing timber wall which was built by the owner of the residence at 10990 Highway 1 has been severely damaged due to continued slide movement at this location. We also observed that a portion of the buried concrete cap connecting all micropiles (pin piles) is exposed behind and adjacent to the existing timber wall (see attached photo #1A, #1B and #1C). The scarp of the slide appears to run along the edge of the southbound shoulder of Highway 1, directly above the timber wall. The scarp of the landslide starts at the south end, and above the existing timber wall, and possibly ends somewhere near the north end of the existing micropiles, a distance of about 250 feet. However, the visible portion of the slide scarp is only about 65 ft to 70 ft long. The rest of the slide scarps are obscure and may be masked by recent shoulder backing materials (placed by Maintenance) and heavy vegetation. We have not identified the landslide toe, but believe it is likely to be at or below the Russian River level.

Figure 1A: Failed Timber Wall at Driveway of 10990 Hwy 1 (April 2009).

- We recommend that the existing failed timber wall be replaced with soldier pile wall. Our recent site visit revealed that the major movement of slope is within the limits of the existing timber wall and slightly beyond the timber wall toward north for the total length of about 70 feet to 75 feet. We believe, at this time, it is only necessary to construct a soldier pile wall within the above-mentioned limits, since there is no sign of significant movement beyond these limits. The soldier pile wall should, however, be designed so that it can be extended northward in case of future movement. It should be mentioned that there is a significant ground movement at the end of the existing micropile around the CIDH pile foundation belonging to the parking area of the River End Restaurant, but has not negatively affected the roadway (See the attached photos #7) at this time.

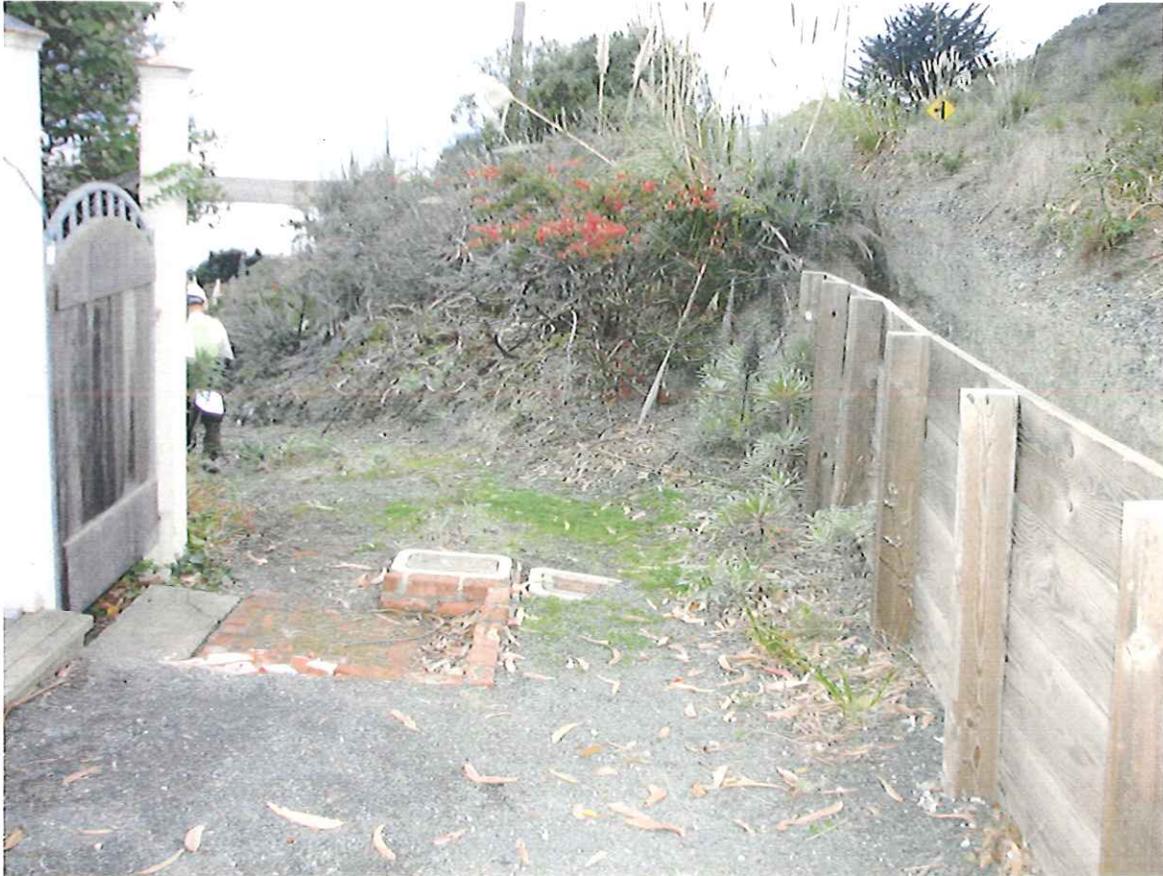
Figure 1B: Failed Timber Wall at Driveway 10990 Hwy 1 (April 2009).

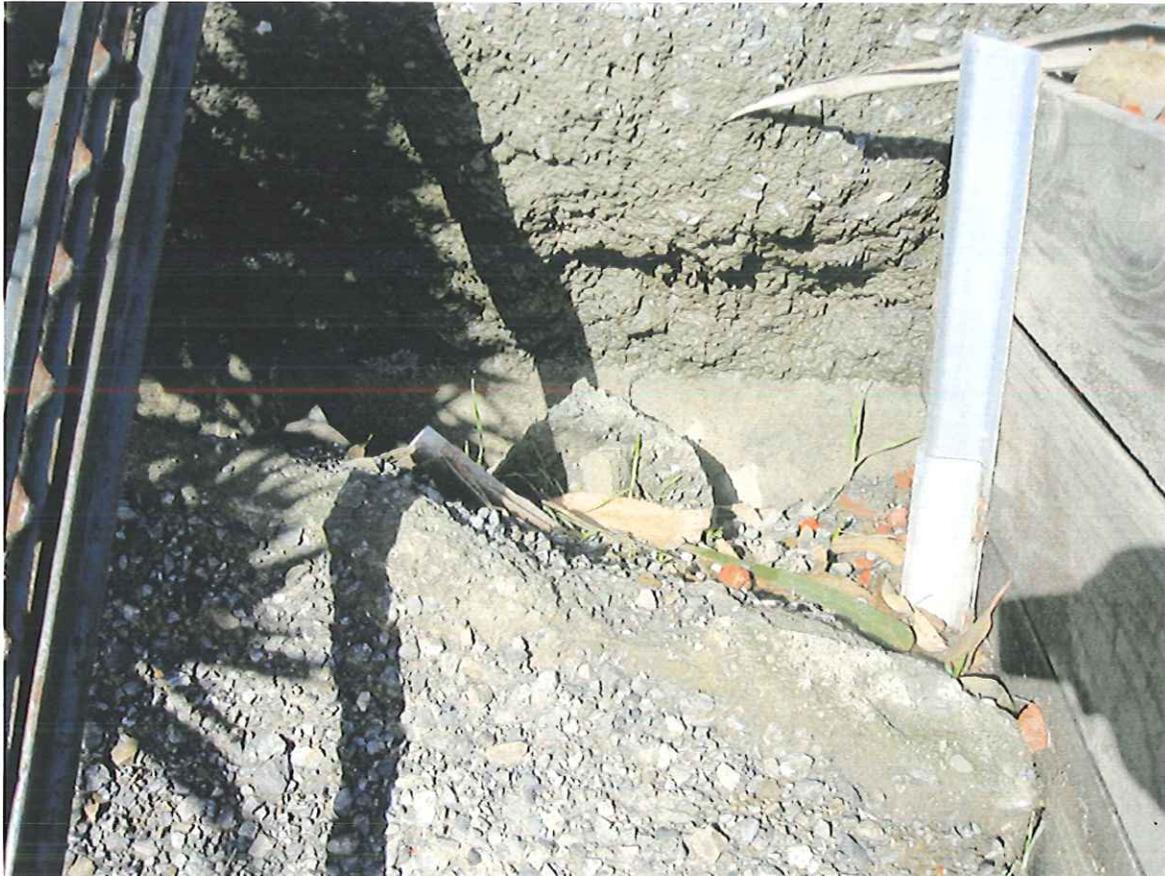
Although the use of micropiles (Pin Piles) were successful in stopping the movement within the roadway itself, there has been some movement of the roadway embankment beyond the pile cap and roadway shoulder in the southbound direction including, the subject area where the existing timber wall has been damaged, and is on verge of failure. After visiting the site in April 2009, we decided to replace the timber wall in kind. However, after further study of the site and search of geotechnical files, we believe that, due to the seriousness of the ground movement at this location, the timber wall, which was initially recommended, would not be appropriate for this site. A timber wall might work temporarily, but will fail within a few years because past monitoring data, as well as our recent site reconnaissance indicates that a portion of slope below the roadway hinge point is creeping down toward the Russian River. Further search of landslide files (see photos #2A, #2D and #2G) and study of the site revealed that the slide movement along the edge of SB shoulder was beyond just timber wall. However, after the construction of the micropiles most of the movements have been stopped. As stated above, the recent site reconnaissance and GPS mapping by our geologists revealed that there are no signs indicating the slope instability beyond those visible cracks absorbed on the roadway SB shoulder above and slightly north of the existing timber wall.

Figure 1C: Exposed Concrete Pile Cap of Micropiles at the Scarp of the slide (1/23/2010).

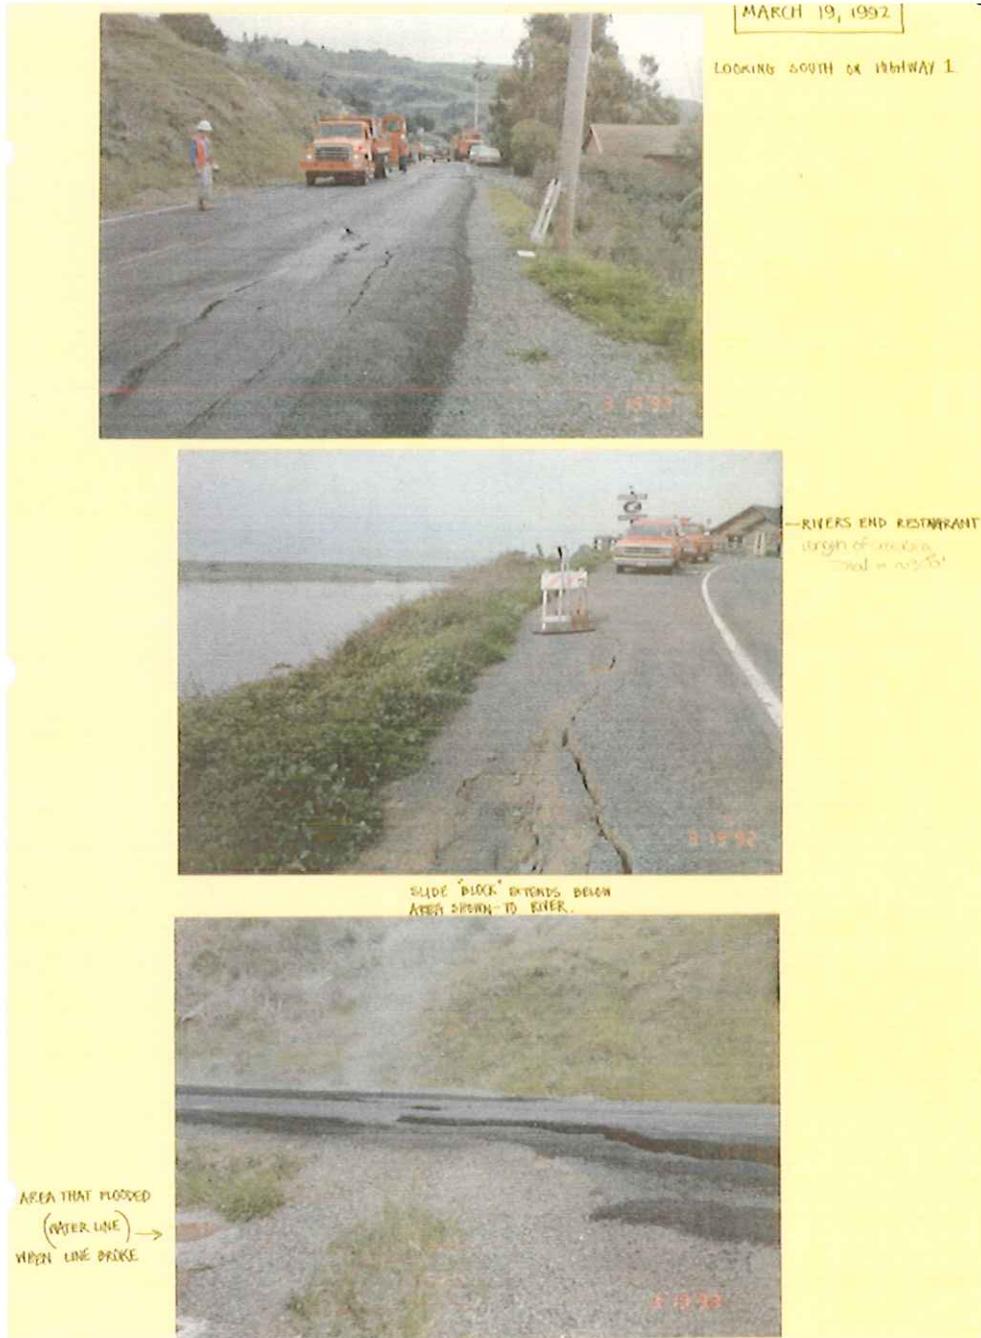
The slope movement at the site has been an on-going problem since early 1992 and accelerated during the heavy rains in the Winter of 1992-1993. Observation of the performance of the roadway in 1992 and 1993, as well as a detailed geologic investigation shows that the upper slide scarp is clearly defined by arcuate cracking in the highway pavement and shoulder area. Slope movement was occurring within and below the roadway in the southbound lane, and extending well into the northbound lane. Major cracking was observed in the edge of the southbound shoulder and in the driveway of the garage apartment in the Winter of 1992 (see attached photos #2A through #2G). The toe of the slide could not be identified but it is believed to be at or below the river level. The slipout was approximately 300 feet wide; however only 250 feet of the slipout affected the highway.

Figure 2A: Photos of the landslide (1992).

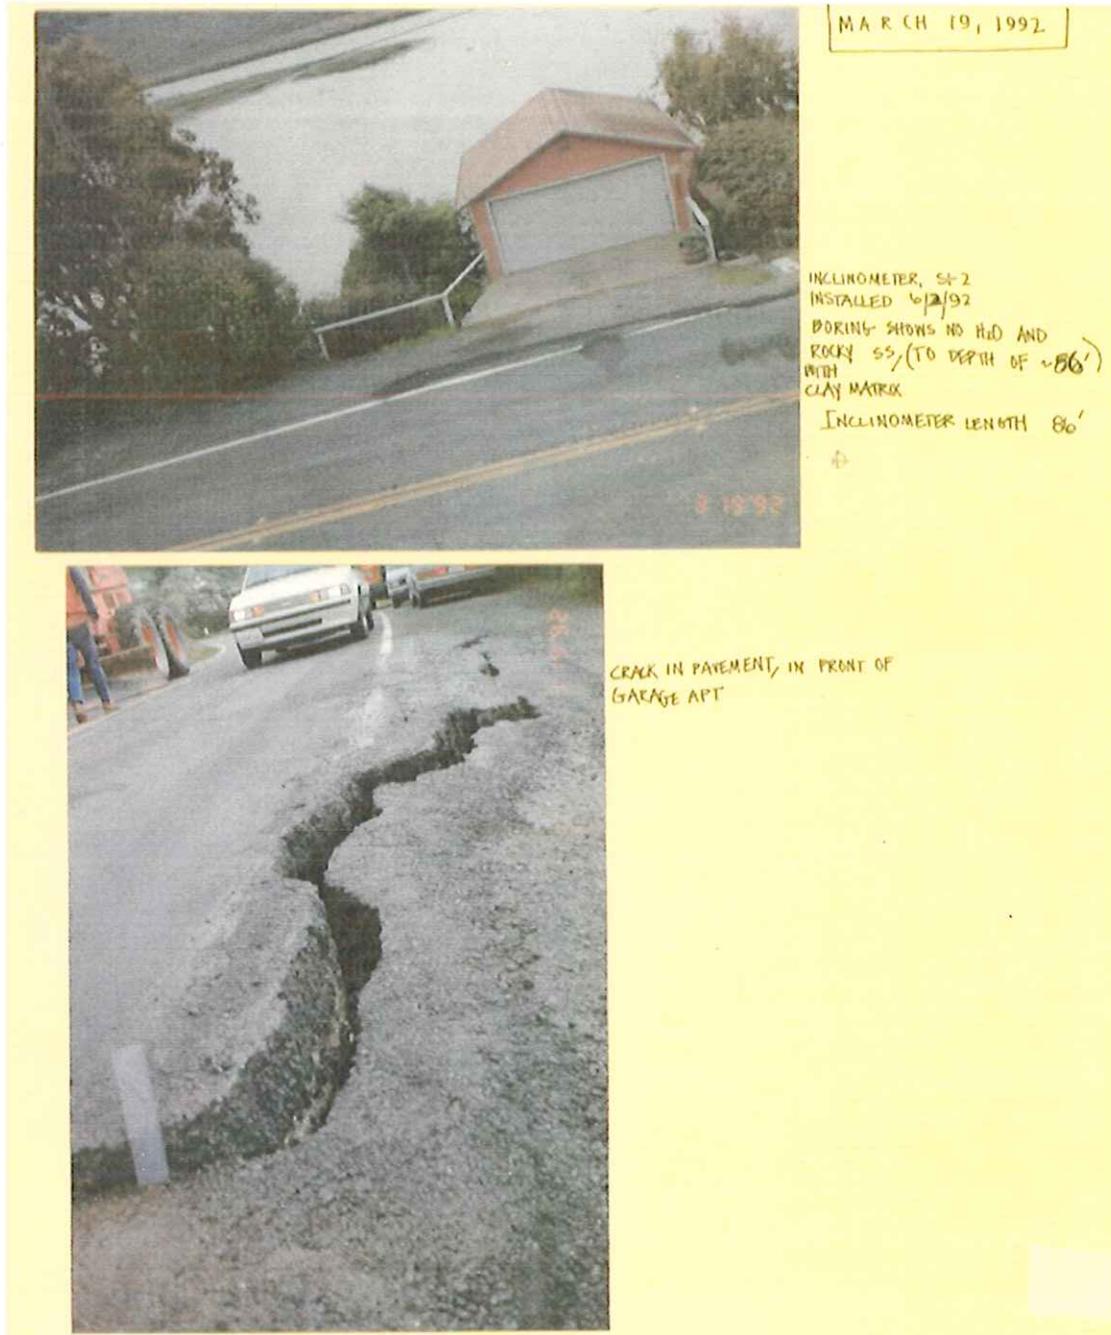
Figure 2B: Large crack in front of the Garage Apartment Driveway (1992).

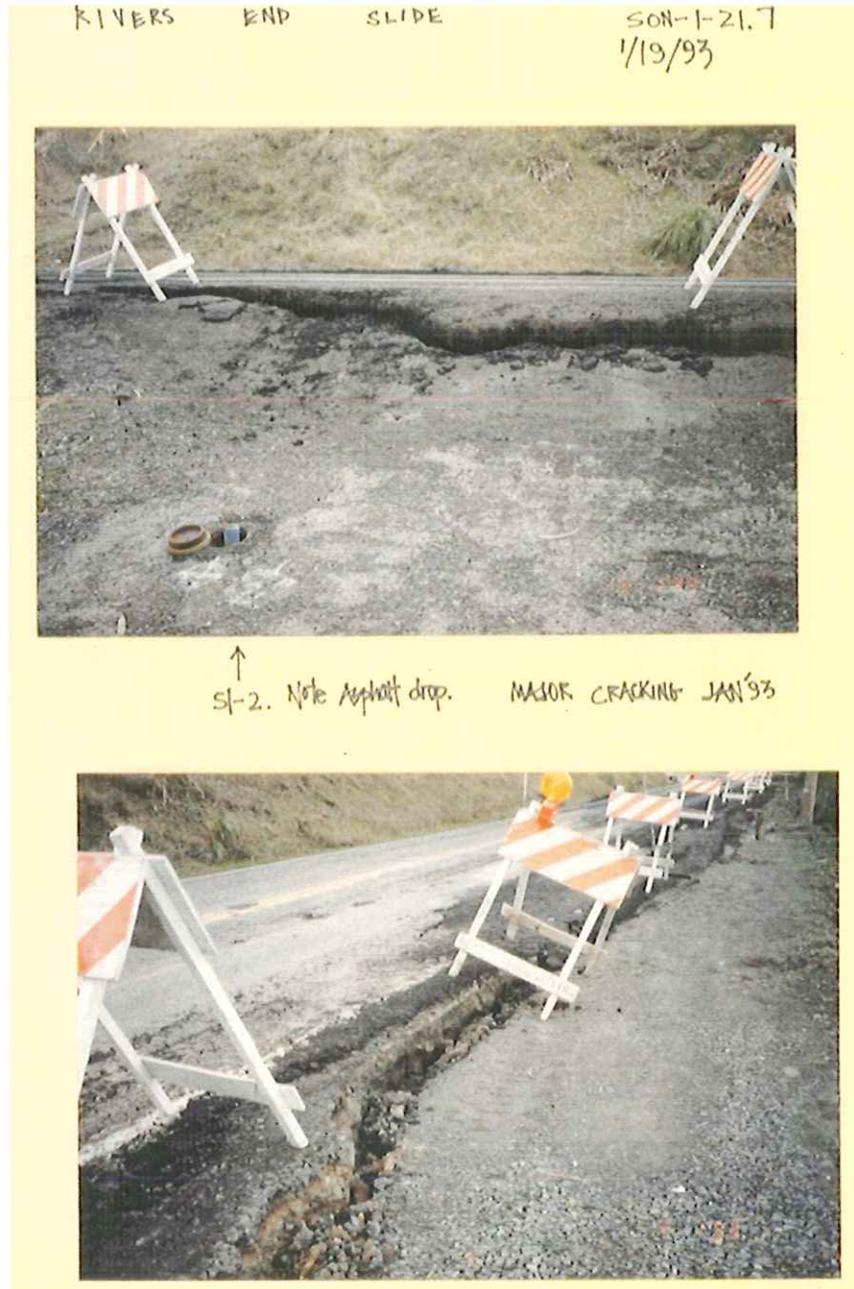
Figure 2C: Cracks associated with slide movement – Crack in front of the Garage Apartment where the timber Wall is located now (January 1993).

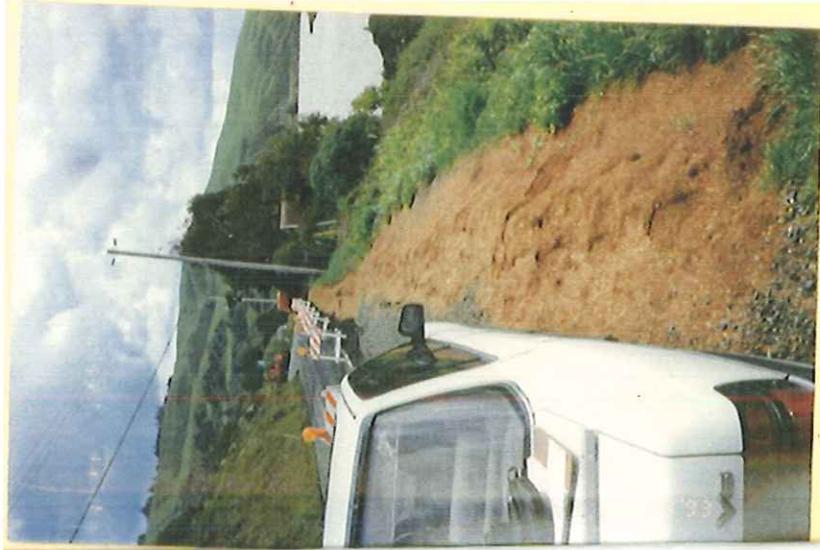
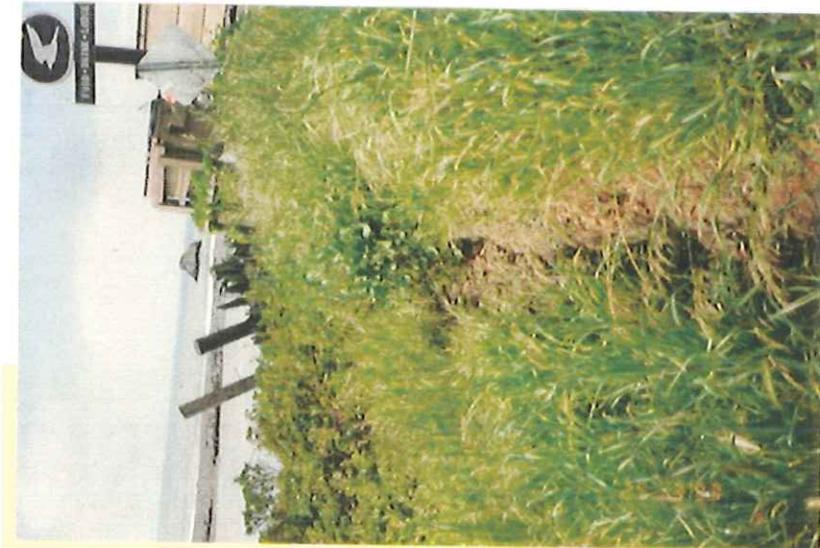
Figure 2D: Saw dust placed by Maintenance crew to lever the dropping SB shoulder due to sliding. Photo taken before the Micropile construction (1993).

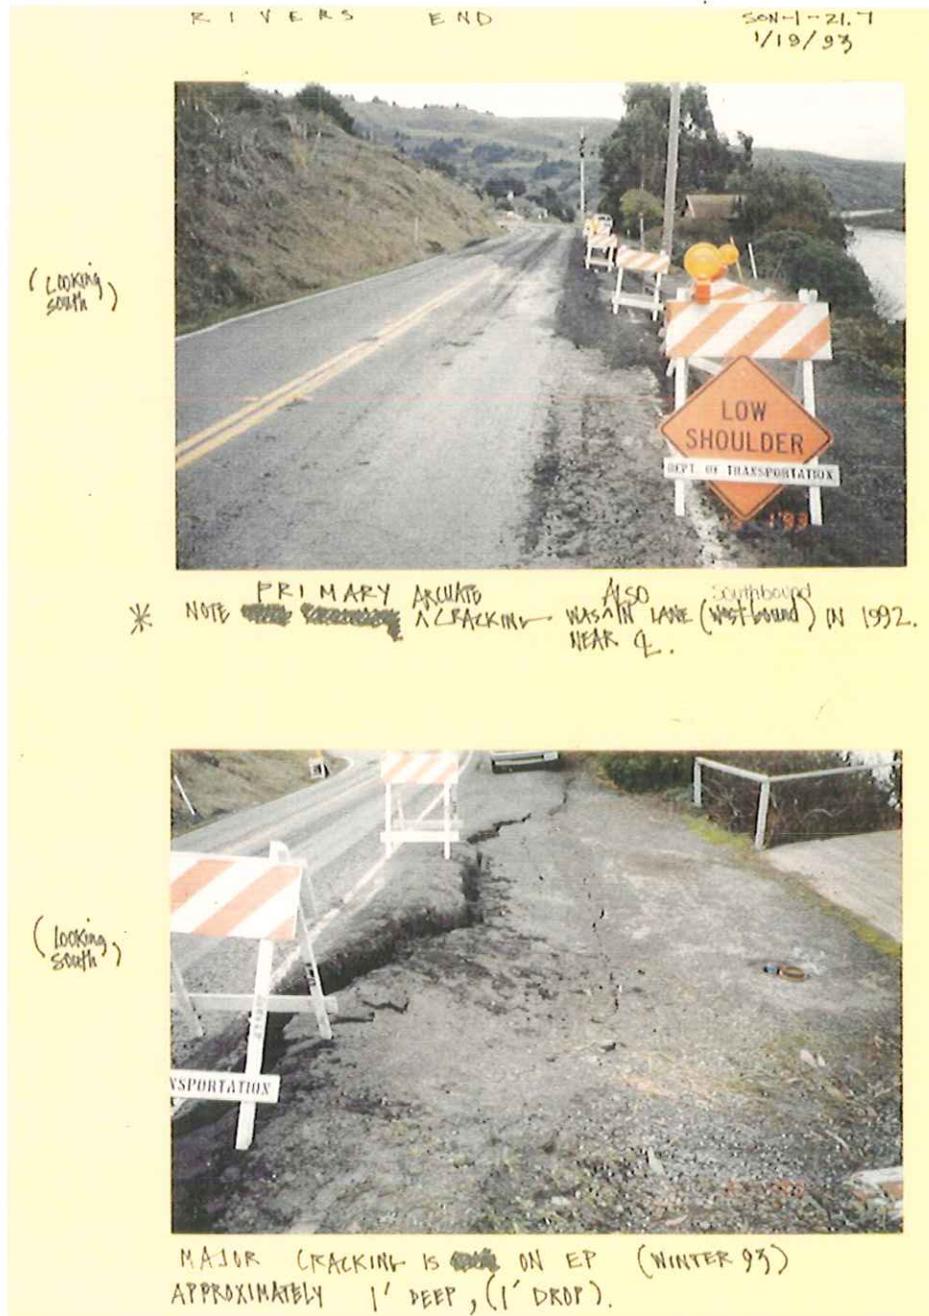
Based on our geotechnical record, in 1993 the driveway of the garage apartment (10990 Highway 1) was approximately at roadway level (maybe 1 to 2 feet differential- see Photo# 2E, #2F, #4). The record indicates that the driveway for the garage and the garage foundation were experiencing settlement and distortion, making the driveway difficult to use. The private residence (10990 Highway 1) is located approximately 30 ft downslope from highway elevation. Both home and the driveway apartment have an on-site sewage disposal system, which contributes to the long-term saturation of the slope. On December 1992, the owner of the residence (10990 Highway 1) Mr. Brown, contacted the Geotechnical Section several times and expressed his concerns about the distortion in the

Figure 2E: Cracks in front of the Garage Apartment Driveway; also showing SI-2 (January 1993).

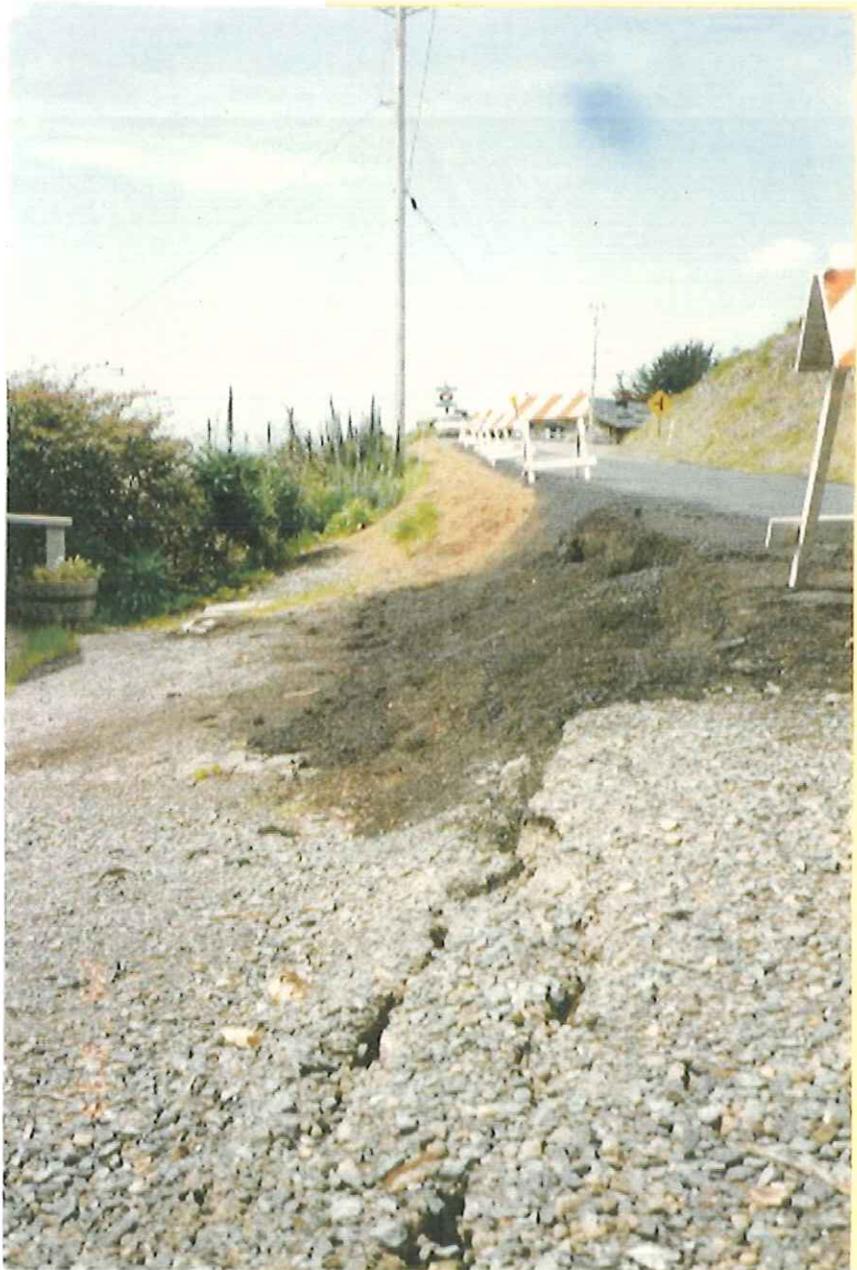
Figure 2F: Slide in front of Garage Apartment where the timber wall is now (1993).

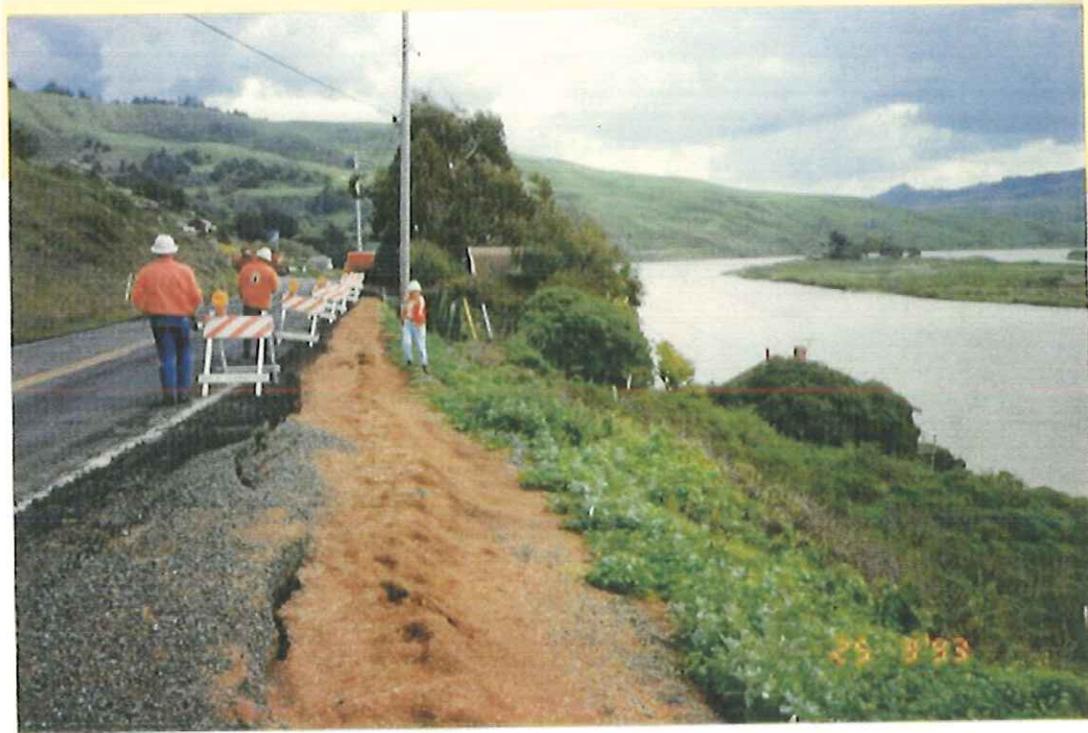
Figure 2G: Sawdust was placed by Maintenance crew to level the SB shoulder area. Photo taken prior to micropile construction (1993).

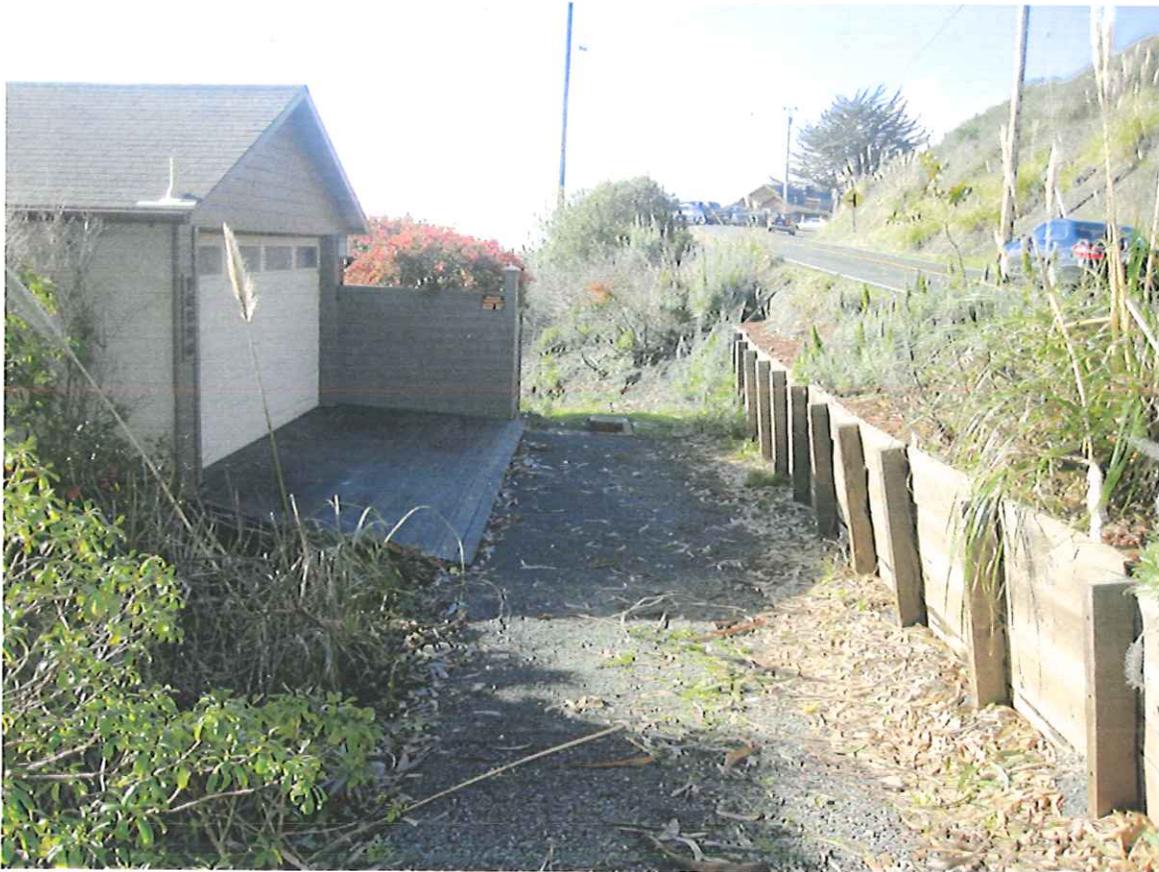
We have asked Maintenance to immediately place some lightweight fill behind the existing timber wall to fill up all the cavities and voids, which has already been done (see attached photos #3A and #3B). No signs of movement were observed in the roadway pavement. In fact, roadway surface (Route 1) is in excellent condition within the limits of the micropile system.

Figure 3A: Failed Timber Wall with Lightweight Backfill (1/23/2010).

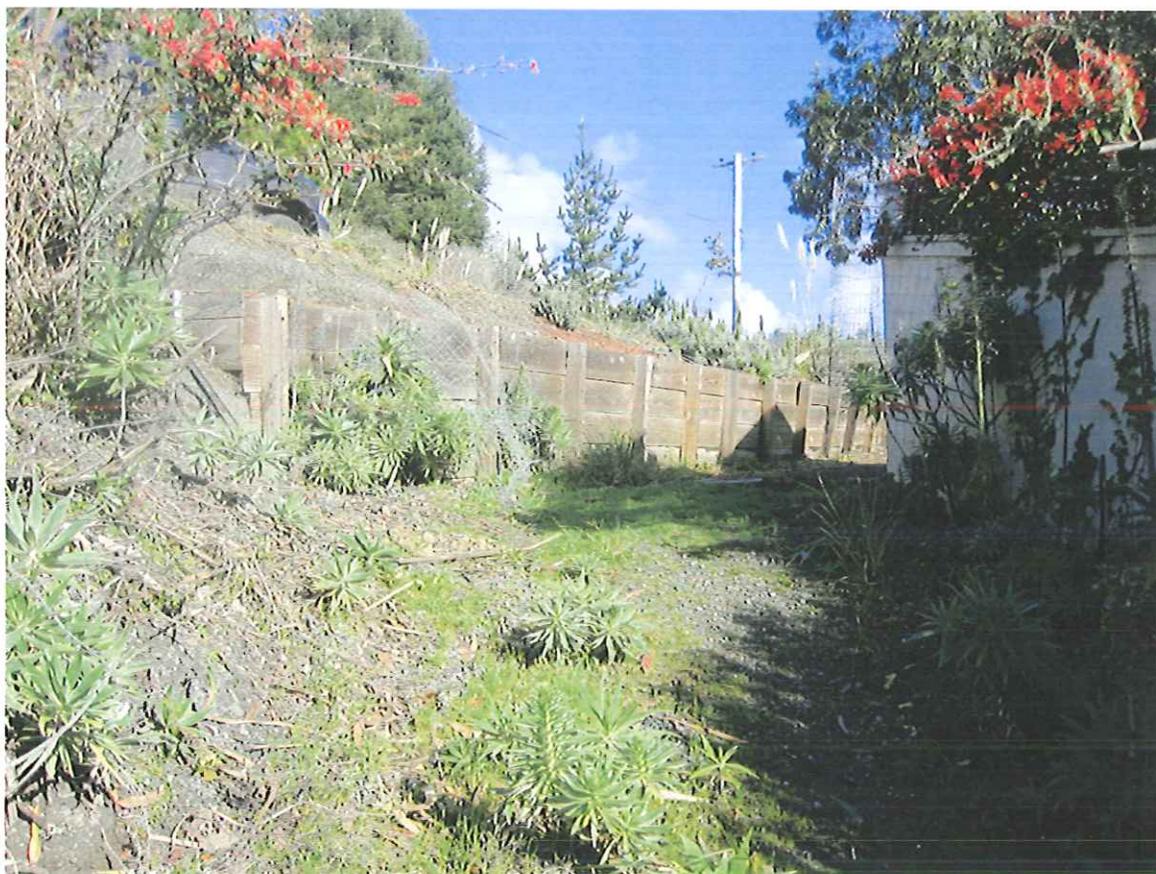
Figure 3B: Failed Timber Wall with Lightweight Backfill (1/23/2010).

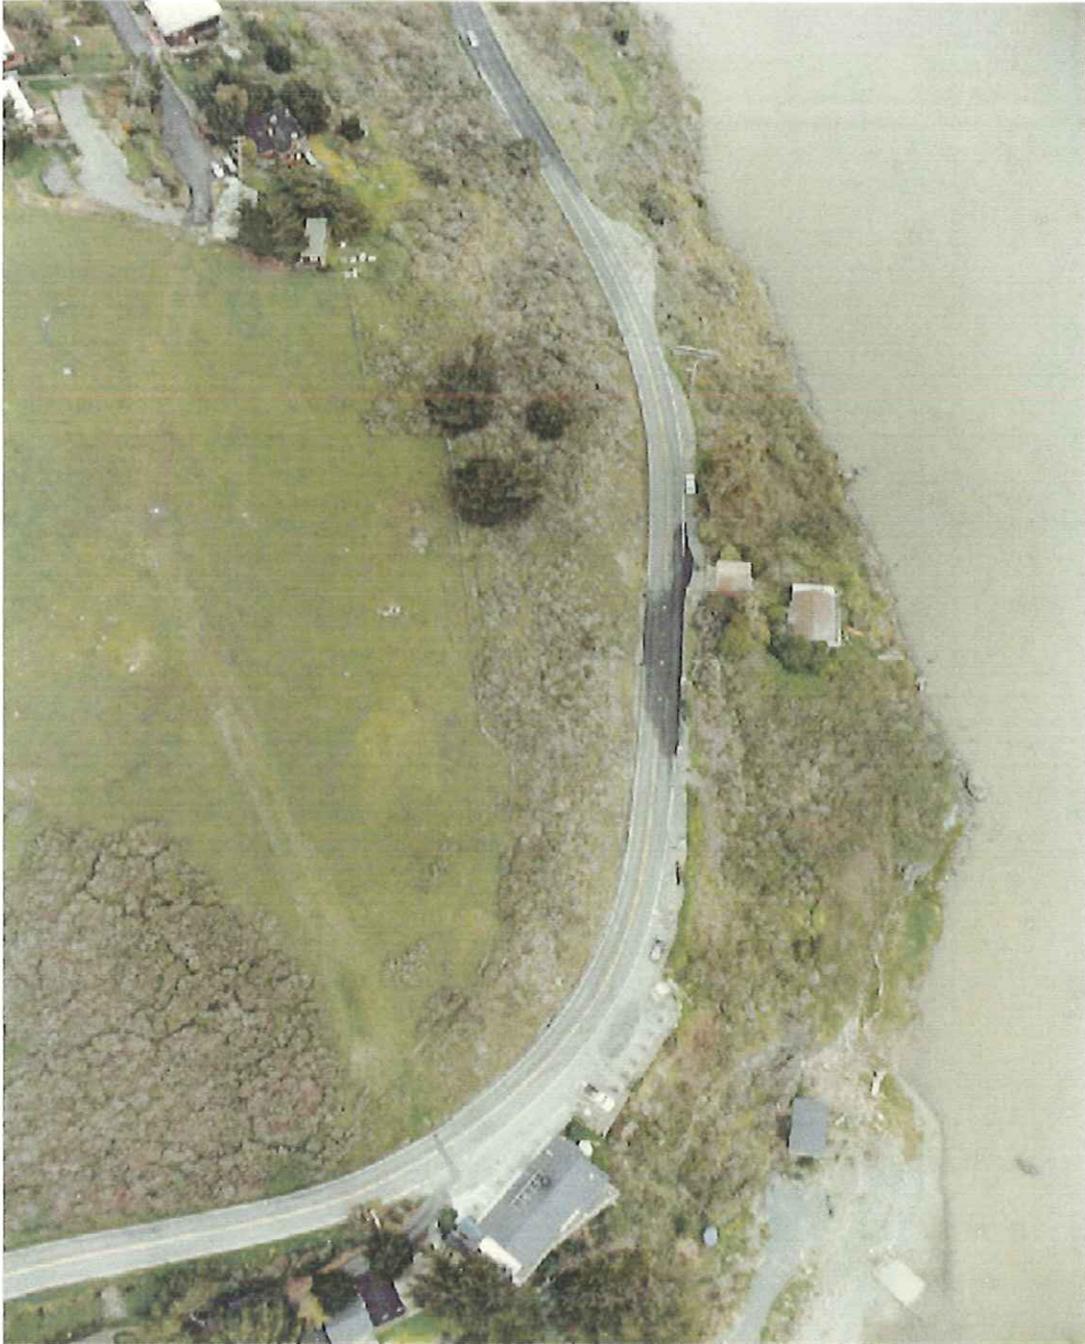
Figure 4: Air Photo of Son-1 PM 21.7-21.67 (1993).

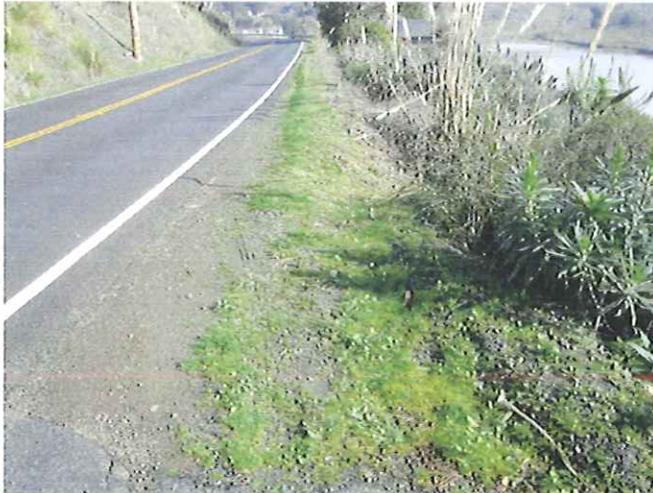
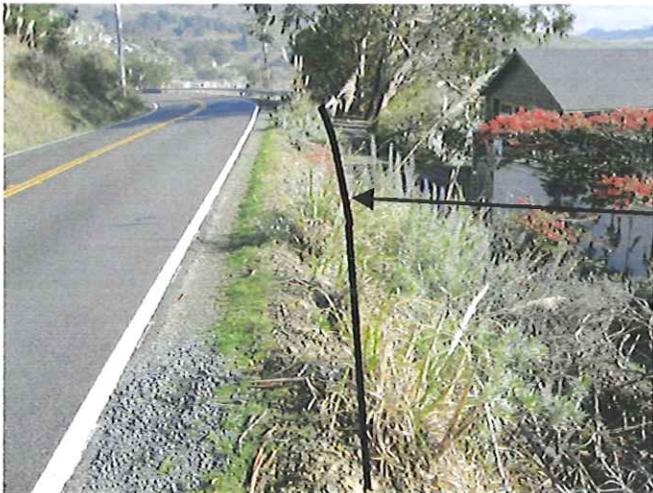
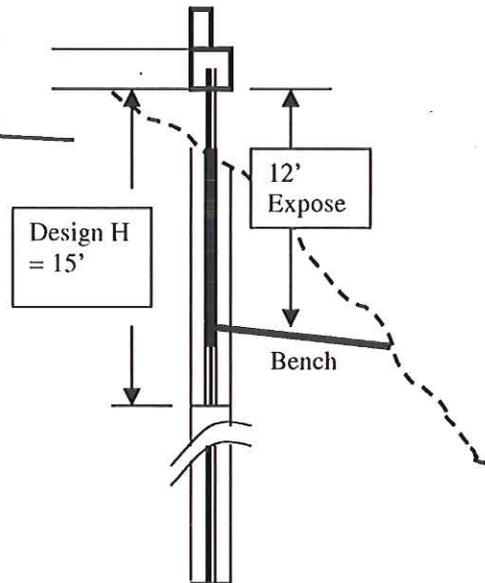
Figure 5A: Upper photo - Existing roadway condition within the existing buried micropiles/cap looking south. Lower photo - Approximate Location of the proposed Soldier Pile Wall Looking South.

We recommend the soldier pile wall be designed for a maximum height of 15 feet future cantilever wall with wood lagging and lightweight fill backfill. However, the height of the wall, which will be exposed within the limits of existing timber wall (in front of the 10990 Highway 1 residence), is to be determined by Project Development. We recommend that the wall length be about 95 ft starting somewhere near the south end of the existing timber wall. Project Development should determine the exact location and alignment of the proposed soldier pile wall. The exposed height of the proposed wall beyond the north end of the existing timber wall should be limited to 12 feet. Refer to attached Exhibit A, Photo #5A and #5B.

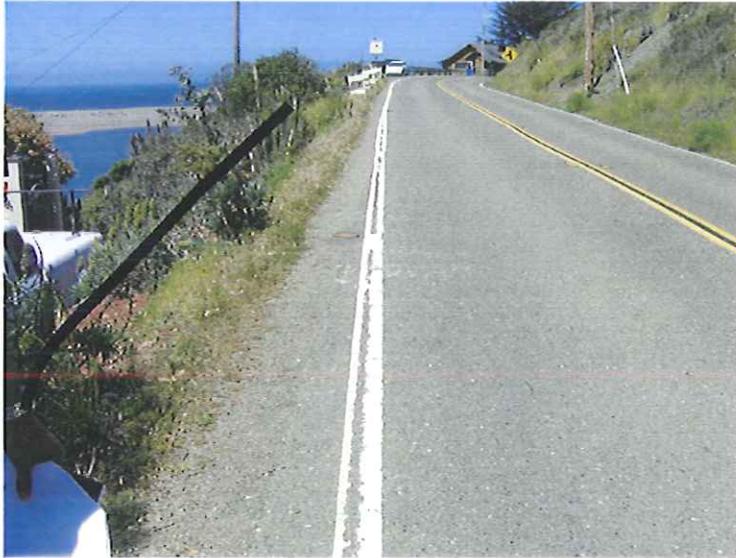
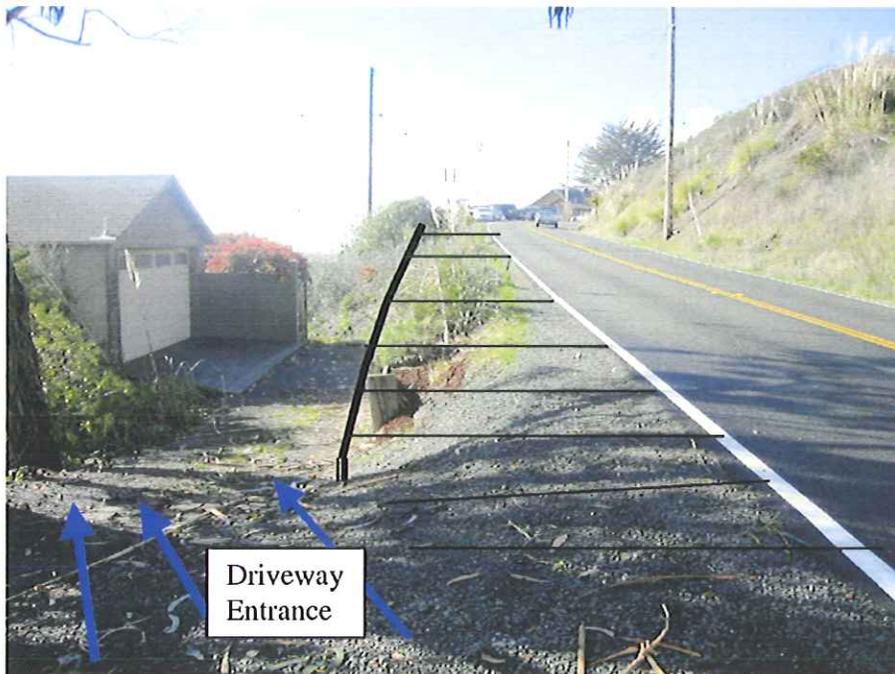
Figure 5B: Upper photo - Approximate location of the Proposed Wall looking north.
Lower photo - Approximate Location of the Beginning of the Proposed Soldier Pile Wall looking north.
