MATERIALS INFORMATION

Asbestos Survey Report

Alternative-in-Line Terminal System

Subject: ASBESTOS SURVEY REPORT
HANFORD-ARMONA ROAD UNDERCROSSING (45-0078)
KINGS COUNTY, CALIFORNIA
CONTRACT NO. 06A1895, E-FIS 06-1400-0172-1 (EA 06-462211)
TASK ORDER NO. 35

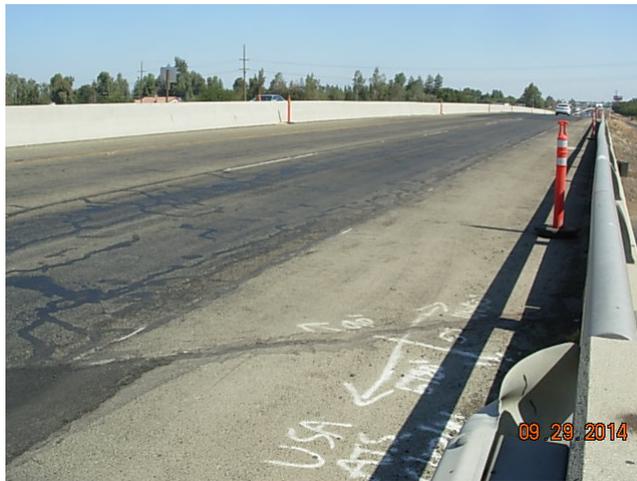
Photo 2 – Bridge deck and barriers

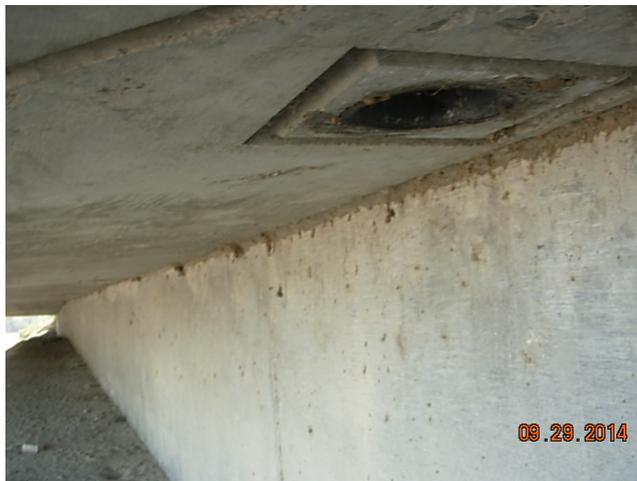
Chrysotile asbestos at a concentration of 2.5% was detected in samples representing nonfriable drainpipe encased within the bridge abutments. We were not able to quantify the material. The asbestos content was determined using PLM point count analysis (1,000 points).

Photo 3 – East abutment (drainpipe is asbestos-containing)

NESHAP regulations require that asbestos-containing drainpipe (a Category II nonfriable/nonhazardous material) be removed and disposed of prior to demolition or other activities that would disturb the material. We recommend that the removal of the material be performed by a licensed contractor who is registered with Cal/OSHA for asbestos-related work. Contractors are responsible for informing the landfill of the contractor's intent to dispose of asbestos waste. Some landfills may require additional waste characterization. Contractors are responsible for segregating and characterizing waste streams prior to disposal.

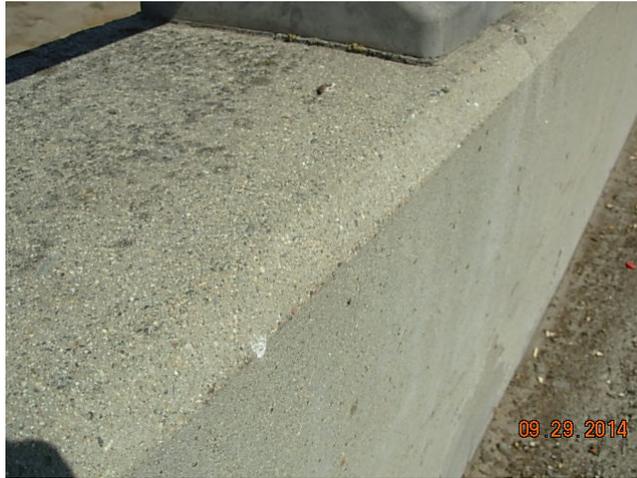
Chrysotile asbestos at a concentration of 80% was detected in samples representing approximately 6 square feet of nonfriable asbestos sheet packing used as shims on the bridge barrier rail systems.

Photo 4 – Asbestos sheet packing on barrier rail systems

NESHAP regulations do not require that asbestos-containing sheet packing (a Category I nonfriable/nonhazardous material) identified during our survey be removed prior to demolition/renovation or be treated as hazardous waste. The sheet packing may also be reused or stored. However, activities causing *disturbance* of the sheet packing (i.e., cutting, abrading, sanding, grinding, etc.) would require compliance with the Cal/OSHA asbestos standard (Title 8, CCR §1529).

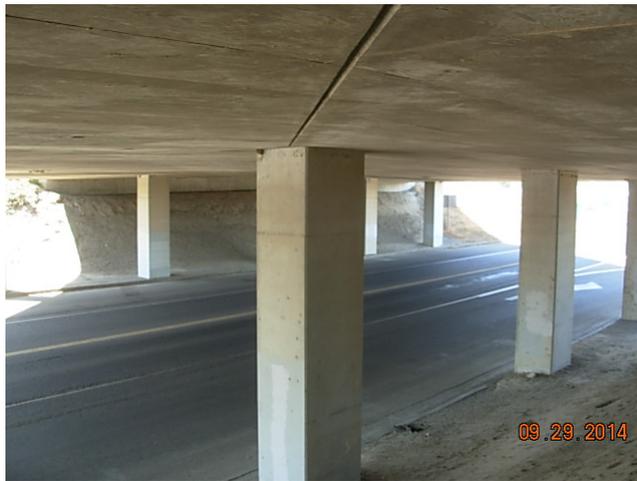
Photo 5 – Bridge columns

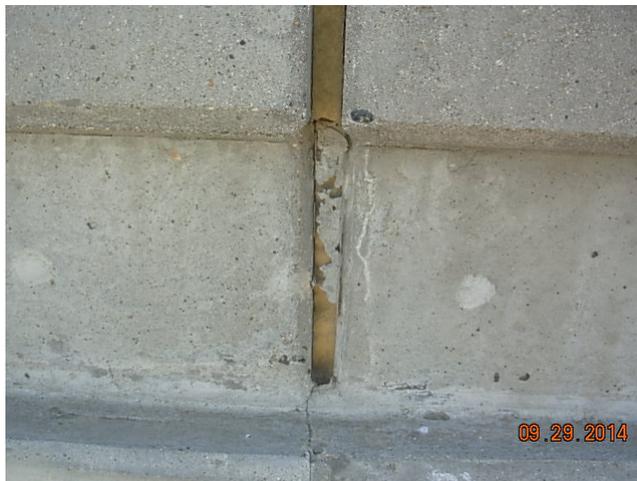
Photo 6 – Polyurethane joint fill material (non-suspect)
