GEOTECHNICAL DESIGN REPORT

File: 07-VEN-23-PM 6.01
Proj. No. 0700020865
Two Sinkholes

Subject: Geotechnical Design Recommendations for Two Sinkholes adjacent to Southbound Route 23 Avenida De Los Arboles Off-Ramp

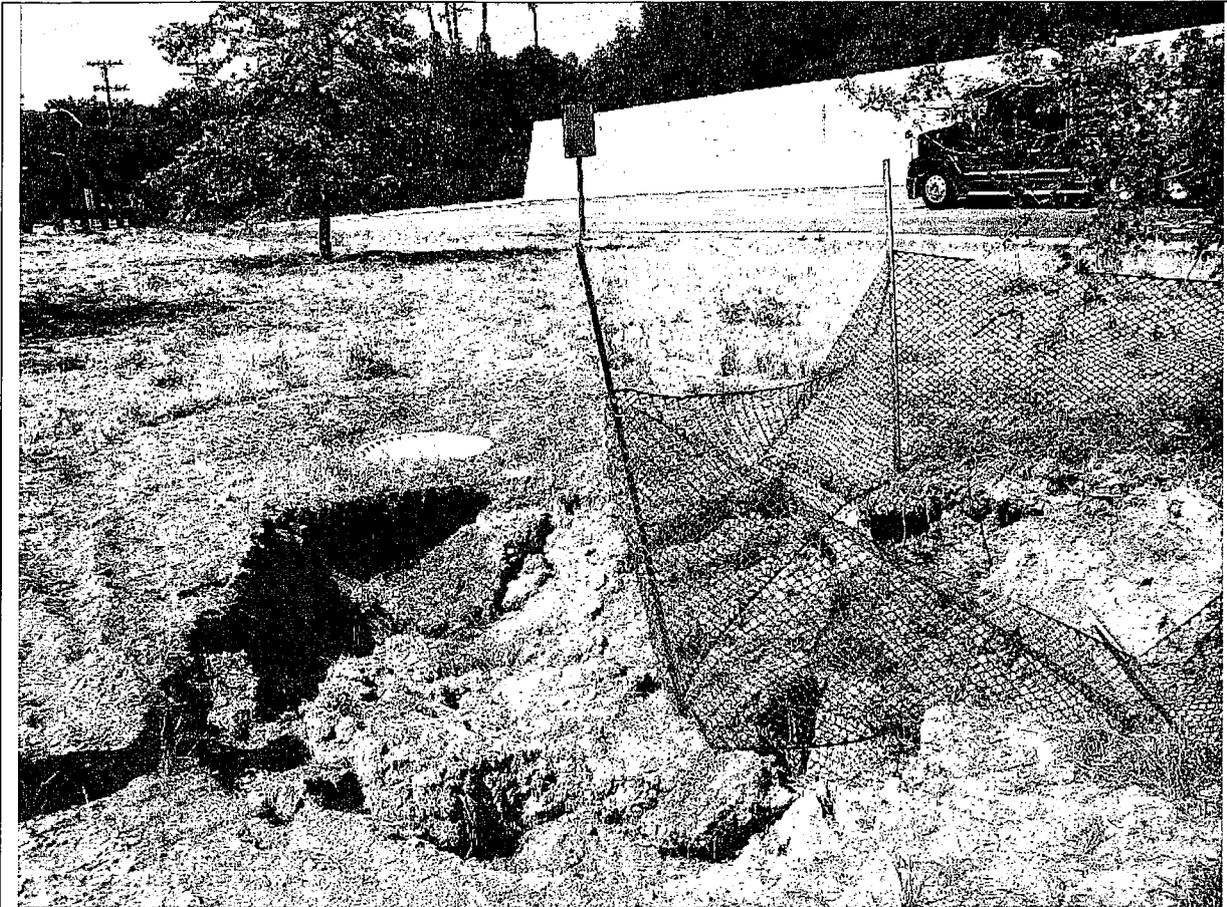
Figure 1 : 07-VEN-23 PM6.01 Sinkhole No.1

Sinkhole No. 1 is approximately 20 by 20 feet wide and 7 feet deep and is located adjacent to an existing grate/inlet. Sinkhole No. 2 is approximately 30 by 30 feet wide with variable depth up to 8 feet and is located about 50 feet north of the first sinkhole. These two sinkholes are located from 30 to 40 feet east of Avenida De Los Arboles Off-Ramp shoulder (between the Off-Ramp and southbound Route 23). The on-site soil consists of predominantly silty sand and sandy silt.

OGDS1 considers these two sinkholes were at least partially developed due to burrowing animal activity in the area and excessive runoff due to heavy rain and saturation of the ground. On site soil may also have been washed out in the existing CMP culvert.

1. The condition and integrity of the nearby CMP culvert needs to be checked by District Maintenance Engineering to inspect damage to the pipe and any separation at the joints.
2. After the condition of CMP culvert is checked and repaired, OGDS1 recommends removing loose material from sinkholes and backfilling it with gravel or gravel-size crushed rock. This would prevent further burrowing by animals.

3. A representative of OGDS1 needs to be present at the site to provide direction on excavation and backfilling of the sinkholes.
