Initial and Long-Term Evaluation of the Tire-Pavement Noise Produced by Various Portland Cement Concrete Surface Textures

*Measurements on the State Route KN 58 Mojave Bypass
2003 to 2010*

Paul R. Donovan, Sc.D.
Illingworth & Rodkin, Inc.
505 Petaluma Boulevard South
Petaluma, CA 94952

June 6, 2011

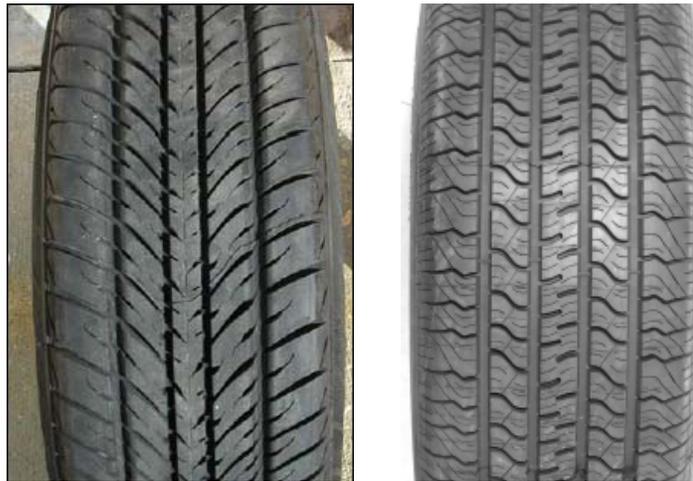
(a) Aquatred 3

(b) SRTT

Figure 1: Photograph of each test tires

The sound intensity measurements were performed using the same methodology as those completed for Caltrans throughout California⁵. Through 2006, the test vehicle was exclusively a Subaru Legacy Outback equipped with Goodyear Aquatred 3 test tires and sound intensity data was acquired with a single probe mounted on the right rear spindle of the test vehicle. Photographs of the Aquatred test tire and single probe OBSI fixture installed on the vehicle are provided in Figs. 1a and 2a. The probe

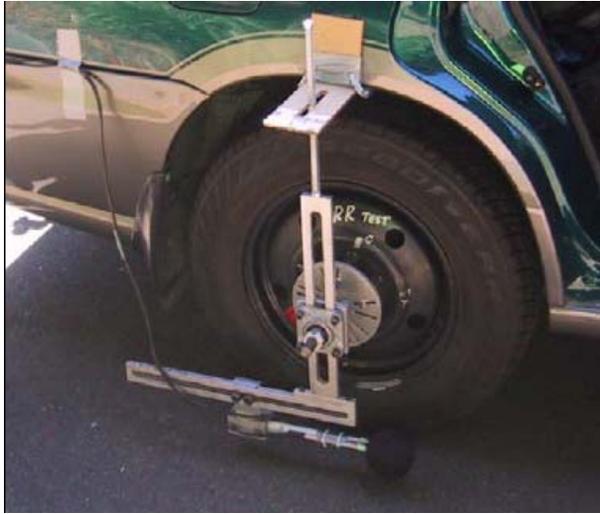
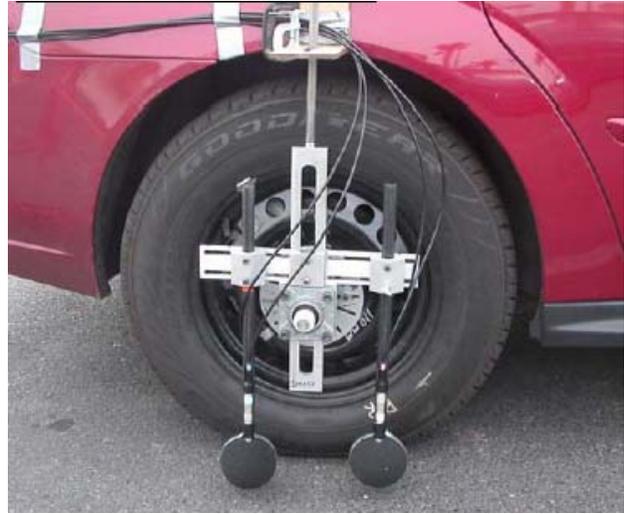
(a) Single probe configuration (leading edge) installed on the Subaru test vehicle (2003)

(b) Dual probe configuration installed on the Malibu test vehicle (2006)

Figure 2: OBSI equipment installed on the test vehicles

consisted of two G.R.A.S. Type 40AI ½ inch diameter condenser microphones and two G.R.A.S. Type 26AK preamplifiers spaced 0.63 inches (16 mm) apart in a “side-by-side” orientation. Prior to measurement, a foam windscreen was placed over the microphones. Sound intensity was measured in real time using a 2-channel Larson Davis 2900 real time analyzer (RTA). The OBSI measurements were made with the probe located 4 inches outboard of the trailing edge of the tire contact patch and 4

inches outboard of the leading edge at a height of 3 inches above the pavement. With this probe and fixture configuration, sound intensity is measured at only one probe location per pass over the test pavement. The probe is repositioned, and the run repeated. The data from each position are later averaged together on an energy basis to obtain the average sound intensity for the tire operating on each test surface. This average intensity characterizes the sound power radiated to the sideline of the vehicle and is known to correlate well with the corresponding pass-by data². Consistent with the statewide database, the vehicle was operated at the standard speed of 60 mph although data was also taken at 45 mph in the March 2003 baseline tests. Because of the interest in characterizing the noise from joints and the lack of interference from traffic, some sound intensity data was also acquired at 45 mph in the 2003 measurements. The RTA was set to capture a “linear” (energy) average over a 5 second interval consistent with other pavement tests. The data were reduced to provide overall, A-weighted sound intensity levels for the 400 to 5000 hertz (Hz) one-third octave band spectra. For each test section and probe location, two to three passes over the pavements were measured. In all cases, the difference between successive runs was 0.5 dB or less in terms of overall A-weighted level. The reported data is then an arithmetic average of the two (or more) runs.

In 2006, it was verified that the probe could also be used mounted vertically which allowed the simultaneous measurement at both points reducing the measurement time by half. Switching to a dual probe system required the use of a new Brüel & Kjaer Pulse four-channel analyzer. The second probe added to the system used the same type of microphones and preamplifiers as described for the single probe. Although these changes were rather minor, some small average differences (on the order of 0.3 to 0.5 dB) were documented⁶. Beginning in 2007, the OBSI measurements were also made with the P215/R16 ASTM Standard Reference Test Tire (SRTT) as specified in the proposed AASHTO Standard Method of test for OBSI as the Aquatred tire was becoming no longer available. The use of this larger tire also resulted in a test vehicle change to a Chevrolet Malibu in order to accommodate the new tire. The dual probe fixture is shown in Figure 2b as installed on the Malibu test vehicle with the SRTT shown in Figure 1b. A second Aquatred tire was acquired for use on the Malibu as mounted on a wheel with a different bolt pattern. For the 2008 measurements, extensive comparative testing was completed examining all these permutations on the Mojave sites. For the 2009 and 2010 tests, the Malibu

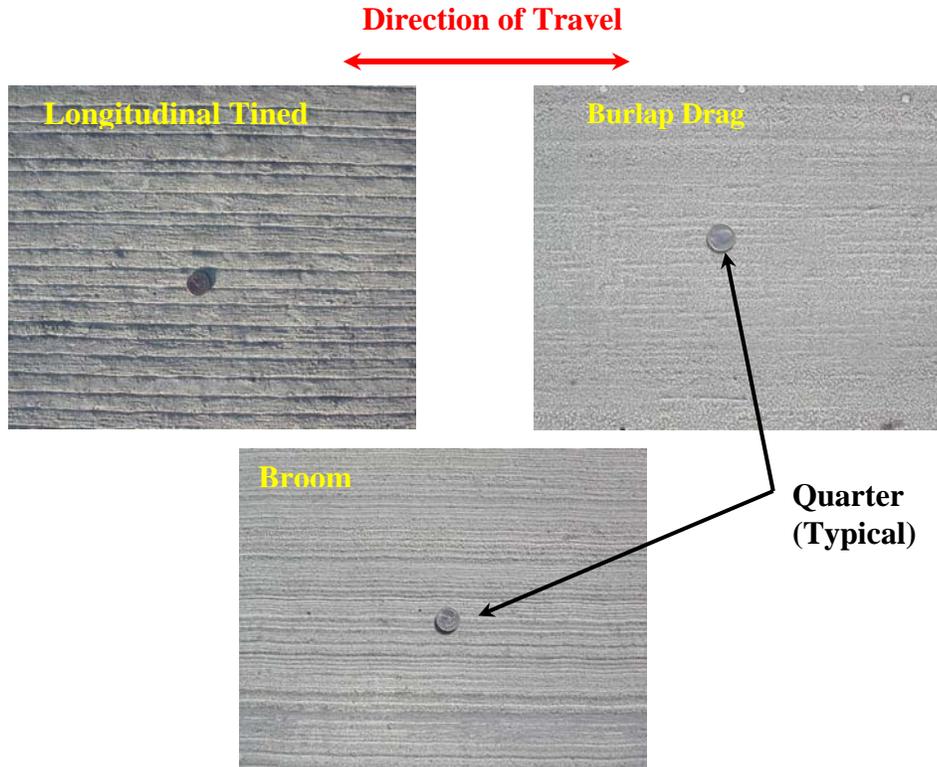
Figure 3: SR 58 Bypass PCC baseline test section textures

The three baseline pavement surfaces were textured with longitudinal tining, burlap dragging, and broom finish (Figure 3). The longitudinal tine grooves were 0.09 inch (2.4 mm) to 0.13 inch (3.2 mm)

wide, $\frac{1}{16}$ inch (1.5 mm) to $\frac{5}{16}$ inch (8 mm) deep, and randomized at $\frac{1}{4}$ inch (6.4 mm) to $\frac{3}{4}$ inch (19.1 mm) apart. The burlap drag and broom textures were applied to the uncured surfaces in the longitudinal direction. The surfaces were all placed in the eastbound direction of travel on both lanes of vehicle travel. In addition to the texturing, the PCC surfaces contained discontinuities in the transverse direction due to joints between the concrete slabs. To prevent future faulting, the slabs were dowelled together at the joints, which occurred at a randomized spacing ranging from 11 ft (3.35 m) to 14 ft (4.27 m). The joints were nominally $\frac{1}{2}$ inch (12.5 mm) wide and partially filled with an epoxy plug recessed below the upper surface of the pavement (Fig. 4). These joints were found to produce an audible “slap” sound perceived both inside the test vehicle as it was driven on the surfaces and outside the vehicle as it drove by. Photographs of the joints for each of the three textures are shown in Figure 5.

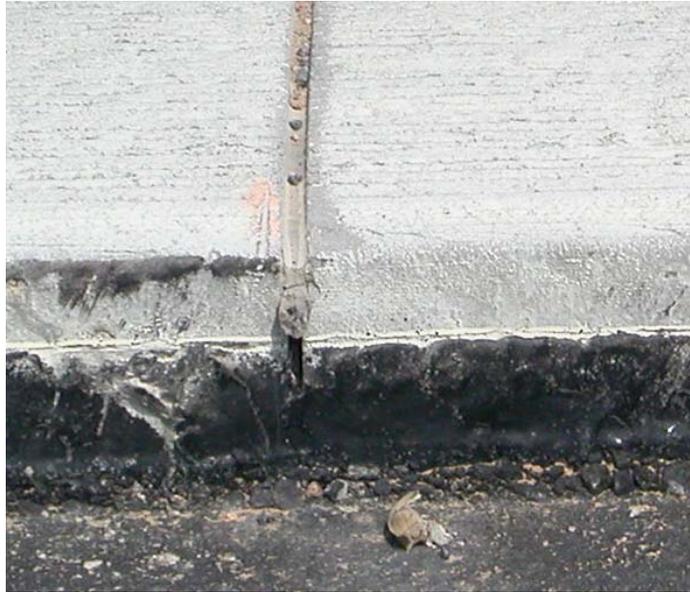
Figure 4: Cross section view of typical pavement joint

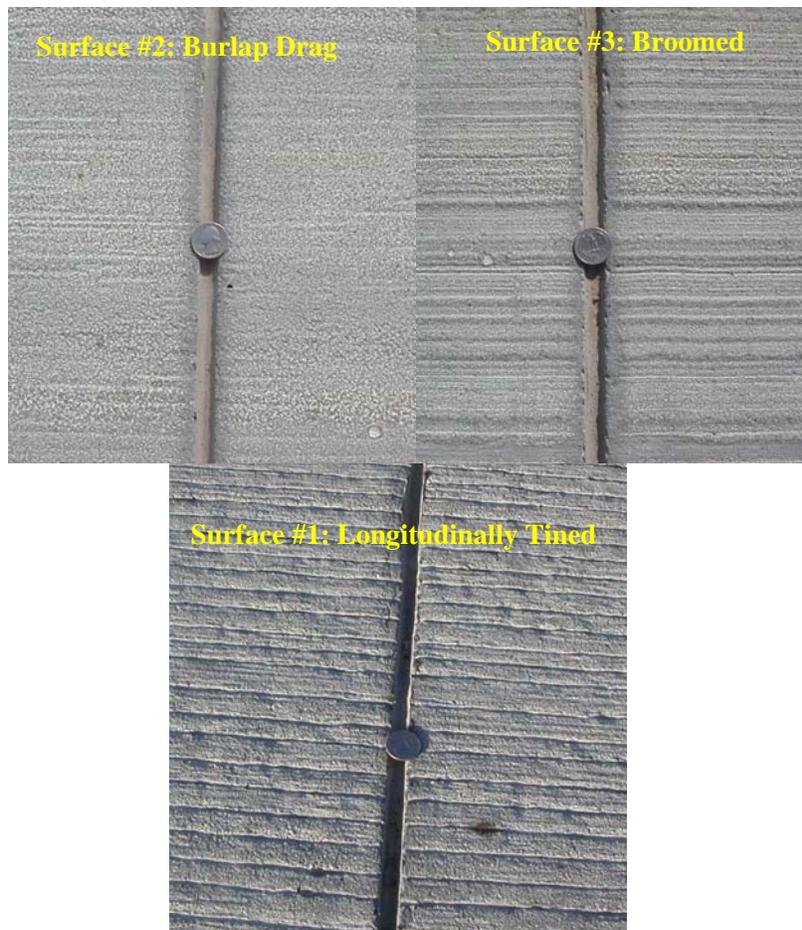
Figure 5: Typical pavement joints for each baseline test surface

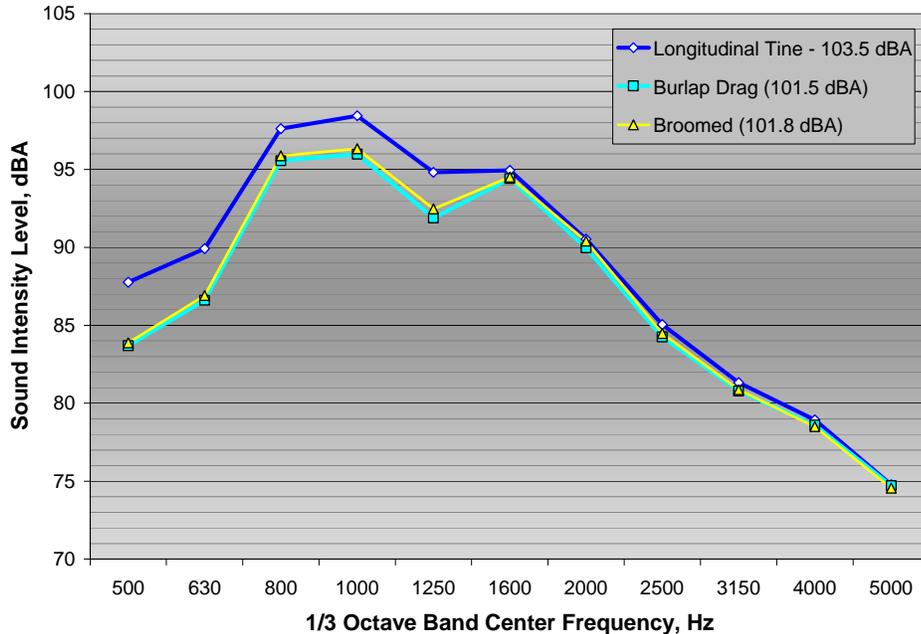
Figure 6: 1/3 Octave band spectra for baseline surfaces measured at 60 mph

The one-third octave and overall OBSI levels for the three baseline textures are presented in Figure 6 as measured at the standard speed of 60 mph. At 103.4 dBA, the longitudinal tine surface is 2.0 and 1.7 dB

higher in level than the burlap drag and broom surfaces, respectively. This difference is dictated by the higher levels seen below 1600 Hz in which the differences range from 1½ dB to as much as 4 dB. From Figure 3, the longitudinal tine surface appears to have more surface roughness than the other two which may be the cause of the higher levels in lower frequency bands. The spectral shapes of the burlap drag and broom surface virtually overlay throughout the entire spectrum. Especially for these two surfaces, there is a secondary “peak” at 1600 Hz which is the second harmonic of the tread passage frequency that occurs at about 825 Hz for this tire for 60 mph. At 45 mph as shown in Figure 7, the 1600 Hz is reduced in frequency to about 1200 Hz, which in turn fills in the “valley” apparent in the 60 mph results for the 1250 Hz one-third octave band. At the lower speed, the difference between the longitudinal tine and other two surfaces is only more pronounced below the 1250 Hz band. The differences in overall level, however, remain about the same as those at 60 mph.

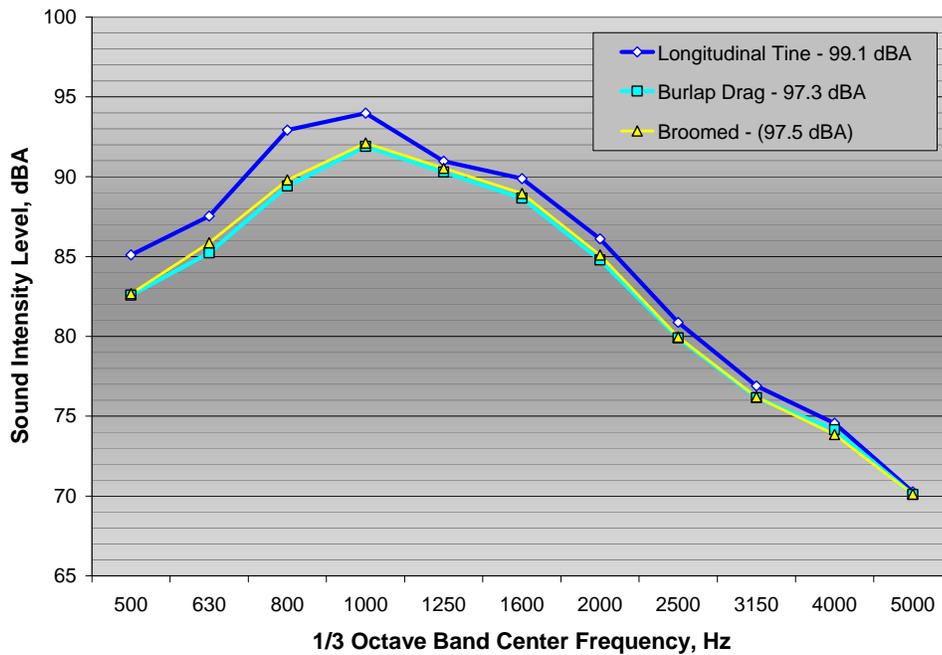
Figure 7: 1/3 Octave band spectra for baseline surfaces measured at 45 mph

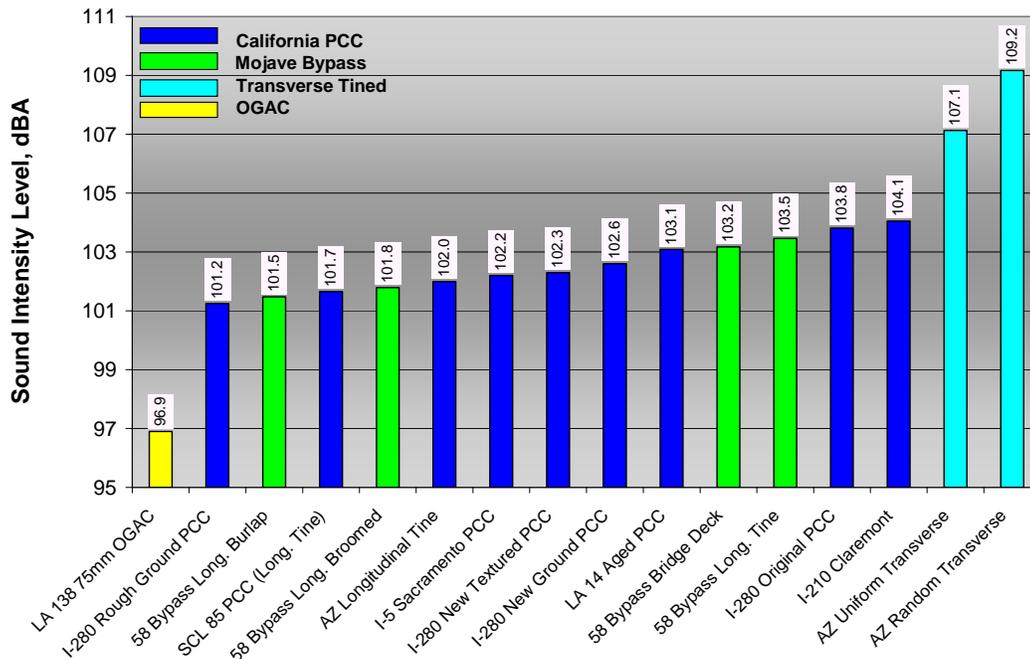
Figure 8: Comparison of Mojave test sections to other California and Arizona pavements

Comparison of the Mojave Bypass baseline textures to the OBSI overall levels of other pavements is presented in Figure 8. These comparisons include PCC surfaces measured in California and Arizona and, for reference, the level measured for the new 75mm thick open graded asphalt concrete (OGAC) surface of the Caltrans Quieter Pavement Research Test Sections of LA 138 near Neenach, California. Relative to the other PCC surfaces, the burlap drag and broom surfaces tend to be among the quietest tested through 2003. Conversely, the longitudinally tined surface produced the levels on the higher end for this type of texture, 1.5 dB higher than an ADOT test surface on SR 202, and 1.8 dB higher than California Santa Clara 85 pavement. However, the Mojave pavement is slightly lower (0.6 dB) than the texture of the new I-210 pavement in Los County. The one-third octave spectra for these four longitudinal tine pavements are shown in Figure 9 and photographs of the four surfaces are compared in

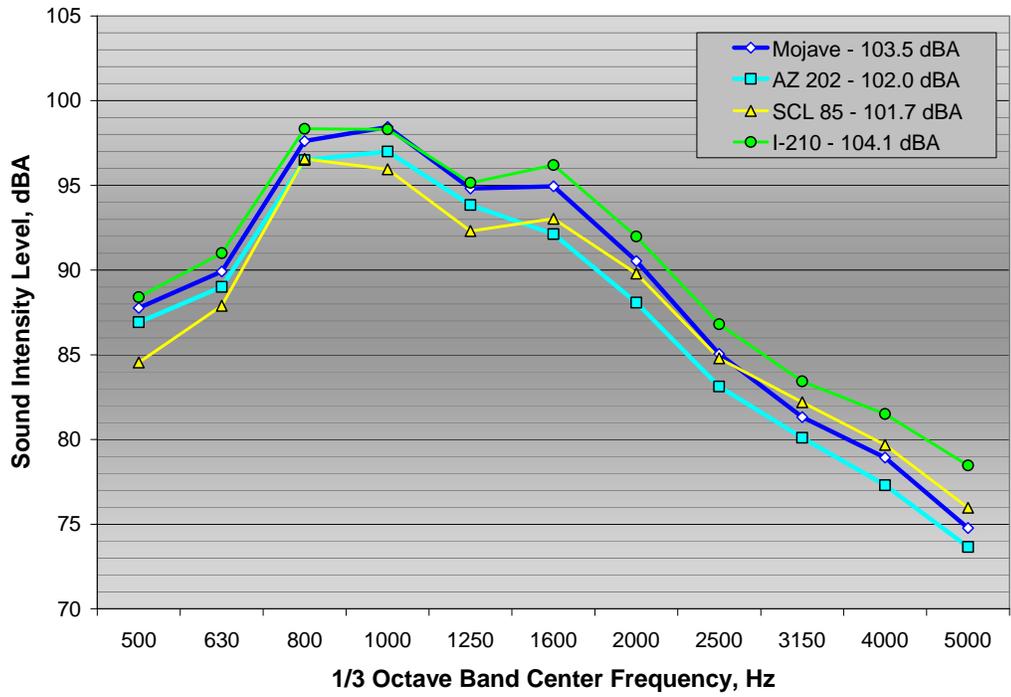
Figure 9: 1/3 Octave band spectra for different longitudinal tine PCC surfaces

Figure 10. In the spectral data, results for I-210 are similar to Mojave although at 1600 Hz and above the levels I-210 range about 1½ dB to 3½ dB higher. From Figure 10, it appears as if there is less small scale texture in the I-210 surface which could induce more friction related noise in these frequencies⁷. In general, however, there is little else from the photographs that appear to explain the total 2½ dB difference between the pavements. The SCL 85 may have slightly less positive texture which could

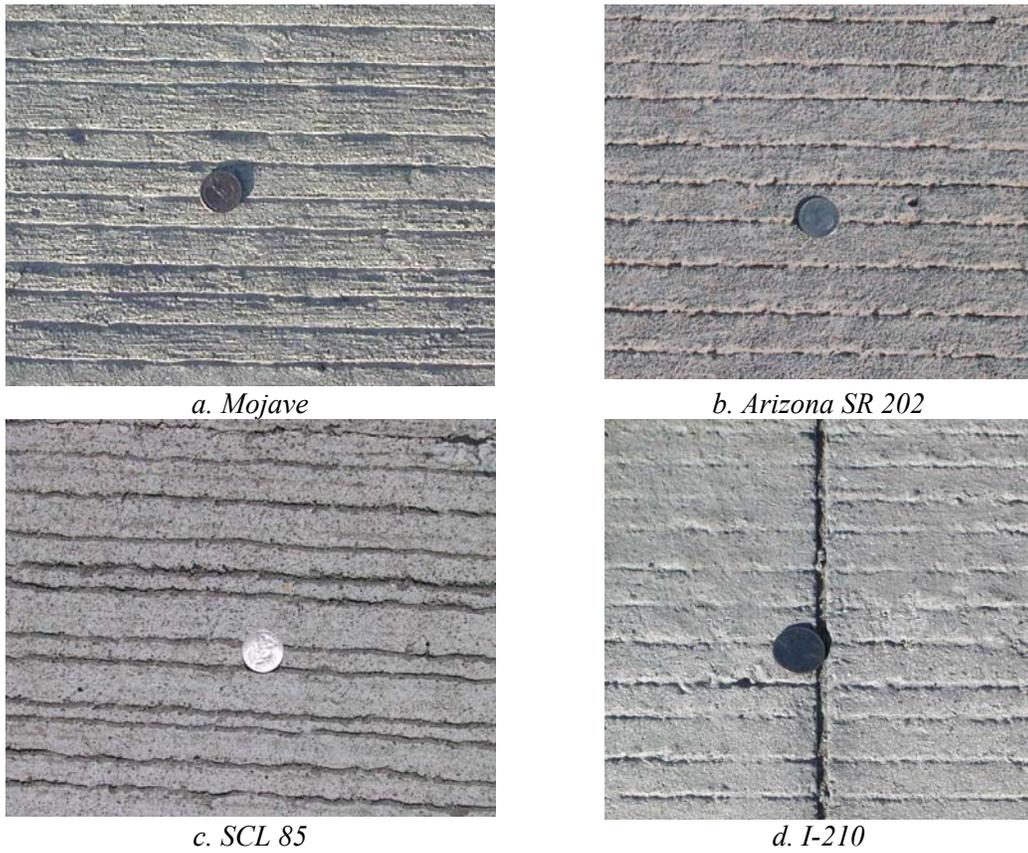
Figure 10: Photographs of different longitudinal tine PCC surfaces

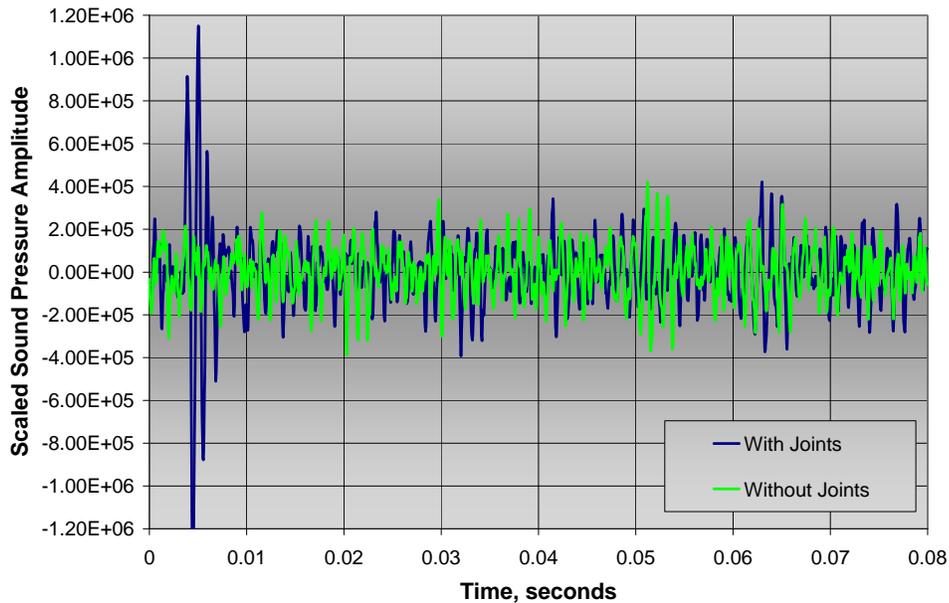
Figure 11: Sound Pressure time signals for burlap drag test section with and without joint slap included (scaled by reference pressure, $20\mu\text{Pa}$)

During the sound intensity tests, the sound pressure signals from the two intensity microphones were audibly monitored for each segment of the roadway surface. In this monitoring, the joints between pavement sections were found to produce audible slaps. After the tests, the signals of sound pressure as a function of time were reviewed on an oscilloscope and noticeable “spikes” in the sound pressure occurred corresponding to the joints. These spikes were of sufficient amplitude relative to the rest of the signal that it was possible to reliably trigger the Larson Davis 2900 Analyzer with these spikes. Using an 80 m-sec time window, the joint spike is clearly visible compared to the more continuous, random signal produced by the surface between the joints as shown in Fig. 11 these sound pressures were

recorded for the inboard, leading edge microphone for the broom finish PCC. To produce a direct comparison of noise level with and without the slap, the time windows including and excluding the slap were produced by delaying the time window relative to the slap. Using this technique, Fast Fourier Transform (FFT) spectra were produced by averaging over eight occurrences with and without the joint slap. To complete the comparison, the narrow band spectra were summed into one-third octave band levels.

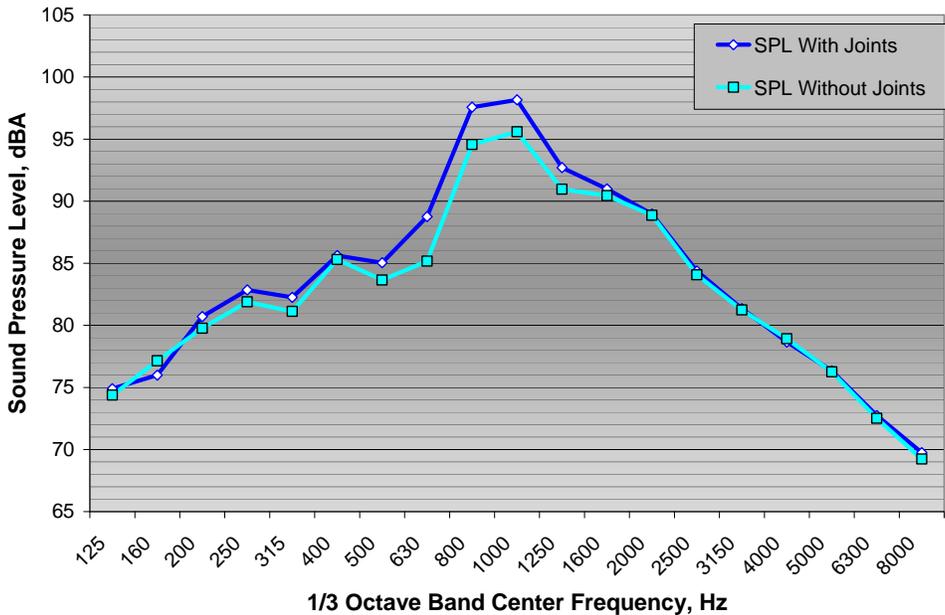
Figure 12: Comparison of 1/3 octave band sound pressure levels with and without joint slap on burlap drag texture surface

The analysis described in the previous section was applied to joints occurring in each of the three baseline pavements. Based on the above discussion, spectral data based on the 80 m-sec window can be properly used for comparing tire/pavement noise with and without the joints included. It should be noted, however, that these spectra are only indicators of OBSI performance as they are constructed from sound pressure level data only. As an example, Figure 12 illustrates that the primary differences with and without the joints for the burlap drag baseline pavement corresponding to the joint slap of Figure 11.

Differences with and without the joint occur at frequencies below 1600 hertz where the levels with the joints are higher. Common to the longitudinal tine and broom surfaces, the differences in individual one-third octave bands were typically 2 to 3 dB or more in the frequencies around 800 hertz. Slightly smaller differences were seen for the longitudinally tined surface. The overall A-weighted levels with and without the joints included can also be calculated by summing the one-third octave band levels. In doing this, it was found that the joints for the longitudinal tine surface increased the level by 1.3 dB, and for the burlap drag and broom surfaces, the joints added 1.9 and 2.0 dB, respectively. As would be expected, the increase for the louder longitudinal tine surface is less than the quieter surfaces because the level between the joints is lower providing less “masking” of the joints.

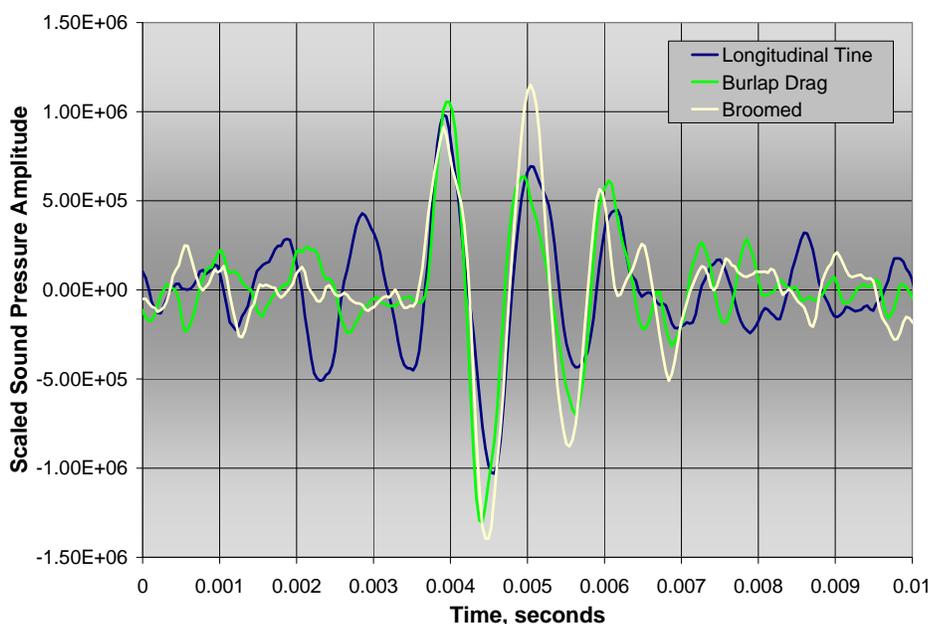
Figure 13: Sound Pressure time signals for joint slaps on baseline surfaces at 60 mph (scaled by reference pressure, 20 μ Pa)

The sound pressure impulses for the three different surfaces can also be compared to gain insight into the events, at least on a qualitative basis. For three events occurring on each surface, it appears that there is little difference in the joint generated impulse as shown in Fig. 13. The joints generate two

positive pressure peaks and possibly a third compared to the rest of the pavement. The cycle of impulse is about 0.001 seconds corresponding to about 1000 Hz. These oscillations decay quickly and fall back into the texture generated sound pressure by the time of the third oscillation. In these data, the second oscillation for the broom surface is slightly higher than the other surfaces, however, this is considered to be more a random occurrence in response as the initial oscillations are almost identical. Data for joint slap at 45 mph is compared to that obtained at 60 mph in Figure 14 for the burlap drag surface. This comparison indicated that the oscillations for the joint are independent of speed in the temporal pattern while the sound pressures for the slower speed are slightly reduced in amplitude. This behavior was later confirmed with an analysis of air-pumping from the pavement grooves in which the frequency of oscillation dependent only the length of the tube formed when the tire contact patch covers the pavement groove⁸.

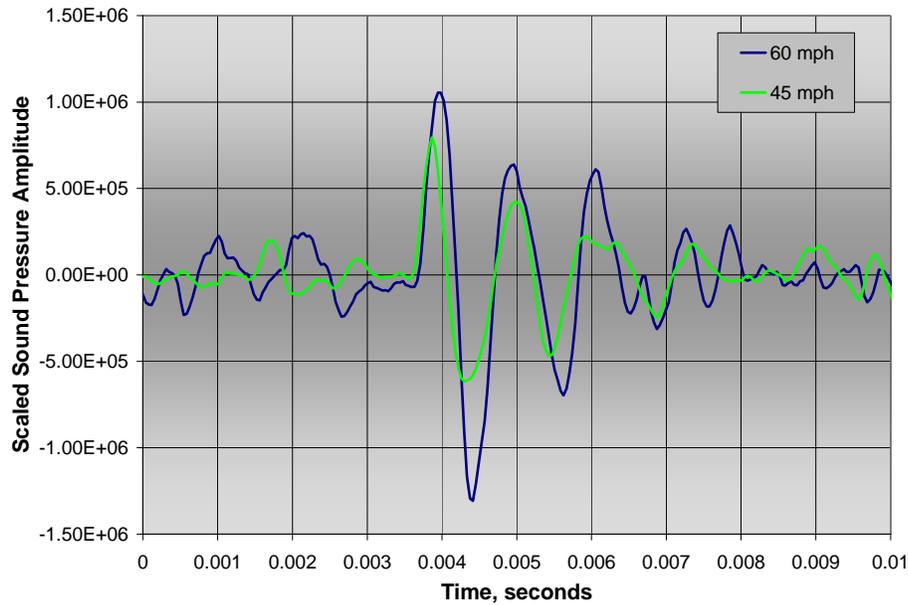
Figure 14: Sound Pressure time signals for joint slaps on burlap drag baseline surface for vehicle speeds of 60 and 45 mph (scaled by reference pressure, $20\mu\text{Pa}$)

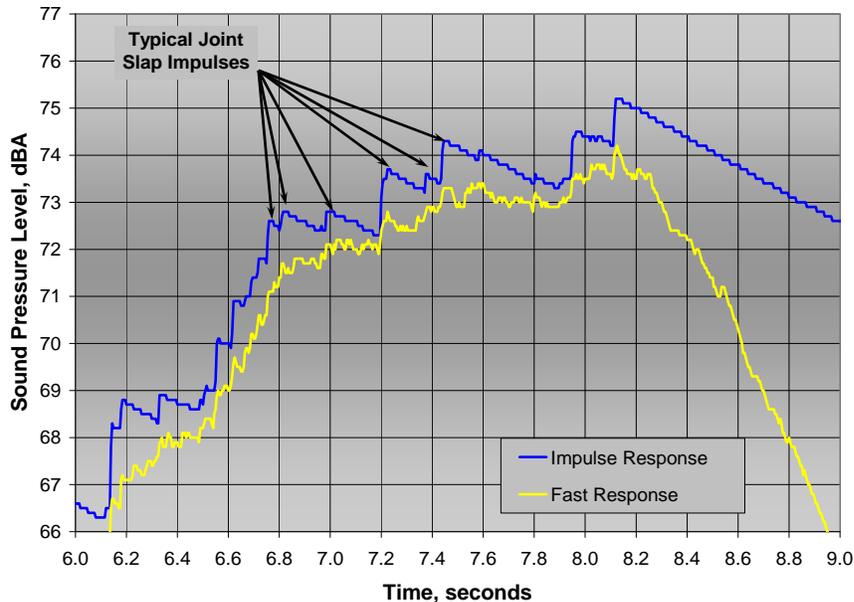
Figure 15: Occurrence of joint slap impulses in pass-by data – 15 m microphone location, 60 mph for longitudinal tine surface texture

The influence of impulsive slap joint noise was also examined in the pass-by data (see Appendix A for further details). To capture this, individual pass-by data were examined using a 5 m-sec sampling of the overall A-weighted “impulse” level and A-weighted “fast” meter response. The impulse function has a 35 m-sec exponential response time which is more suitable for detecting the 5 m-sec impulse generated by the joints, however, its decay time is 1500 m-sec. The fast response corresponds to a 125 m-sec exponential averaging and is used to determine the maximum level during a vehicle pass-by. This type of sound level analysis for a pass-by on the longitudinal tined surface is presented in Figure 15 for the

15 m microphone location. The slaps from the joints are clearly indicated by the impulse response and occur at a rate dictated by the vehicle wheelbase, spacing of the joints and vehicle speed. For 60 mph as shown in Figure 15, the slaps can be as close together as 22 m-sec and as far apart as 160 m-sec. Once the slaps are identified by the impulse response, their effect on the fast response level becomes more apparent. Given the rate of occurrence of the slaps, it was not possible to quantitatively extract the joints from the pavement texture; however, it is apparent that the joints do contribute to the maximum pass-by level.

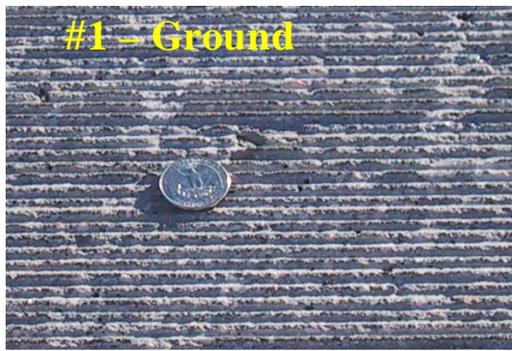
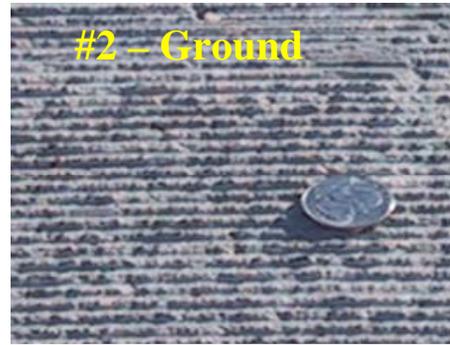
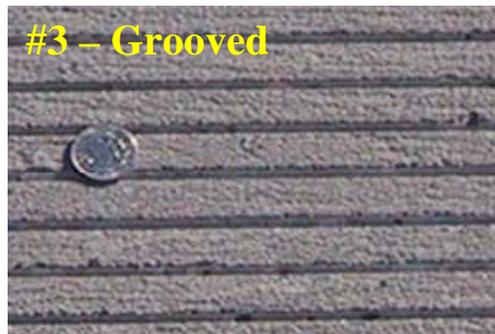
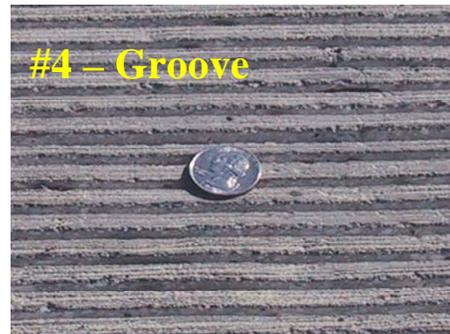
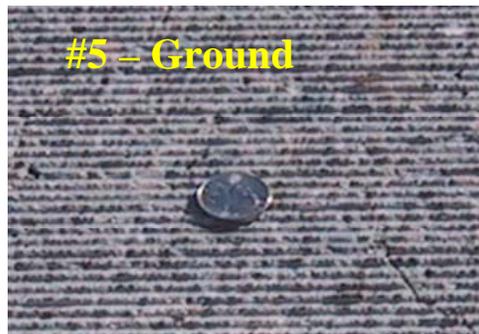
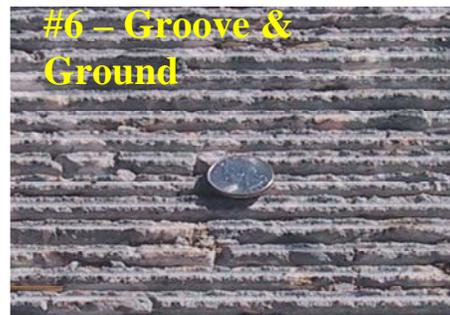
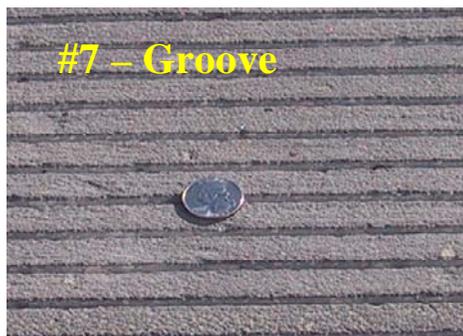
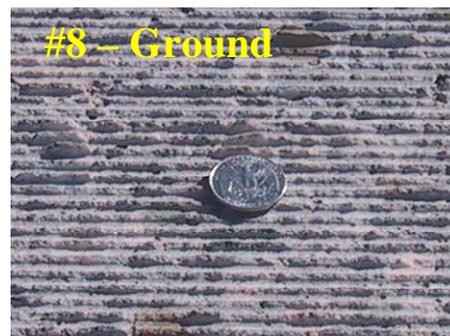
Figure 16: Photographs of modified SR 58 surfaces with various grinding and grooving operations (see Table 1)

In May of 2003, two basic types of surface modifications were applied to the existing PCC surfaces on the Mojave Bypass. The first was “texture grind” in which the blade spacing was varied. For this operation, the grinding did not follow the existing pavement profile, but rather averaged the depth of cut over a fixed distance. This operation tended to eliminate any height discontinuities between adjacent slabs. The grooving operations cut constant depth longitudinal grooves into the pavement following the surface profile. These grooves were varied in both separation and depth for different test sections. Since this operation follows the surface profile and it does not affect any discontinuities at the slab joints. For one of the eight sections, grooving and texture grinding operations were both applied. Specific information on the eight test sections is provided in Table 1 and photographs of each are given in Figure 16.

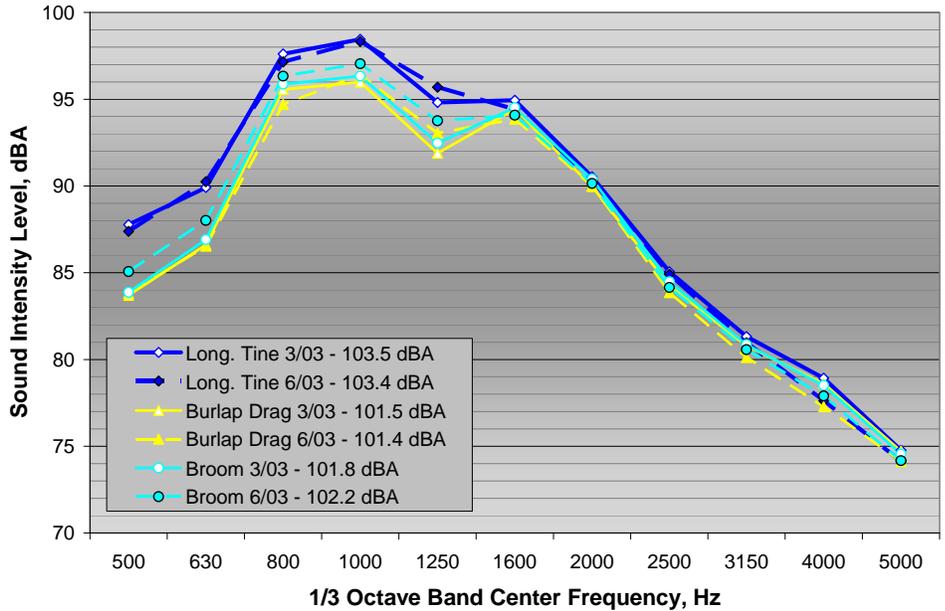
Figure 17: Overall and 1/3 octave band OBSI level comparison of baseline surfaces between March and June testing in 2003

were used, the test vehicle was similar to that used in March, but not identical (1998 Subaru Legacy Outback versus a 1997 model). These somewhat subtle differences, however, appeared not to be an issue as the overall levels were within 0.1 to 0.4 dBA of each other and one-third octave band spectra between the March and June testing compared quite closely as shown in Figure 17. Also, as before, joint slap was audible for all three surfaces.

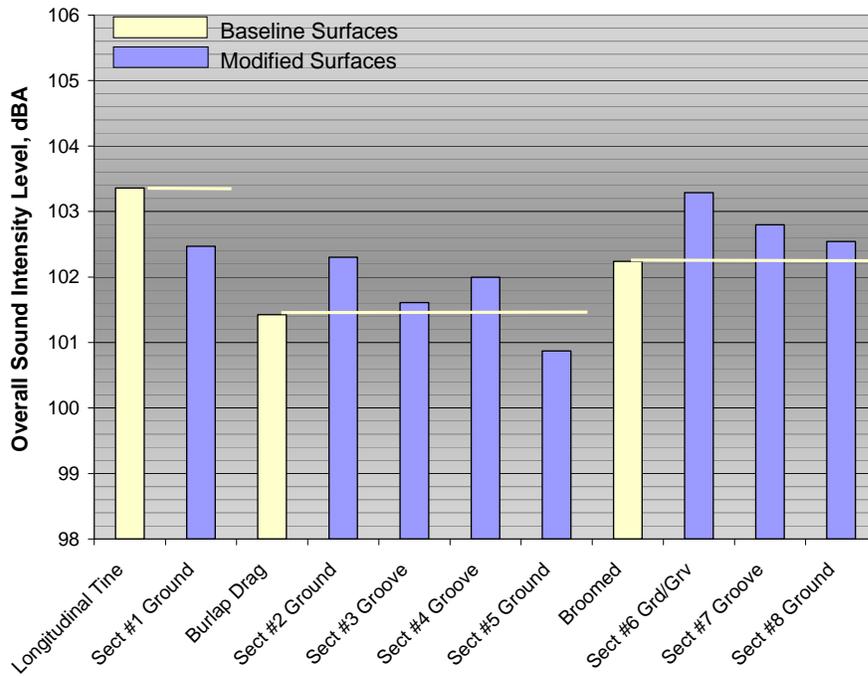
Figure 18: Comparison of overall A-weighted sound intensity levels for baseline and modified surfaces

Overall A-weighted sound intensity levels for the original surfaces and the eight new test sections are presented in Figure 18. Compared to the “base” surface, the test sections produced higher noise level in six of the eight cases. The two that produced lower levels, Section #1 & #5, were both texture grind surfaces. In general, the texture grind surfaces did not have audible joint slap, however, this did not always result in lower levels relative to the base surface (e.g. Sections #2, #6, and #8). Spectral differences are also apparent between the different surface treatments as shown in Figure 19. These occur in two frequency ranges: lower frequency, at 800 hertz and below; and higher frequencies of 1,600 to 2,000 hertz. With the exception of the longitudinal tined base surface, the texture grind surfaces tend to produce higher levels in the lower frequency region while they produce consistently lower levels in the higher frequency range.

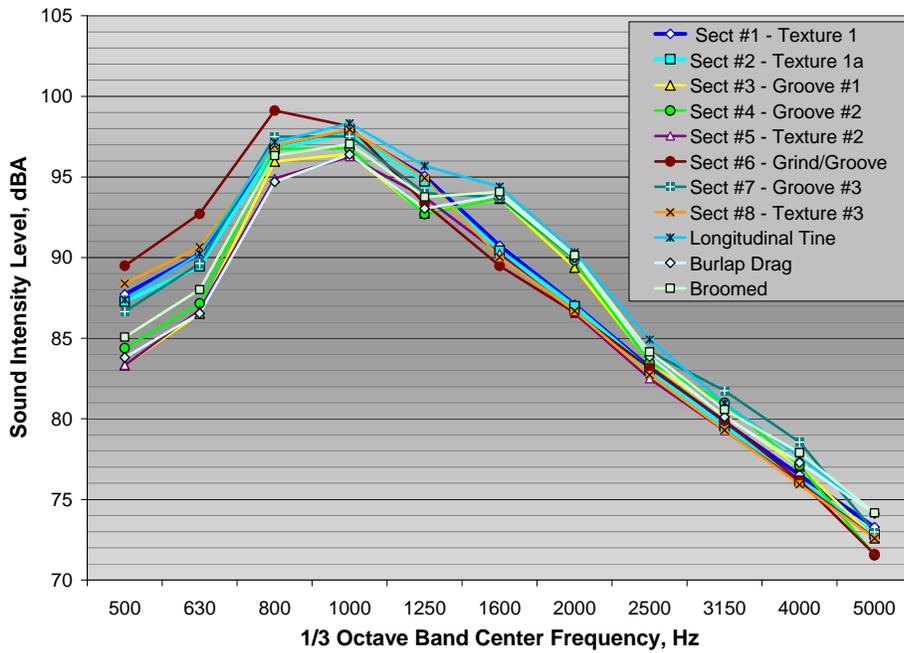
Figure 19: Comparison of one-third octave band A-weighted sound intensity spectra for the Mojave SR 58 baseline and modified surfaces

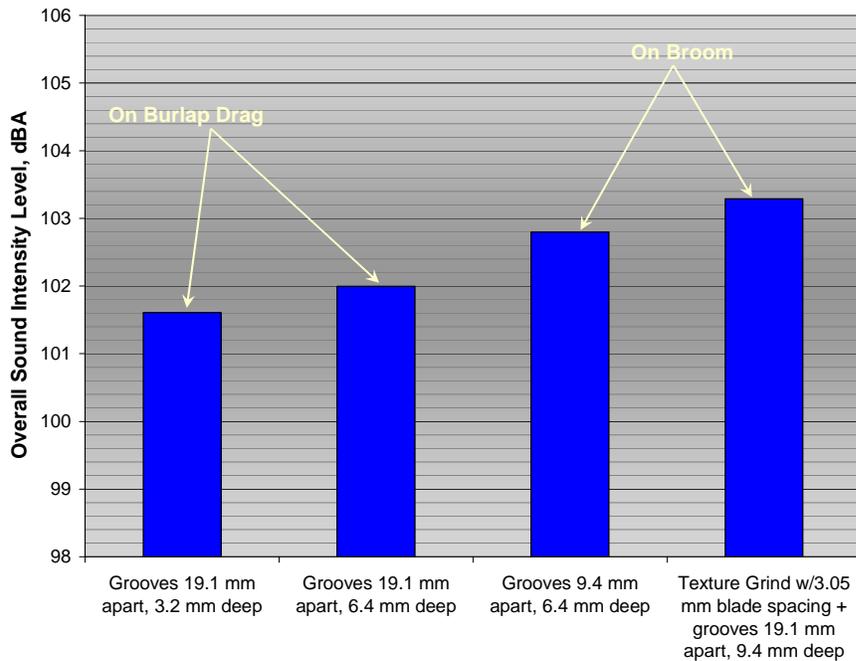
Figure 20: Comparison of overall A-weighted sound intensity levels for various grooved test surfaces

Given the small range in noise level for the base surfaces, it is difficult, at best, to draw conclusions within each type of surface treatment. In Figure 20, the overall A-weighted sound intensities for the various grooved test sections are compared. Excluding the surface that is both grooved and ground, the range in the ground surfaces is small, just over 1 dB. In what should be direct comparison of the groove parameters, it is seen that with groove depth held constant at 1/4 inch, the closer spacing (3/8 inch) produced slightly higher levels than the wider spacing (3/4 inch). However, the difference in level between the burlap drag and broomed base surfaces alone are greater than this apparent difference from the grooving. For constant groove spacing, the shallower depth (1/8 inch) produced directionally lower

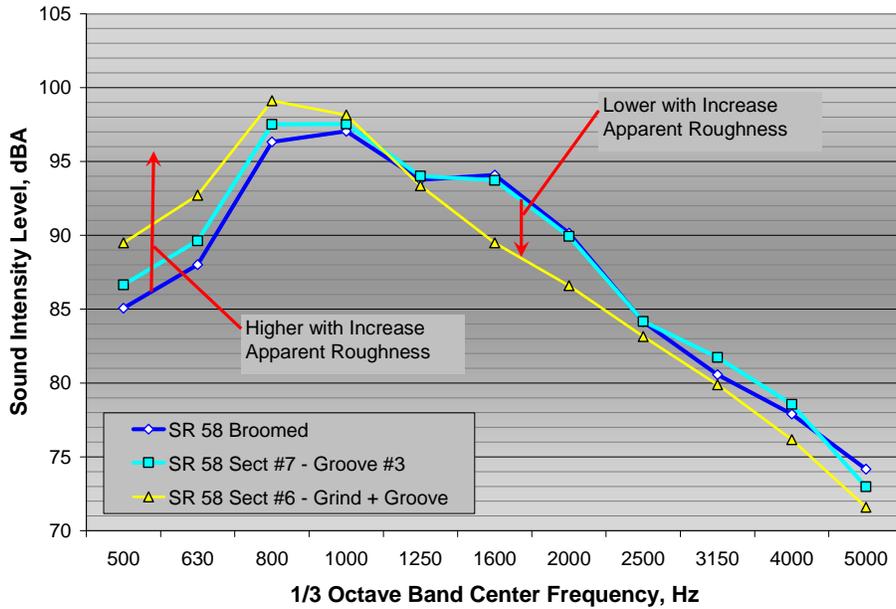
Figure 21: Comparison of one-third octave band A-weighted sound intensity spectra for various grooved test surfaces

levels than the deeper grooves (1/4 inch) on the same burlap drag base surface. However, given the typical measurement uncertainty on the order of ± 0.2 dB for “back-to-back” runs, the significance of the difference measured for these different groove depths is questionable. Further, in comparing the different groove parameter cases to the base surface (see Figure 18), in each case, grooving raised the noise level over the base surface. On the broomed surface, combining texture grinding with grooving displayed no noise benefit, and may have slightly increased the noise over grooving alone. As suggested previously, adding grinding to a grooved surface improved the noise at higher frequency from 1,600 to 2,000 hertz at the expense of raising levels in the lower frequencies as shown in Figure 21.

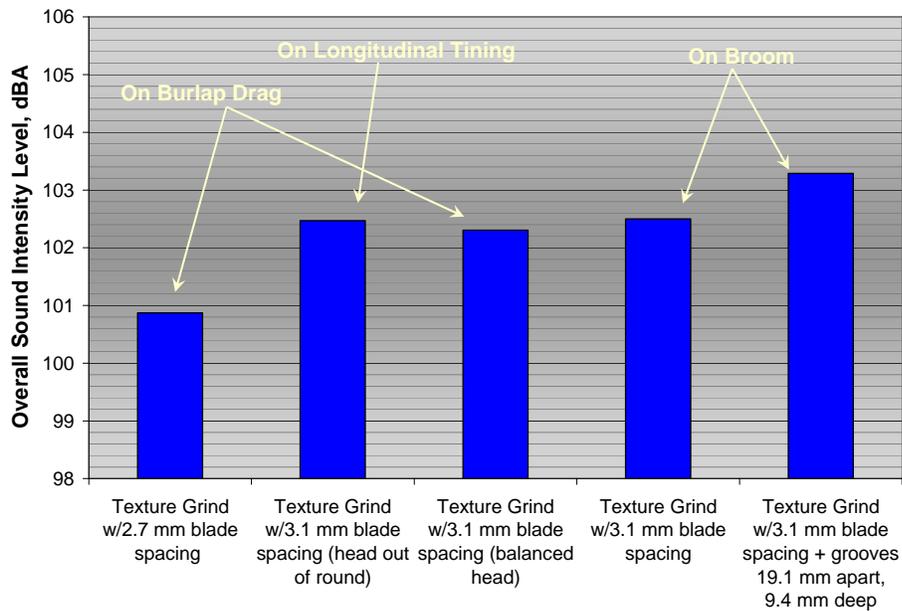
Figure 22: Comparison of overall A-weighted sound intensity levels for texture ground test surfaces

Based only on the elimination of audible joints slaps with the different grinding parameters, it would be expected that the ground surfaces would be quieter than the corresponding base surfaces. For Test Section #1 and #5 this is apparently the case (Figure 18). However, for Sections #2 and #8, the ground surfaces are actually higher in level than the base surfaces. Comparing the overall levels of the texture grind surfaces shown in Figure 22, some noise levels differences are sufficiently large and comparisons sufficiently direct that some differences are apparently significant. On the burlap drag base surface, a smaller blade spacing of 0.105 inches versus 0.120 inches lowered the noise level by 1.4 dB. For a constant blade spacing of 0.120 inches, there was no dependence on the base surface. This implies that the texture grinding process eliminates other surface features which would normally create differences between PCC surfaces. Visually, this is seen in comparing the photographs of Test Sections #1, #2, and #8, which were originally longitudinally tined, burlap drag, and broom surfaces, respectively. This is also confirmed by spectral data presented in Figure 23 which shows virtually no frequency content difference between the 0.120 inch spacing, texture grind surfaces as applied to the three difference base surfaces. In contrast, the 0.105 inch spacing, texture grind surface displays reduced low frequency

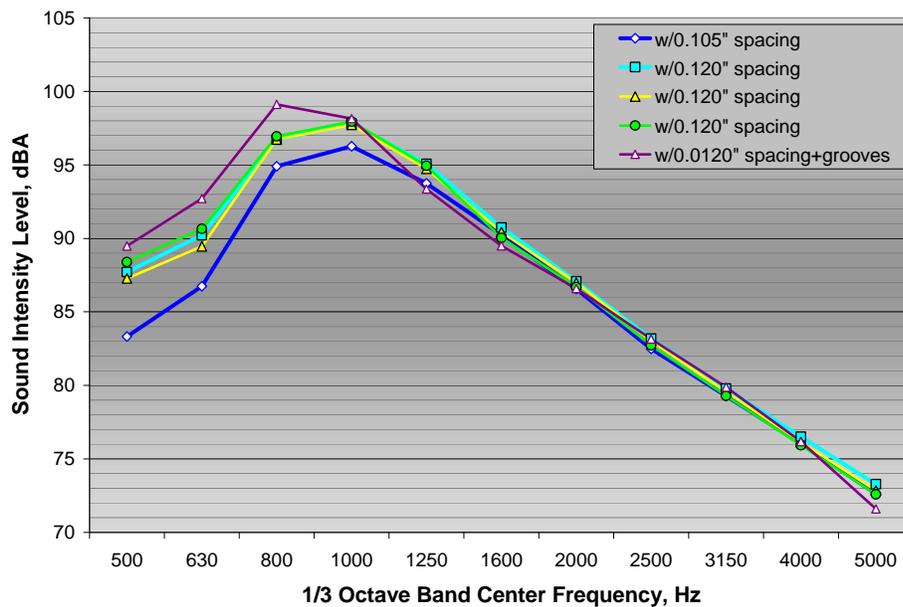
Figure 23: Comparison of one-third octave band sound intensity spectra for texture ground test surfaces with different blade spacings and grooves

content below 1,250 hertz. This is consistent with results from other pavement surfaces in which lower visual “roughness” produced lower, low frequency levels also³. This trend is also seen for the surface that had both texture grinding and grooving. For this case, visually (see Figure 16), the surface was rougher than the surfaces that were only ground (Sections #7 and #8). This surface also produced more low frequency content than the comparable surfaces that were only ground

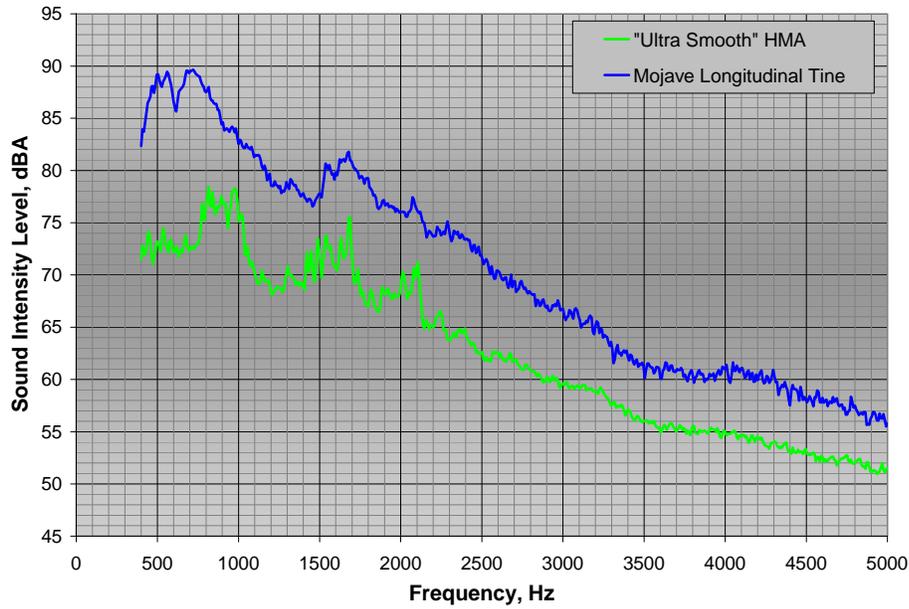
Figure 24: Comparison of narrow band sound intensity spectra for fine texture asphalt test track surface and Mojave longitudinal tine test surface

In regard to the higher frequency differences between the texture grind and non-ground surfaces, comparison to other pavements is useful to understand the nature of the tire noise in the frequencies in the range of 1,500 to 2,300 hertz. On very fine texture surfaces such the “ultra smooth” HMA pavement tested at the Hyundai-Kia (H-K) Proving Ground in California City, California using narrow band analysis, it appears that the energy in this region is related to the tread of the Aquatred tire⁹. Data for this surface is presented in Figure 24 along with data from the longitudinal tine Mojave Bypass surface. For the H-K surface, it is seen that discrete frequencies modulated by the tread passage frequency around 850 Hz account for much of the spectral content between about 750 and 1050 Hz. . The second harmonic of this grouping of frequencies appears in the range from about 1500 Hz to 2100 Hz. Although the levels on the H-K track are lower than the Mojave surface, evidence of the peaks in the range from 1,500 to 2,200 Hz are clearly visible. Comparing the grooved S4 and ground S5 Mojave narrow band data shown in Figure 25, the differences between the two textures occur in this same range related the tread pattern. This implies that difference is at least partially due to tire noise mechanisms associated with higher harmonics of the tread passage frequency. Several of these can hypothesized including air-pumping from the tread voids, higher frequency tread vibration, and scrubbing¹⁰. From Figure 16, it is seen that both S4 and S5 have longitudinal grooves in their surface. These should help to relieve air-pumping in both cases and therefore not a likely candidate to explain these differences. For tread vibration, it is seen that the S4 surface has more apparent and random roughness. These features could tends to “break-up” the higher frequency noise which is dependent on a constant repetition rate

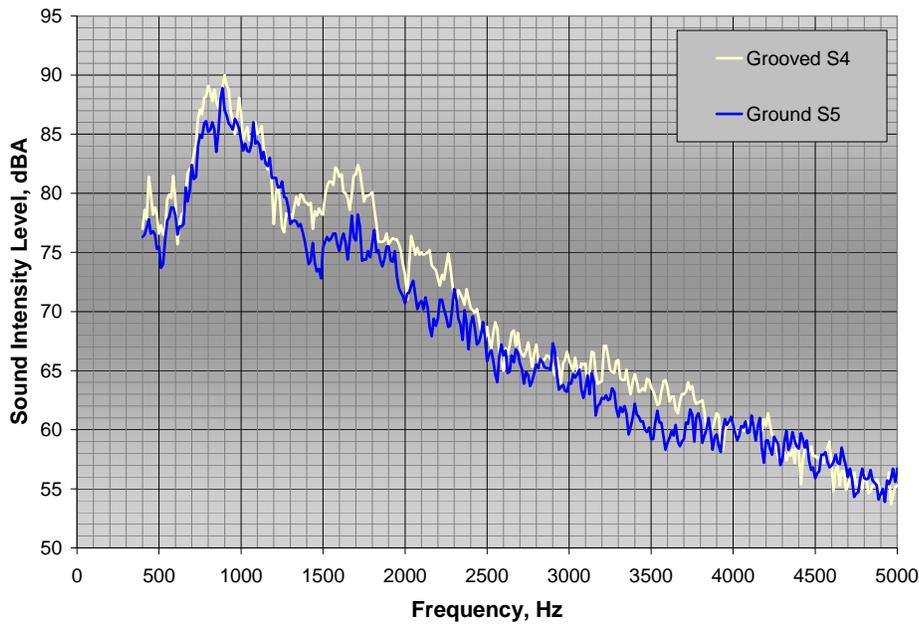
Figure 25: Comparison of narrow band sound intensity spectra for fine texture asphalt test track surface and Mojave longitudinal tine test surface

and shift some energy to the lower frequencies as indicated by Figures 21 and 25. Finally, surface S5 has more fine scale roughness than S4 and possibly slightly higher friction. This could account for a reduction in higher frequency scrubbing noise¹¹. Higher frequency noise mechanisms are discussed further in Chapter 5 in regard to acoustic longevity.
