Initial and Long-Term Evaluation of the Tire-Pavement Noise Produced by Various Portland Cement Concrete Surface Textures

*Measurements on the State Route KN 58 Mojave Bypass
2003 to 2010*

Paul R. Donovan, Sc.D.
Illingworth & Rodkin, Inc.
505 Petaluma Boulevard South
Petaluma, CA 94952

June 6, 2011

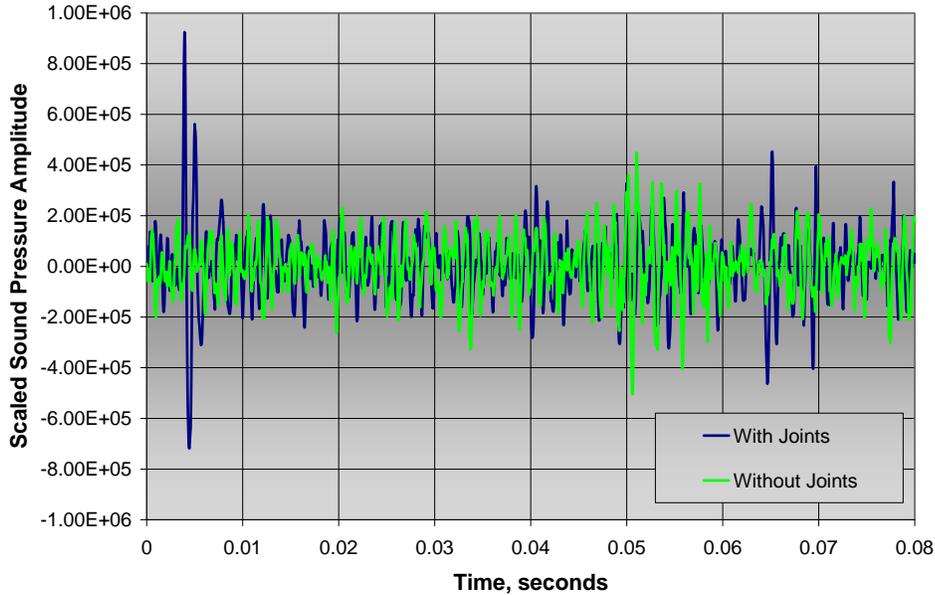
Figure 26: Sound Pressure time signals for grooved test section #3 with and without joint slap included (scaled by reference pressure, $20\mu\text{Pa}$)

Following the process used to analyze the March 2003 recordings, analysis of the sound pressure signals of the inboard microphone of the sound intensity probe opposite the leading edge of the contact patch were performed in the time domain to isolate the contribution of joint slap. As before, post and pre trigger delays were used capture time histories with and without the joint slap included. The resultant time signals for the grooved surface of Section #3 are shown in Figure 26. Comparing these data to

Figure 11, it is apparent that the impulse produced by the grooved was little changed over the base burlap drag texture. This is not surprising as the grooving operation did not effect any slab misalignment at the joint. For the ground surfaces, the slaps were not nearly so pronounced as the base or grooved surfaces. For these cases, the trigger level was lowered until the analyzer captured individual time blocks corresponding to the barely discernable peak pressures in the time signal. An example of the resulting time traces is given in Figure 27 for the ground surface of Section #5. The one-third octave band levels derived from the narrow band averaged sound pressure levels are given in Figures 28 and 29 for the grooved and ground surfaces of Figure 26 and 27, respectively. In Figure 29, there is only a small difference in the spectra with and without the (apparent) joints with individual bands being 1 dB or less. When the joints were audible in the recorded data as for grooved Section #3, the spectra levels below 2000 hertz were higher with the joints included by typically 1 to 3 dB (Figure 28).

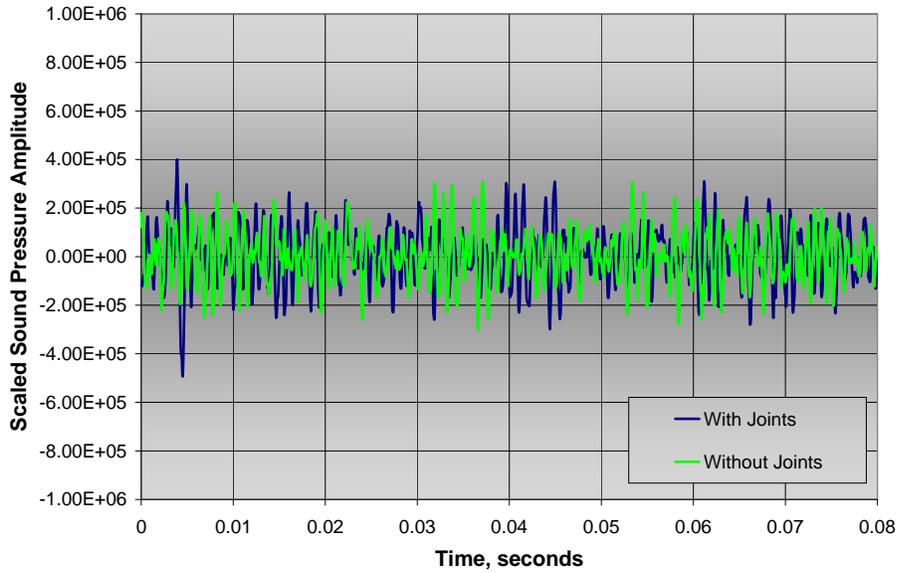
Figure 27: Sound Pressure time signals for ground test section #5 with and without (weak) joint slap included (scaled by reference pressure, $20\mu\text{Pa}$)

Since the contribution of joints is included in the 5-second average sound intensity data reported in Figure 18, the rank ordering includes both the effect of texture differences and the joints. As a result, it is not possible to isolate and rank order differences due to textures for the OBSI data. However, this can be approximated by considering the overall sound pressure levels calculated from the no-slap sound pressure traces such as the no slap date from Figures 26 and 27. These results are shown in Figure 31

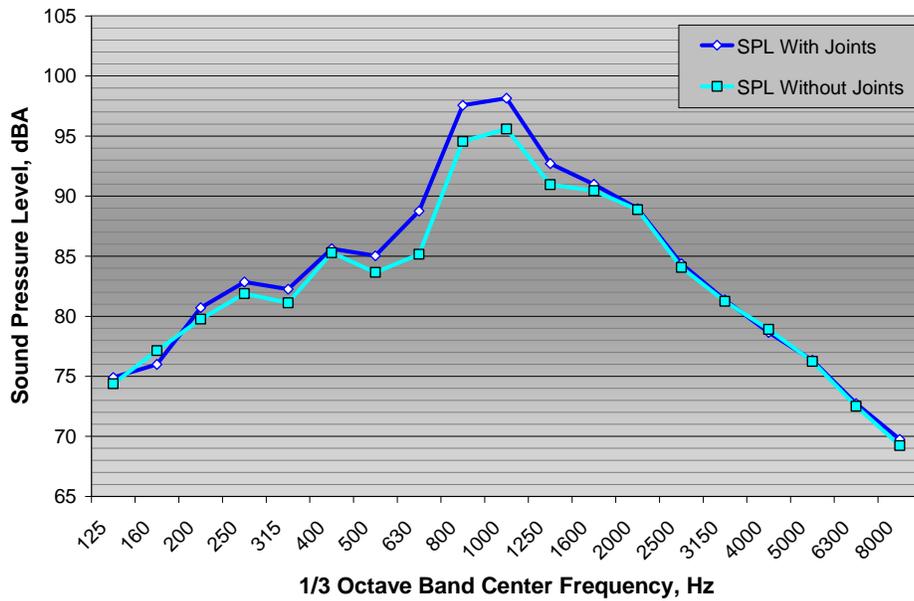
Figure 28: Comparison of 1/3 octave band sound pressure levels with and without joint slap on grooved surface #3

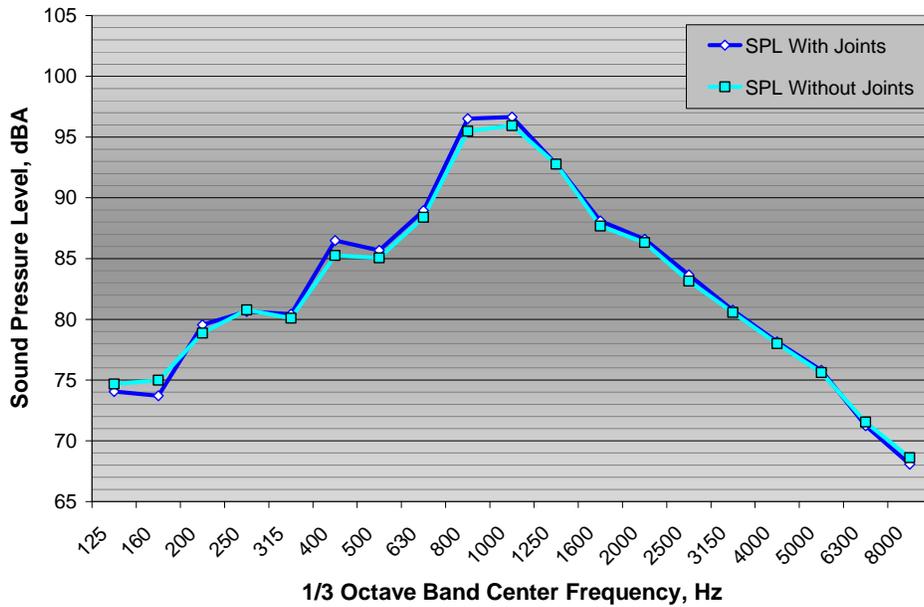
Figure 29: Comparison of 1/3 octave band sound pressure levels with and without joint slap on ground surface #5

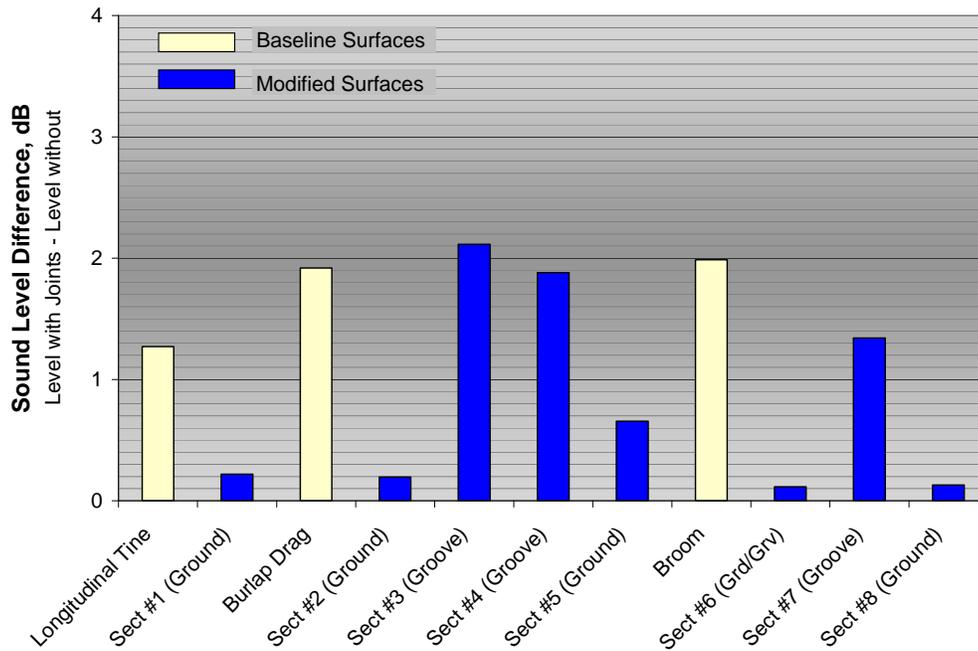
Figure 30: Difference in overall A-weighted sound pressure level with and without joint slap included

The one-third octave band data can be further summed into overall A-weighted sound pressure levels and the difference with and without the joints examined. This approximate indicator of joint noise contribution is presented in Figure 30 for all eleven of the surfaces tested. This comparison reveals that the surfaces which were not ground consistently had more contribution from the joints (1 to 2 dB) while the ground surfaces had typically $\frac{1}{2}$ dB or less contribution.

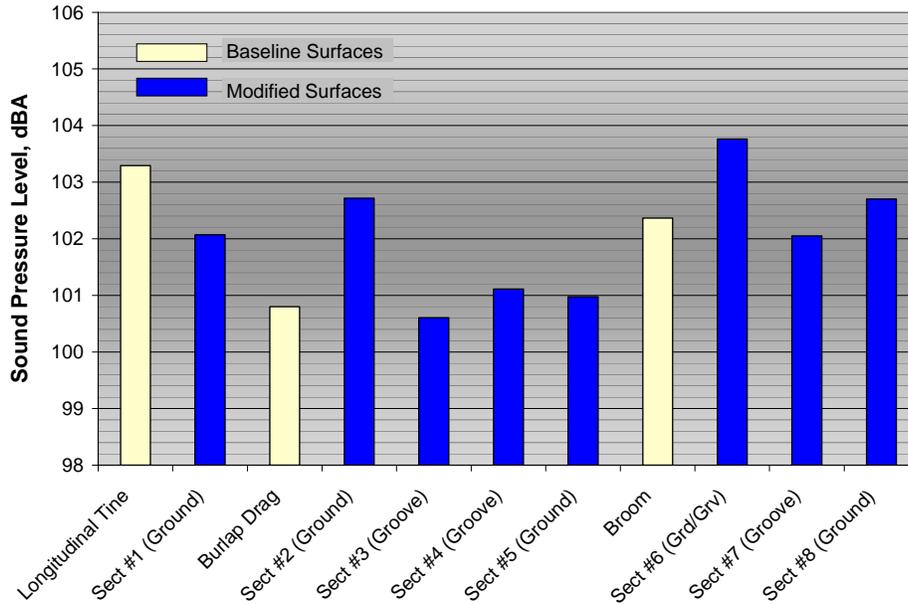
Figure 31: Comparison of overall A-weighted sound pressure levels for baseline and modified surfaces with joint slap impulses excluded

and data help to confirm some the interpretation of the sound intensity data regarding differences in the surface treatments. As speculated previously, it appears from Figure 31 that adding grooves the existing burlap drag or broomed surface has virtually no effect on the noise over that dictated by the base surface treatment. Aside from the longitudinal tine section, higher levels generally were produced by those surfaces receiving the 0.120 texture grind surfaces (Sections #1, #2, #6 and #8). The 0.105 ground surface, however, appears to produce levels lower than the 0.120 surfaces and is similar to the quietest, burlap drag existing surface. This texturing also has the benefit of reducing joint slap noise. As a result, it is not surprising that this surface produced the overall lowest time-averaged sound intensity level. From the results of Figures 29 and 30, it appears that the shallower 0.105 texture grind did not eliminate the joint contribution as effectively as the 0.120. On the other hand, the lower apparent roughness of the 0.105 surface produced considerably less low frequency content in the sound intensity results (Figure 19). For the high frequencies, 1600 and 2000 hertz, the 0.105 surface was just as effective in reducing the tread related noise as were the 0.120 texture grind surfaces. This would suggest that a texture grind for a given pavement could be optimized for a given existing PCC pavement. The optimization considerations would be: 1.) sufficient depth of the grind to reduce the effects of joint and/or slap faulty; 2.) lower surface roughness to minimize mid frequency noise (400 to 1000); 3.) sufficient surface roughness to break-up higher frequency tread related noise.

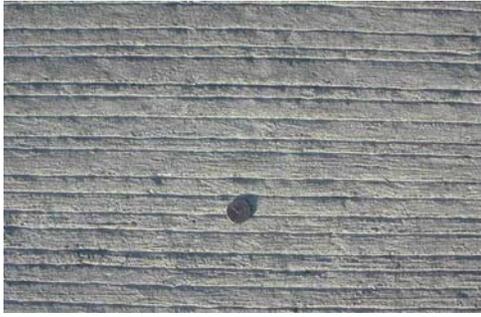
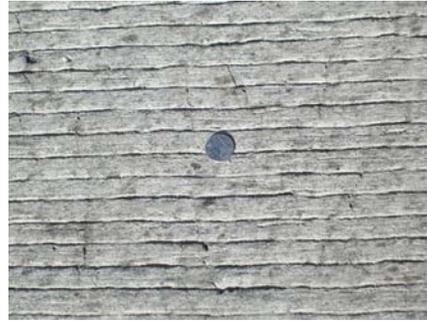
Figure 32: Longitudinally tined PCC in 2003 (left) and 2008 (right)

For the Mojave sections, it appears that air-pumping was not a significant factor in the changes observed in the higher frequencies with aging. Comparing the photographs of the pavement surfaces Figures 32 through 37, none reveal a significant decrease in surface openness. As noted previously, ground surface S1 did possess some initial fins that appear to generate increased roughness that lessened with time. However, this behavior was not evidenced on any of the other surfaces and clearly not for the burlap

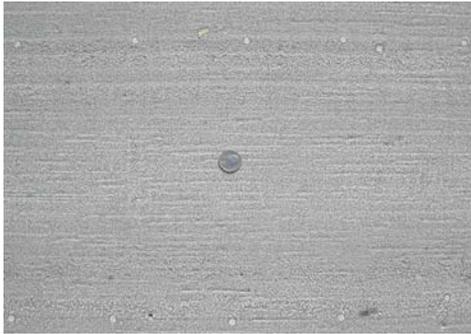
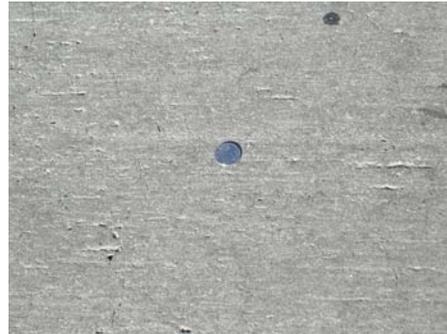
Figure 33: Burlap drag texture PCC in 2003 (left) and 2008 (right)

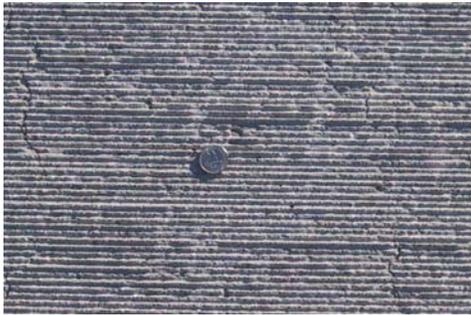
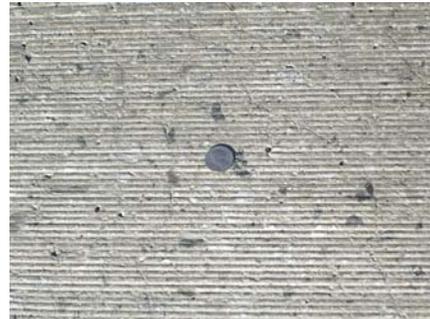
Figure 34: Ground PCC surface Sect #1 in 2003 (left) and 2008 (right)

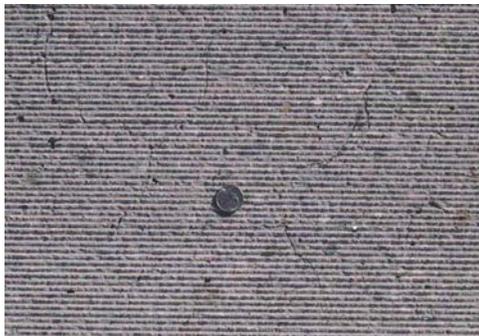
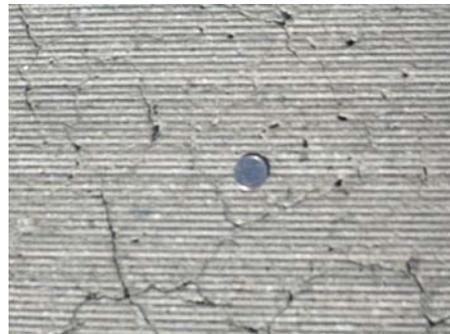
Figure 35: Ground PCC surface Sect #5 in 2003 (left) and 2008 (right)

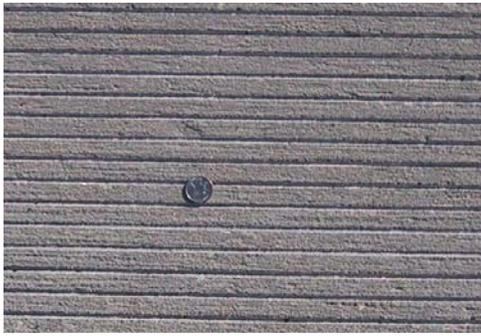
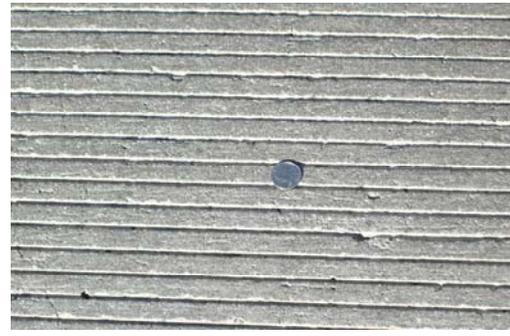
Figure 36: Grooved PCC surface Sect #3 in 2003 (left) and 2008 (right)

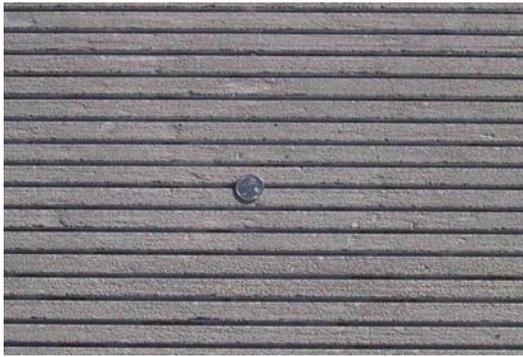
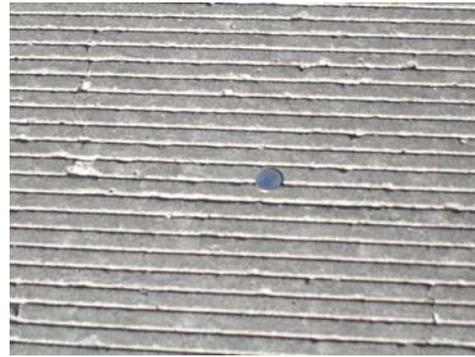
Figure 37: Grooved PCC surface Sect #4 in 2003 (left) and 2008 (right)

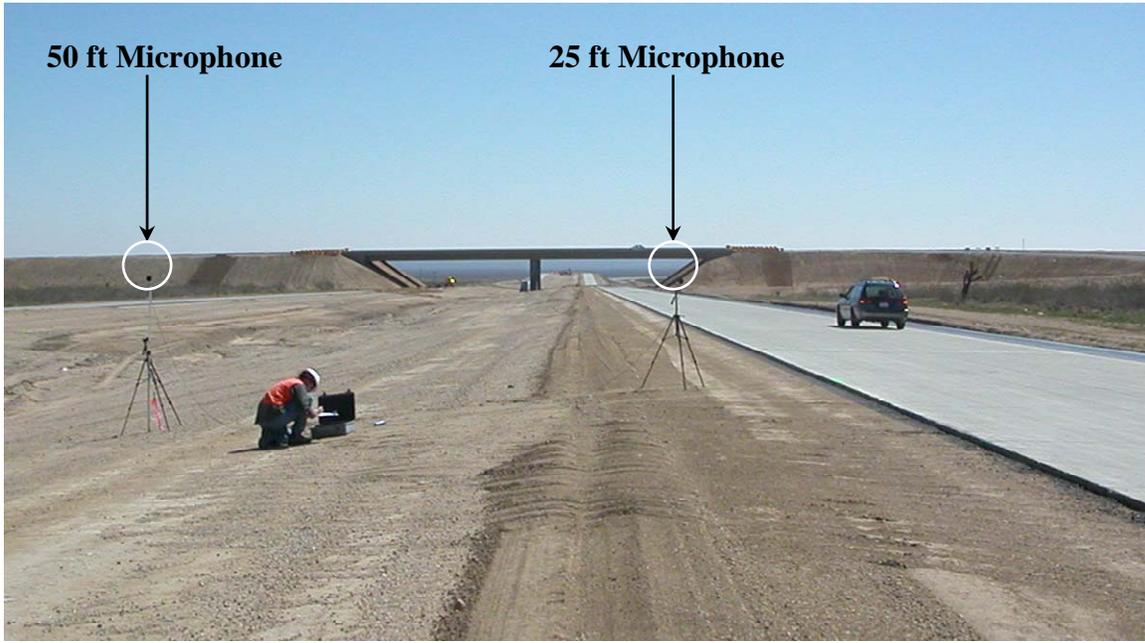
Figure A-1: Typical Setup and site geometry for controlled vehicle pass-by tests

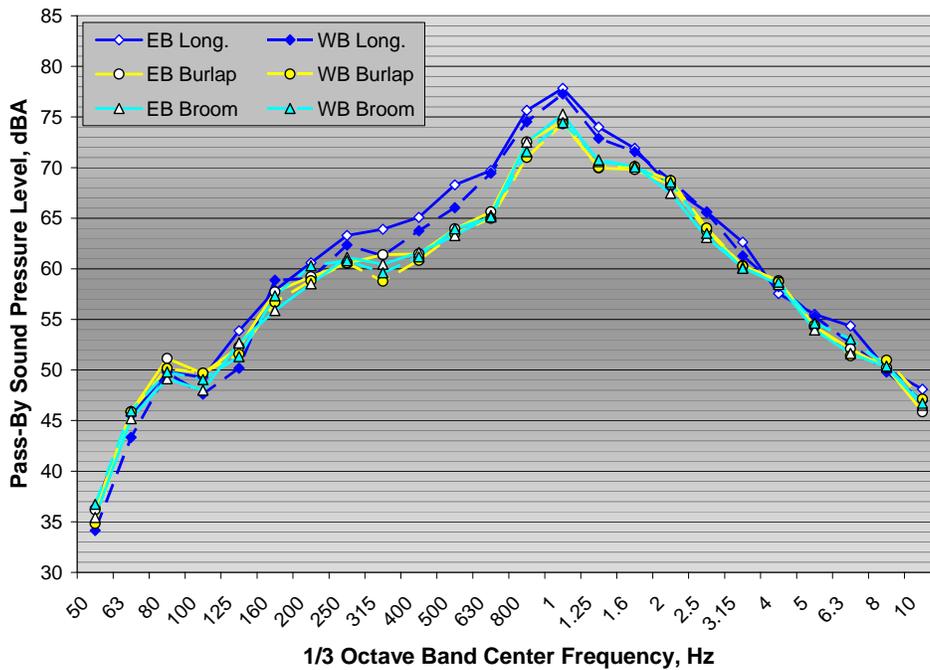
Figure A-2: Controlled pass-by levels for test vehicle in both directions of travel over the same lane as measured at 25 ft

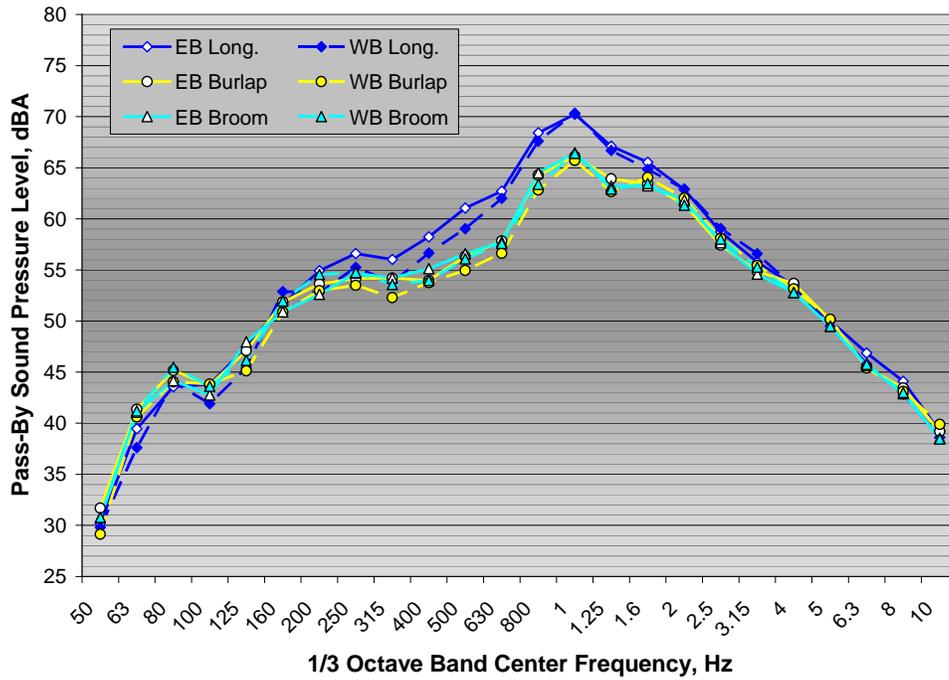
Figure A-3: Controlled pass-by 1/3 octave band sound pressure levels for test vehicle in both directions of travel over the same lane as measured at 50 ft

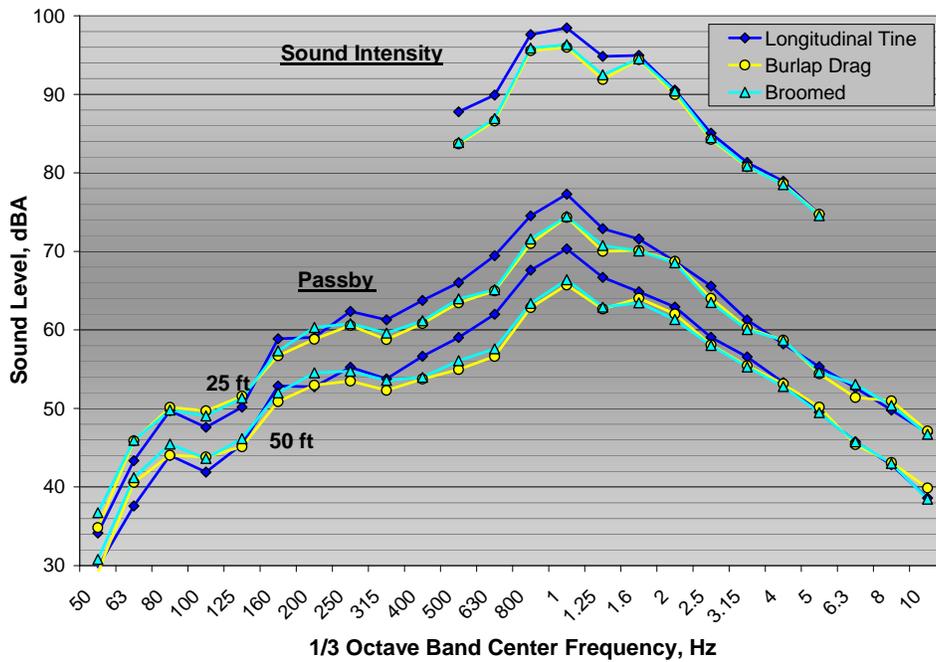
Figure A-4: On-board sound intensity and controlled pass-by sound pressure 1/3 octave band levels as measured at 25 and 50 ft

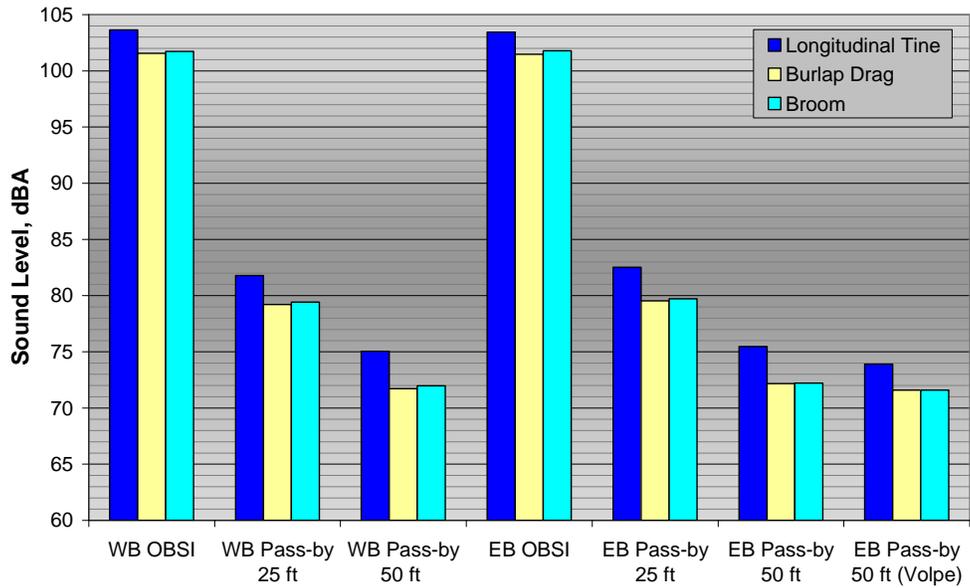
Figure A-5: Overall A-weighted on-board sound intensity and controlled pass-by sound pressure levels as measured at 25 and 50 ft in both directions of travel

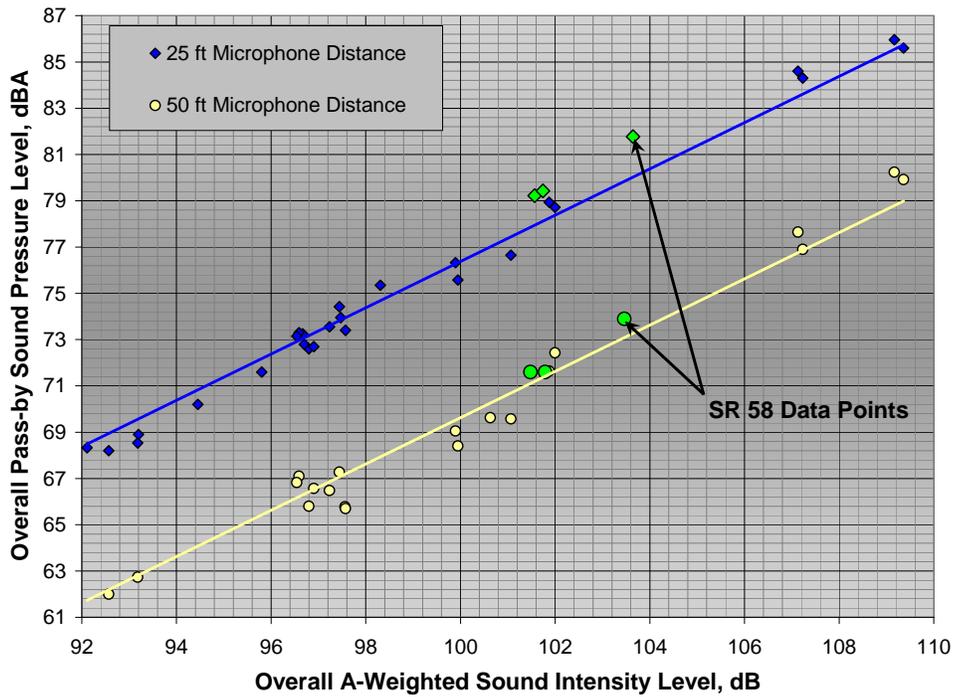
Figure A-6: Overall A-weighted controlled pass-by sound pressure levels versus on-board sound intensity levels as measured at 25 and 50 ft for Mojave Bypass and other locations

controlled pass-by levels are plotted versus OBSI levels for the Mojave Bypass as well as other locations in California and Arizona. The indicated constant offset lines correspond to average differences of 23.6 and 30.4 for the 25 and 50 ft data, respectively. The standard deviation about these average differences is 0.8 dB for both microphone distances.

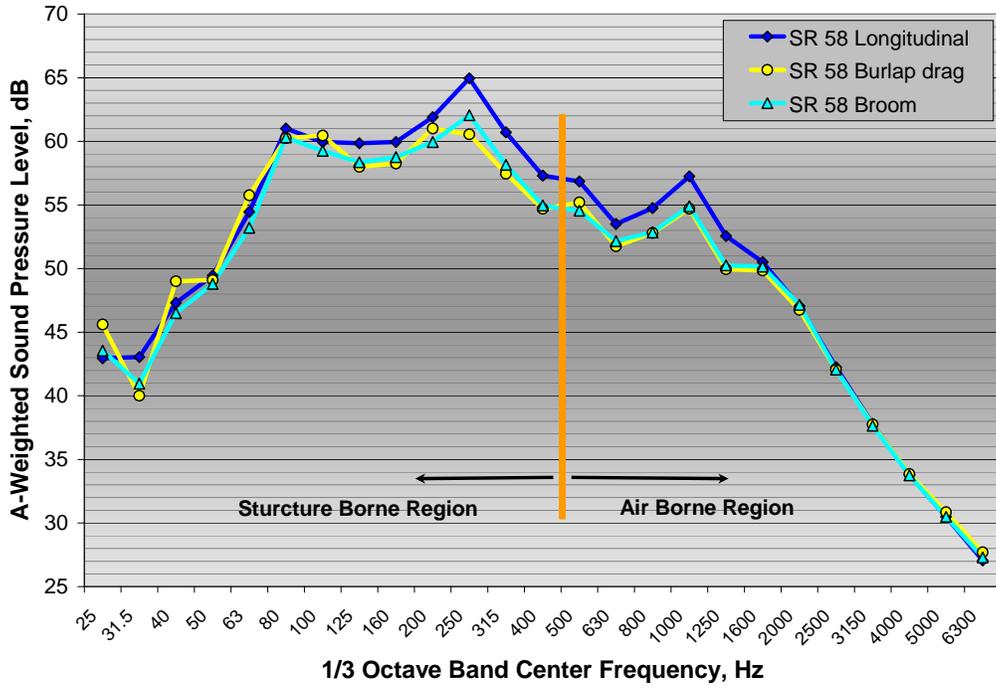
Figure B-1: Interior noise measurements on Mojave Bypass baseline test surfaces

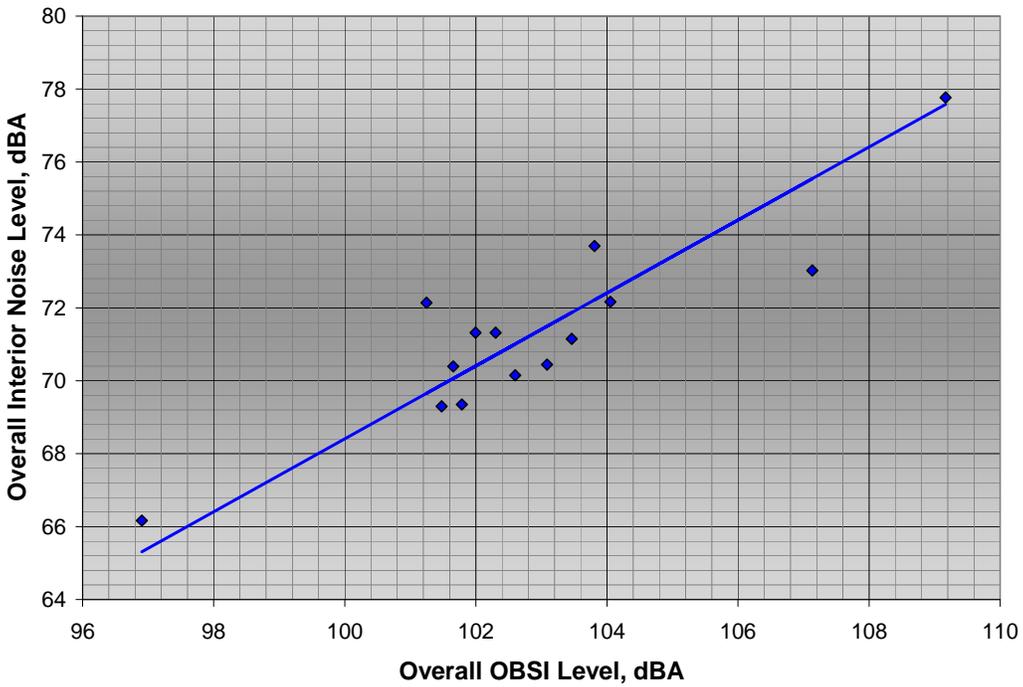
Figure B-2: Interior noise vs. OBSI comparison of Mojave Bypass Sections to other PCC pavements & the LA 138 OGAC test surface (Offset = 31.6 dB, $\sigma = 1.2$ dB)

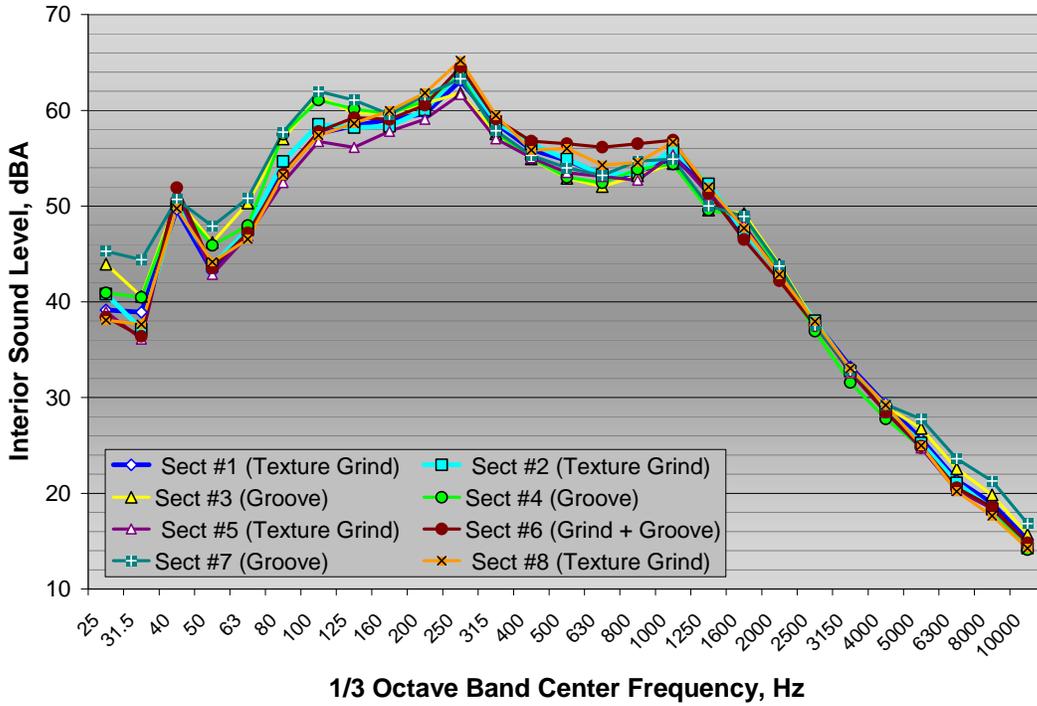
Figure B-3: Interior noise comparison of 1/3 octave band interior noise spectra for different the modified Mojave Bypass tests surfaces

The low frequency differences can also be examined by comparing the interior noise spectra between the base pavement surfaces, a grooved and a ground surface. As shown in Figure B-5, the longitudinally tined, burlap drag, and broom surfaces all produce similar levels in the frequency range from 50 to 160 hertz to that of the grooved surface. All of surfaces produce audible slaps from the joints. Typical of all of the ground surfaces, the data for texture grind Test Section #2 is about 3 dB lower in this range and no audible (or measurable) joint slap occurs. Unlike the results for frequencies above about 500 hertz, the low frequency levels are dictated by structure-borne energy which transmits from the tire/road interface through the suspension into the body panels of the vehicle. These panel vibrations then radiate into the interior of the vehicle. The higher frequencies are due to airborne paths and sound radiated directly by the tire. Using the interior results and those of the sound intensity measurements, a more complete understanding of the effect of texture grinding is gained. As discussed previously, in the high frequencies, around 1600 and 2000 hertz, the texture grinding “breaks-up” some of the tread related tire noise to produce lower noise levels both to the exterior and to a less degree, the interior. In the mid frequencies 400 to 1000 hertz, the roughness of the texture grind surfaces tends to increase noise, particularly again, on the exterior. In the lower frequencies, 50 to 160 hertz, the texture grinding reduces the discontinuities at the joints, lowering the vibration input to the vehicle, and thereby reducing the interior (structure-borne) noise.

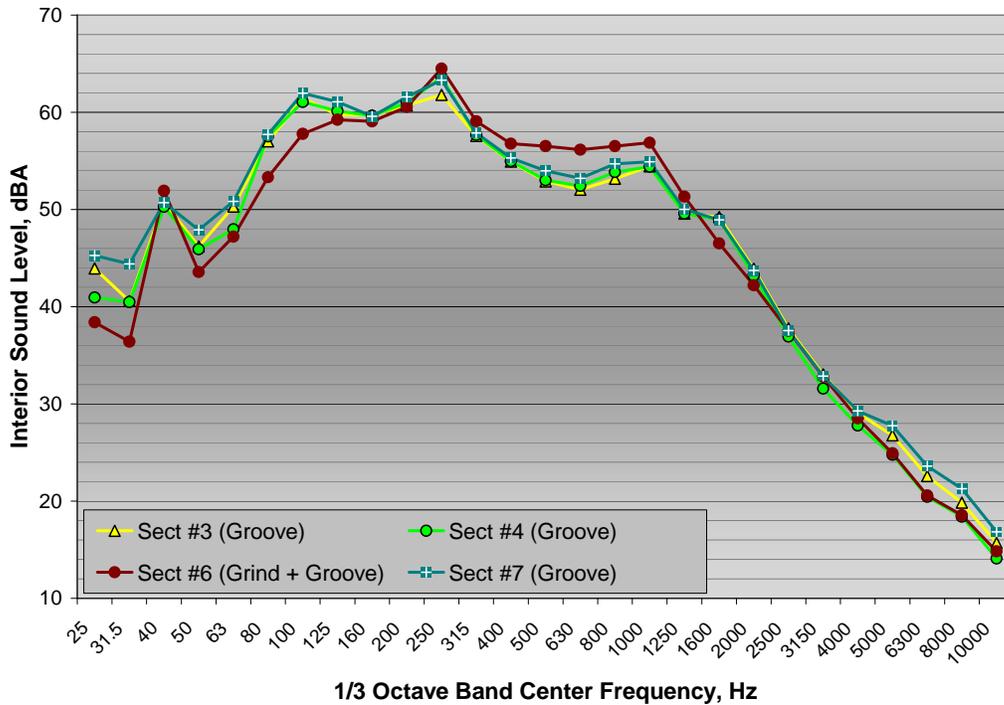
Figure B-4: Comparison of 1/3 octave band interior noise spectra for different grooved test surfaces

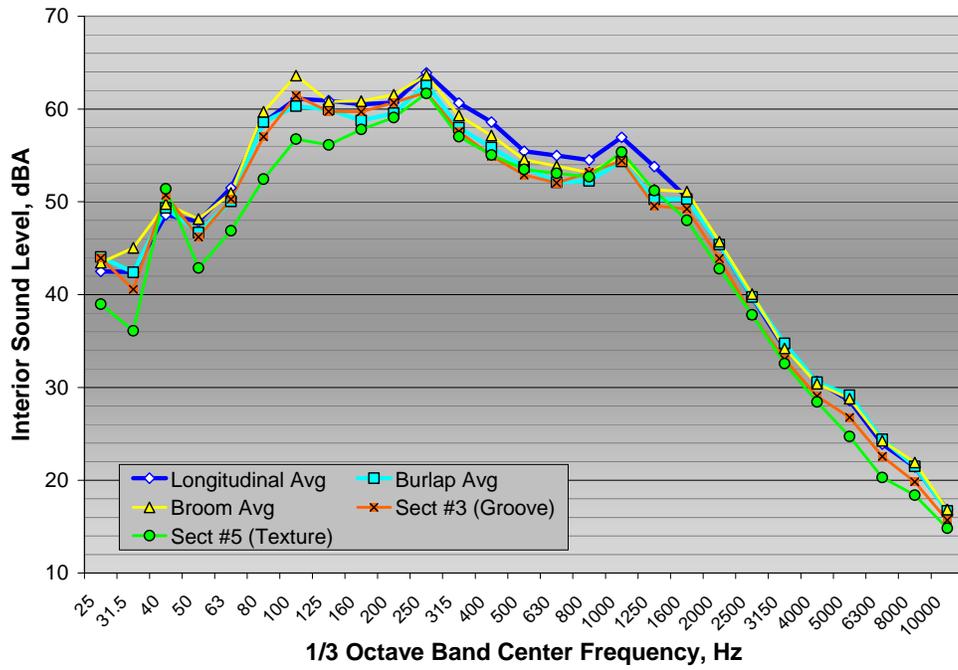
Figure B-5: Comparison of 1/3 octave band interior noise spectra for various original and modified Mojave Bypass surfaces
