# INFORMATION HANDOUT

ASBESTOS AND LEAD-CONTAINING PAINT SURVEY REPORTS

**ROUTE: 01-HUM-255-0.2/1.8**

Subject: ASBESTOS AND LEAD-CONTAINING PAINT SURVEY REPORT  
RICHARD F. DENBO MEMORIAL BRIDGE (04-0228)  
HUMBOLDT COUNTY, CALIFORNIA  
CONTRACT NO. 03A1368, E-FIS 01 0002 0313 (EA 01-0A3800)  
TASK ORDER NO. 162, 01-HUM-255, PM 1.37

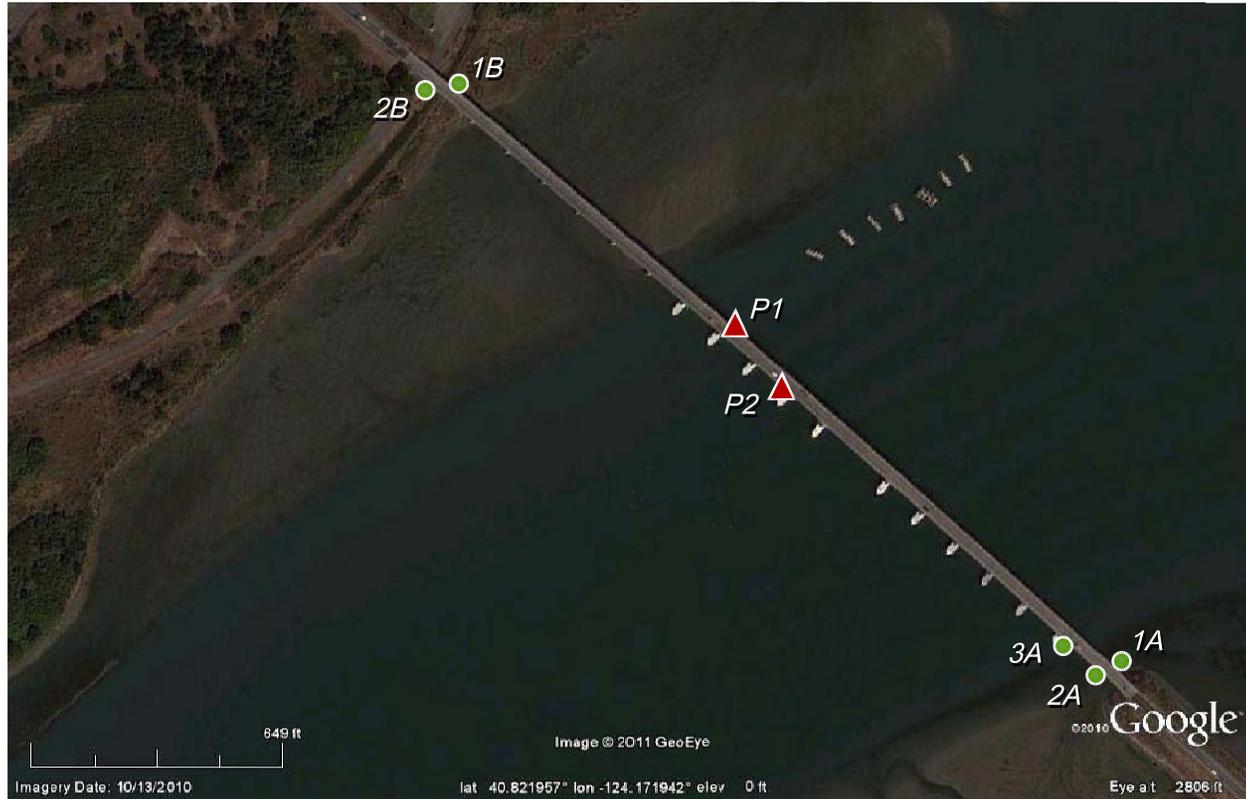
Figure 2

Approximate sample locations are presented on Figure 2. Materials represented by the samples collected are shown in the attached photographs.

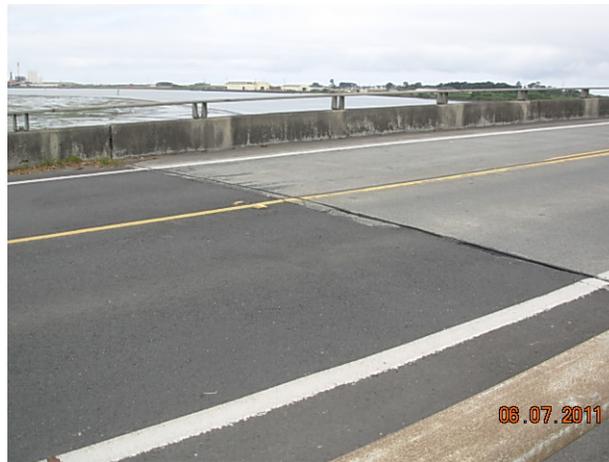
**Photo 2 – Bridge deck and barrier rails**

Chrysotile asbestos at a concentration of 80% was detected in a sample representing approximately 300 square feet of nonfriable sheet packing used as shims on the bridge barrier rail systems.

We recommend that a licensed contractor registered with Cal/OSHA for asbestos-related work perform any activities that would *disturb* the asbestos-containing materials identified during our survey. Contractors are responsible for informing the landfill of the contractor's intent to dispose of asbestos waste. Some landfills and recycling facilities may require additional waste characterization. Contractors are responsible for segregating and characterizing waste streams prior to disposal.
