1. REPORT NO. FHWA/CA10-0645	2. GOVERNMENT ACCESSION NO.	3. RECIPIENT'S CATALOG NO.	
4. TITLE AND SUBTITLE DEVELOPMENT AND TESTING OF A LOW-PROFILE BARRIER		5. REPORT DATE April 2012

DEVELOPMENT AND TESTING OF A LOW-PROFILE BARRIER

DEPARTMENT OF TRANSPORTATION
DIVISION OF RESEARCH AND INNOVATION
OFFICE OF SAFETY INNOVATION AND COOPERATIVE RESEARCH
ROADSIDE SAFETY RESEARCH GROUP

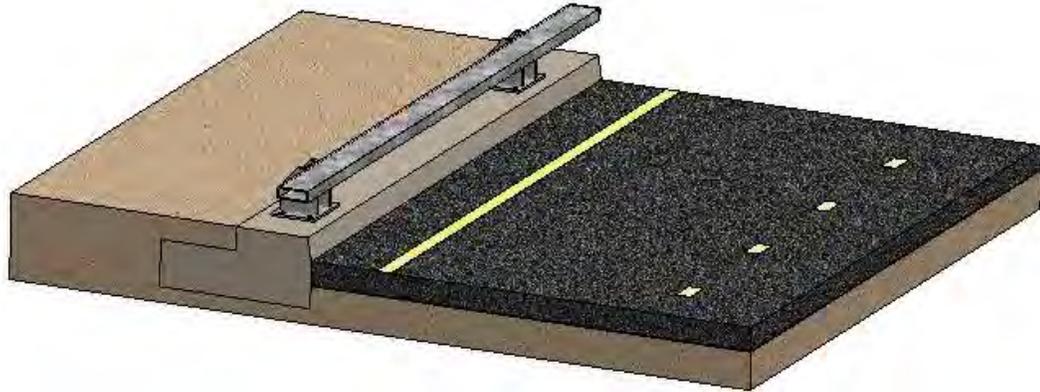
Figure 1-1. Computer Generated Barrier Design Concept

The barrier design concept is shown in Figure 1-1. The total height of the barrier is 18 inches measured from the ground with posts spaced at 10 feet apart. Regarding aesthetics, the leading request is for openings in the barrier, which would provide a less monolithic and more see-through appearance.

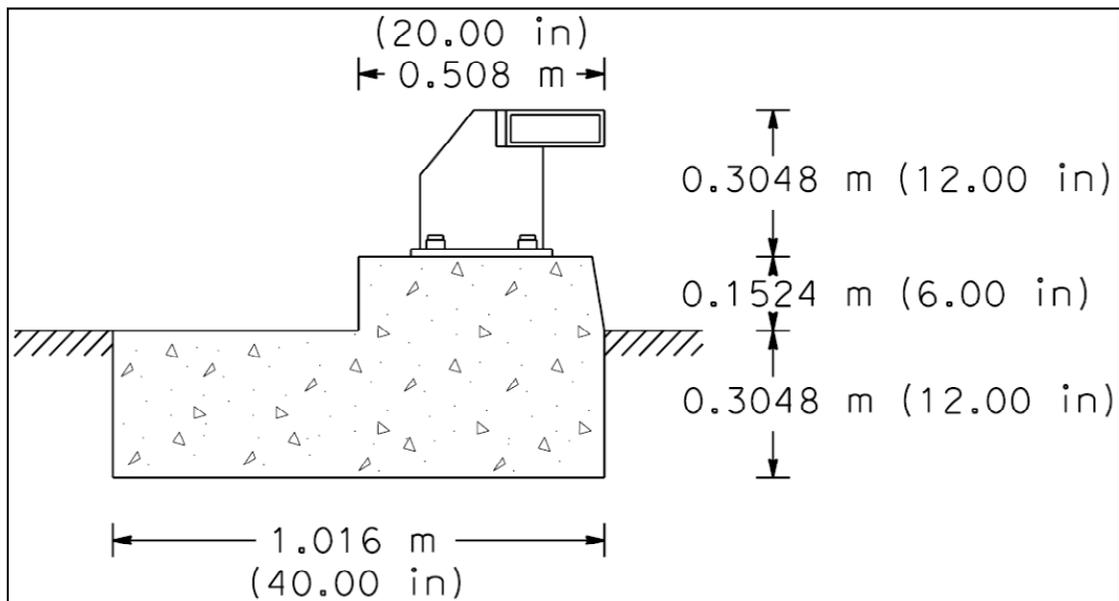
Figure 2-1. Low-Profile Barrier Cross-Section

A cross-section of the barrier is shown in Figure 2-1.

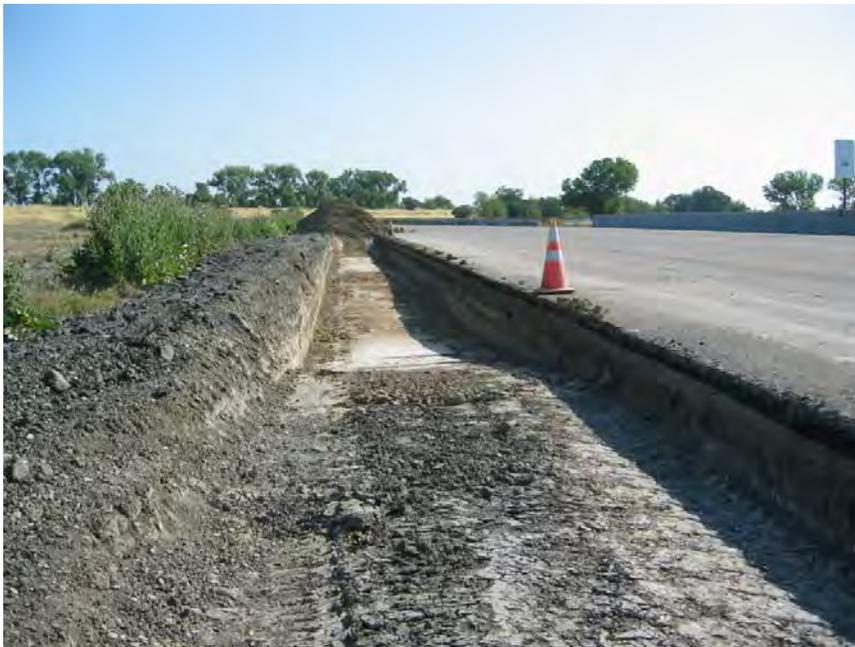
Figure 2-2. Excavation of Existing Soil

The low-profile barrier test article was constructed at the Caltrans Dynamic Test Facility. The test article was 30.48 m (100 feet) long with a nominal height of 0.4572 m (18 inches). It consisted of a 0.305 m (12 inch) deep foundation, a 0.105 m (6 inch) curb, with nine 0.305 m (12 inch) posts spaced at 3.048 m (10 feet) on center, and a 3x8x3/8 inch structural steel rail. In order to validate a LS-DYNA computer model, it was necessary that the low-profile barrier footing was built in a uniform soil bed to get a homogeneous soil reaction. Because existing soils were non-homogeneous due to an assortment of previous projects at the construction location, a 2.44 x 0.61 x 30.48 meter (8 x 2 x 100 feet) soil bed was excavated then backfilled with soil from a local gravel provider (Cascade Rock, Inc.). The soil analysis of the fill soil was completed by the Caltrans Geotechnical Lab and classified as fine sandy silt. At a 90% relative compaction and an optimum moisture content of 12.3%, the maximum dry density was 114.6 pcf¹.

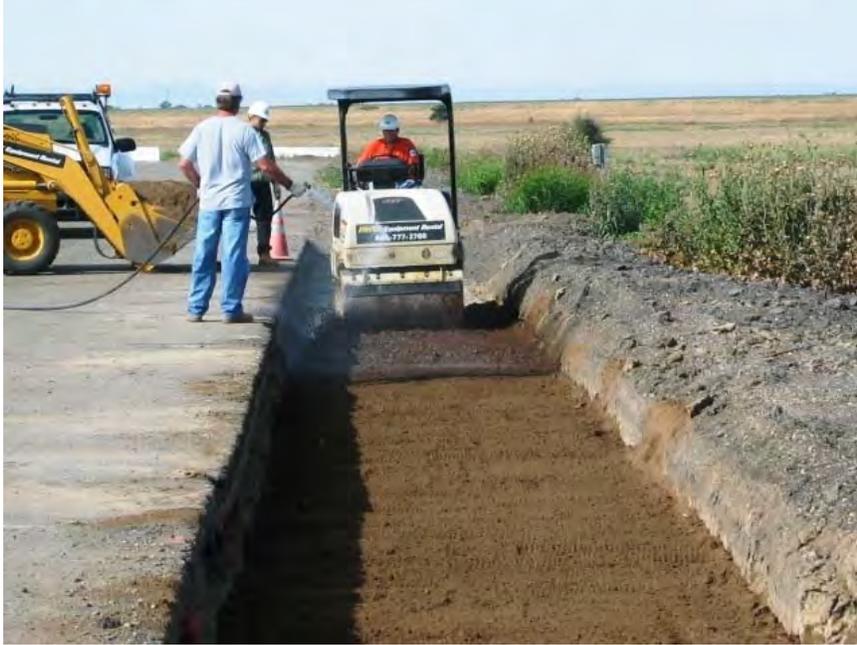
Figure 2-3. Soil Compaction of Fill Soil in 4 to 6 Inch Lifts

Once the excavation was complete, the bed was filled with soil, 0.1016 to 0.1524 meters (4 to 6 inches) per lift. Each lift was moisture-conditioned and compacted using a vibratory roller.

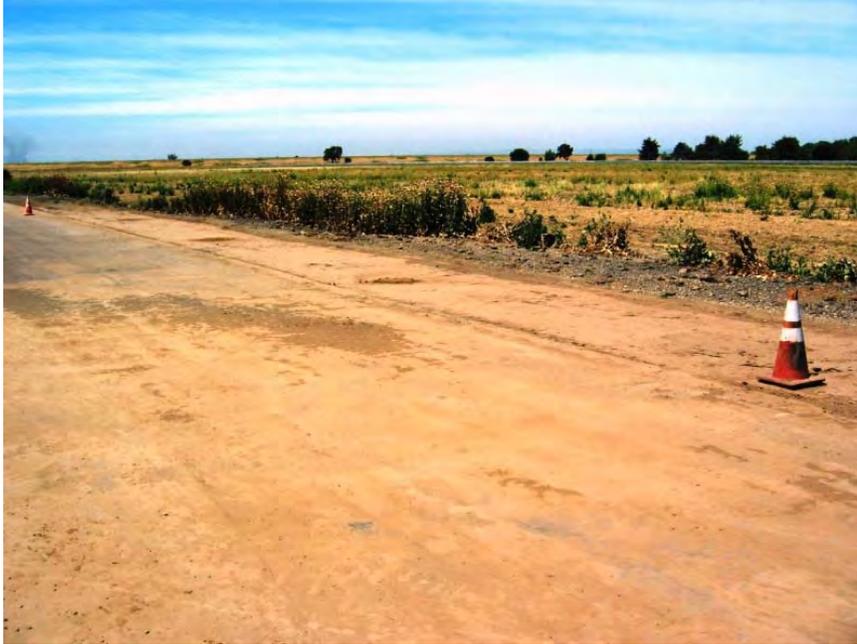
Figure 2-4. Completed Soil Bed (between cones)

Once the bed was completely filled and compacted, a nuclear gauge was used to test the compaction. The minimum relative compaction required was 90% under Caltrans 2006 Standard Specifications. A 93% relative compaction was achieved with a density of 122.4 pcf.

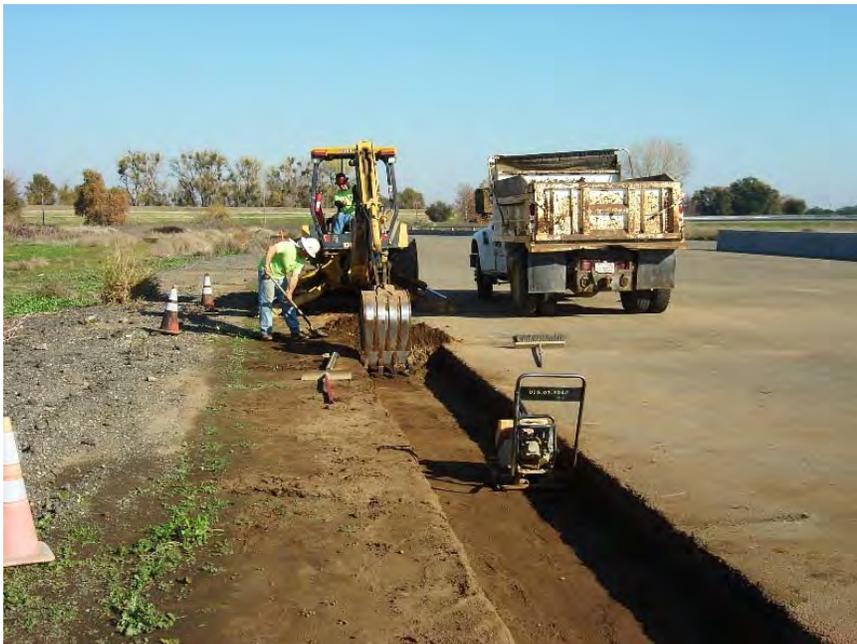
Figure 2-5. Excavation for Barrier Installation

The low-profile barrier was constructed and installed in two phases: pouring of the footing and attachment of the rail. The soil was re-excavated 1.016 x 0.3048 x 30.48 meters (3.3 x 1 x 100 feet) to install the footing of the barrier. The footing and the curb were constructed in a single pour.

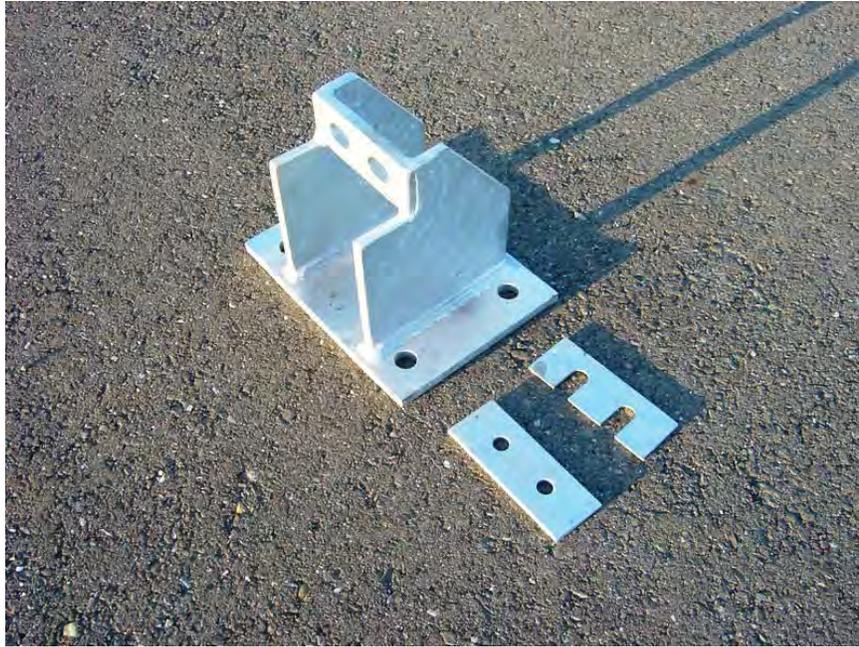
Figure 2-6. Post, Plate, and Shim

The footing was 30.48 m (100 feet) long and had 9 posts spaced 3.048 m (10 feet) on center. The rail came in 4 pieces and spanned 30.48 m (100 feet).

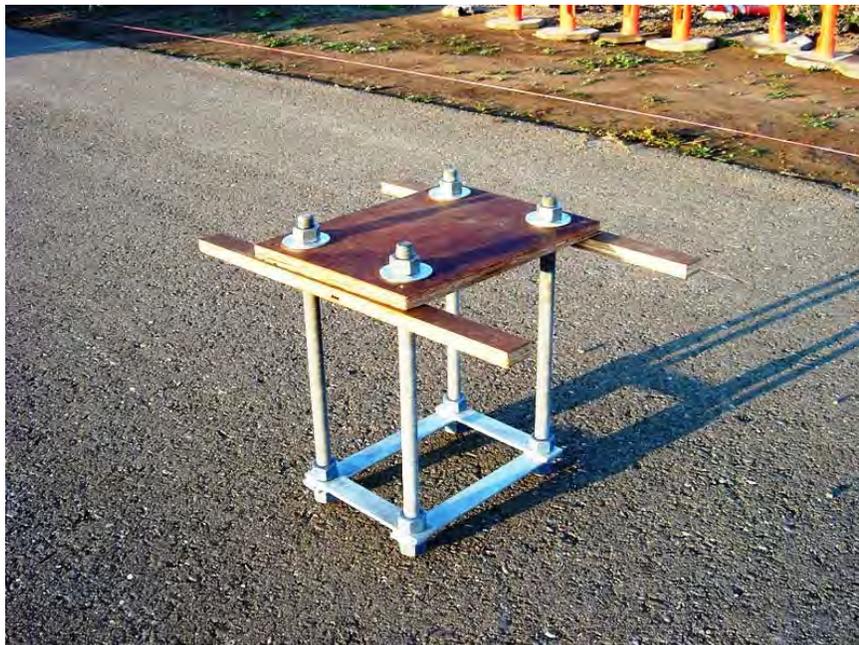
Figure 2-7. Post Anchor Setup

Once the formwork for the footing was complete, the reinforcing steel and anchor bolts were position and tied in. Concrete was then poured into the formwork while being consolidated with a concrete vibrator. All exposed steel components were galvanized from the manufacturer prior to installation. The footing was placed on December 4, 2009. The posts and rails were installed on December 15, 2009.

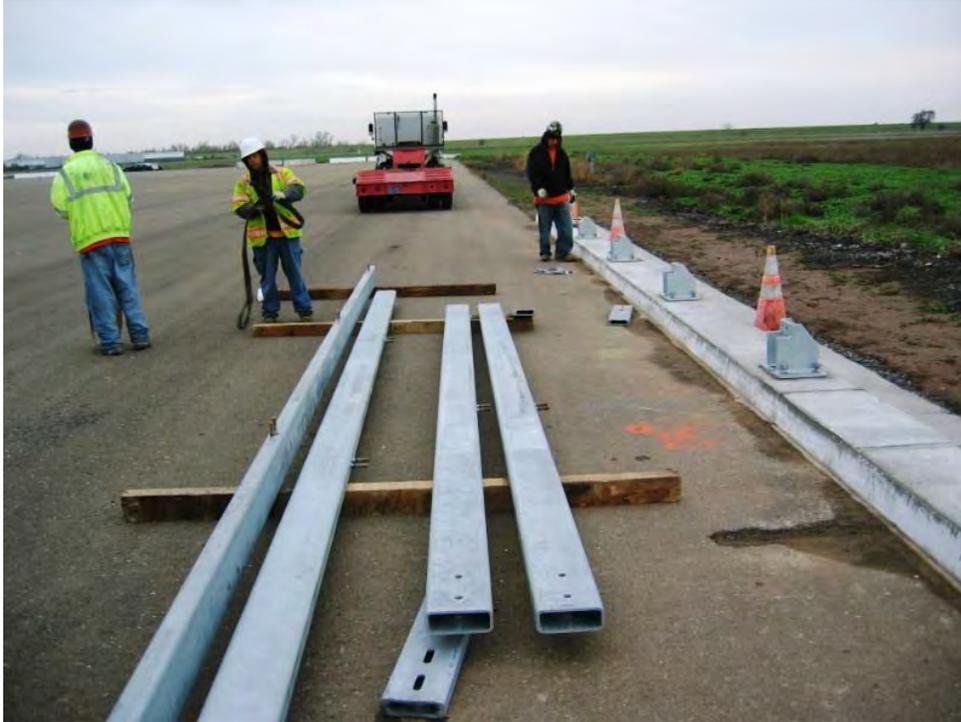
Figure 2-8. Rails

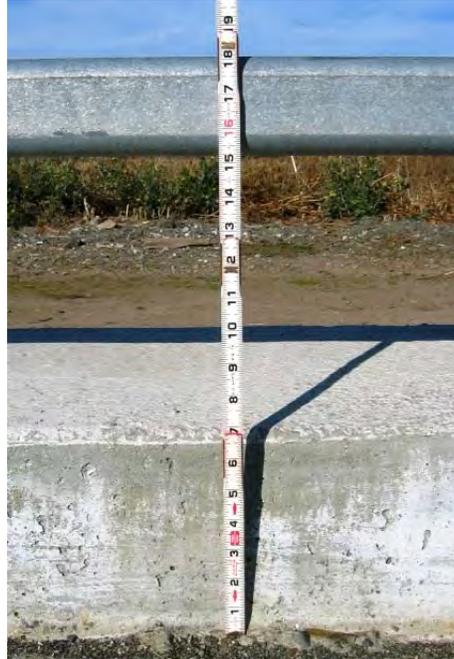
Figure 2-9. Height of Low-Profile Barrier

Because the adjacent pavement elevation varied along the length of the low-profile barrier, the as-built height of the barrier ranged from 0.4572 to 0.4826 meters (18 to 19 inches).

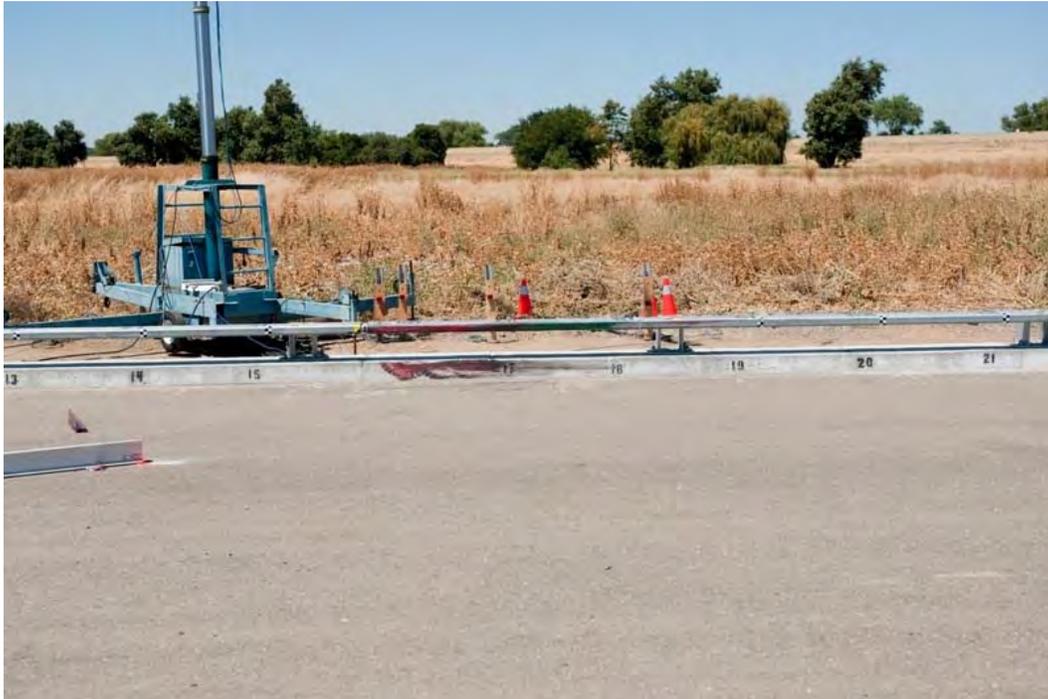
Figure 3-1. Test 701 Barrier Post Impact

There was minimal damage to the barrier. Stringpots and angular rate sensors were used to measure the displacements and rotations of the barrier for Test 701. The maximum permanent deflections for rail and the footing were 9.823 mm and 0.408 mm. See Section 8-6 in the Appendix for stringpot and rate gyro data. Damage to the barrier was considered cosmetic and would not have required field repairs.

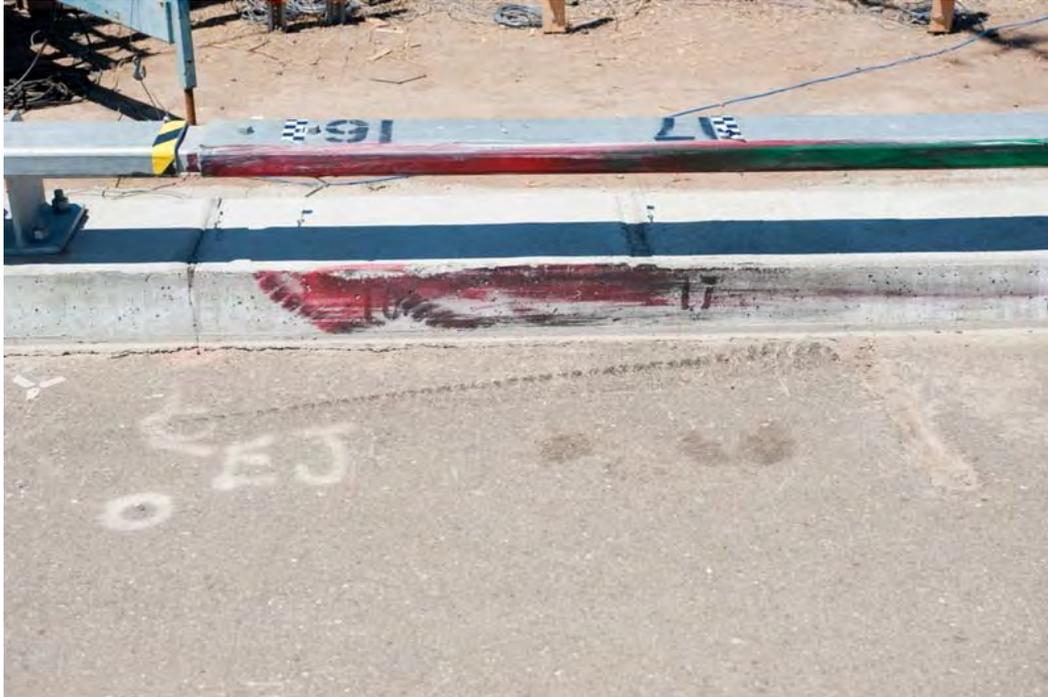
Figure 3-2. Test 701 - Front Wheel (red) / Rear Wheel (green)

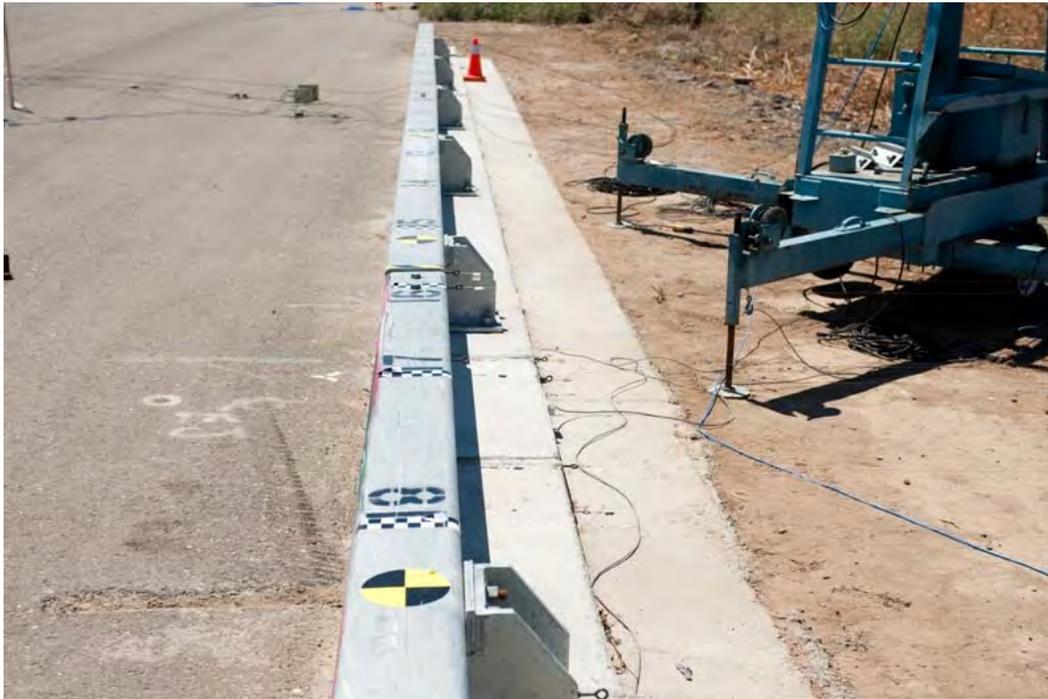
Figure 3-3. Test 701 Upstream View of Barrier Impact Location

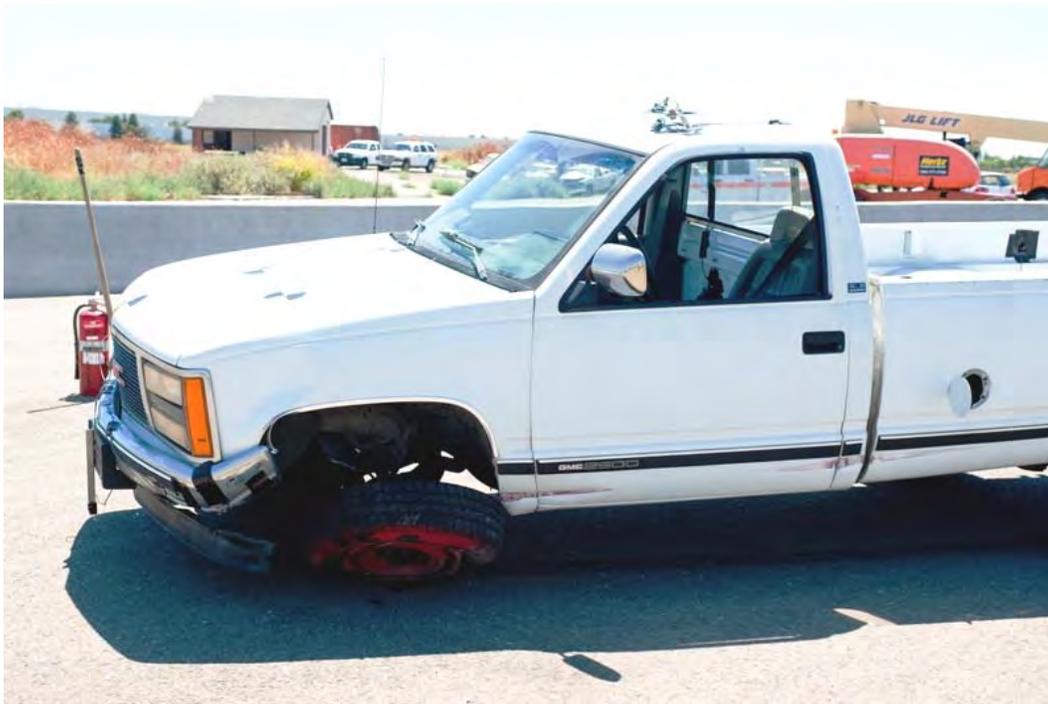
Figure 3-4. Test 701 Front Left Damage

The front left corner and wheel of the test vehicle sustained most of the damage. Additional damage also occurred to the floorboard and side of the vehicle as it scraped the barrier when redirected. The front left tire was flat and the wheel assembly came loose from the ball-joint. The front left bumper was bent in and up towards the left fender when it made contact with the barrier rail. The wheel assembly was pushed back into the wheel well, eliminating the ability to steer the vehicle after impact. See Figures 3-4 to 3-7 for pictures of the truck vehicle damage. The floorboard buckled due to the tire being pushed back in the wheel well. The maximum floorboard deformation was 45 mm, located just right of the center on the driver's floor (see Figure 3-7).

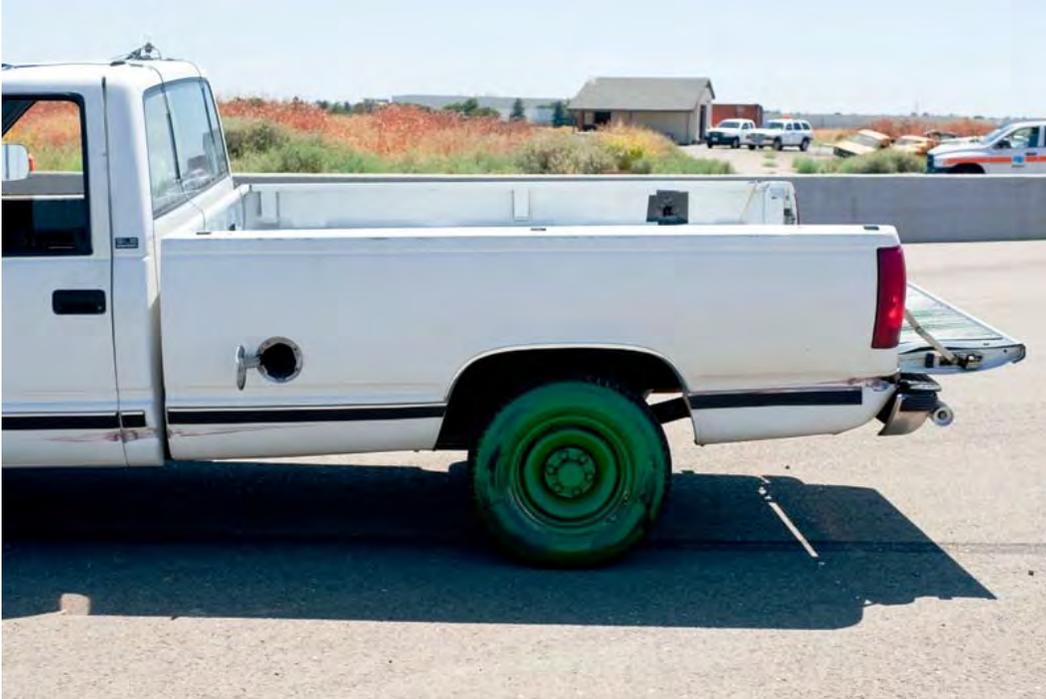
Figure 3-5. Test 701 Rear Left Damage

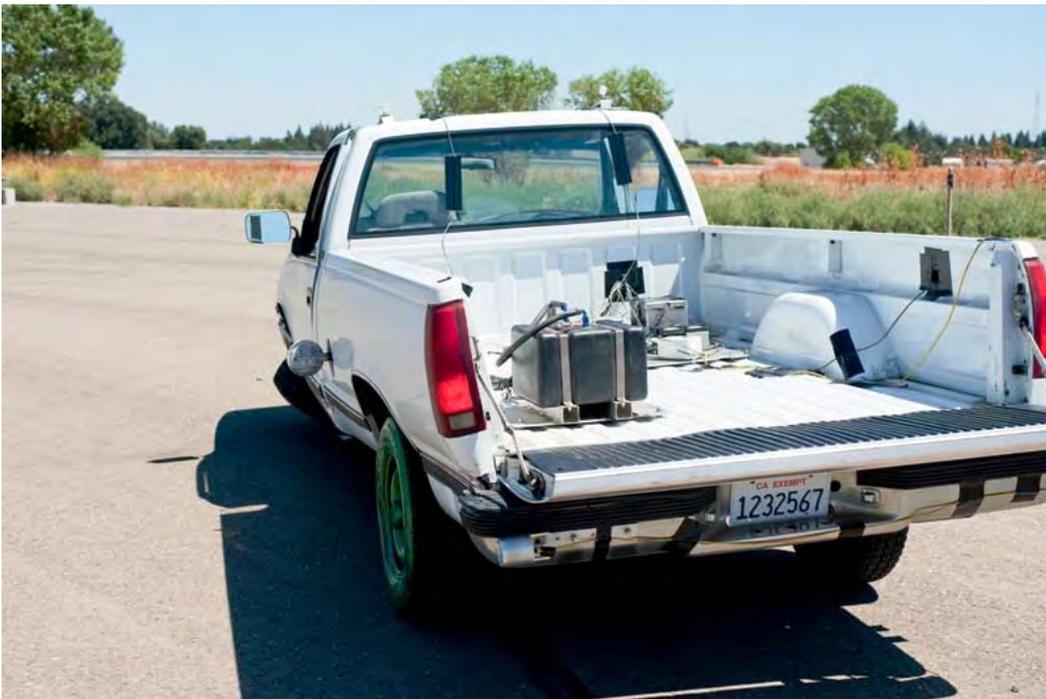
Figure 3-6. Test 701 Rear View Side Damage

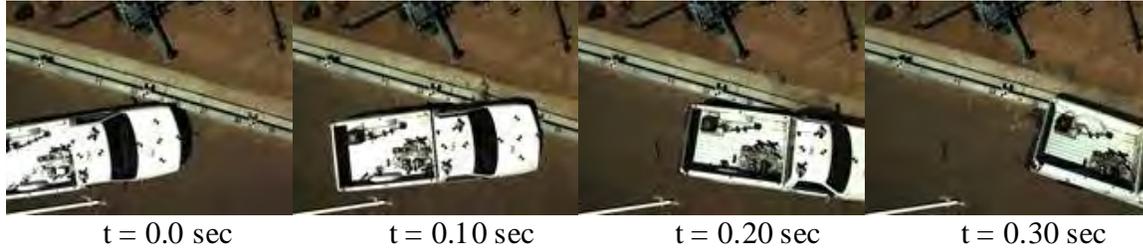
Figure 3-8. Test 701 Data Summary Sheet

The deflection of the rail and footing was 9.823 mm and 0.408 mm. Damage to the barrier was minimal and considered cosmetic.

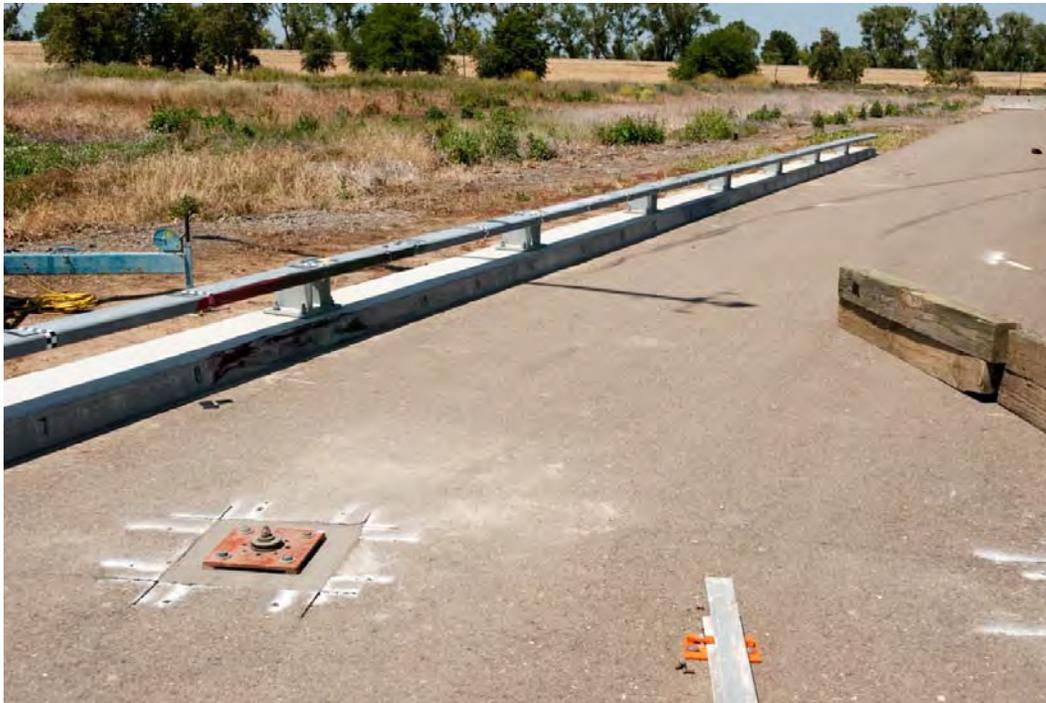
Figure 3-9. Test 702 Barrier Post Impact

There was no discernable permanent deflection of the barrier. Damage to the barrier was considered cosmetic and would not have required field repairs.

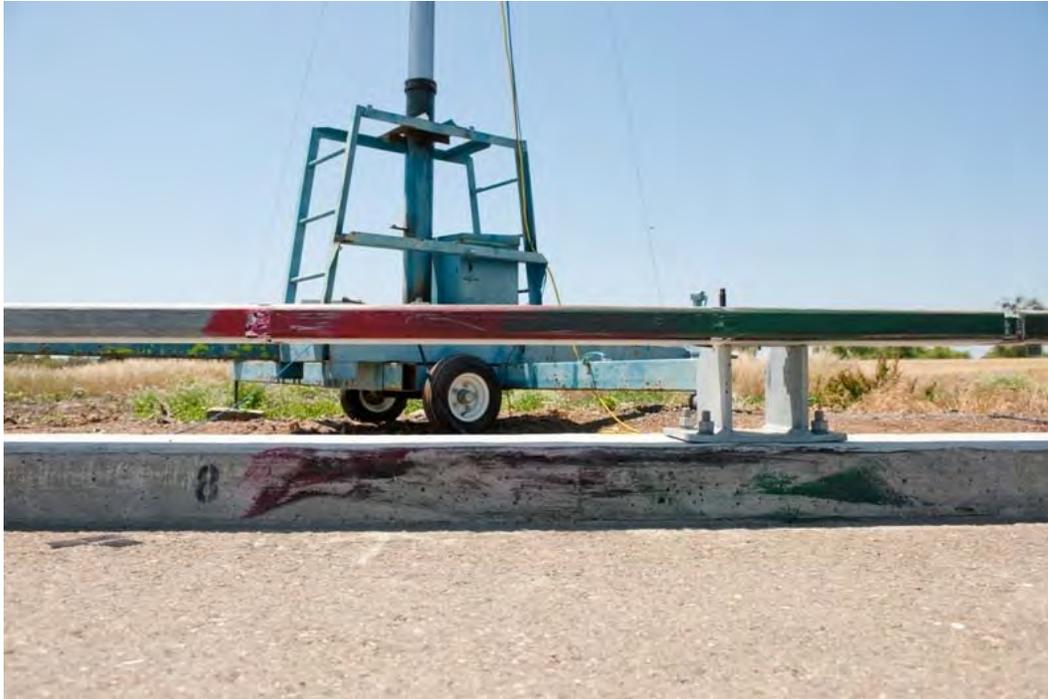
Figure 3-10. Test 702 - Front Wheel (red) / Rear Wheel (green)

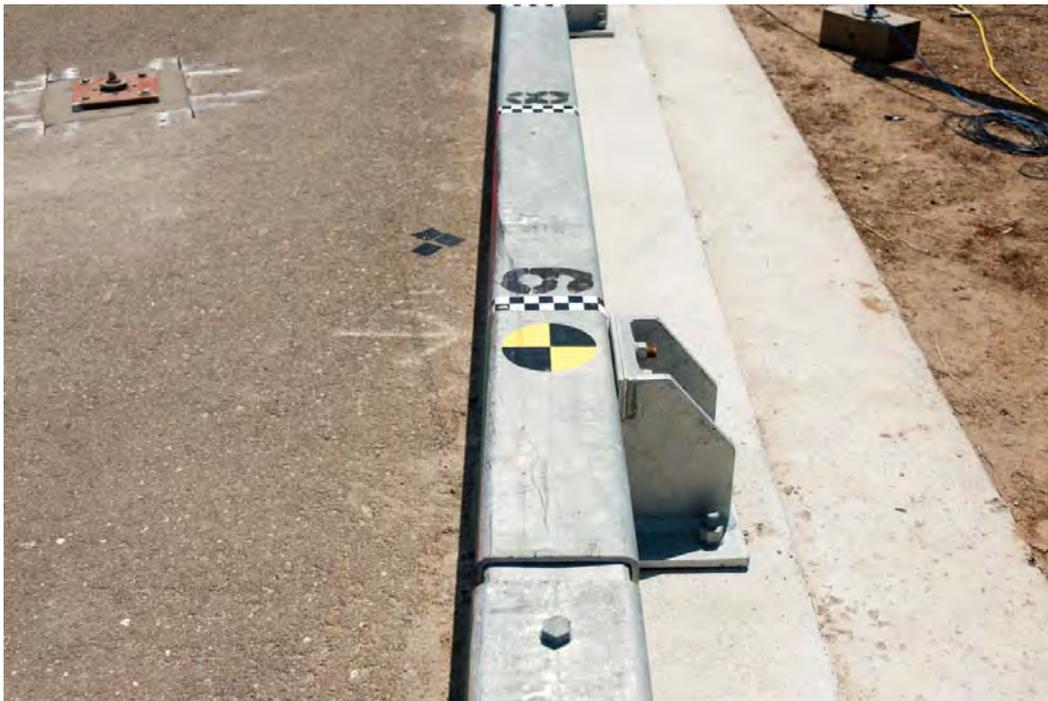
Figure 3-11. Test 702 Upstream View of Barrier Impact Location

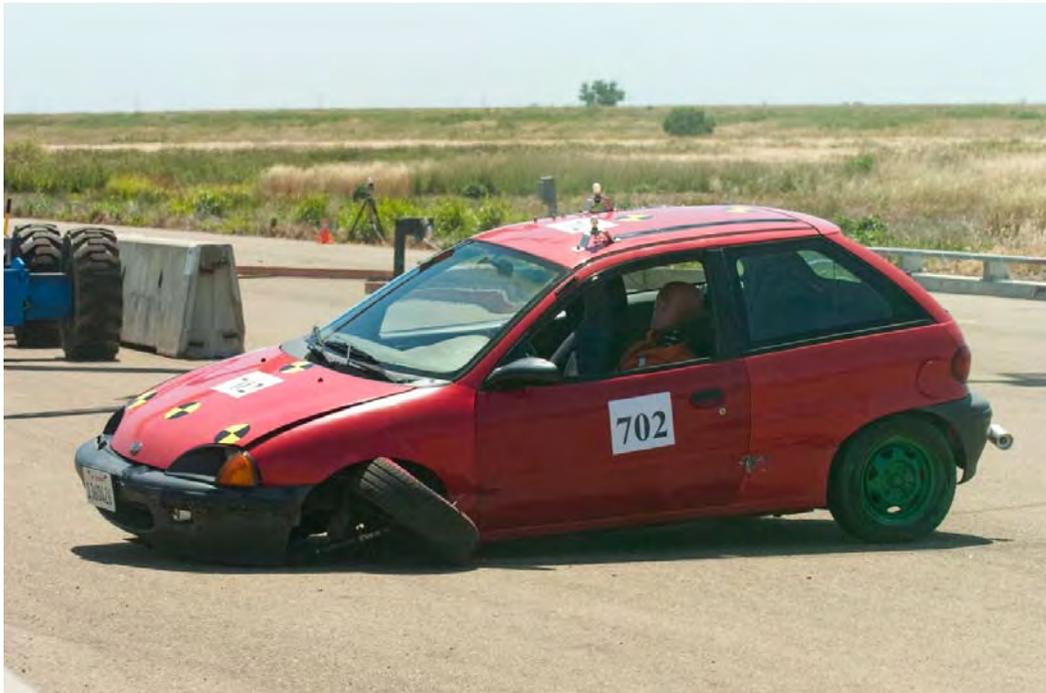
Figure 3-12. Test 702 Side Damage

The front left wheel absorbed most of the impact. The rim was bent during impact causing the tire to deflate. The wheel well of the test vehicle sustained most of the damage. Additional damage also occurred to the side of the vehicle as it scraped the barrier when redirected. The CV axle and strut broke, eliminating the ability to steer the vehicle after impact. Refer to Figures 3-12 to 3-15 for pictures of vehicle damage. Since the front left wheel took most of the impact, there was no distinguishable damage to the floorboard (see Figure 3-15).

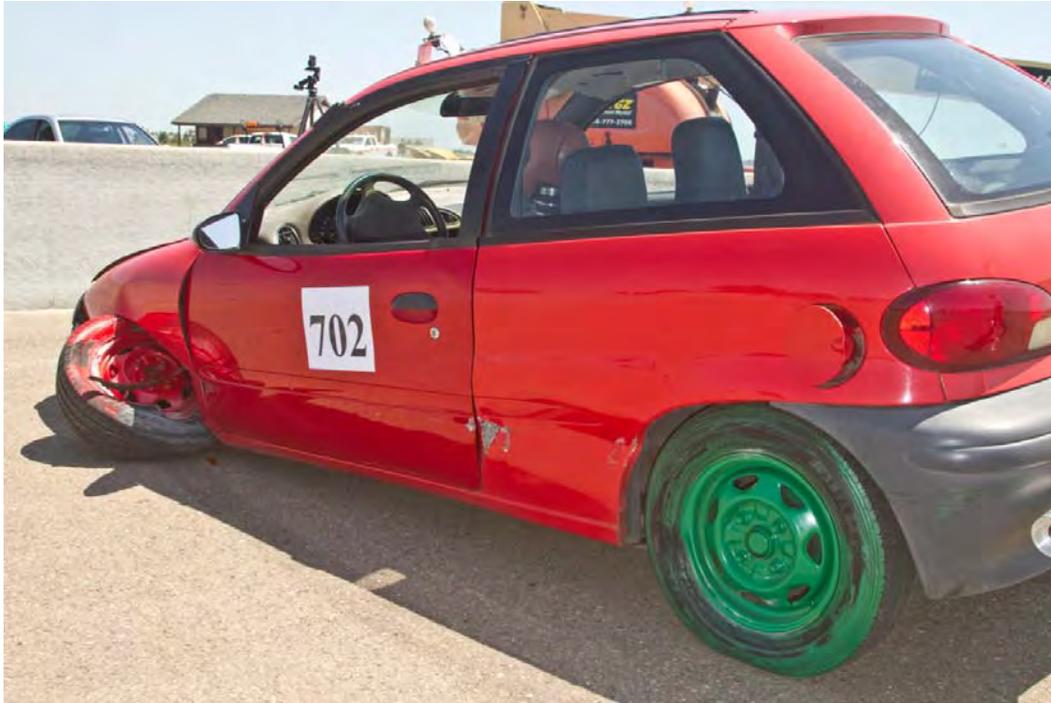
Figure 3-13. Test 702 Rear View Side Damage

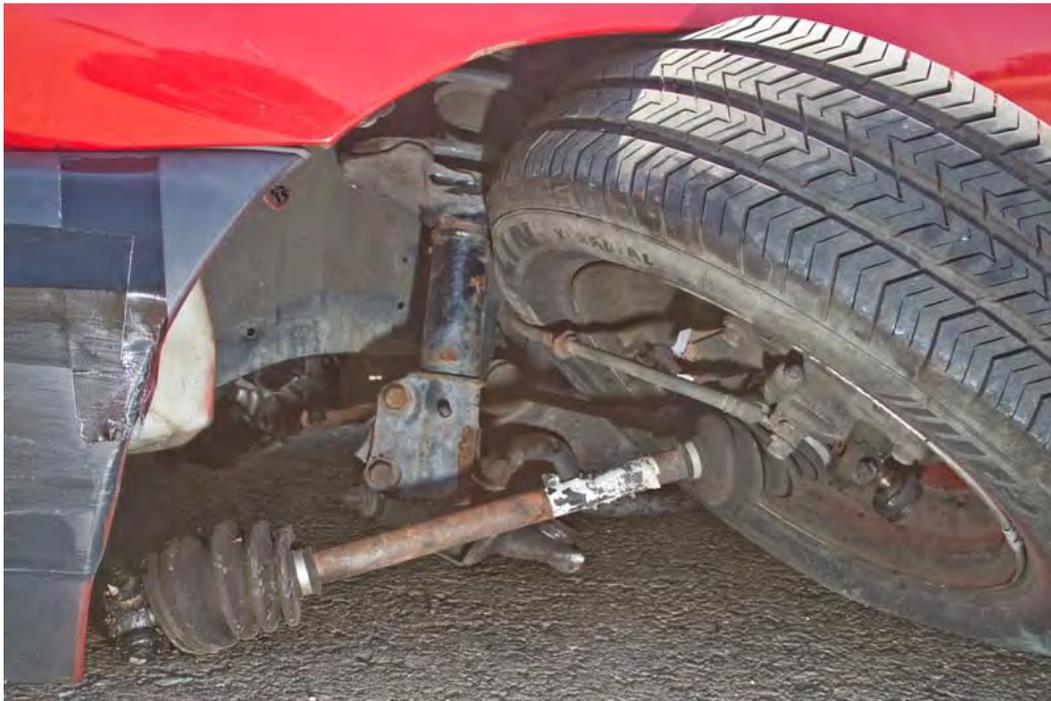
Figure 3-14. Test 702 Front Left Wheel Damage

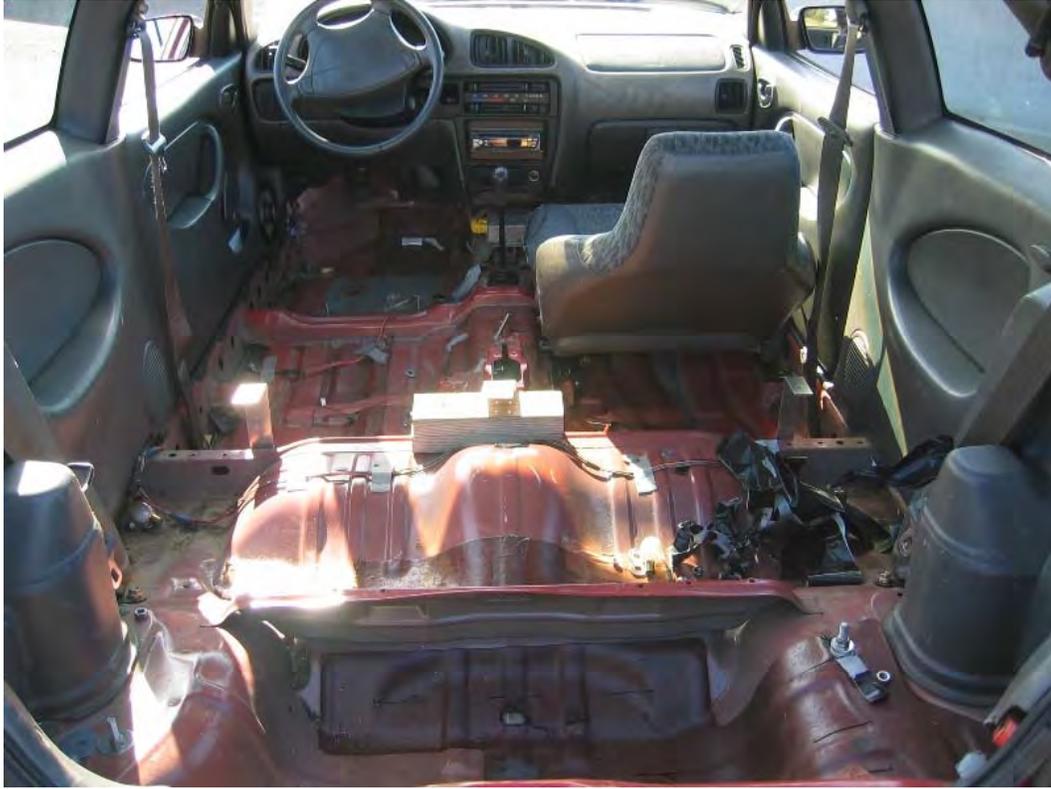
Figure 3-15. Test 702 Cab Post-Crash (no damage)

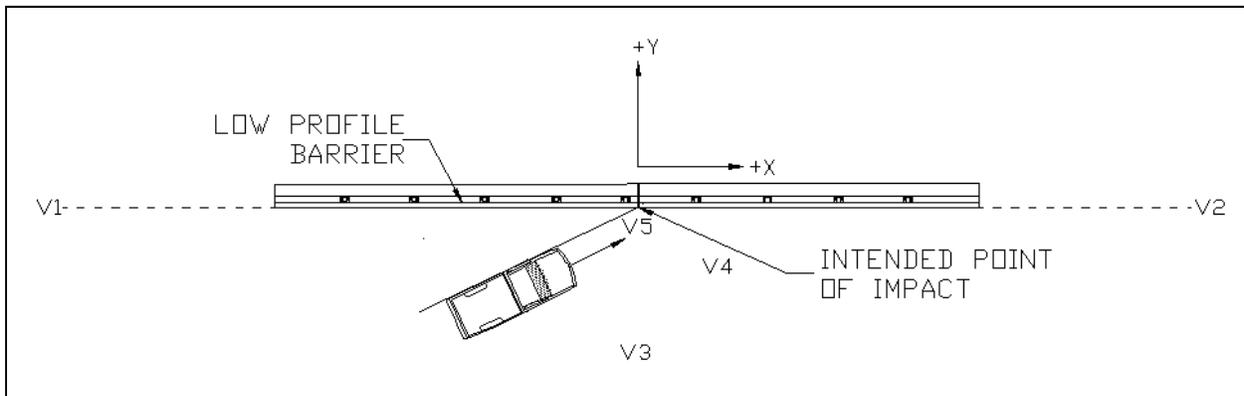
Figure 8-1. Test 701 Camera Locations

Several high-speed video cameras recorded the impact during the tests. The high-speed video frame rates were set to 500 frames per second. The types of cameras and their locations are shown in Figures 8-1 to 8-2 and Tables 8-3 to 8-4. The origin of the coordinates is at the intended point of impact.

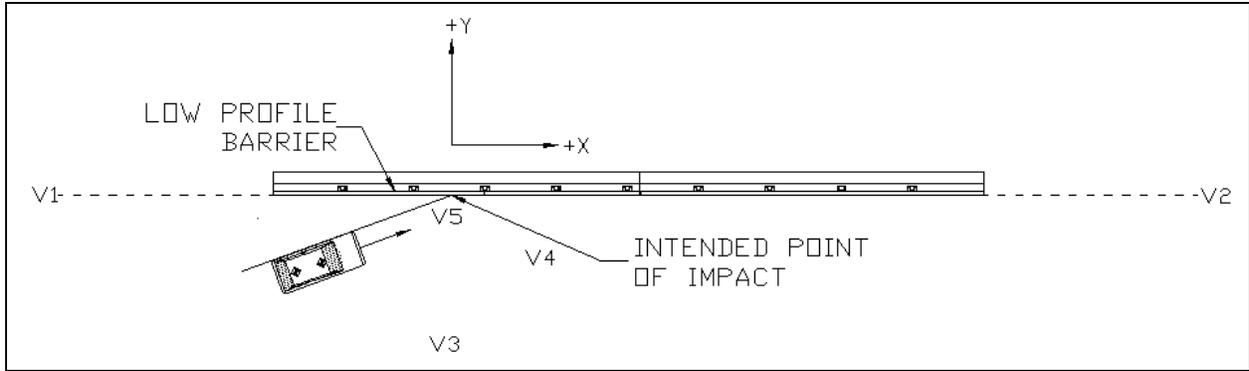
Figure 8-2. Test 702 Camera Locations

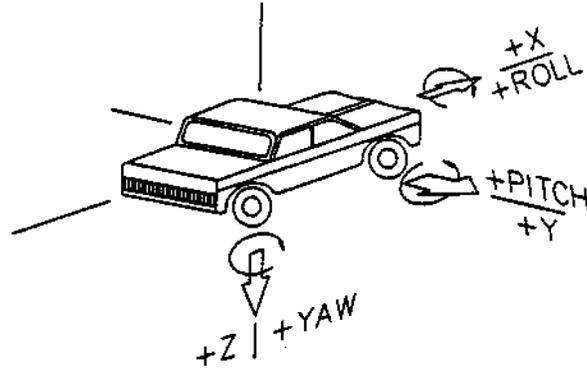
Figure 8-3. Vehicle Accelerometer Sign Convention

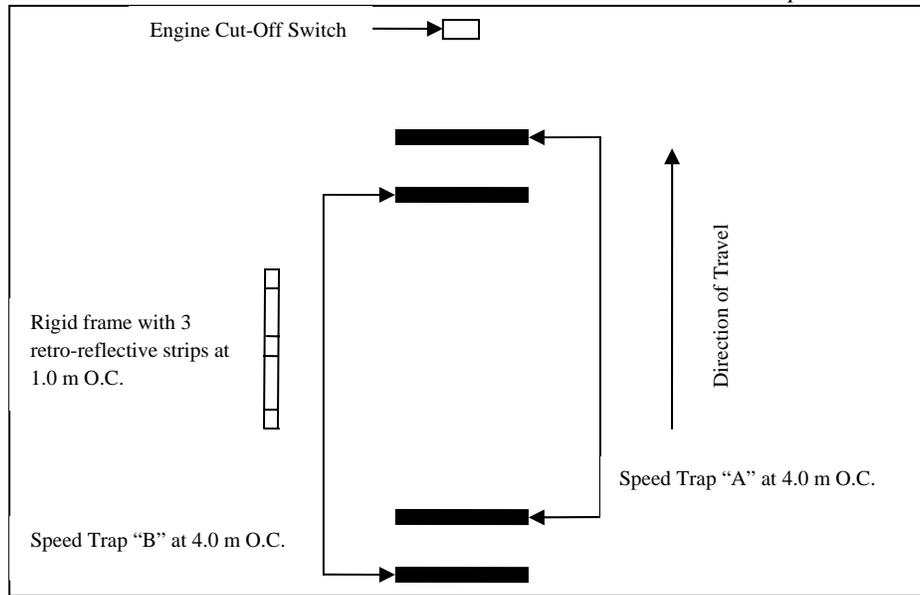
Figure 8-4. Tape Switch Layout

A rigid stand with three retro-reflective 90° polarizing tape strips was placed on the ground near the test article and alongside the path of the test vehicle. The strips were spaced at carefully measured intervals of 1000 mm. The test vehicle had an onboard optical sensor that produced sequential impulses or “event blips” as the vehicle passed the reflective tape strips. The event blips were recorded concurrently with the accelerometer signals on the TDR, serving as “event markers”. The impact velocity of the vehicle could be determined from these sensor impulses, the data record time, and the known distance between the tape strips. A pressure sensitive tape switch on the front bumper of the vehicle closed at the instant of impact and triggered two events: 1) “event marker” was added to the recorded data, and 2) a flashbulb mounted on the top of the vehicle was activated. Two sets of pressure activated tape switches, connected to a speed trap, were placed 4 m apart just upstream of the test article specifically to establish the impact speed of the test vehicle. The layout for all of the pressure sensitive tape switches and reflective tape is shown in Figure 8-4.
