1. REPORT NO. FHWA/CA10-0645	2. GOVERNMENT ACCESSION NO.	3. RECIPIENT'S CATALOG NO.	
4. TITLE AND SUBTITLE DEVELOPMENT AND TESTING OF A LOW-PROFILE BARRIER		5. REPORT DATE April 2012

DEVELOPMENT AND TESTING OF A LOW-PROFILE BARRIER

DEPARTMENT OF TRANSPORTATION
DIVISION OF RESEARCH AND INNOVATION
OFFICE OF SAFETY INNOVATION AND COOPERATIVE RESEARCH
ROADSIDE SAFETY RESEARCH GROUP

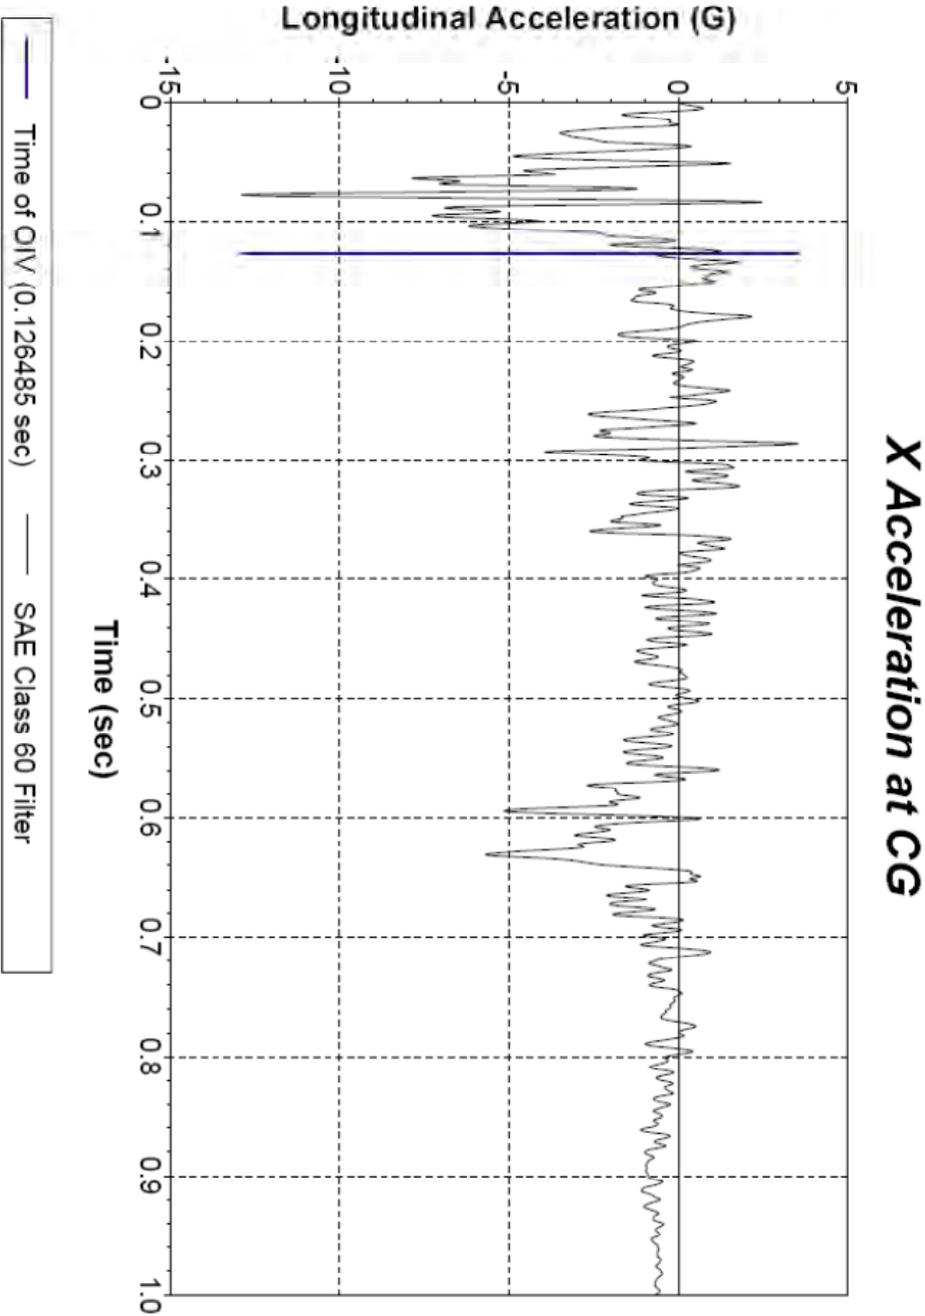
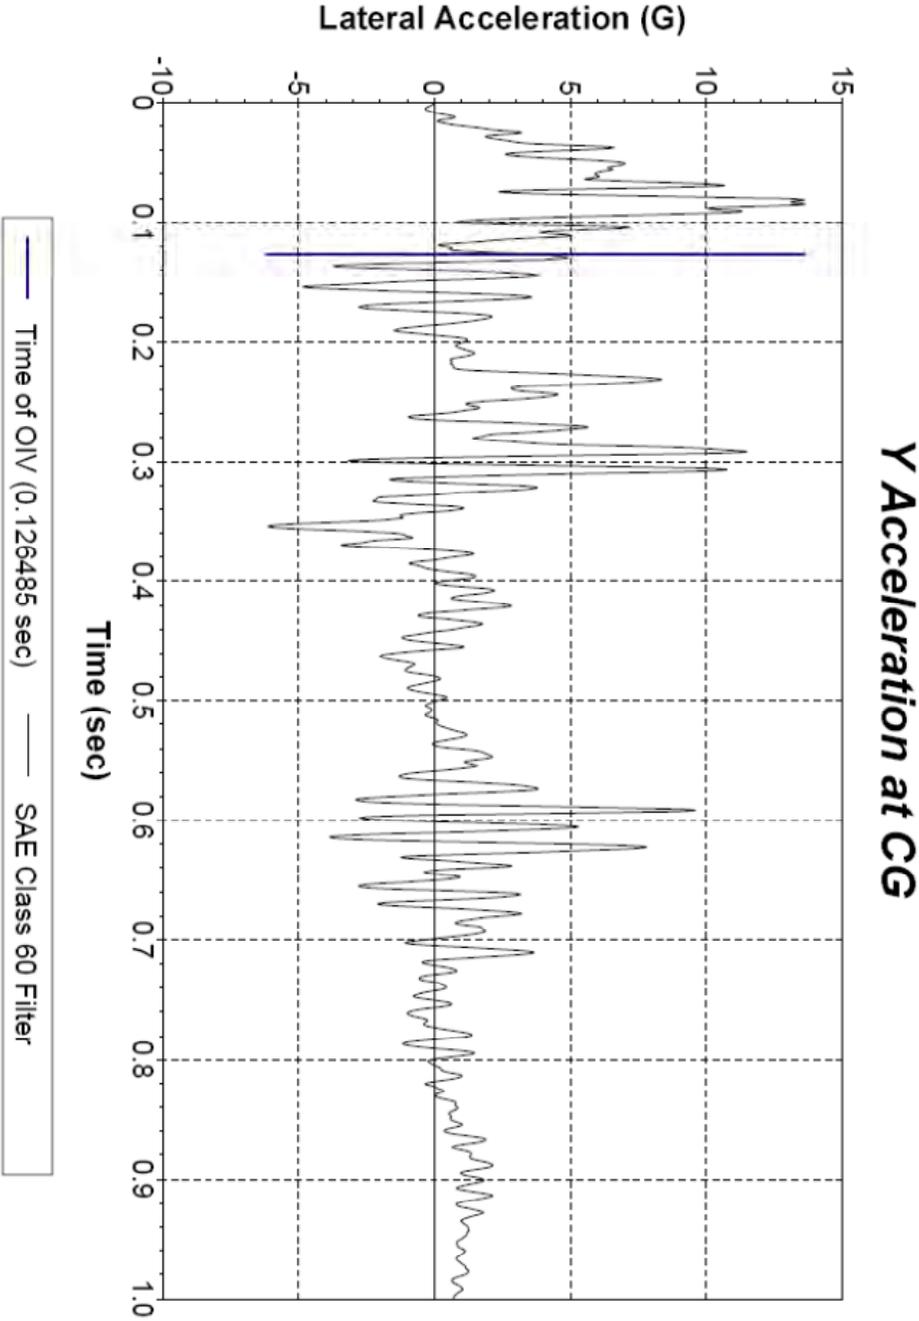
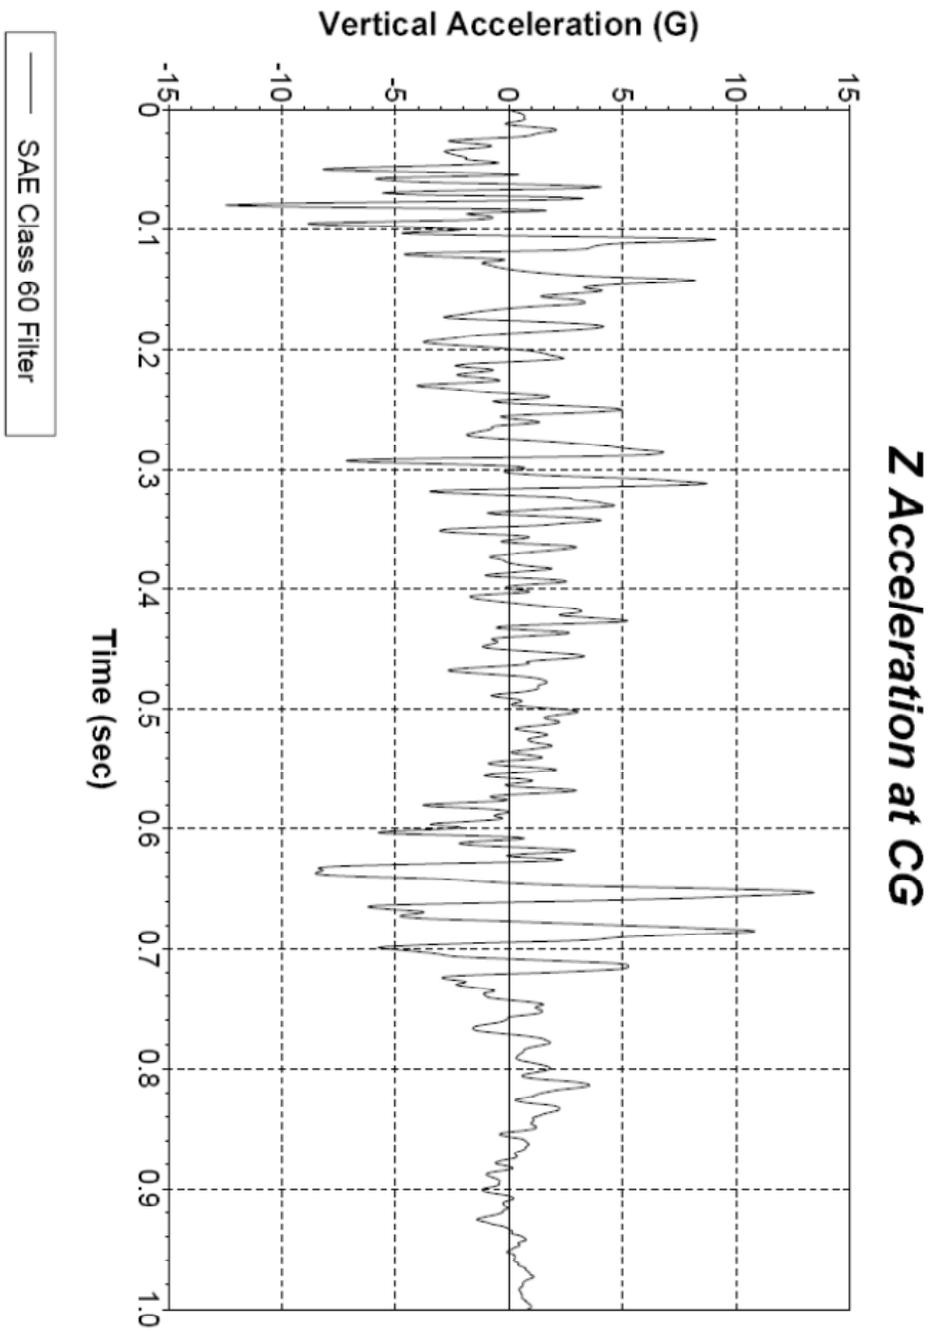
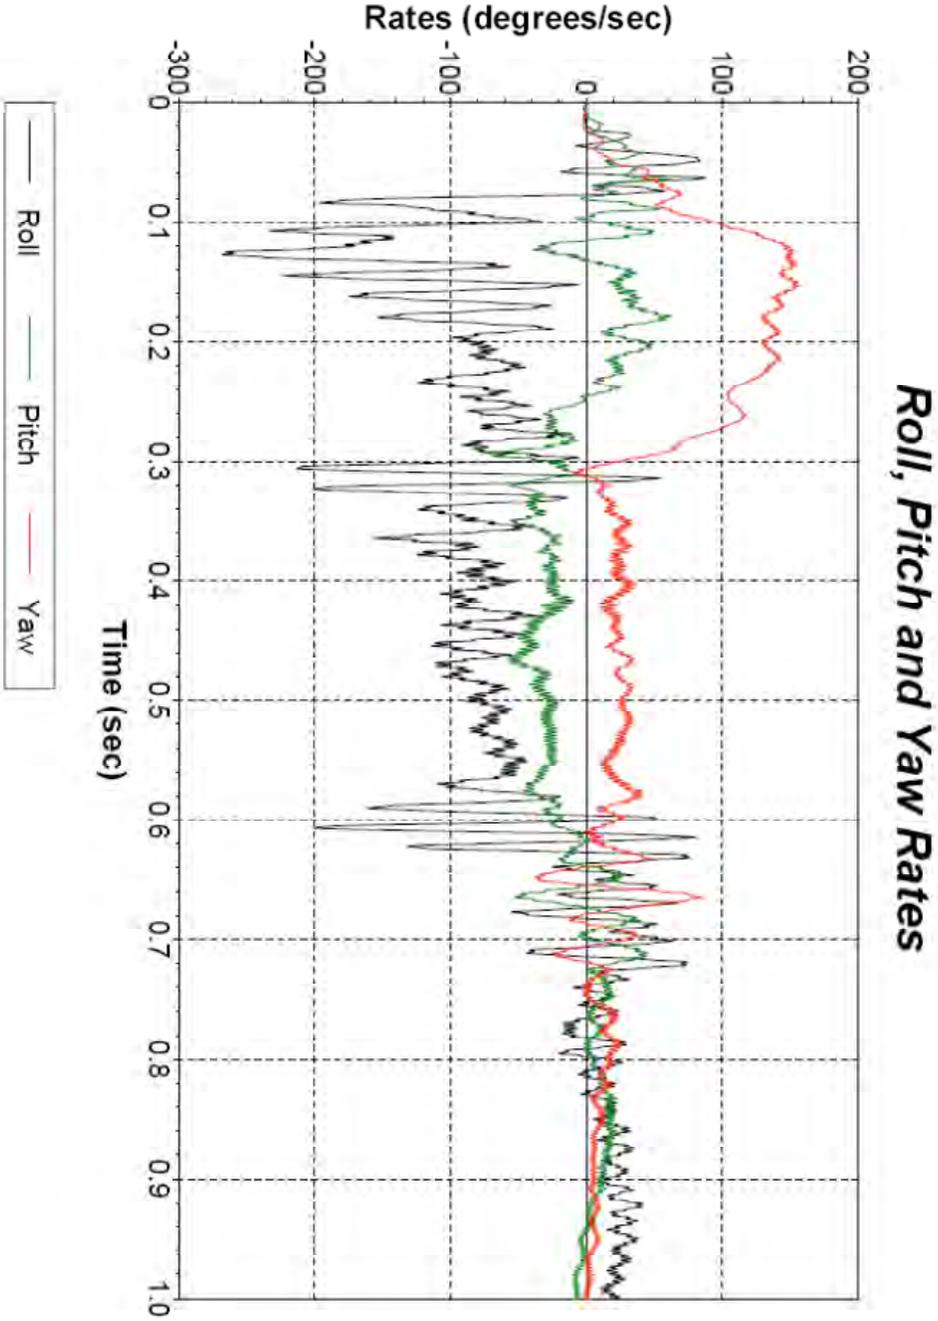
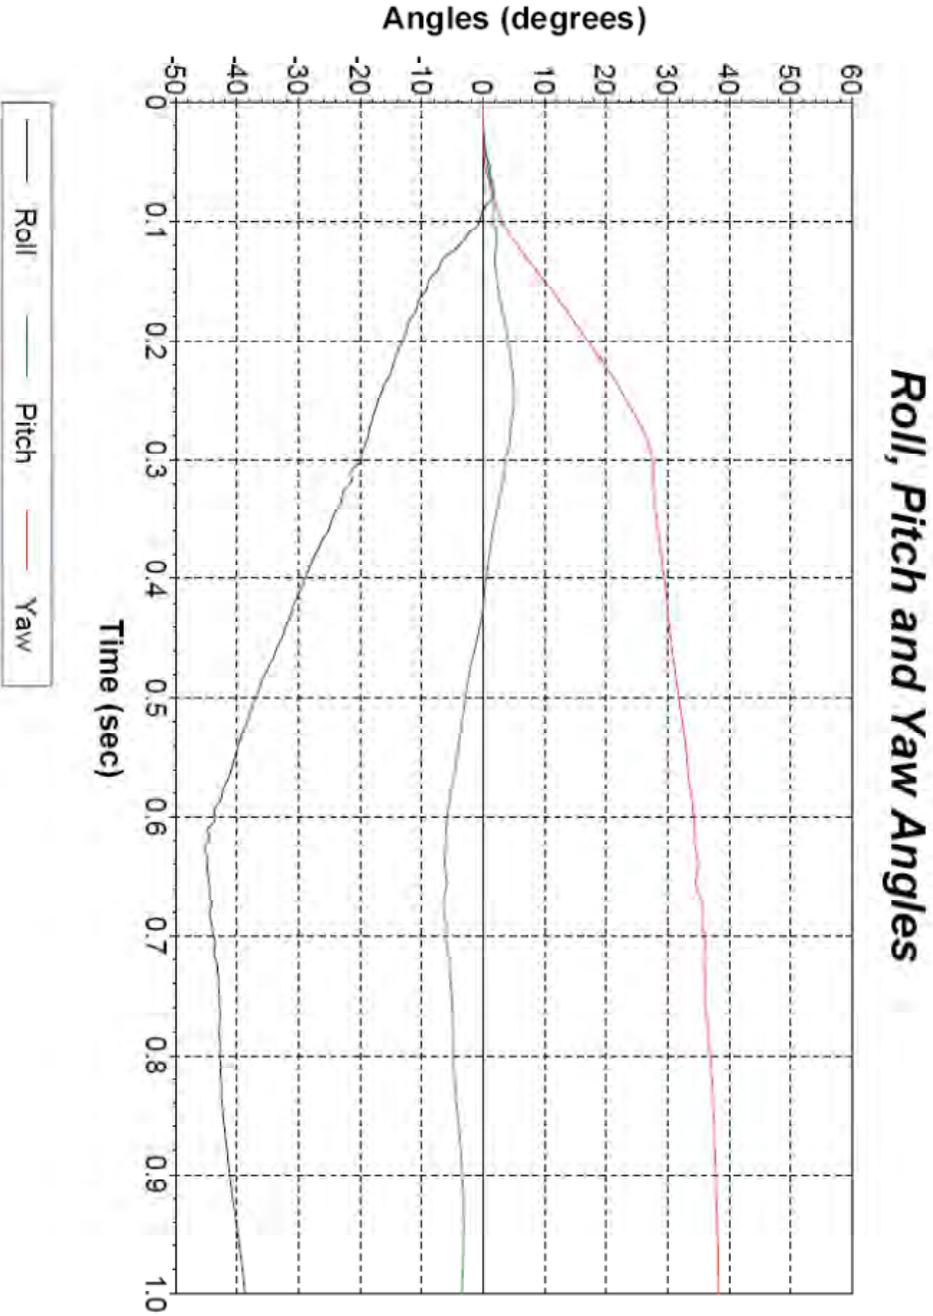
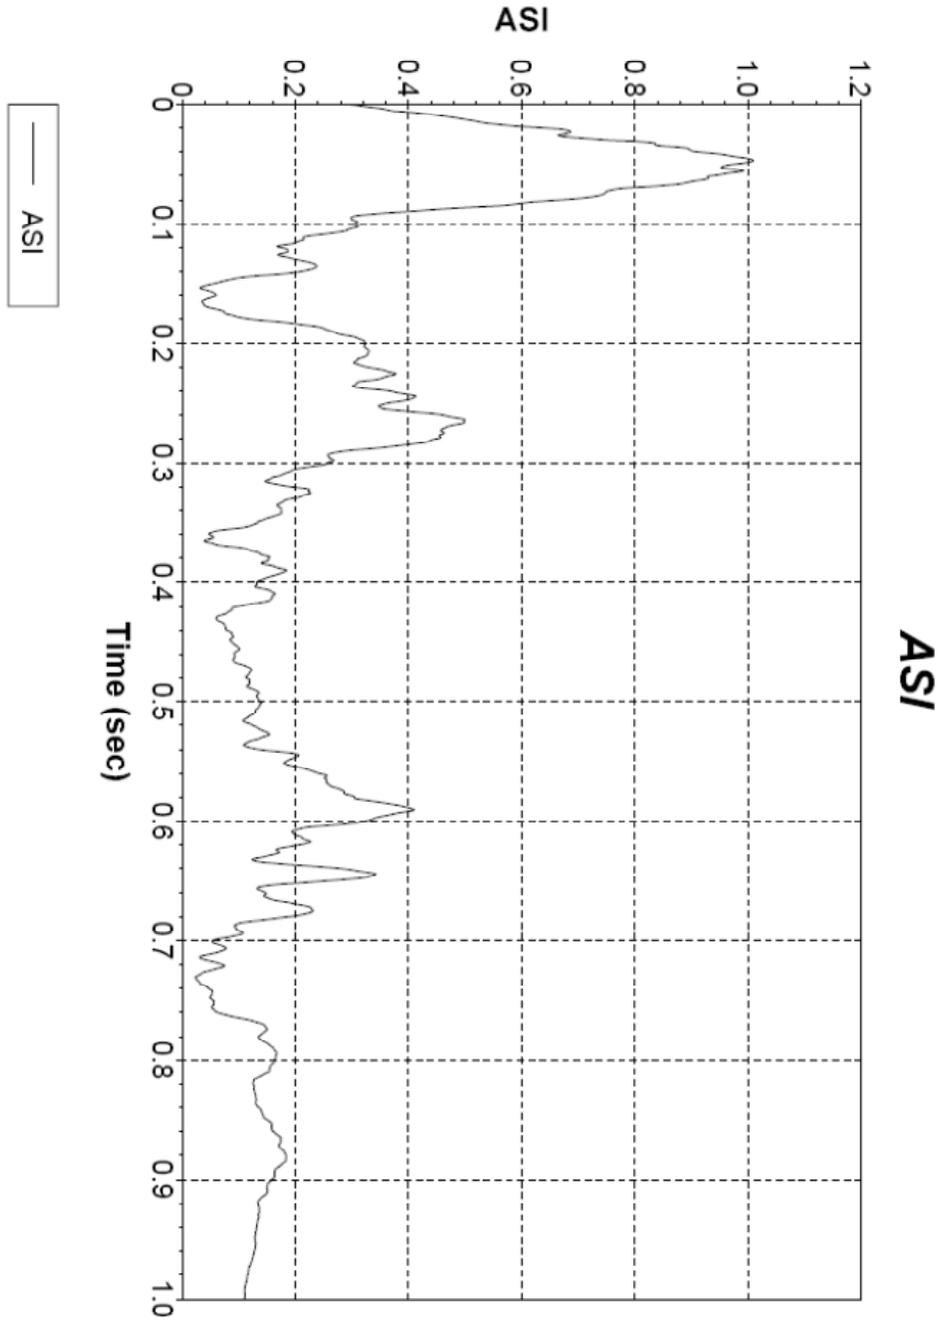
Figure 8-5. Test 701 X (Longitudinal) Acceleration at C.G. Vs Time

Figure 8-6. Test 701 Y (Lateral) Acceleration at C.G. Vs Time

Figure 8-7. Test 701 Z (Vertical) Acceleration at C.G. Vs Time

Figure 8-8. Test 701 Roll, Pitch, and Yaw Rates Vs Time

Figure 8-9. Test 701 Roll, Pitch, and Yaw Angles Vs Time

Figure 8-10. Test 701 Vehicle Acceleration Severity Index (ASI) Vs Time

The data curves are shown in Figure 8-5 through 8-16 include the accelerometer and angular rate sensor records from the test vehicles. They also show the velocity and displacement curves for the longitudinal and lateral components. These plots are required to calculate the occupant impact velocity defined in NCHRP Report 350. All data were analyzed using TRAP.

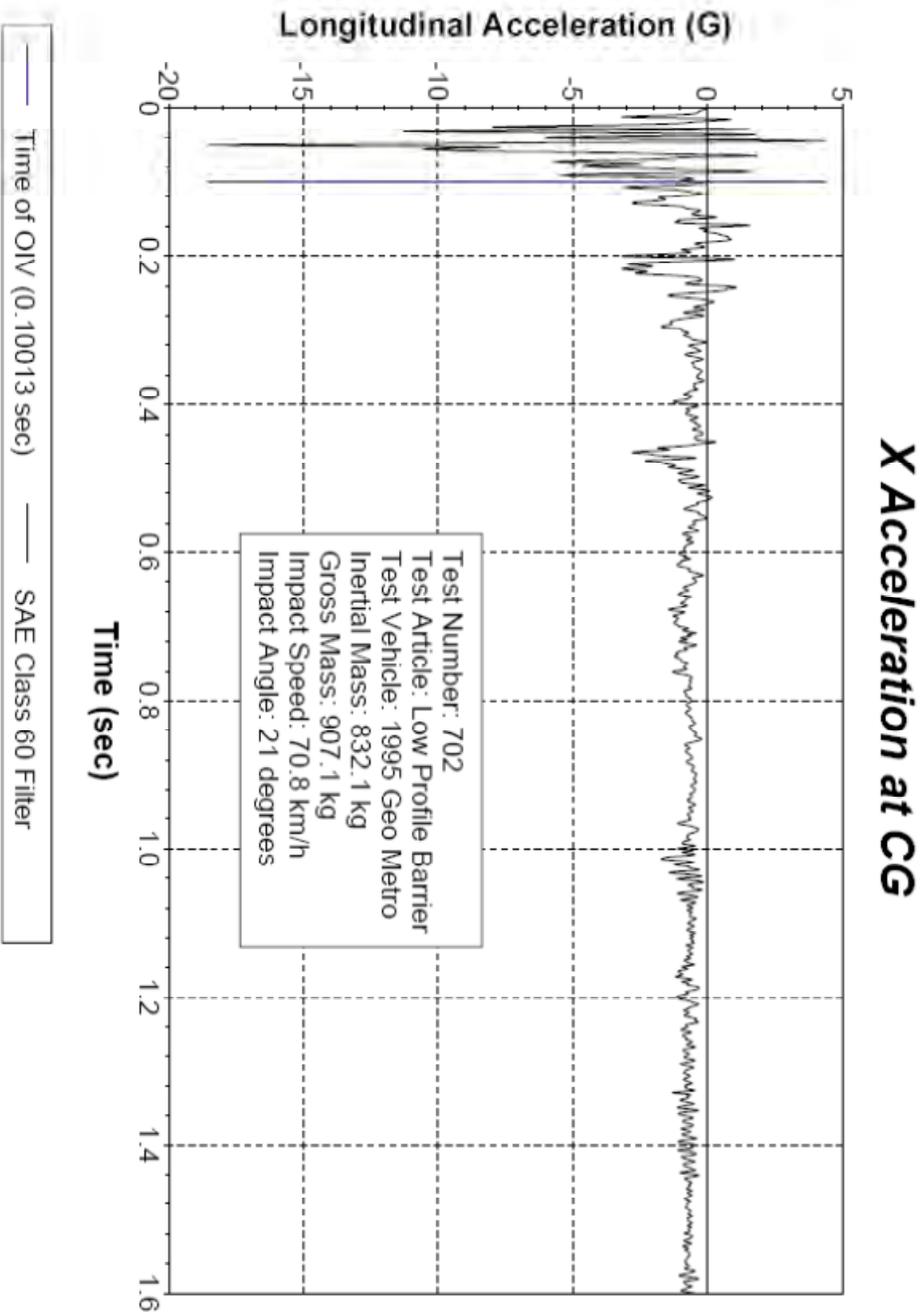
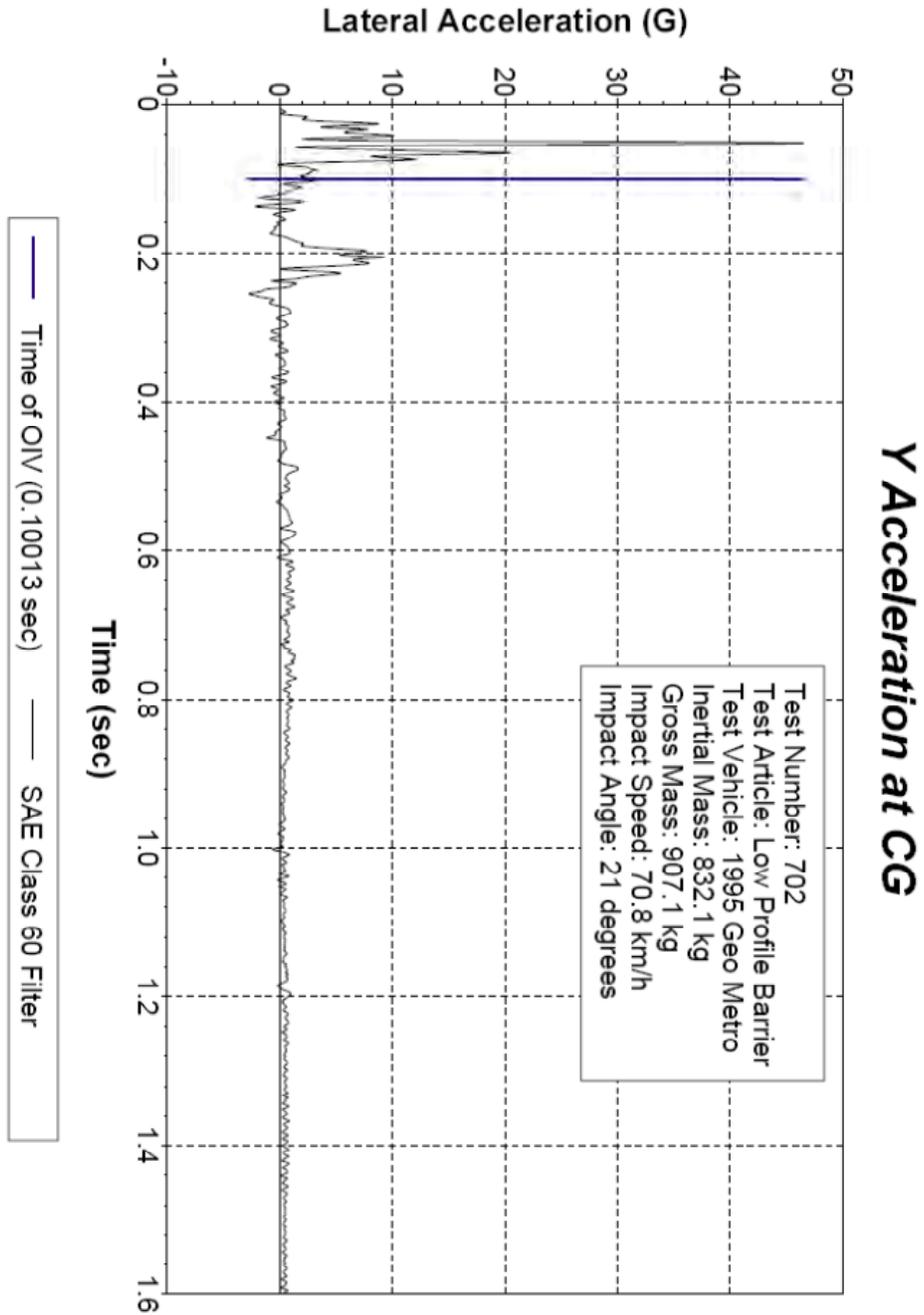
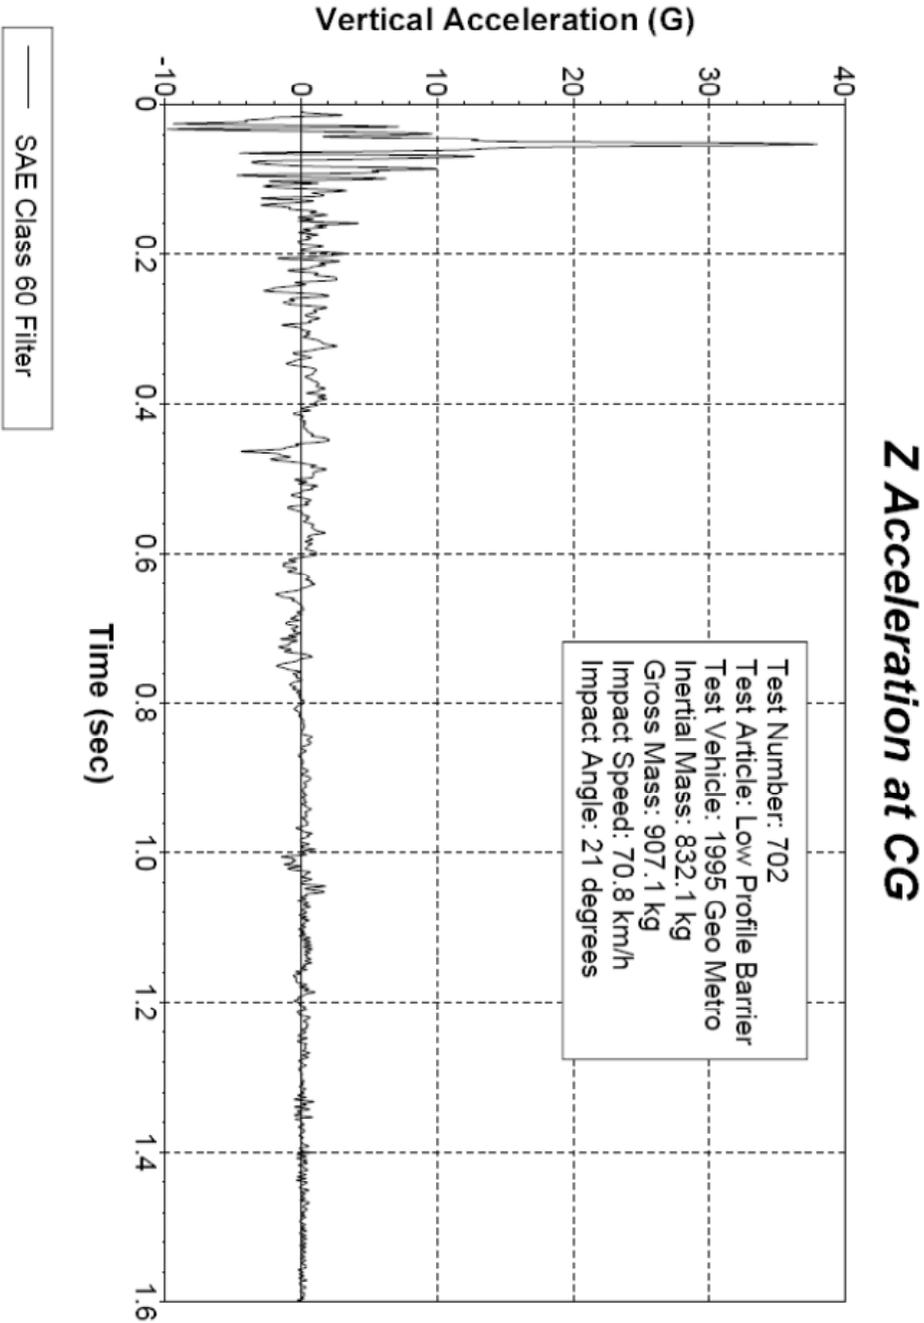
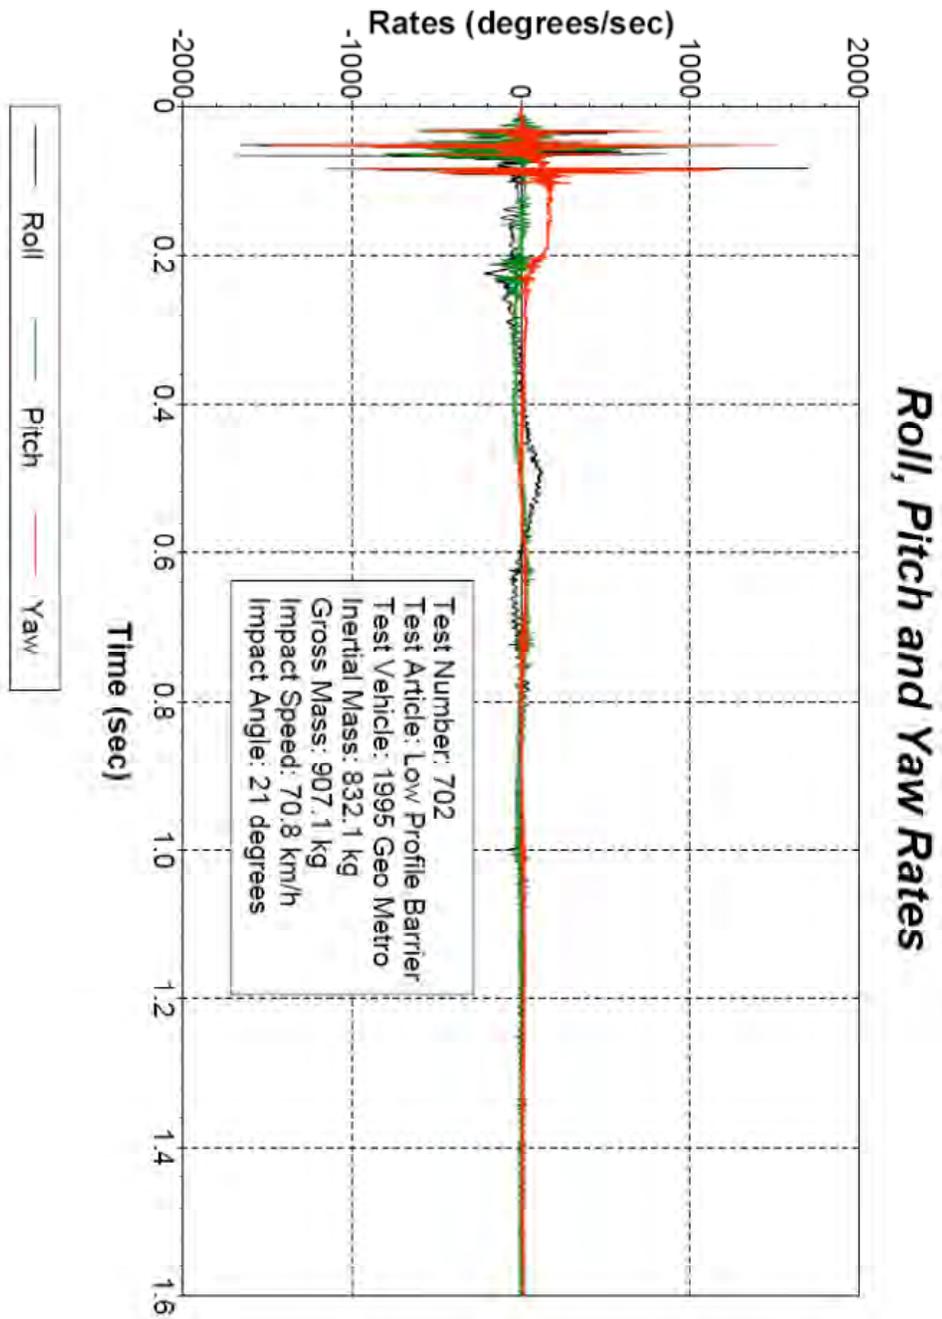
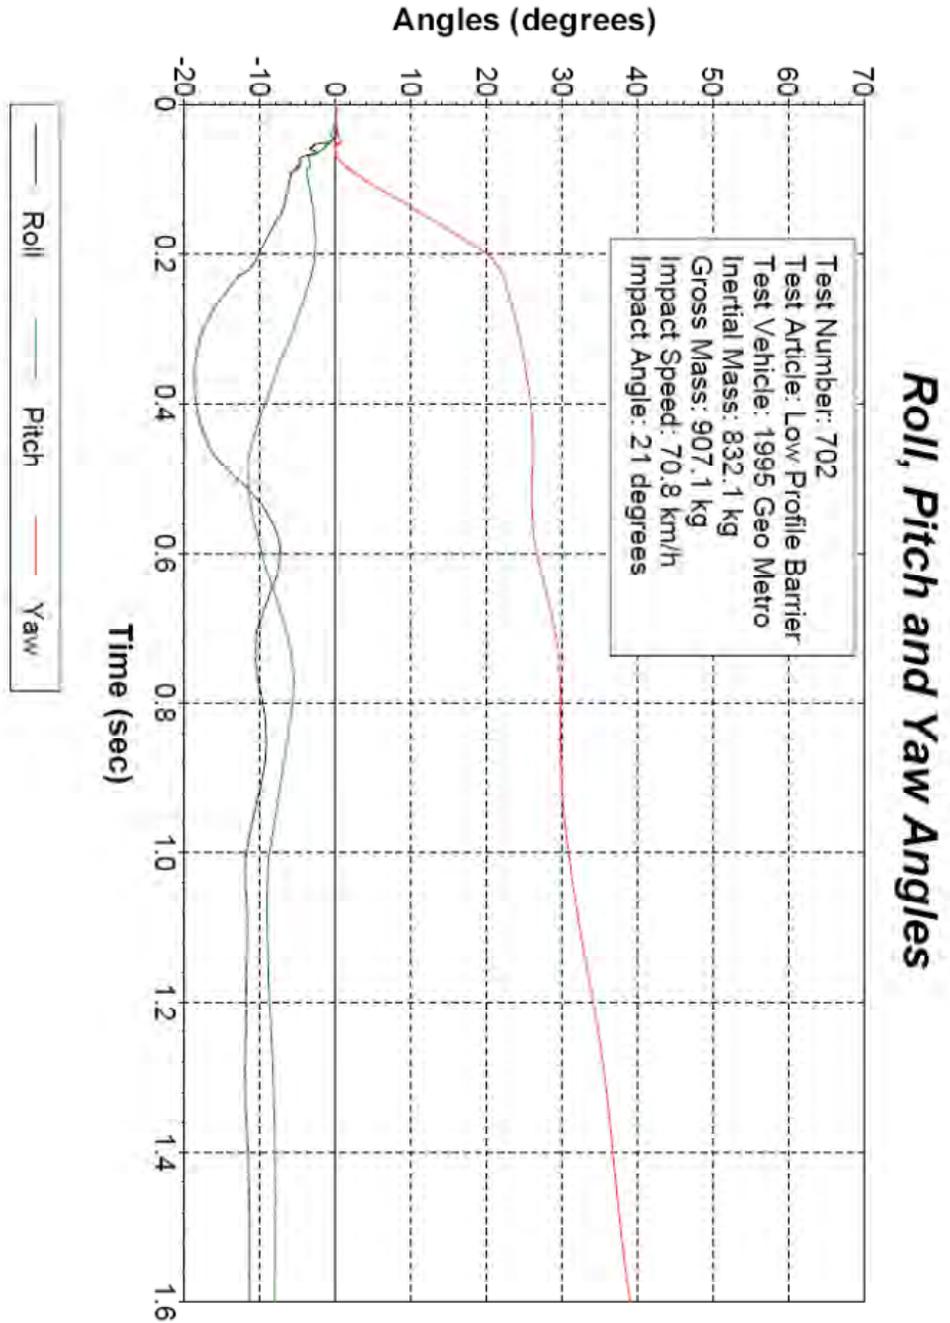
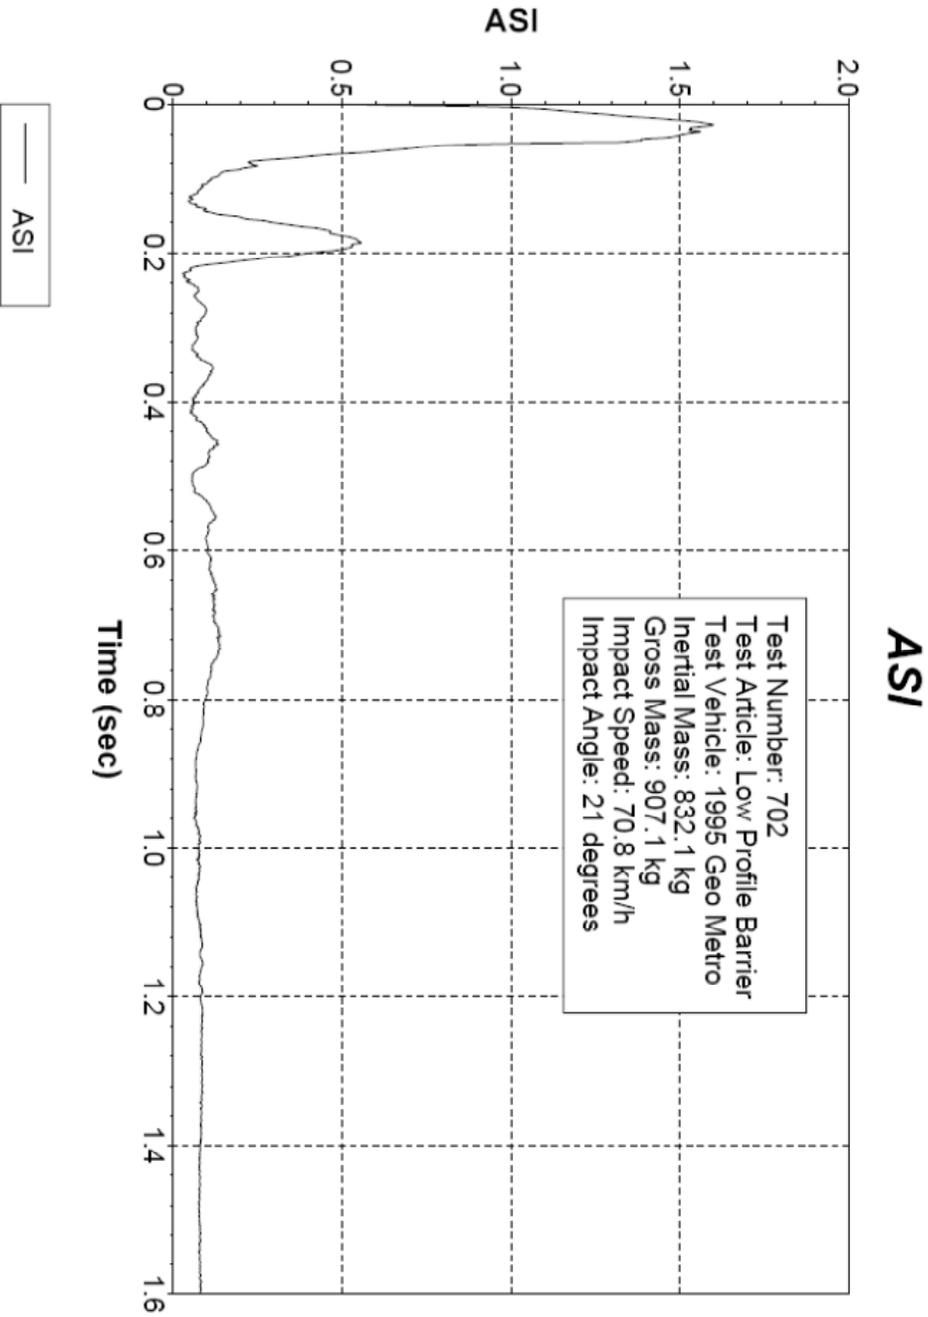
Figure 8-11. Test 702 X (Longitudinal) Acceleration at C.G. Vs Time

Figure 8-12. Test 702 Y (Lateral) Acceleration at C.G. Vs Time

Figure 8-13. Test 702 Z (Vertical) Acceleration at C.G. Vs Time

Figure 8-14. Test 702 Roll, Pitch, and Yaw Rates Vs Time

Figure 8-15. Test 702 Roll, Pitch, and Yaw Angles Vs Time

Figure 8-16. Test 702 Vehicle Acceleration Severity Index (ASI) Vs Time

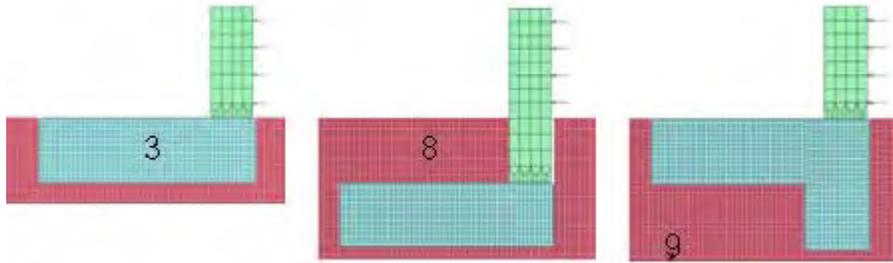
Figure 8-17. Cross-Sections 3, 8, and 9

The next step after calibrating the soil model was to determine the most effective foundation cross-section in resisting vehicle impacts. A parametric design study of various cross-sections of the foundation was performed using LS-DYNA to determine effective sizes and geometries. Ten different foundation cross-sections were modeled. The parametric study narrowed the selection of the cross-sections down to sections 3, 8, 9. (See Figure 8-17)

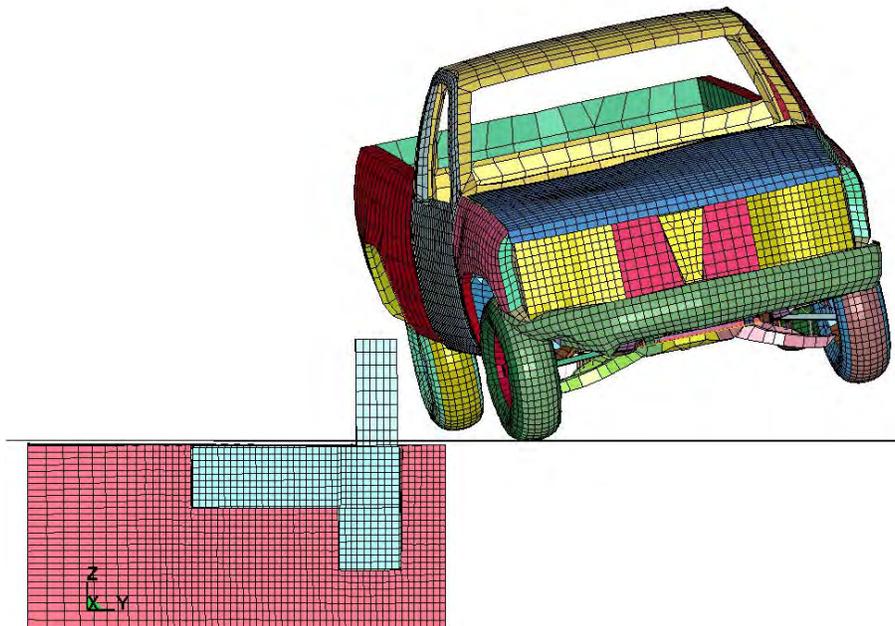
Figure 8-18. C2500 Pickup Impact on Cross-Section 9

The full length rigid barrier impact with a C2500 pickup was completed on cross-section 9. (See Figure 8-18) The 3-dimensional simulation of section 9 yielded deflections that were lower than the 2-dimensional parametric cases.

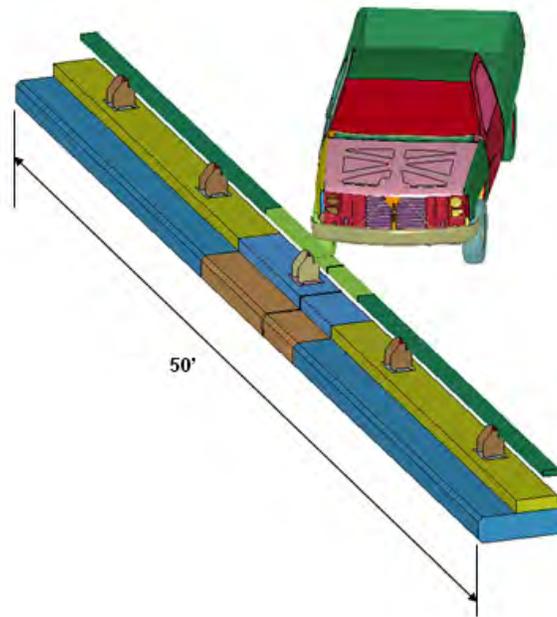
Figure 8-20. 50 Feet Long Test Section

The low-profile barrier model was impacted by the pickup truck in weak soil (loose sand) and in rigid soil to evaluate deflections and foundation strength. Only 50 feet of the low-profile barrier was modeled to reduce computation time although a 100 feet long test section was later built and crash tested to validate the simulation. (See Figure 8-20)

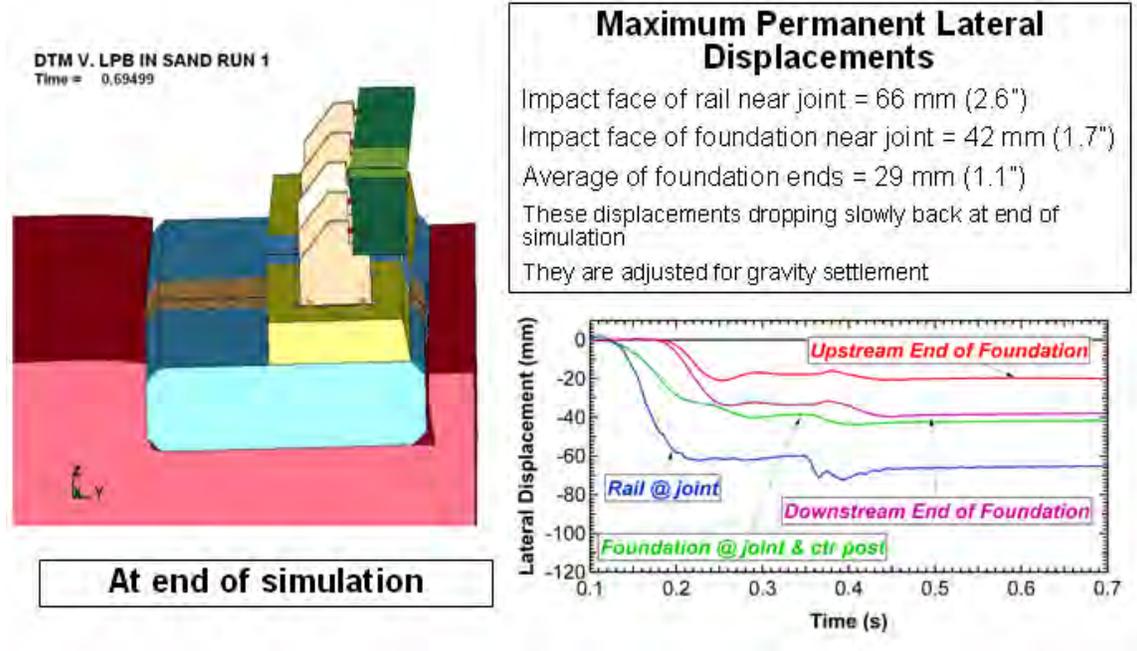
Figure 8-22. Maximum Permanent Lateral Displacements

The vehicle was redirected and did not roll, snag, or pocket. The lateral occupant impact velocity (OIV) was 5.03 m/s. The longitudinal OIV was 4.3 m/s. The preferred value in *NCHRP Report 350* is 9 m/s. The lateral and longitudinal ridedown accelerations were 8.2 g and 5.1 g. The preferred value is 15 g. The maximum lateral permanent rail deflection was 66 mm. (See Figure 8-22) (*ARA Caltrans Barrier Report, July 24, 2008*)

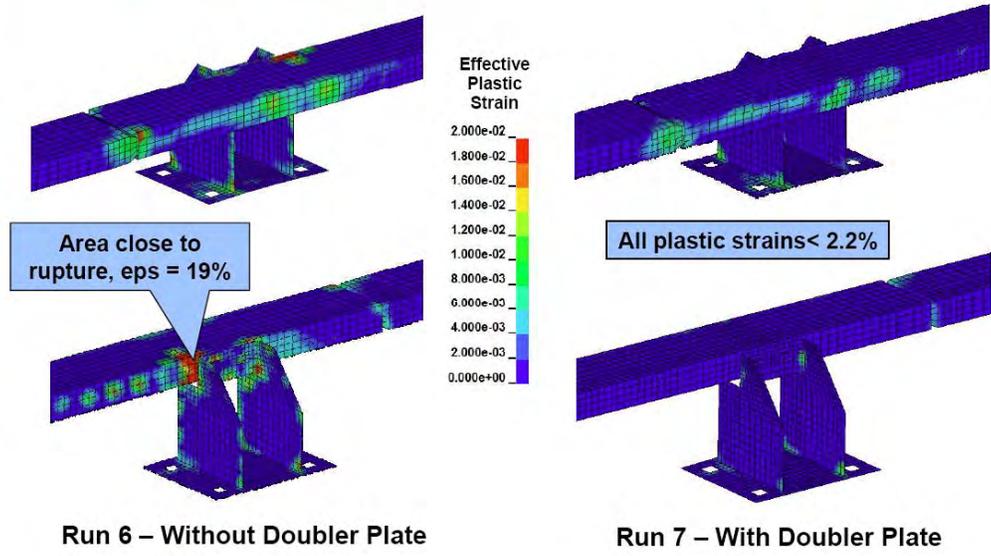
Figure 8-23. Plastic Strains at Post

The focus of the work for the last quarter was on crash simulation at the post and at the mid-span of low-profile barrier with the modifications to the rail post connection and anchor bolts strengths. Both the rigid and weak soil cases were simulated. The rail post connection was reinforced with double plate and higher strength bolts were use. For the rigid soil simulation, the addition of the double plate greatly reduced the peak plastic strains seen in the rail when impacted at the post (19% to 2.2% plastic strain for impact at the post). (See Figure 8-23)

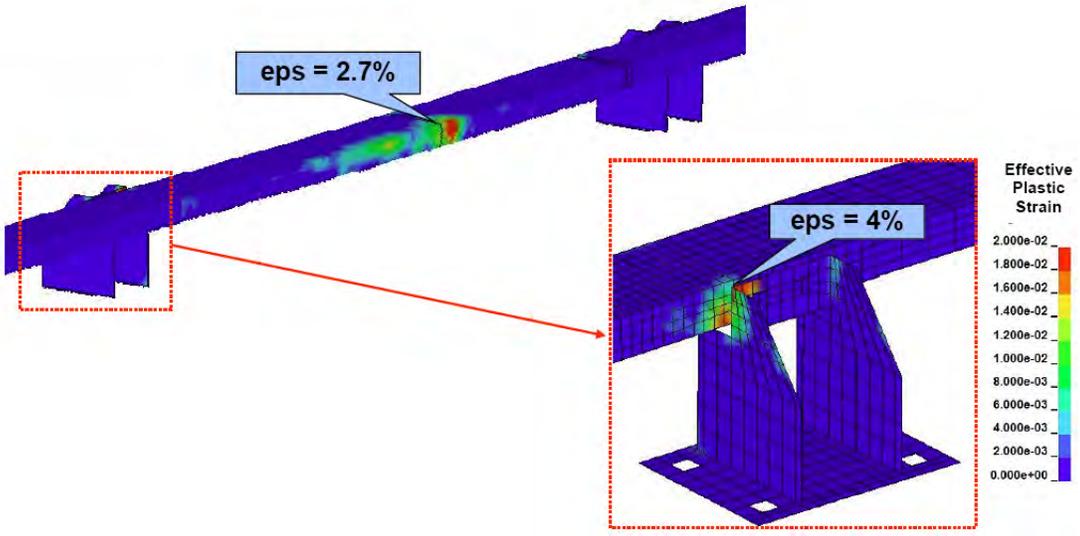
Figure 8-24. Plastic Strains at Mid-Span

The largest plastic strains were seen in the upper corner of the downstream post for the mid-span impact (4% plastic strain). (See Figure 8-24)

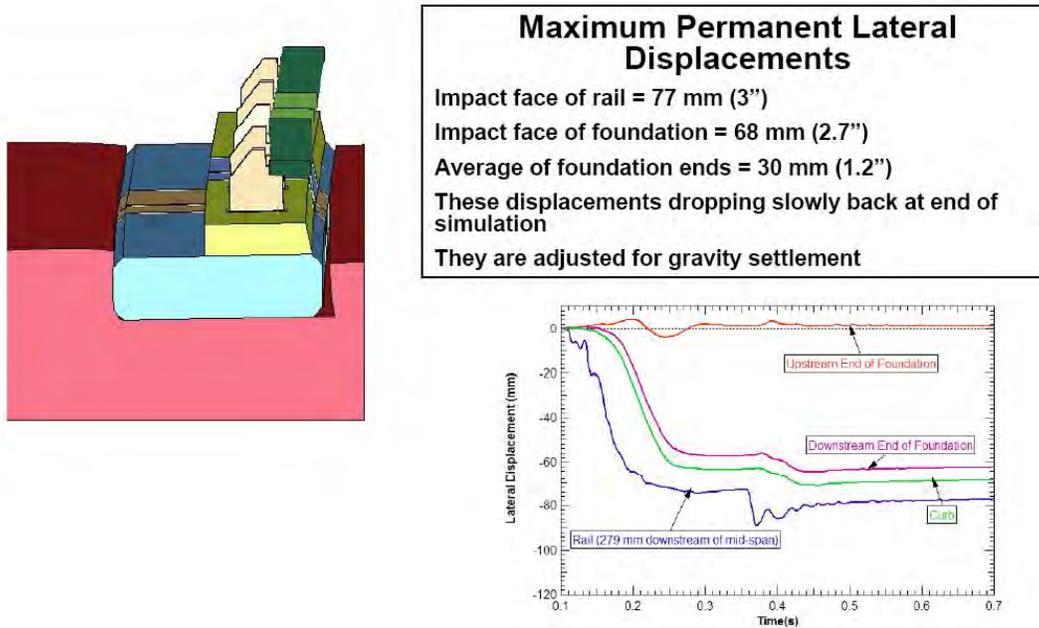
Figure 8-25. Maximum Permanent Lateral Displacements

mm from the impact at the post (66 mm to 77 mm lateral deflection). (See Figure 8-25) (ARA Caltrans Barrier Report, October 16, 2008)

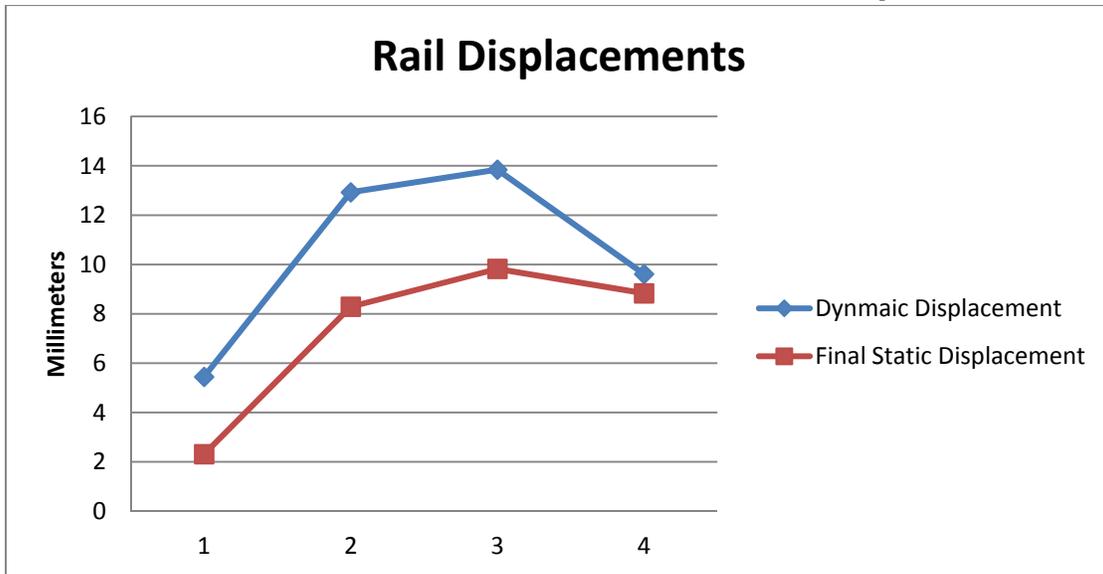
Figure 8-26. Rail Displacement

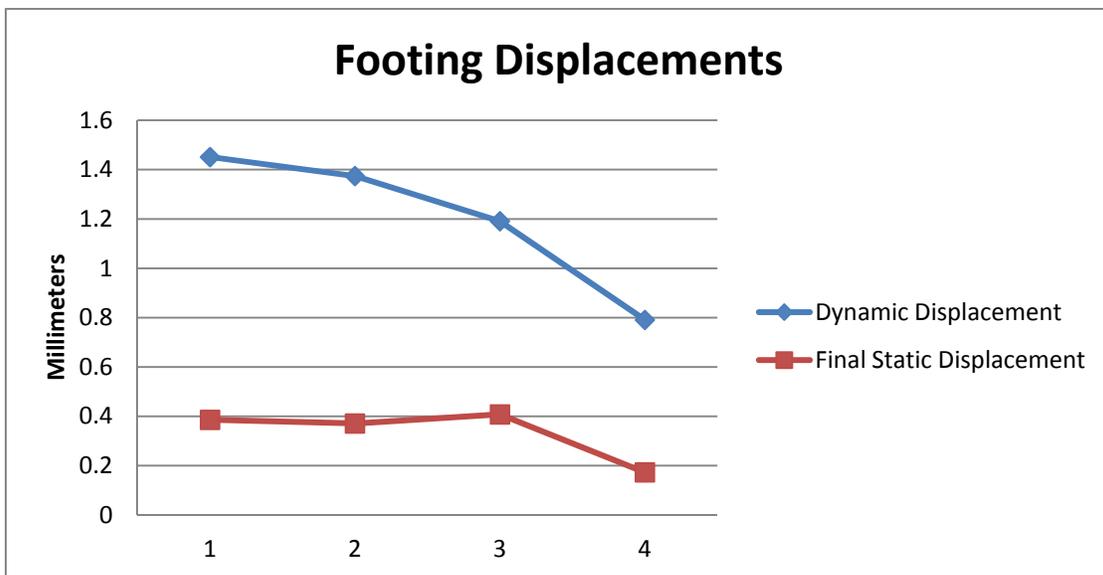
Figure 8-27. Footing Displacement
