1. REPORT NO. FHWA/CA10-0645	2. GOVERNMENT ACCESSION NO.	3. RECIPIENT'S CATALOG NO.	
4. TITLE AND SUBTITLE DEVELOPMENT AND TESTING OF A LOW-PROFILE BARRIER		5. REPORT DATE April 2012

DEVELOPMENT AND TESTING OF A LOW-PROFILE BARRIER

DEPARTMENT OF TRANSPORTATION
DIVISION OF RESEARCH AND INNOVATION
OFFICE OF SAFETY INNOVATION AND COOPERATIVE RESEARCH
ROADSIDE SAFETY RESEARCH GROUP

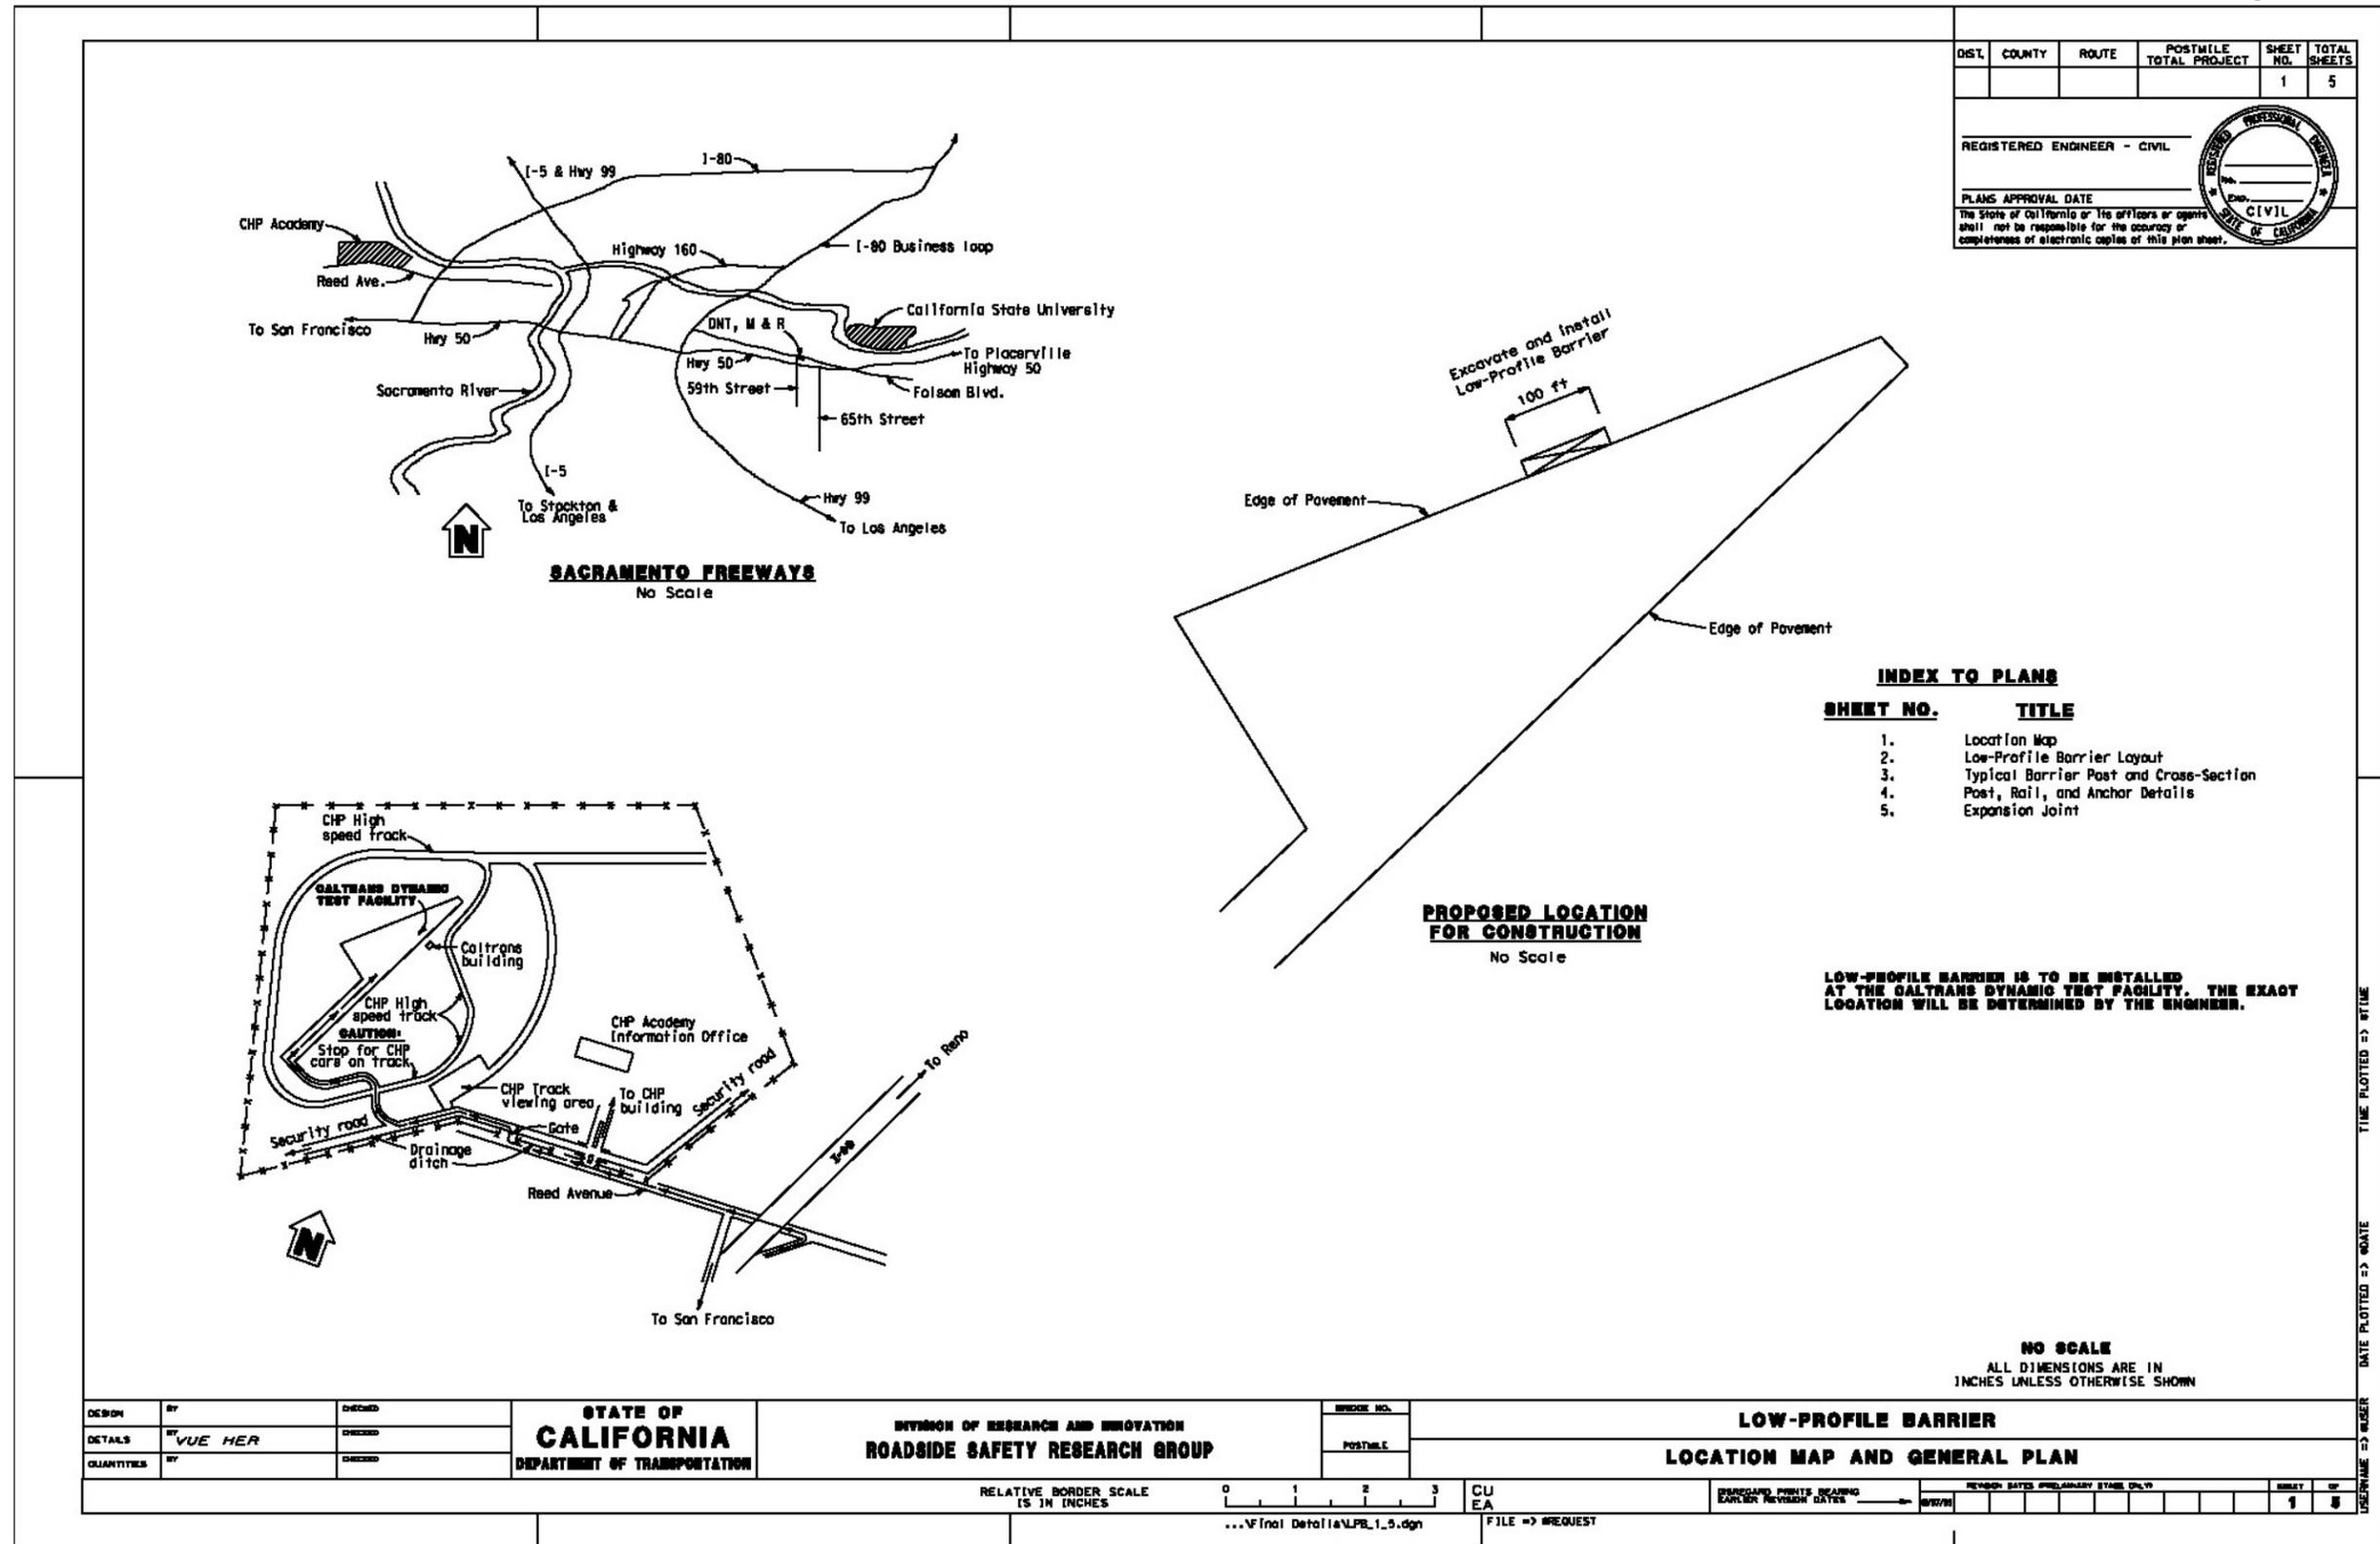
Figure 8-28. Caltrans Low-Profile Barrier Detail No. 1 (Tested Barrier)

The following details in Figure 8-28 to 8-32 are for the tested barrier only.

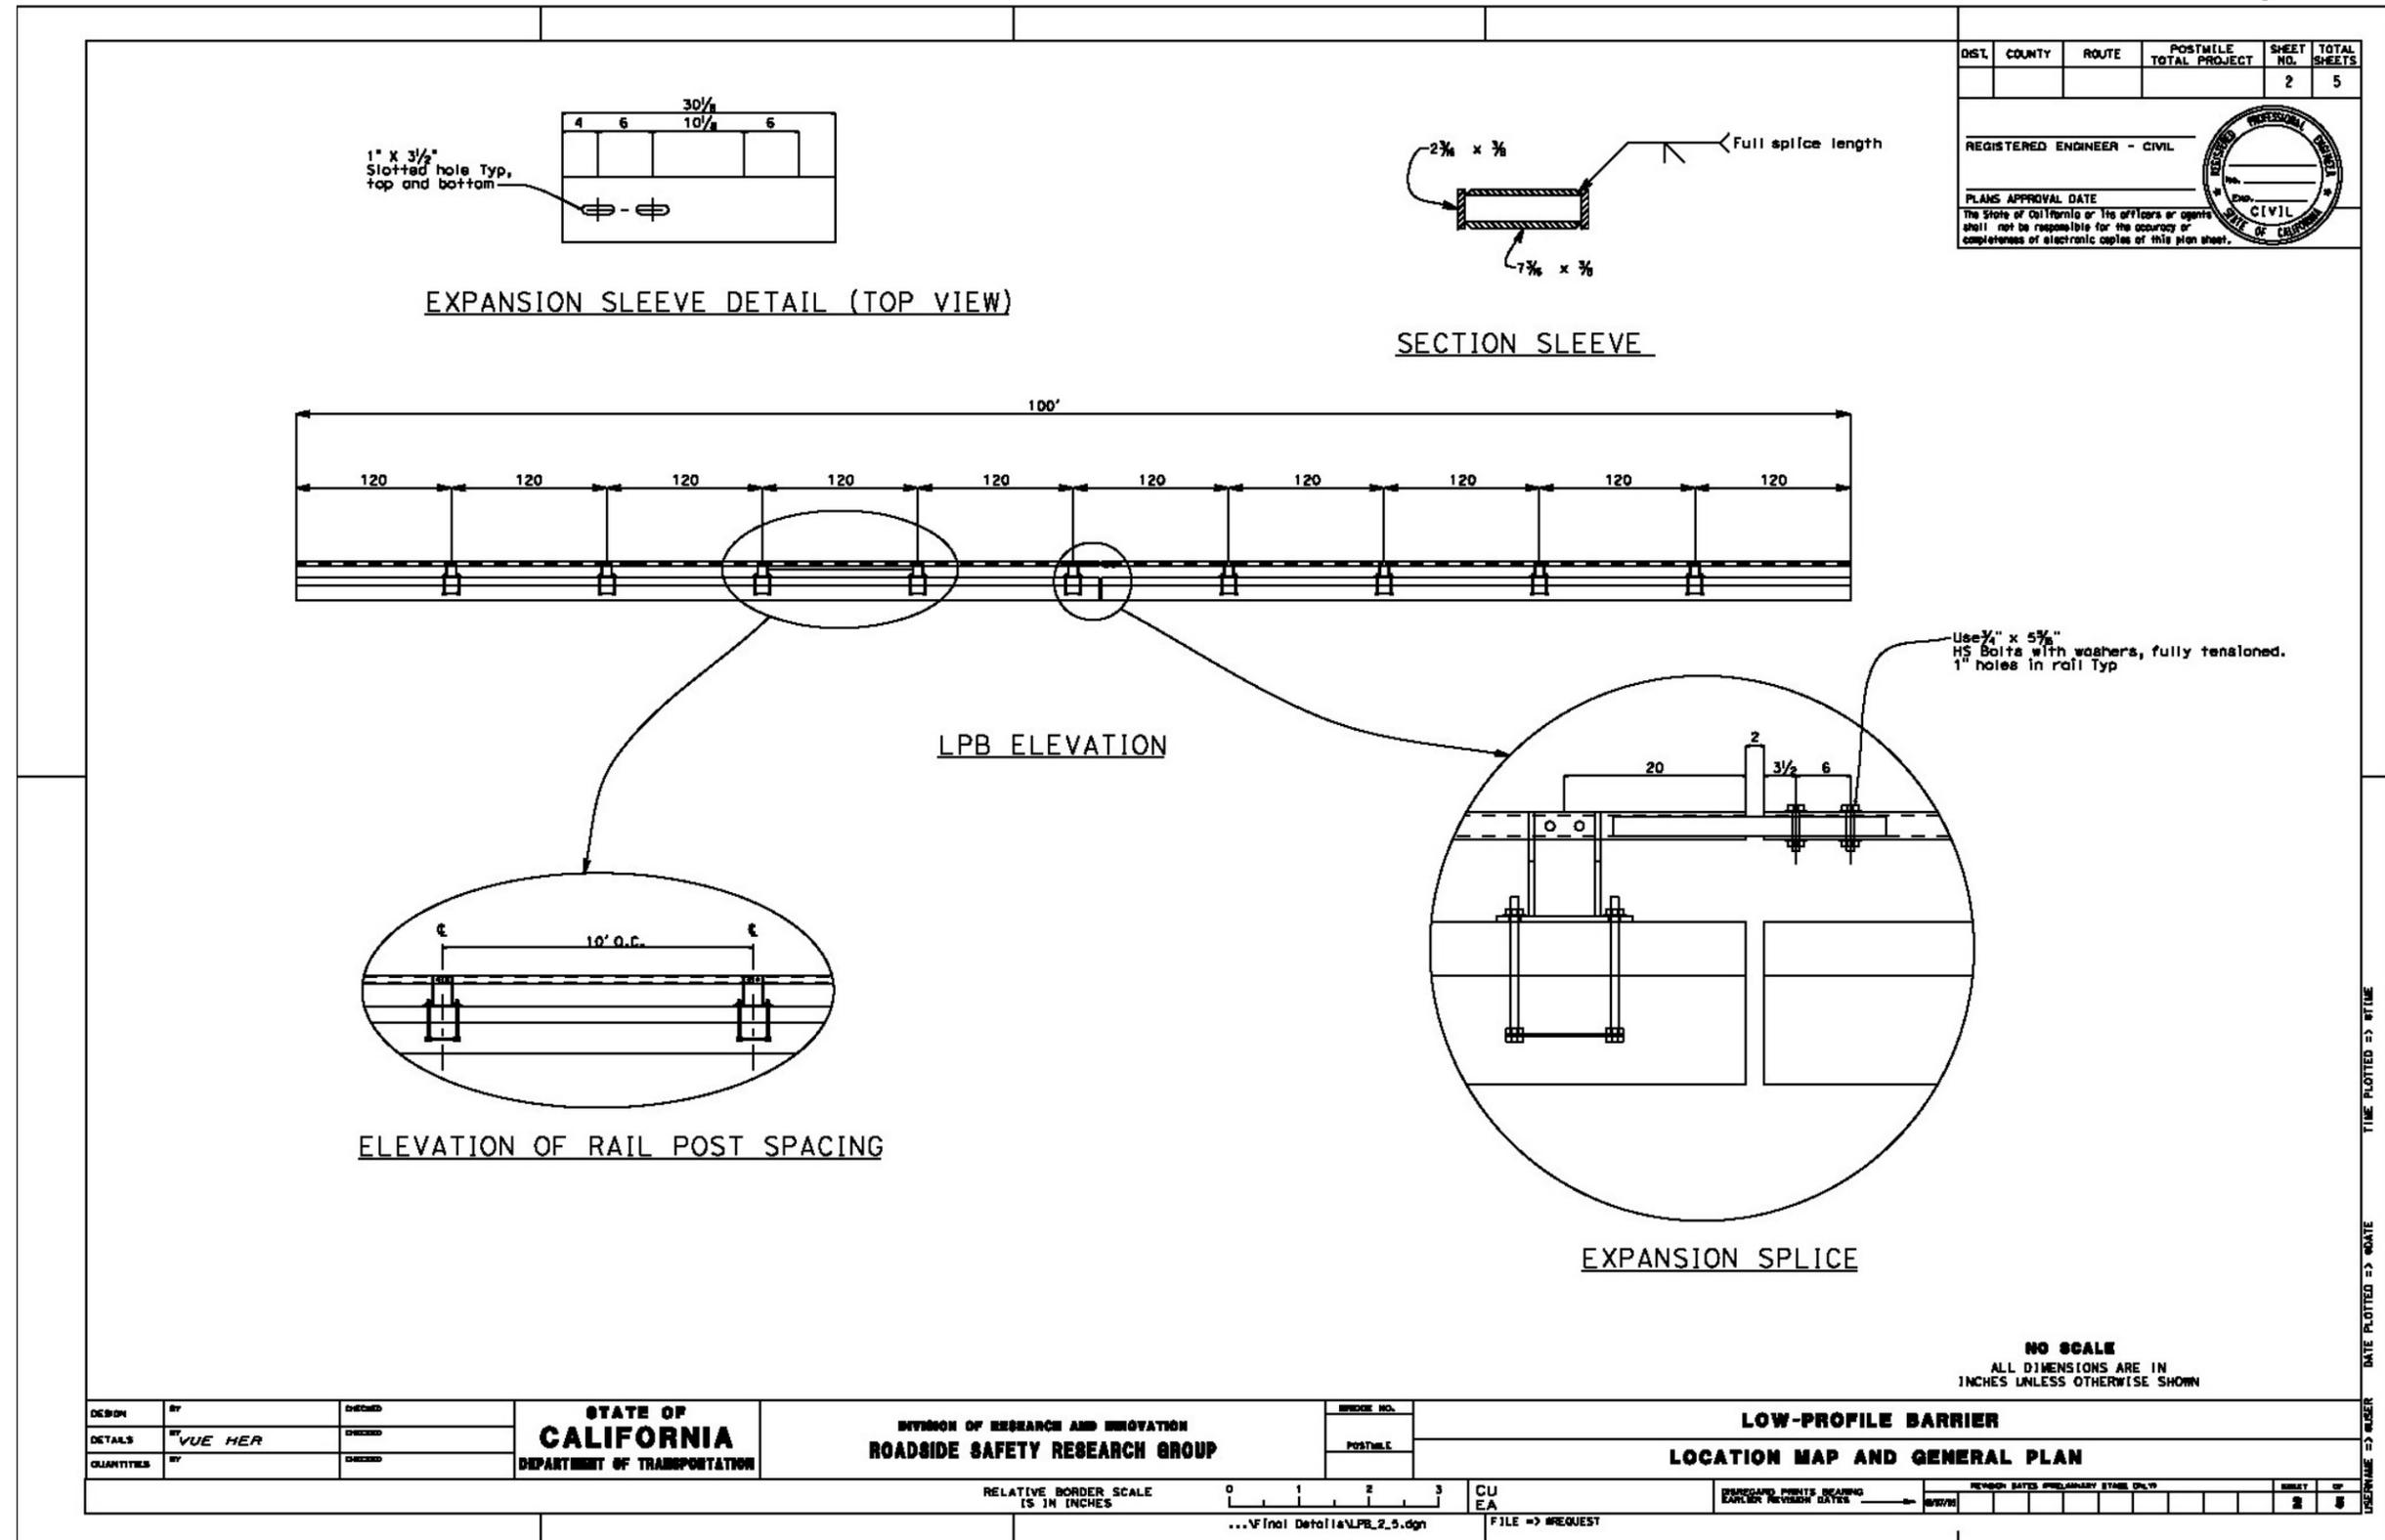
Figure 8-29. Caltrans Low-Profile Barrier Detail No. 2 (Tested Barrier)

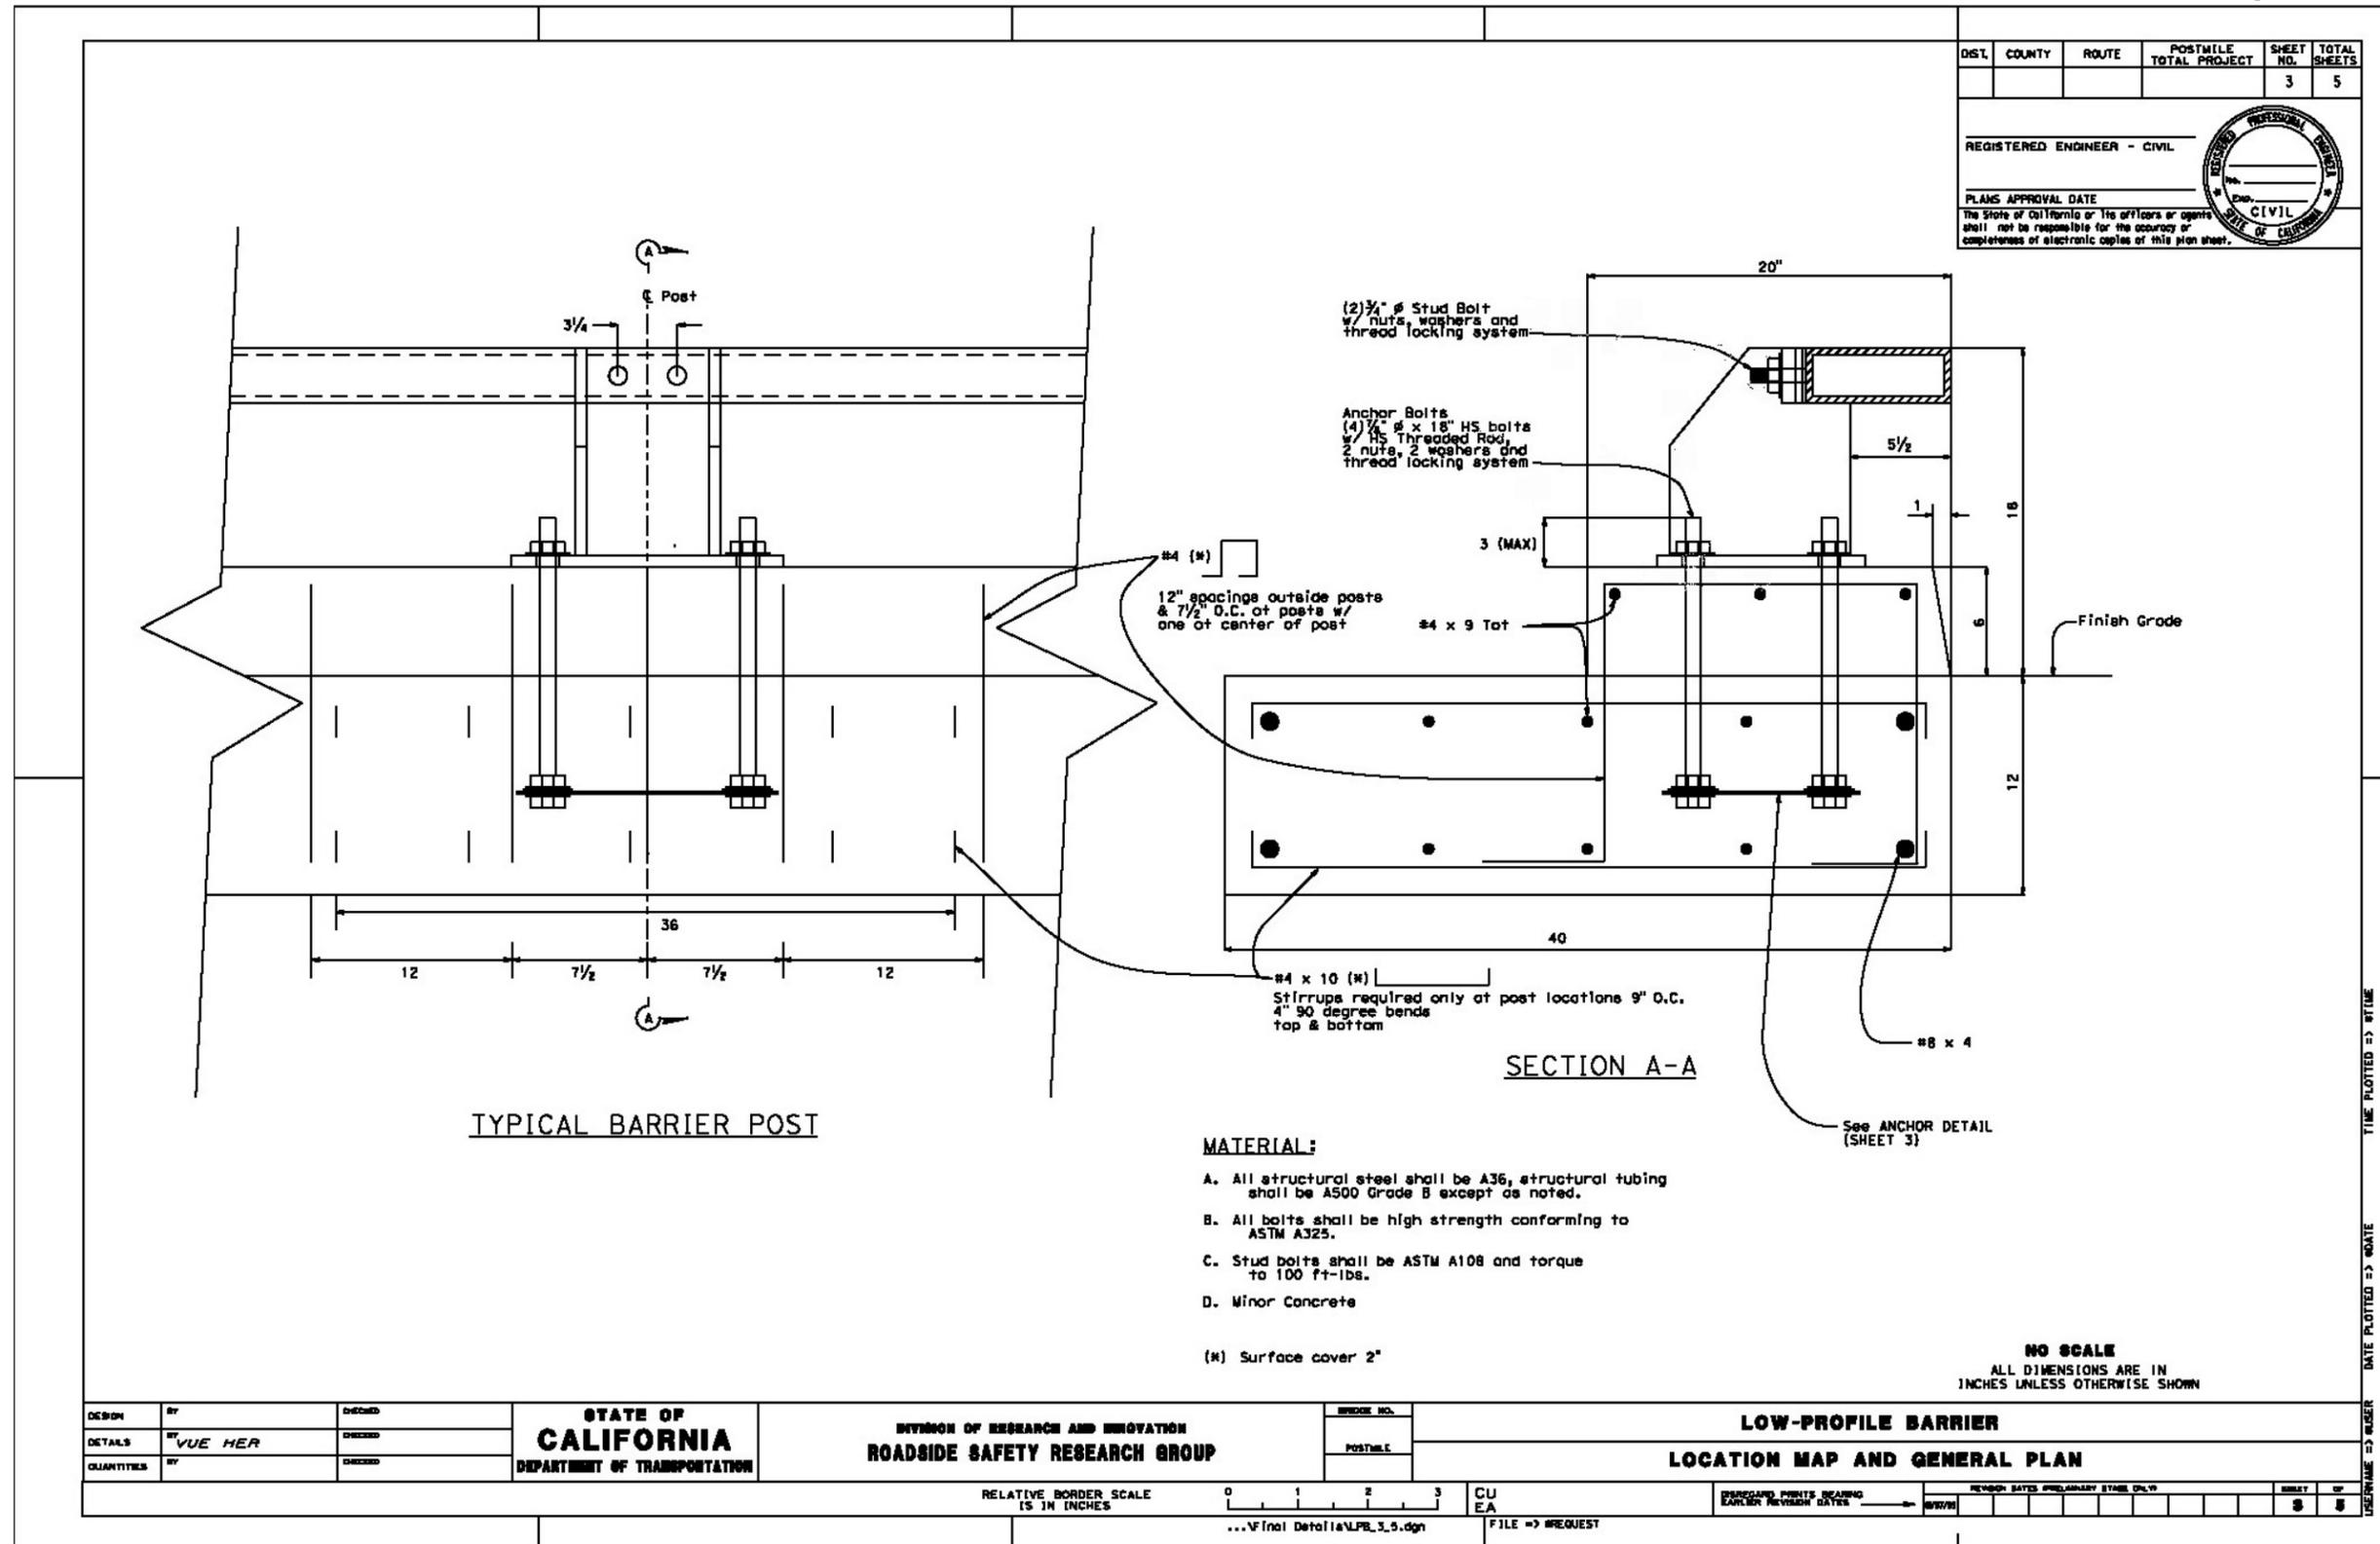
Figure 8-30. Caltrans Low-Profile Barrier Detail No. 3 (Tested Barrier)

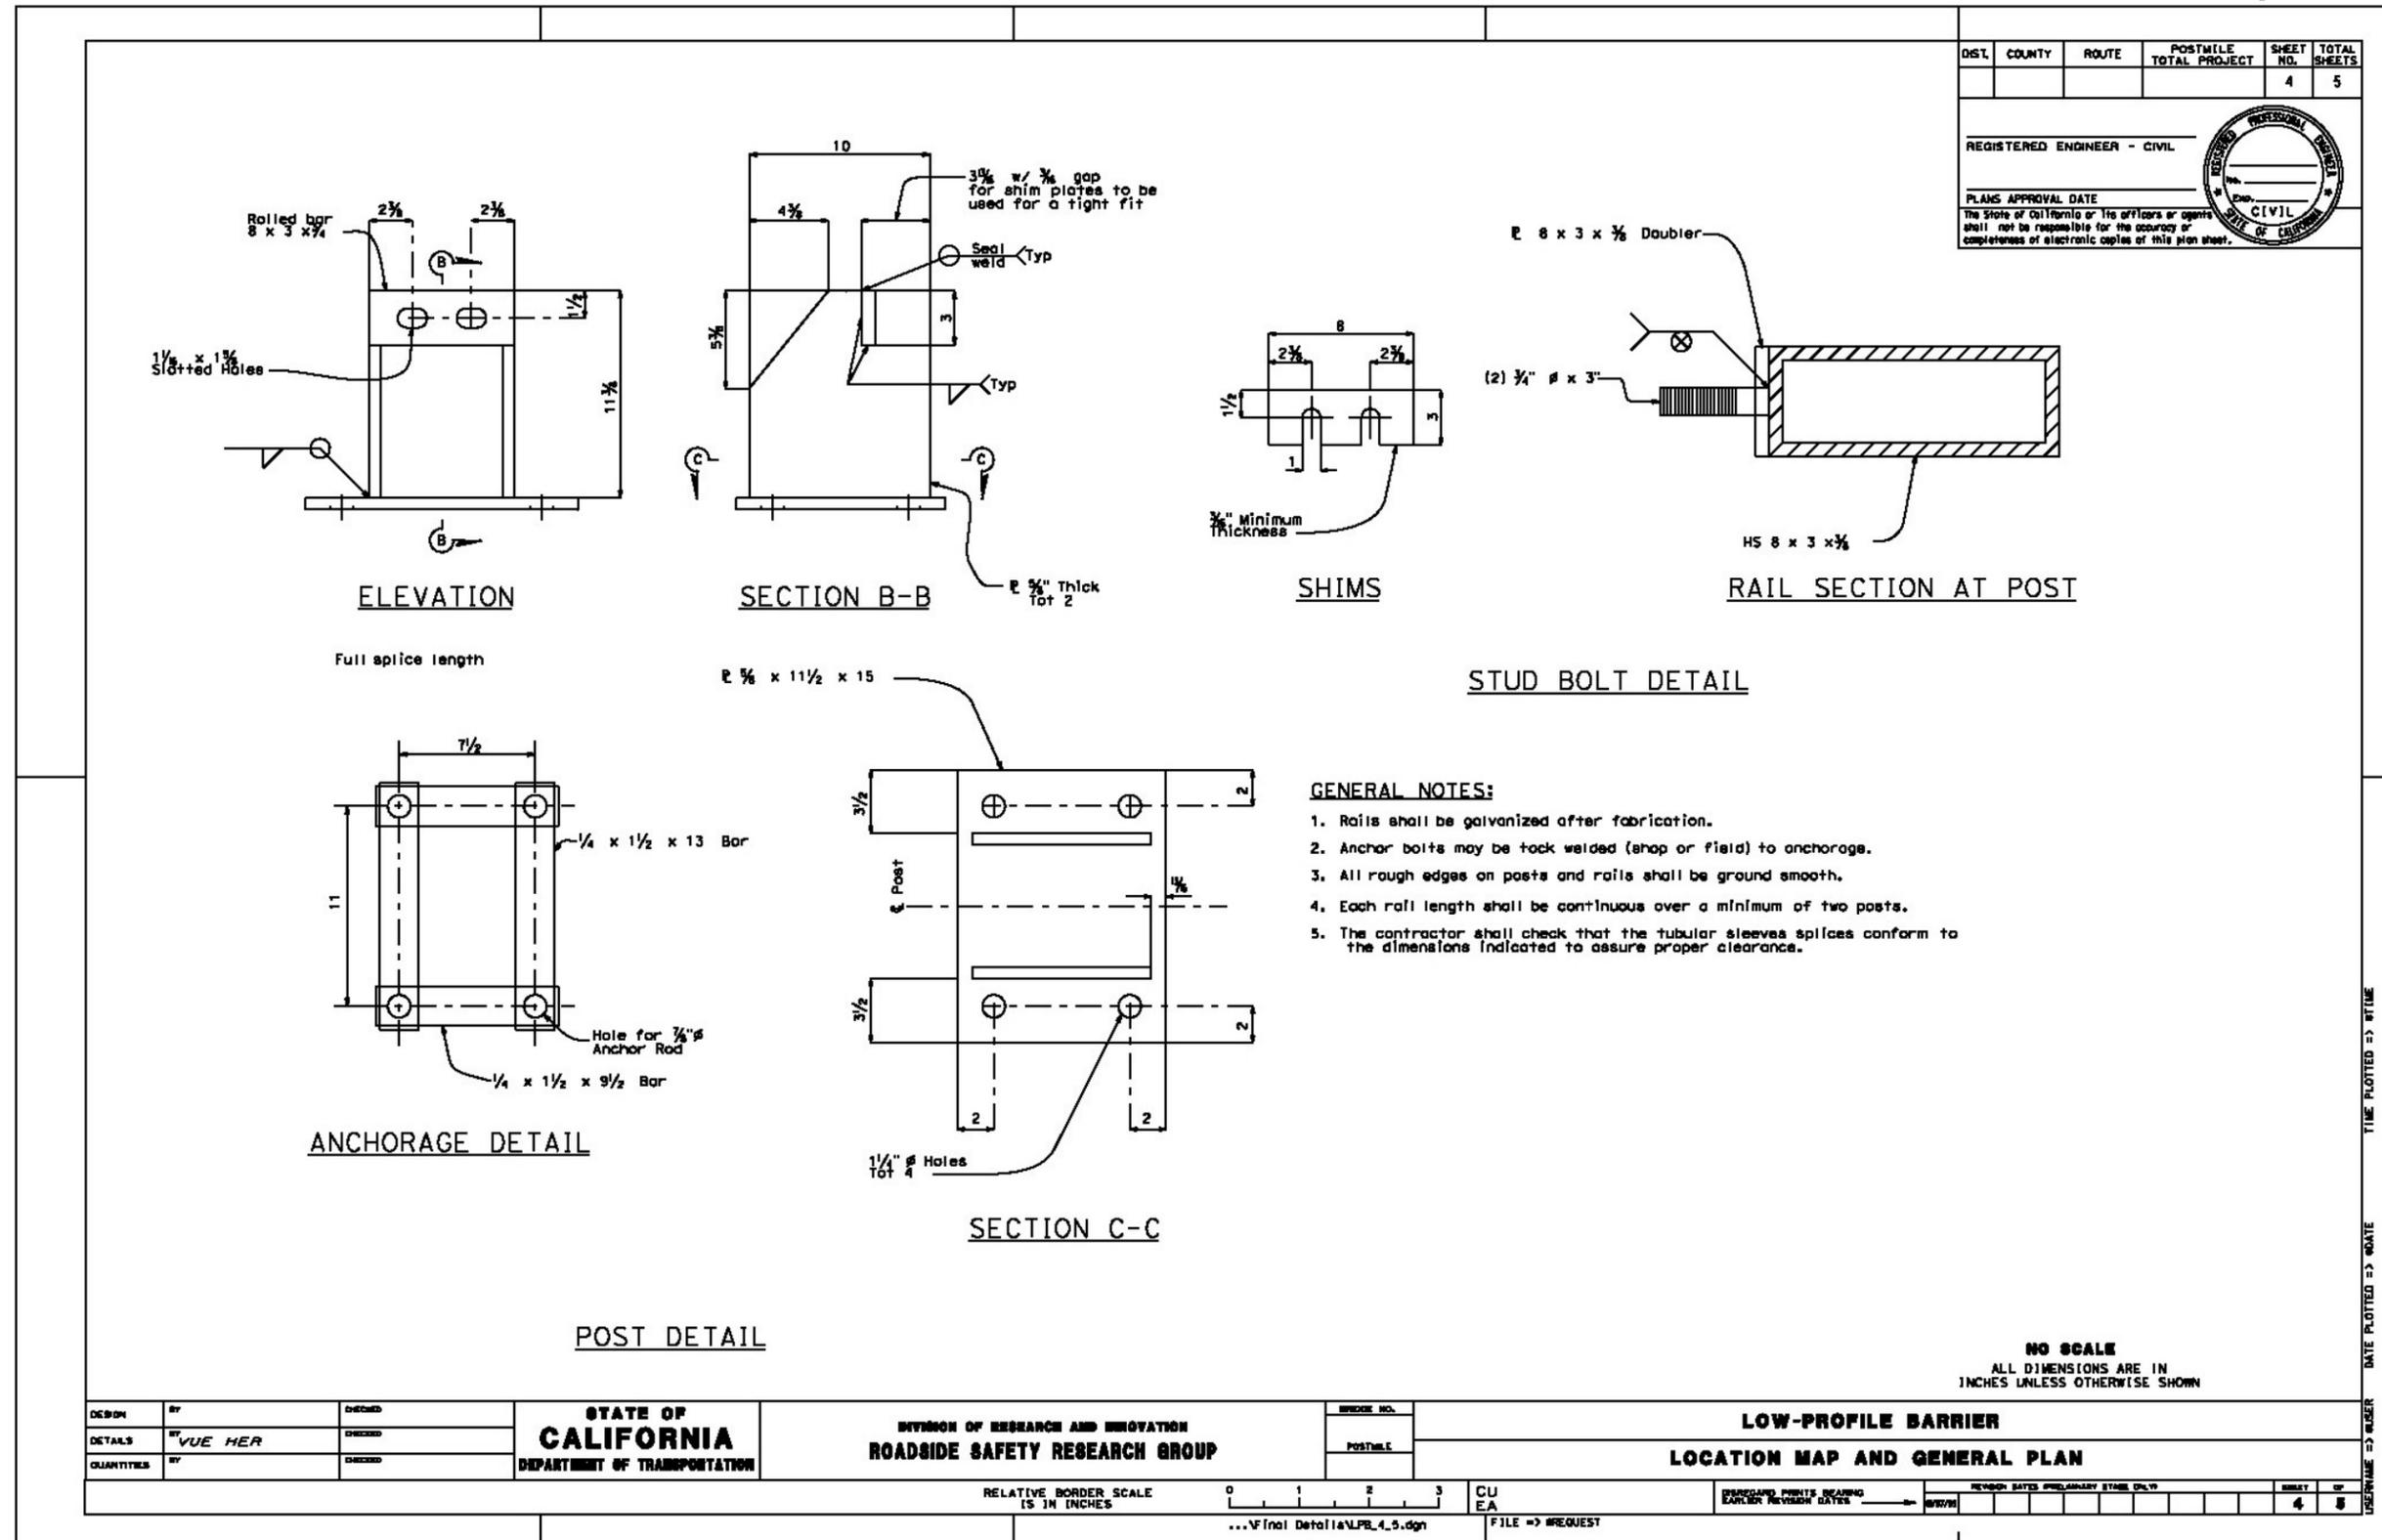
Figure 8-31. Caltrans Low-Profile Barrier Detail No. 4 (Tested Barrier)

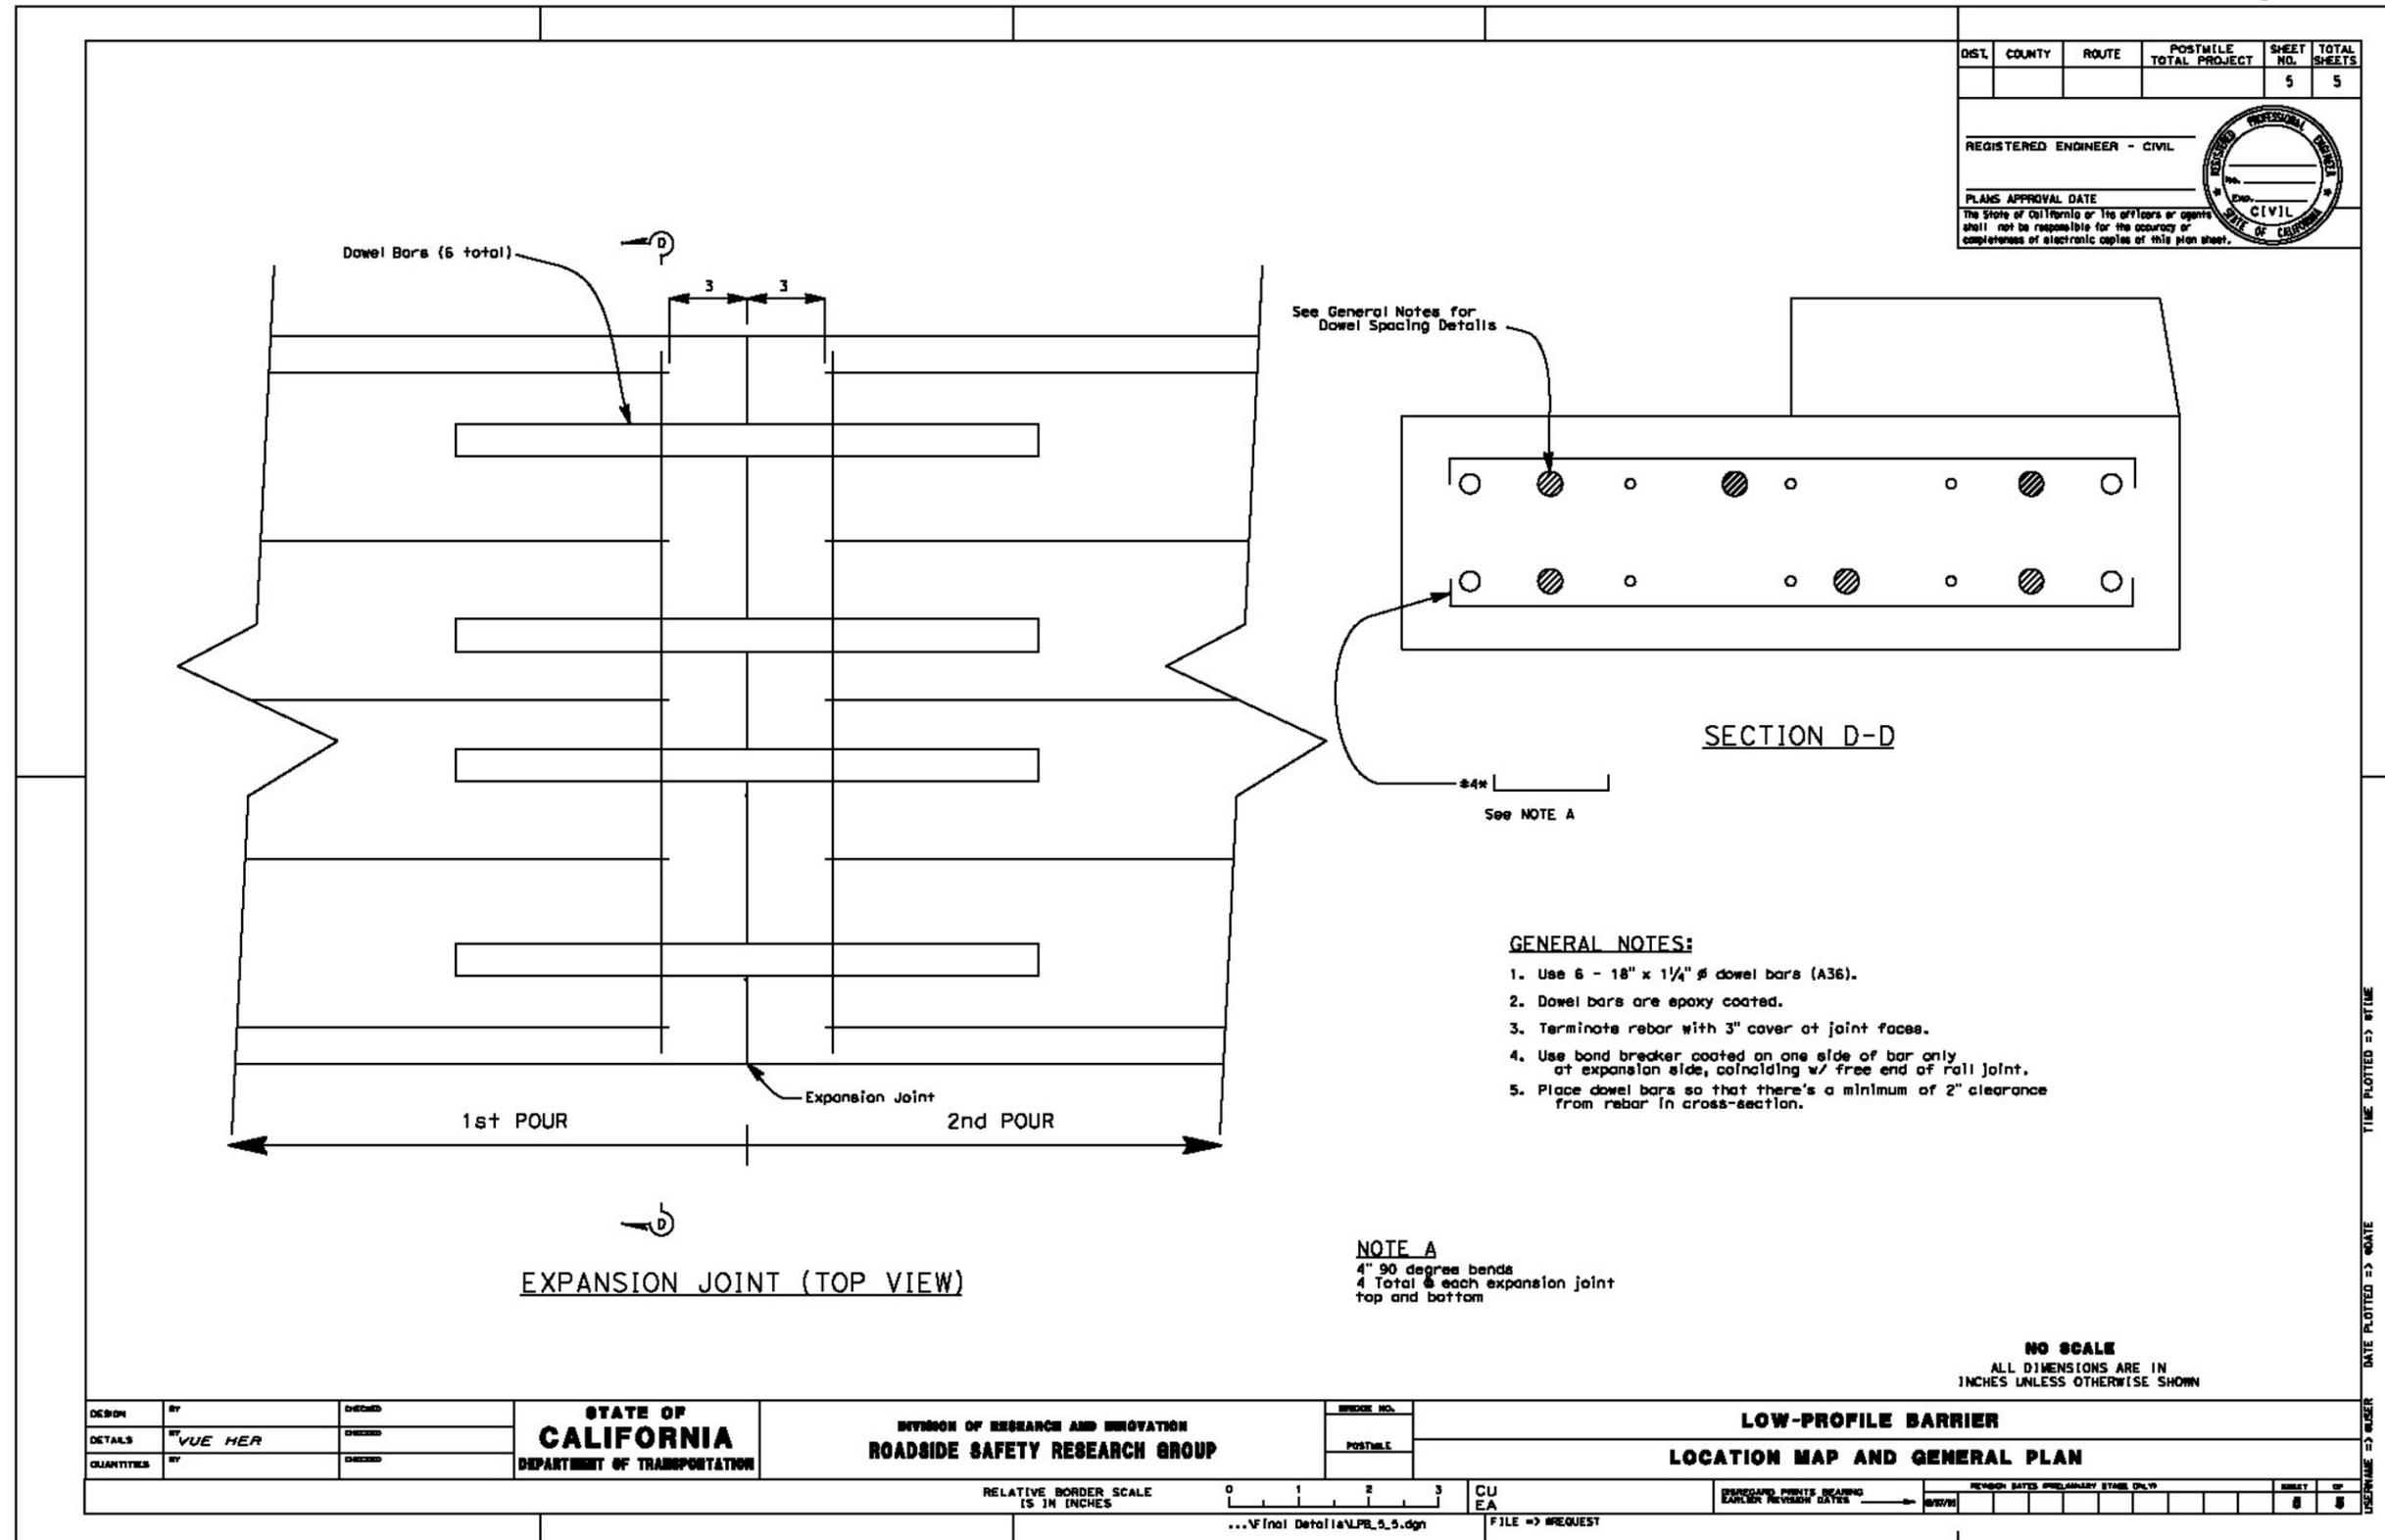
Figure 8-32. Caltrans Low-Profile Barrier Detail No. 5 (Tested Barrier)
