STATE OF CALIFORNIA
DEPARTMENT OF TRANSPORTATION
DIVISION OF FACILITIES CONSTRUCTION
OFFICE OF TRANSPORTATION LABORATORY

ROCKFALL MITIGATION

1 REPORT NO. FHWA/CA/TL-85/12	2. GOVERNMENT ACCESSION NO.	3. RECIPIENT'S CATALOG NO.
4. TITLE AND SUBTITLE ROCKFALL MITIGATION		5. REPORT DATE September, 1985
		6. PERFORMING ORGANIZATION CODE
7. AUTHOR(S) Marvin L. McCAuley, Byron W. Works and Sharon A. Naramore		8. PERFORMING ORGANIZATION REPORT NO. 54322-632173
9. PERFORMING ORGANIZATION NAME AND ADDRESS Office of Transportation Laboratory California Department of Transportation Sacramento, California 95819		10. WORK UNIT NO
		11. CONTRACT OR GRANT NO. F76TL12
12. SPONSORING AGENCY NAME AND ADDRESS California Department of Transportation Sacramento, California 95807		13. TYPE OF REPORT & PERIOD COVERED Final
		14. SPONSORING AGENCY CODE

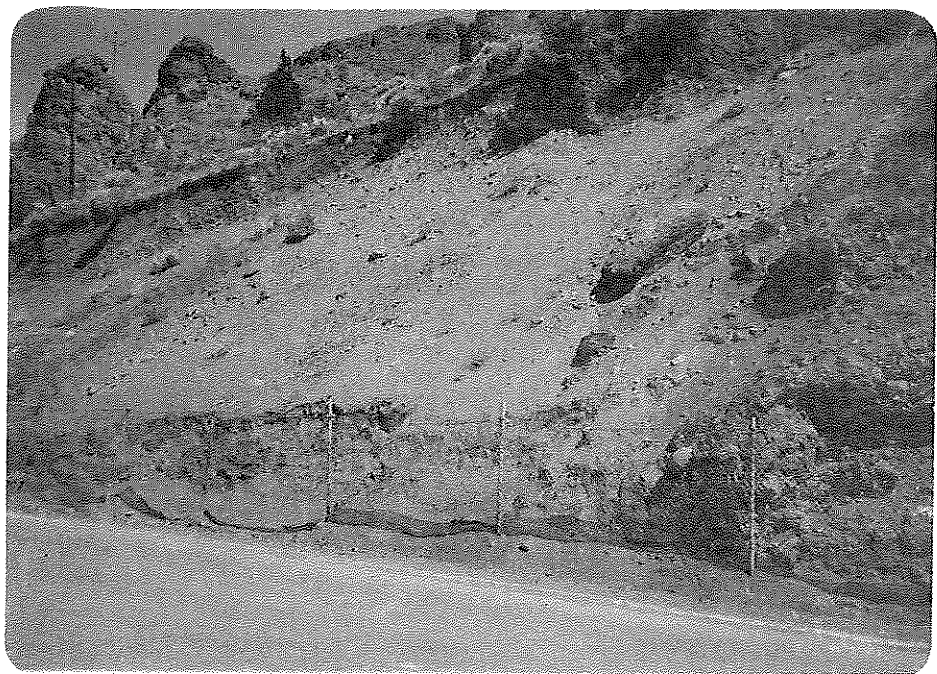
Figure 12. Large gap below bottom of the fence.

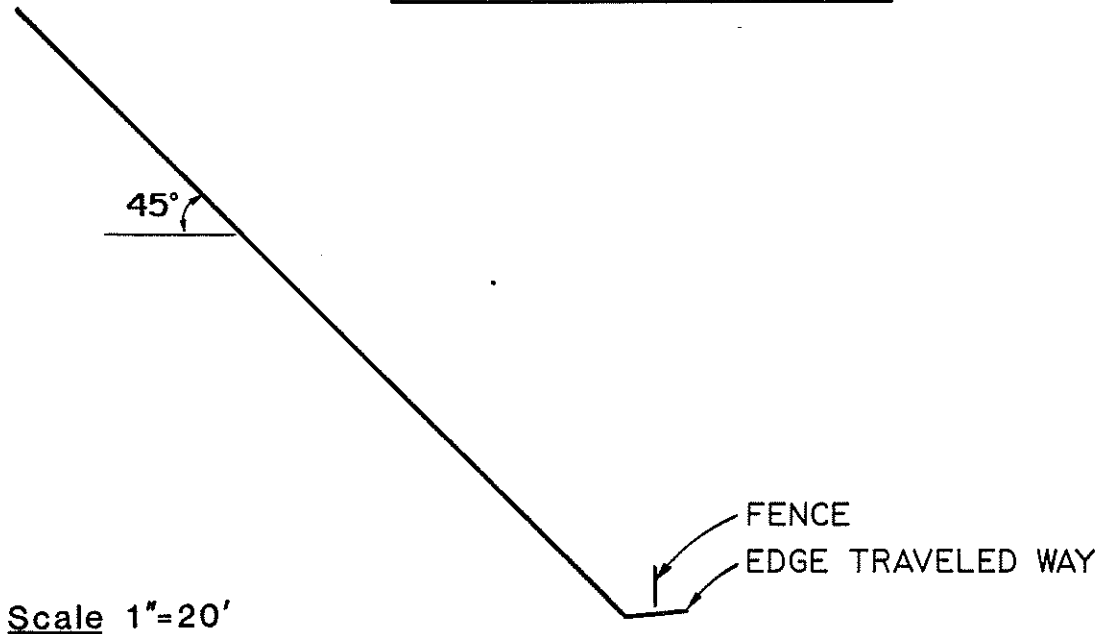
Rocks rolled - 21
Rocks reaching traveled way - 16
Rocks over fence - 7
Rocks under fence - 12

Comments - The bottom of the fence is 15 inches above the
ground which allows many rocks to roll under it. Fence is
too close to toe of slope which allows rocks to free-fall
over it. Effectiveness could be improved by eliminating
gap at bottom of fence. There is insufficient distance
between toe of slope and edge of traveled way to prevent
all rocks from going over the fence. Slope flattening to
1-1/2:1 could prevent rock from going over the fence.

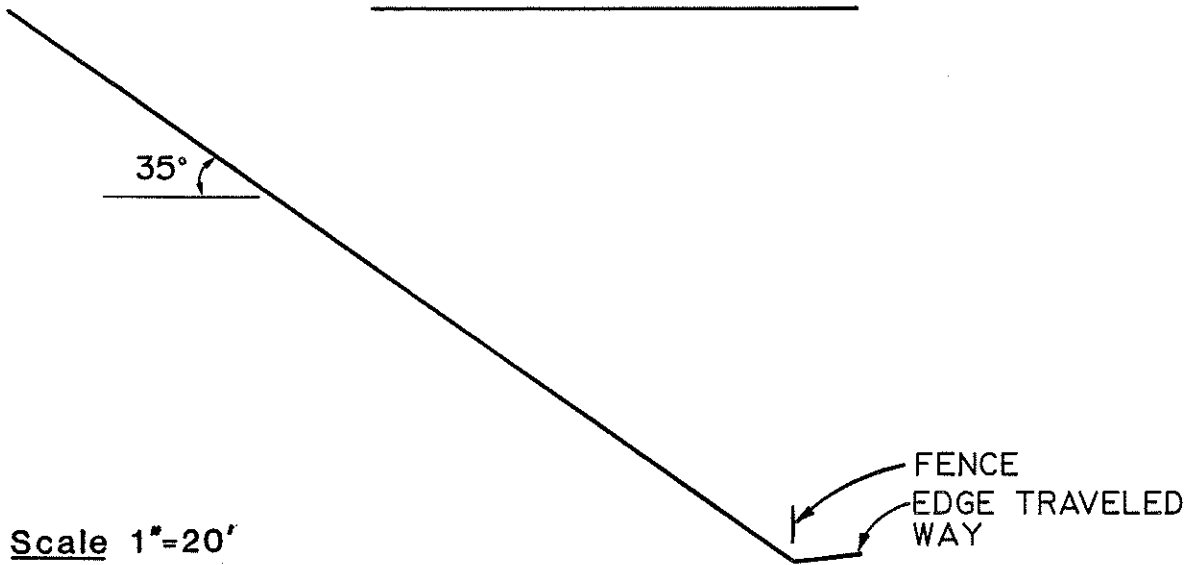
Rocks rolled - 29
Rocks reaching traveled way - 22
Rocks over fence - 0
Rocks under fence - 27

Comments - The bottom of the fence is 4 to 12 inches above
the ground which allows most rocks to roll under the fence.
Installation could be totally effective if clearance were
blocked.

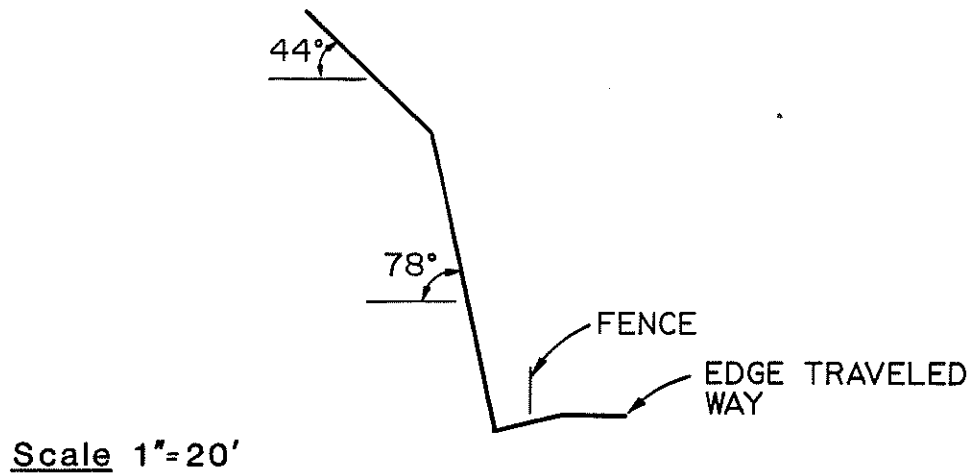
Rocks rolled - 10
Rocks reaching traveled way - 1
Rocks over fence - 9
Rocks under fence - 0

Comments - Widening at grade is effective in keeping rocks off the traveled way even though the width is 1.5 feet short of the Ritchie criteria. The fence is useless at this particular site.

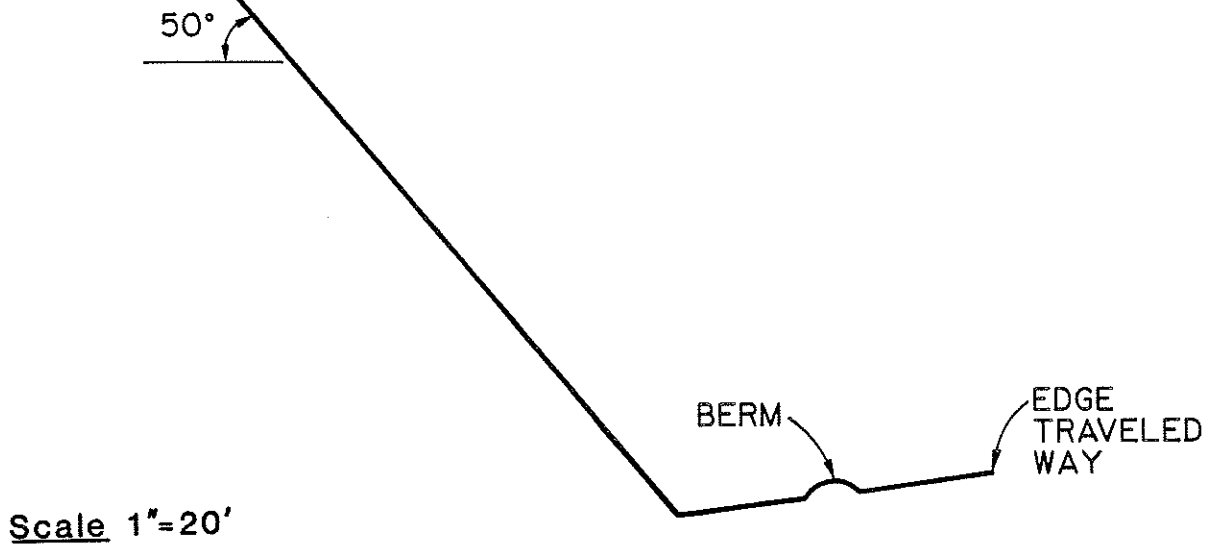
Rocks rolled - 26
Rocks reaching traveled way - 4
Rocks stopped by berm - 17

Comments - All rocks could be contained if berm height were increased to 6 feet.

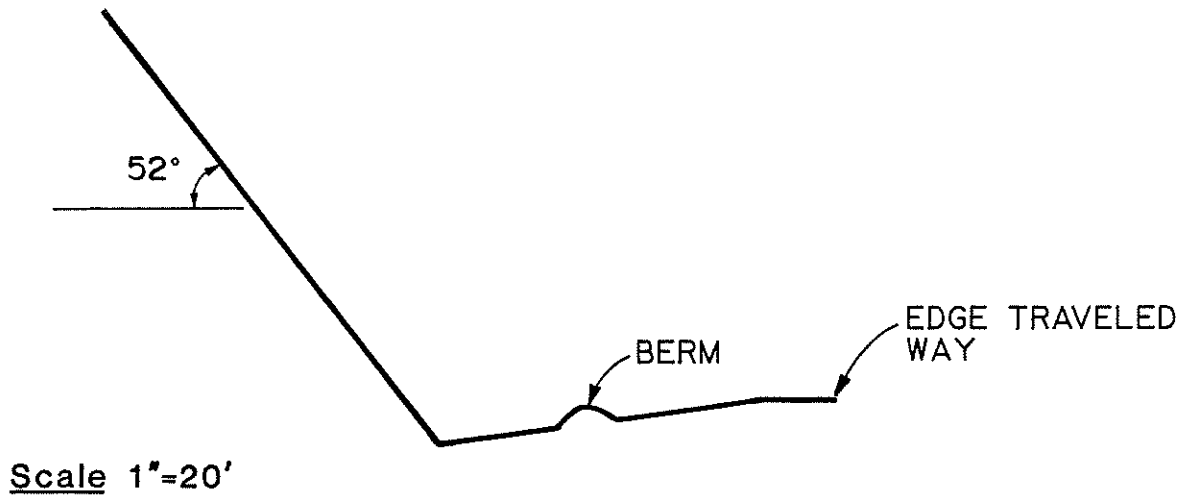
Rocks rolled - 13
Rocks reaching traveled way - 0
Rocks stopped by berm - 8

Comments - All rocks could be contained if berm height were
increased to 4 feet. At this site, 42 feet between the toe
of slope and the edge of traveled way prevents rocks from
reaching the roadway. It is interesting to note that about
the same percent of rocks are stopped by the berm as are
stopped at P.M. 21.5 even though there is a large differ-
ence in slope height at the two sites.

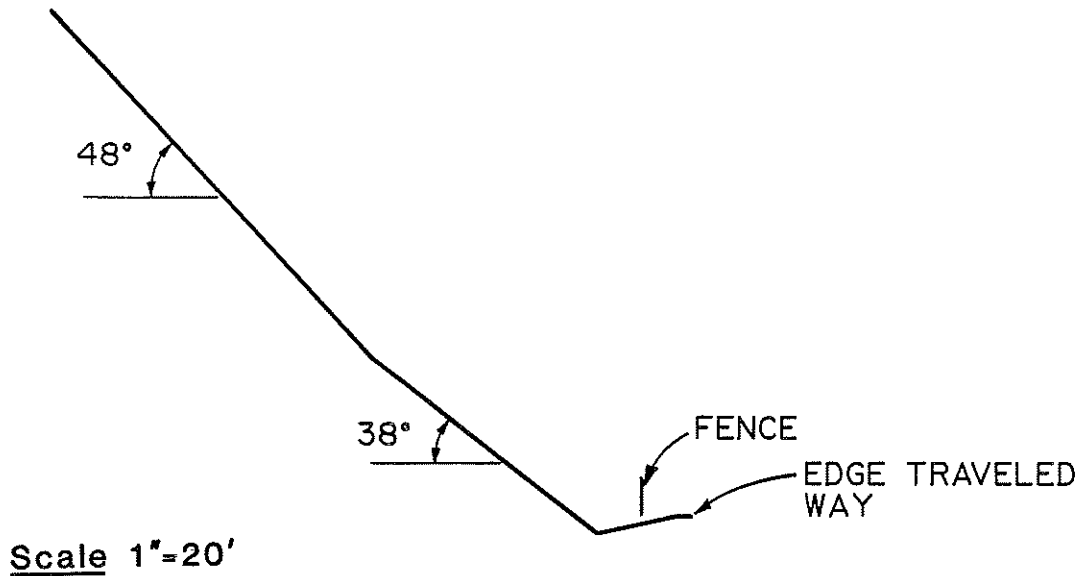
Rocks rolled - 35
Rocks reaching traveled way - 8
Rocks over fence - 1
Rocks under fence - 31

Comments - The bottom of the fence is 13 inches above the ground and allows most of the rocks to roll under the fence. Effectiveness of mitigation could be greatly increased by eliminating the gap below the fence.

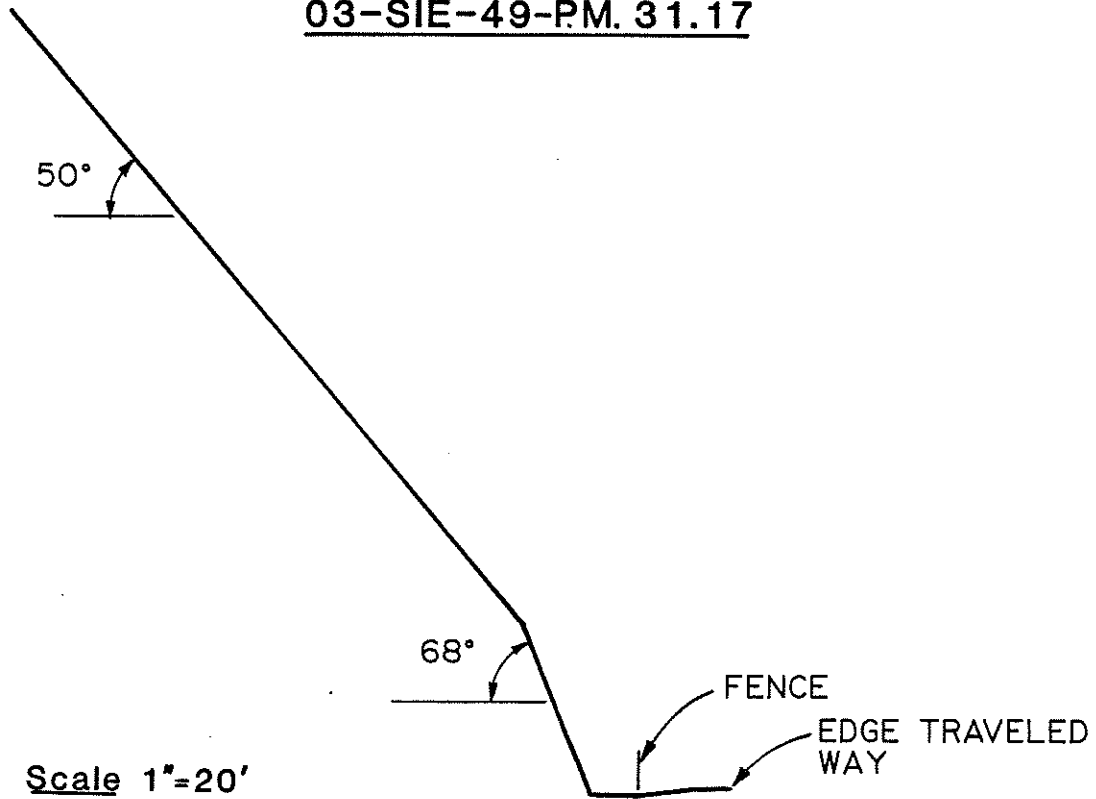
Rocks rolled - 10
Rocks reaching traveled way - 5
Rocks over fence - 7
Rocks under fence - 2

Comments - Effectiveness of fence would be greatly improved
if it were installed at least 10 feet from toe of slope.

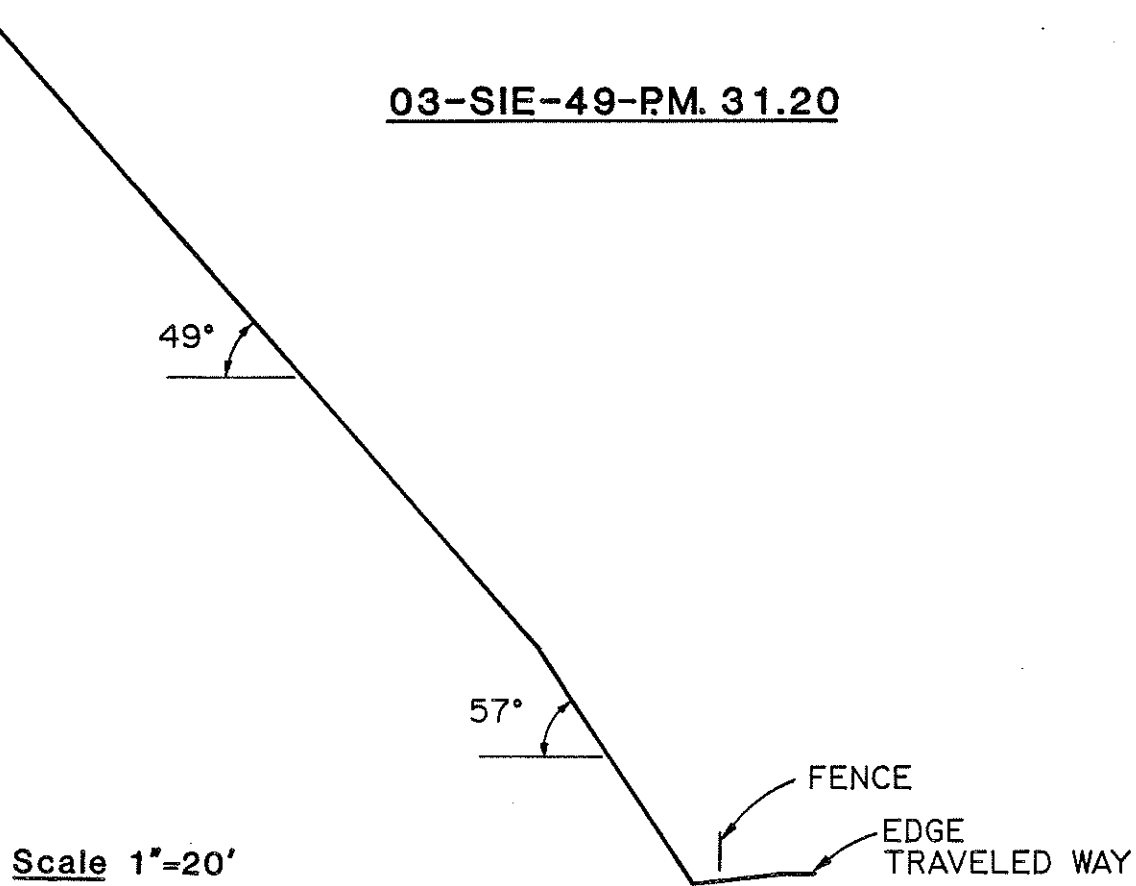
Rocks rolled - 8
Rocks reaching traveled way - 2
Rocks over fence - 2
Rocks under fence - 4

Comments - The rocks that reached the traveled way went
over the fence. Rocks going under the fence were
effectively slowed. Clearance below fence is four inches.
Effectiveness of mitigation could be greatly improved by
moving fence at least 10 feet from toe of slope.

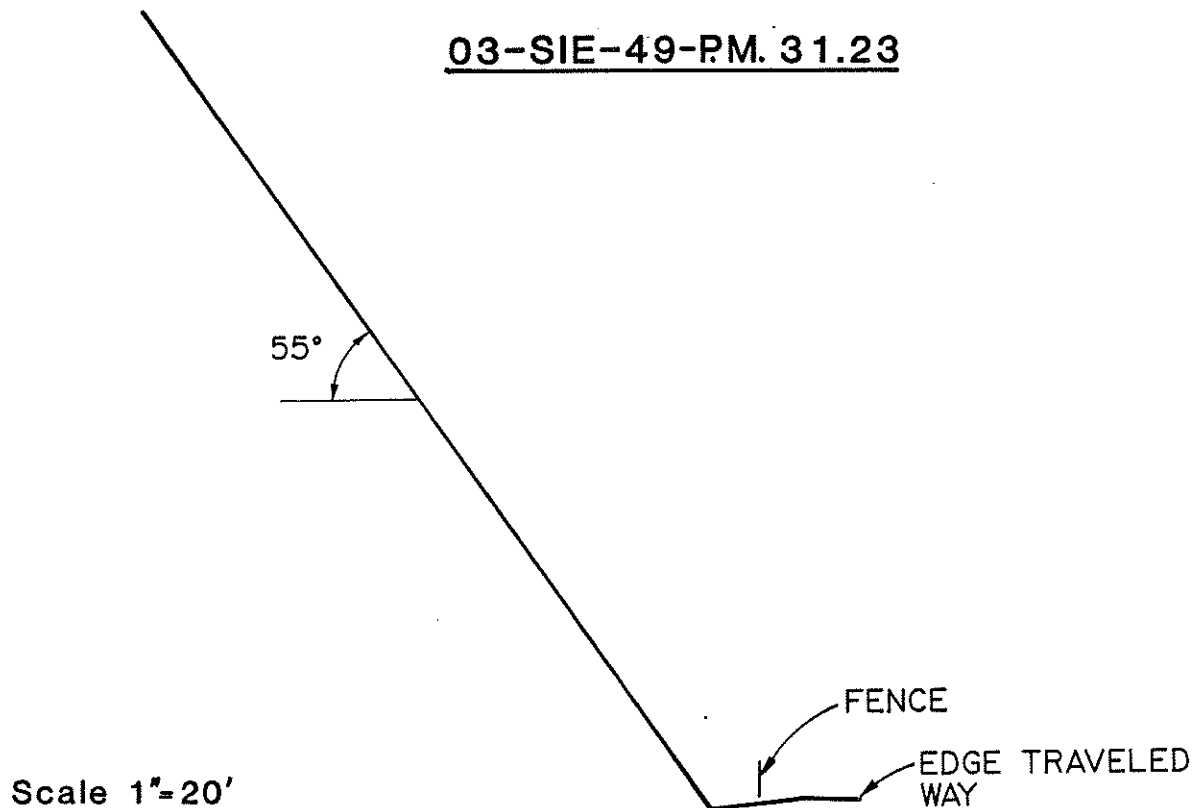
Rocks rolled - 11
Rocks reaching traveled way - 3
Rocks over fence - 0
Rocks under fence - 8

Comments - Fence is not fastened at bottom. There is a
four-inch gap between bottom of fence and the ground.
Effectiveness of mitigation could be improved by fastening
the bottom of the fence.

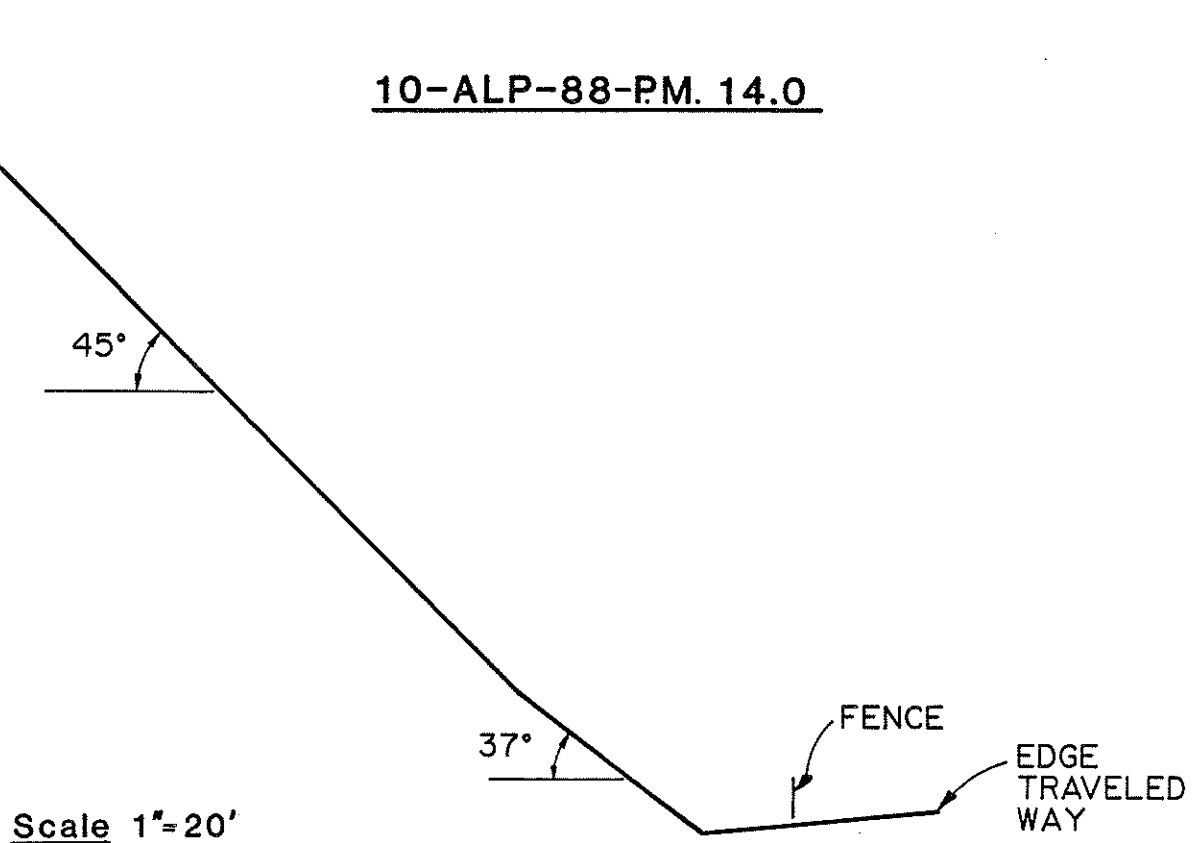
Rocks rolled - 15
Rocks reaching traveled way - 1
Rocks over fence - 1
Rocks under fence - 4

Comments - Bottom of fence is not fastened. There is a
two-inch gap between bottom of fence and the ground.
Effectiveness of mitigation could be improved by fastening
the bottom of the fence. Installing the fence further from
toe of slope would probably make the mitigation completely
effective.
