4. TITLE AND SUBTITLE
Dynamic Tests Of A Prestressed Concrete Median Barrier Type 50, Series XXVI

DYNAMIC TESTS OF A PRESTRESSED CONCRETE MEDIAN BARRIER TYPE 50

SERIES XXVI

CA-HY-MR-6588-1-73-06

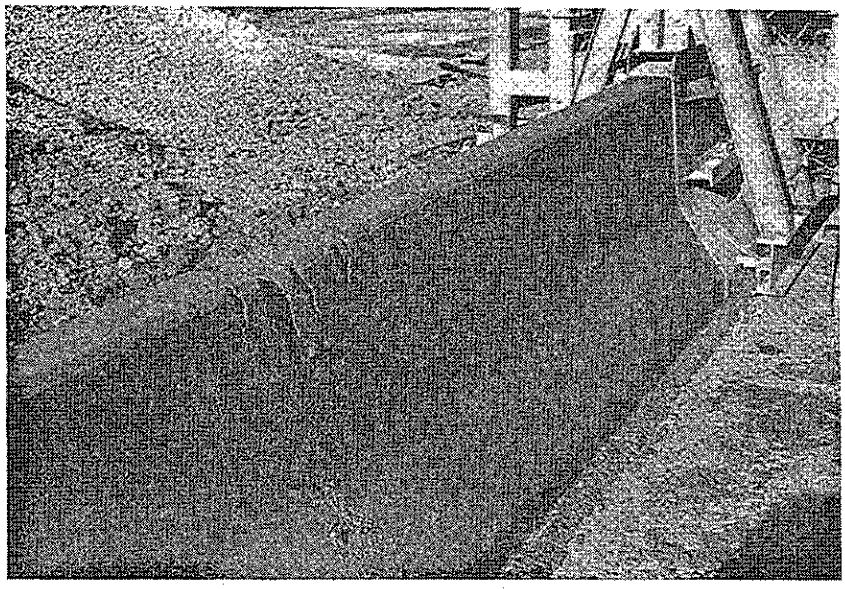
Proper placement of this barrier requires careful control of the concrete mix and, of course, proper control of the slipform equipment. For the slipforming process, the fresh concrete must possess very little slump while retaining workability. Improper control of the concrete mix can result in excessive slump or cracking as illustrated in Figure 5. After experimenting with several mix designs, the developer of the slipform equipment chose the following mix for the test barrier: a 3/4 inch maximum aggregate from California's Bear River; a water/cement ratio of 0.49; six sacks of Type II cement; and 17 ounces of water reducing admixture per cubic yard. The admixture successfully enhanced workability while maintaining a one inch slump during construction of the test barrier.

FIGURE 5, CRACKS RESULTING FROM IMPROPER CONTROL OF CONCRETE MIX.

Having learned that conventional transit mix trucks could not discharge the stiff mix rapidly enough for the slipforming operation, the developer used special transit mix trucks with modified fins to increase the discharge rate. Fed by these trucks, the slipform equipment placed the test barrier at a rate of about four feet per minute with very little hand finishing required. Extensive hand finishing was required on the first two feet of barrier as the machine moved away from

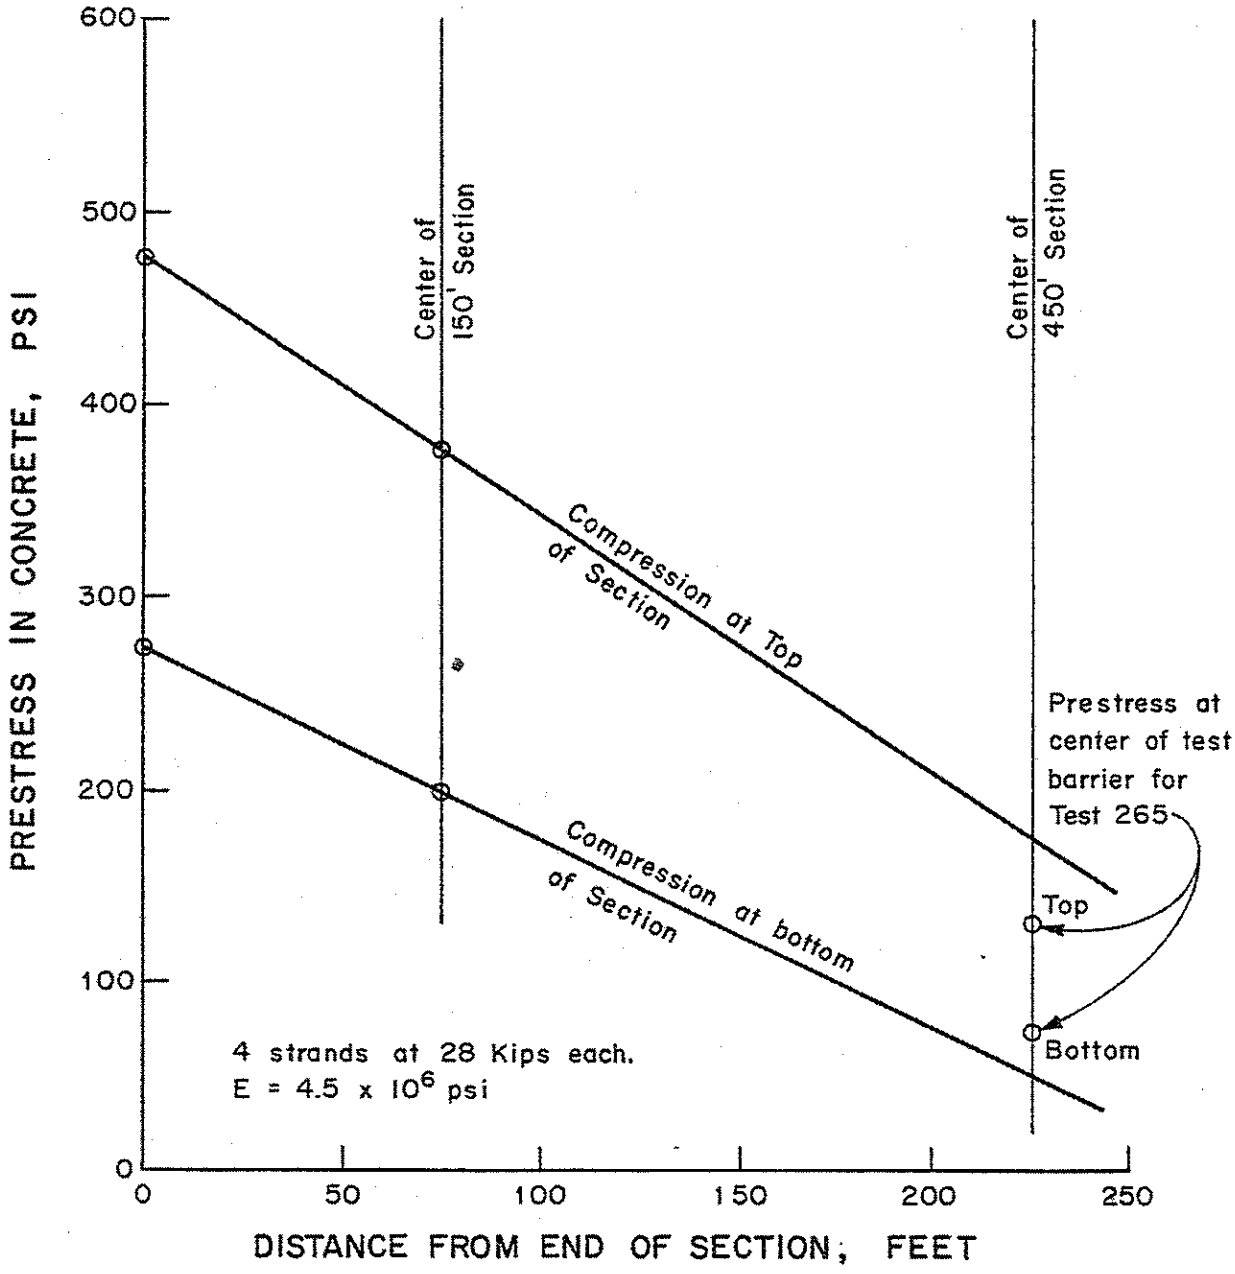
Although the tension in the strands was uniform throughout the length of the barrier, the prestress in the concrete varied significantly. The data obtained from a total of eight strain gages located on the surface of the concrete at the end and center of the 150-foot test barrier indicate that the effective prestress in the concrete is reduced as shown in Figure 8. This reduction in prestress in the concrete is due to friction and/or bond between the barrier and the pavement, and is, therefore, dependent upon many variables including type, condition, and thickness of pavement and length of barrier. The stresses shown in Figure 8 should, therefore, be considered only an estimate of stresses existing in actual installations. More exacting data could only be obtained by extensive testing. The description of instrumentation and details of obtaining this data are presented in the Appendix.

Based on Figure 8, the prestress conditions in the barrier for Test 265 were chosen to simulate the stress at the center of a 450-foot installation of prestressed barrier. Although the concrete stresses in any particular barrier are dependent upon the particular pavement conditions, the stresses existing at the center of the test barrier for Test 265 are considered reasonably conservative for a 450-foot barrier since they were relatively low -- about 130 psi at the top and 72 psi at the bottom of the barrier.

FIGURE 8, ESTIMATED LOSS OF PRESTRESS IN CONCRETE DUE TO FRICTION/BOND WITH PAVEMENT

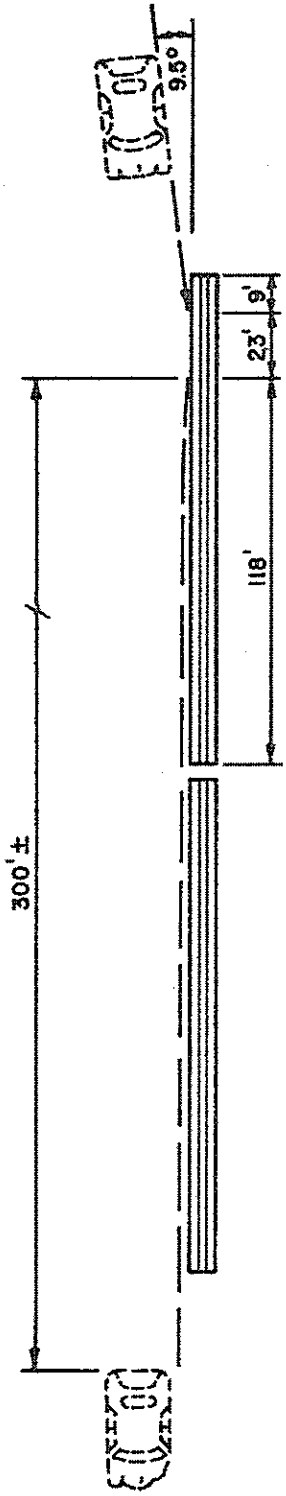
FIGURE 9, TEST 261

TEST NO.	261
DATE	4/21/72
VEHICLE	1970 Mercury
IMPACT VELOCITY	61 mph
APPROACH ANGLE	9.5°
VEHICLE WEIGHT	4960 lb
(W/Dummy & Instrumentation)	
DUMMY RESTRAINT	lap belt

BARRIER TESTED	PRESTRESSED TYPE 50
STRANDS (as seated)	4 @ 28 K ea.
LENGTH OF SECTION	150'
PASSENGER COMP. DECEL. Long.	0.6 g
(Highest 50 ms average) Lat.	3.9 g
MAX. VEHICLE RISE	1.9'
VEHICLE EXIT ANGLE	0°
VEHICLE DAMAGE	Minor
BARRIER DAMAGE	None

A 1970 Mercury sedan traveling at 61 mph hit the barrier at an angle of 9.5 degrees from the barrier. The left front tire contacted the barrier at the same time as the left front fender, rode up to a height of 1.4 feet in the first 10 feet of contact, and remained at that height until it left the barrier 23 feet from the point of contact. Upon leaving the barrier, the car remained parallel to the barrier and within three feet of it for 300± feet although no attempt was made to steer the car.

Vehicle damage was minor, consisting of slight deformation to the left fender and the left end of the front bumper and paint scratches along the length of the left side of the vehicle as shown in Figure 15. There was no mechanical damage to the

vehicle and it was used for a subsequent test the same day without any repairs. There was no barrier damage except for slight scratches and, of course, tire and body marks as shown in Figure 16.

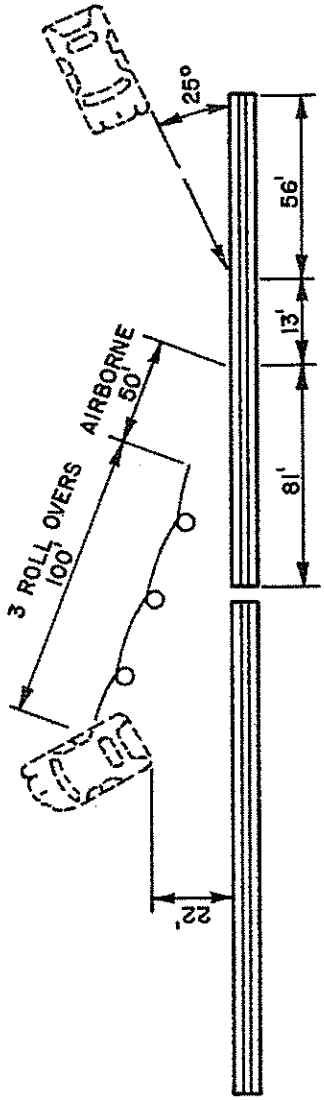
TEST NO. 262
DATE 4/21/72
VEHICLE . . . . . 1970 Mercury
IMPACT VELOCITY . . . . . 59 mph
APPROACH ANGLE . . . . . 25°
VEHICLE WEIGHT . . . . . 4960 lb
(W/Dummy & Instrumentation)
DUMMY RESTRAINT . . . . . lap belt

BARRIER TESTED . . . . . PRESTRESSED TYPE 50
STRANDS (as seated) . . . . . 4 @ 28 K ea.
LENGTH OF SECTION . . . . . 150'
PASSENGER COMP. DECEL., Long. . . . . 7.0 g
(Highest 50ms average) . . . . Lat. . . . . 11.6 g
MAX. VEHICLE RISE . . . . . 2.8'
VEHICLE EXIT ANGLE . . . . . No Data
VEHICLE DAMAGE . . . . Total
BARRIER DAMAGE . . . . None

The same Mercury sedan that was used in Test 261 hit the barrier at an angle of 25 degrees and a speed of 59 mph. Immediately upon impact the left front quarterpanel and undercarriage were severely crushed. As the car was redirected, the left front fender rose about 3.1 feet with the car tilting about 25 degrees away from the barrier. After less than 13 feet of barrier contact, the car left the barrier nearly airborne and yawing to its right until it landed after traveling about 50 feet in the air. Upon

Although the car damage due to impacting the barrier was primarily confined to the left front end, the remainder of the car was totally destroyed by the three roll overs. As shown in Figure 18 the upper framework was severely distorted but the passenger compartment remained intact with the doors locked. Barrier damage was limited to minor scratches in the impact area and tire marks as shown in Figure 19.

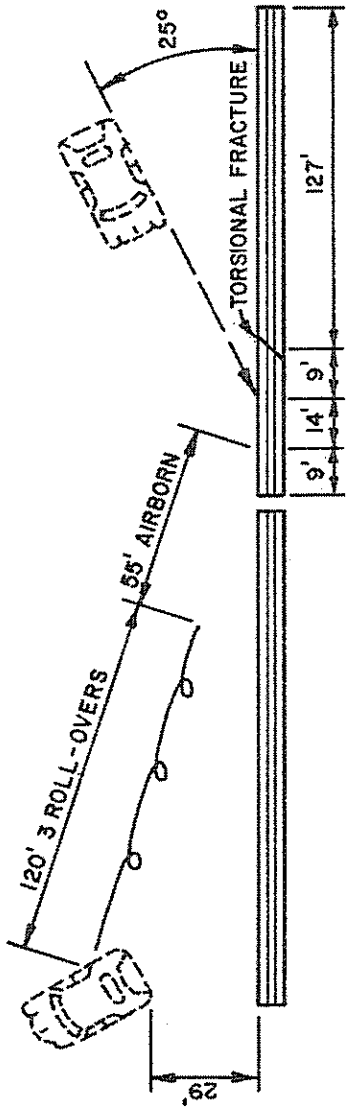
FIGURE 11 ,TEST 263

TEST NO.	263
DATE	5/4/72
VEHICLE	1970 Mercury
IMPACT VELOCITY	66 mph
APPROACH ANGLE	25°
VEHICLE WEIGHT (W/Dummy & Instrumentation)	4960 lb
DUMMY RESTRAINT	lap belt

BARRIER TESTED	PRESTRESSED TYPE 50
STRANDS (as seated)	4 @ 28 K ea.
LENGTH OF SECTION	150'
PASSENGER COMP. DECEL. Long.	No Data
(Highest 50 ms average) Lat.	No Data
MAX. VEHICLE RISE	2.7'
VEHICLE EXIT ANGLE	8°
VEHICLE DAMAGE	Total
BARRIER DAMAGE	Fractured

Although the barrier successfully retained and redirected the car, it suffered what appeared to be a torsional fracture completely through the concrete section about 9 feet upstream of the impact point as shown in Figure 21. The prestressing strand did not allow the barrier to separate and restricted the movement of the free end to a lateral movement of about 5/16 inch at the top and no lateral movement at the base. Because this movement was small, the barrier was able to perform effectively, but its ability to sustain subsequent severe impacts was significantly reduced. Therefore, the construction plans presented in the Appendix require a reinforced cast-in-place joint in order to provide adequate structural continuity through the joint. The fracture plane was injected with epoxy prior to the next test in an attempt to restore the full continuity of the test barrier.

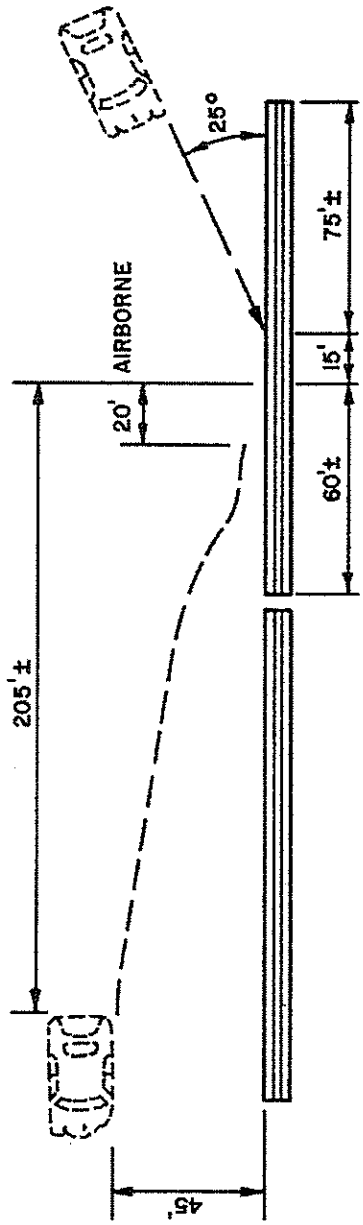
FIGURE 12, TEST 264

BARRIER TESTED	PRESTRESSED TYPE 50
STRANDS (as seated)	3 @ 28 K ea.
LENGTH OF SECTION	150'
PASSENGER COMP. DECEL. Long.	5.2 g
(Highest 50 ms average) Lat.	13.0 g
MAX. VEHICLE RISE	3.0'
VEHICLE EXIT ANGLE	5°
VEHICLE DAMAGE	Severe Frontal
BARRIER DAMAGE	None

TEST NO.	264
DATE	6/2/72
VEHICLE	1969 Dodge
IMPACT VELOCITY	64 mph
APPROACH ANGLE	25°
VEHICLE WEIGHT	4860 lb
(W/Dummy & Instrumentation)	
DUMMY RESTRAINT	lap belt

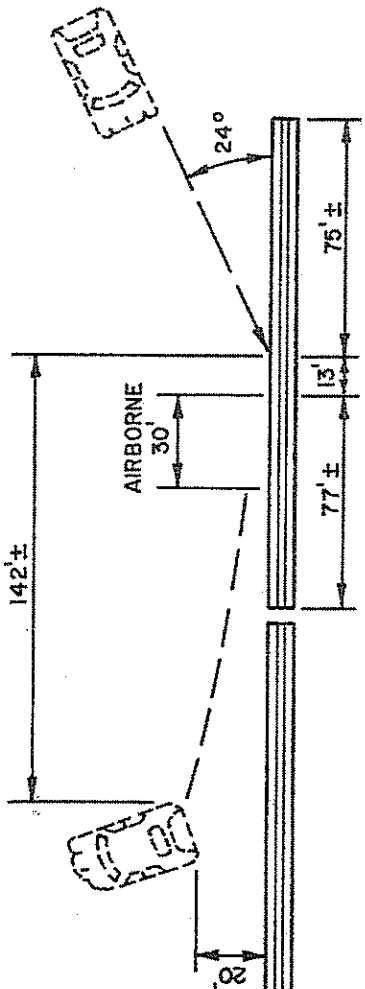
TEST NO.	265
DATE	6/16/72
VEHICLE	1968 Dodge
IMPACT VELOCITY	62 mph
APPROACH ANGLE	24°
VEHICLE WEIGHT (W/Dummy & Instrumentation)	4780 lb
DUMMY RESTRAINT	lap belt

BARRIER TESTED	PRESTRESSED TYPE 50
STRANDS (as seated)	4 @ 10 K ea.
LENGTH OF SECTION	150'
PASSENGER COMP. DECEL. Long.	No Data
(Highest 50 ms average) Lat.	No Data
MAX. VEHICLE RISE	3.7'
VEHICLE EXIT ANGLE	4°
VEHICLE DAMAGE	Severe frontal
BARRIER DAMAGE	Hairline fracture

A 1968 Dodge sedan traveling at 62 mph hit the center of the barrier at an angle of 24 degrees. The response of the car was almost identical to that of the previous test and the only damage to the barrier was a hairline tension crack running vertically on the face of the barrier opposite the impact point. As shown in Figure 22 damage to the car was similar to, but a little more extensive than, the damage encountered in Test 264. The hood of the car was torn loose upon impact and the rear window shattered as the car landed after redirection. The dummy's response was not filmed during this test, but was probably similar to that of Test 264.

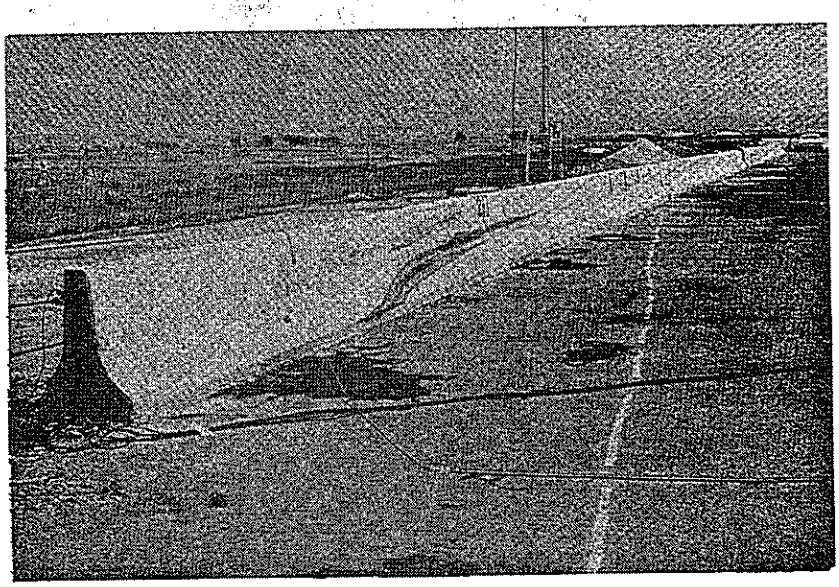
FIGURE 16, TIRE AND BODY MARKS FROM 9.5 DEGREE ANGLE IMPACT, TEST 261. NOTE FINAL LOCATION OF CAR.

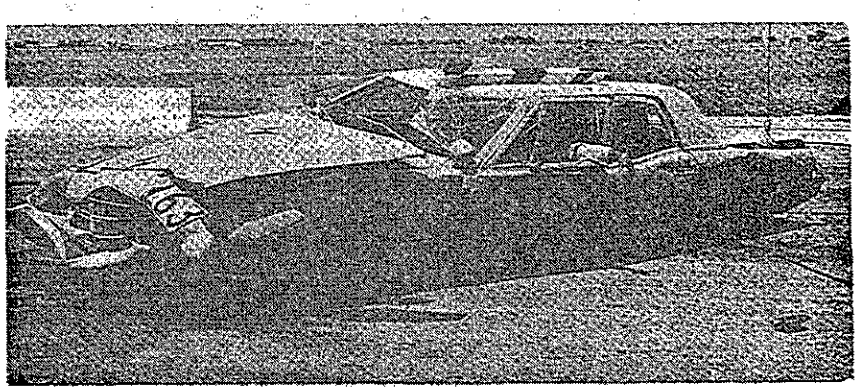
FIGURE 18, TYPICAL DAMAGE RESULTING FROM TESTS 262 AND 263.

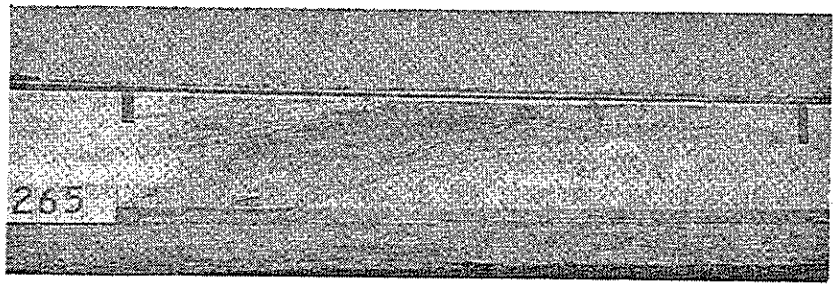
FIGURE 19, TYPICAL TIRE AND BODY MARKS FROM 25 DEGREE IMPACT.

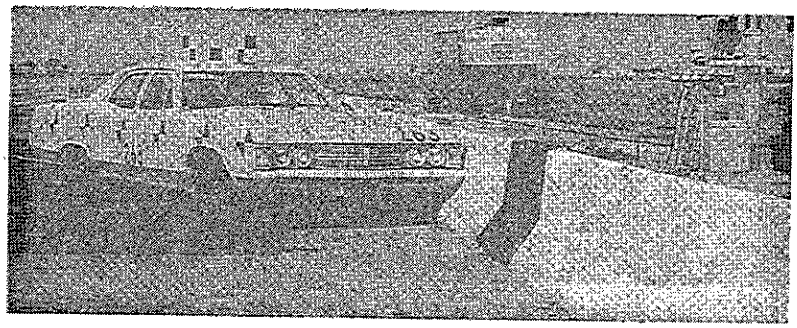
The test conditions for Test 263 were nominally equivalent to Test 262 except that the point of impact was near the proposed construction joint as shown in Figure 20. The joint consisted of steel plate, bent to match the contours of the barrier, which spanned the 3 foot gap between the two sections of barrier. The steel plate was bolted in place but did not provide any structural continuity through the joint. Test 263 was, therefore, performed to test the adequacy of this joint design.

FIGURE 20, IMPACT NEAR JOINT TO PROOF TEST THE JOINT DESIGN.

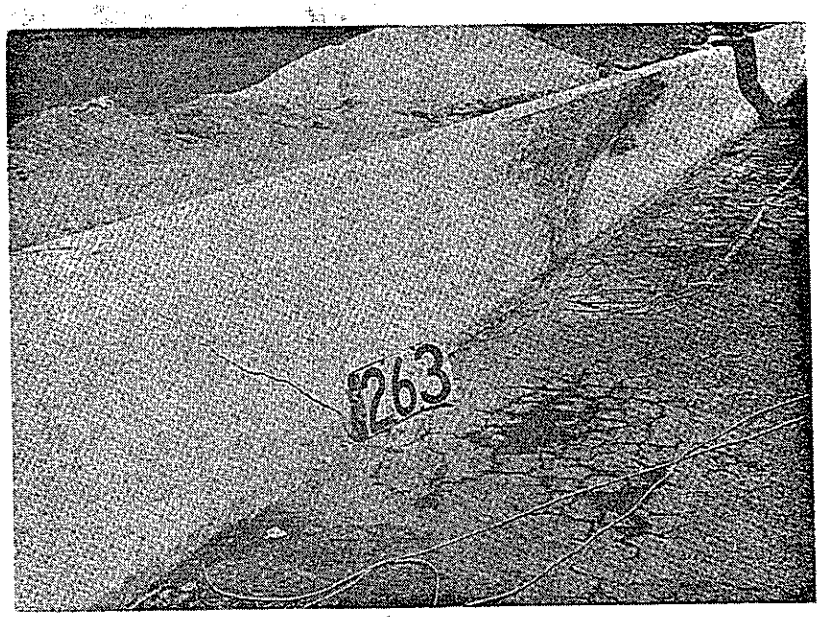
FIGURE 21, TORSIONAL FRACTURE RESULTING FROM IMPACT NEAR JOINT.

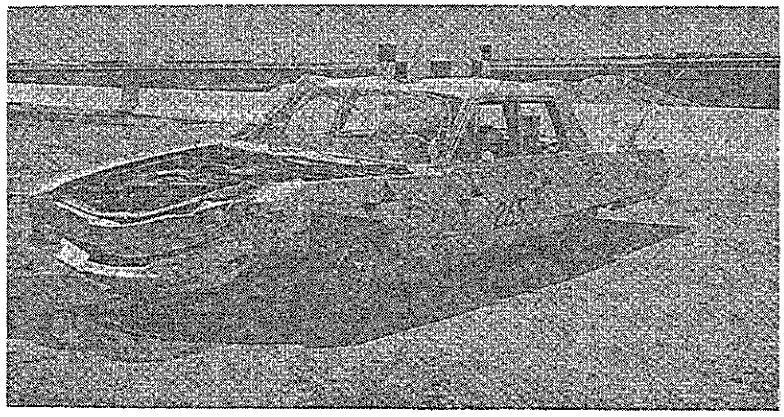
A 1969 Dodge sedan traveling at 64 mph hit the center of the barrier at an angle of 25 degrees. The redirection of the car was very similar to the two previous tests except that the car did not roll over. As the car left the barrier, it traveled about 20 feet nearly airborne. Upon landing the weight of the car seemed to be carried by the entire left side of the car as opposed to the previous tests where the car tended to land on its left front. Following the landing, the rear of the car bounced high throwing the weight of the car onto its left front but not enough to make it roll over. As shown in Figure 22, the vehicle suffered severe damage to its left front area, but its exterior was otherwise undamaged except for sheet metal damage along its left side. There was no damage to the barrier.

FIGURE 22, TYPICAL DAMAGE RESULTING FROM TESTS 264 AND 265.
