REPORT NO. FHWA/CA/TL-80/17

ROADWAY DAMAGE DURING THE SAN FERNANDO, CALIFORNIA EARTHQUAKE OF FEB. 9, 1971

FEB., 1981

6. PERFORMING ORGANIZATION CODE		
7. AUTHOR(S) R. H. Prysock and J. P. Egan, Jr.			8. PERFORMING ORGANIZATION REPORT NO. 19305-632119		
9. PERFORMING ORGANIZATION NAME AND ADDRESS Office of Transportation Laboratory California Department of Transportation Sacramento, California 95819			10. WORK UNIT NO.

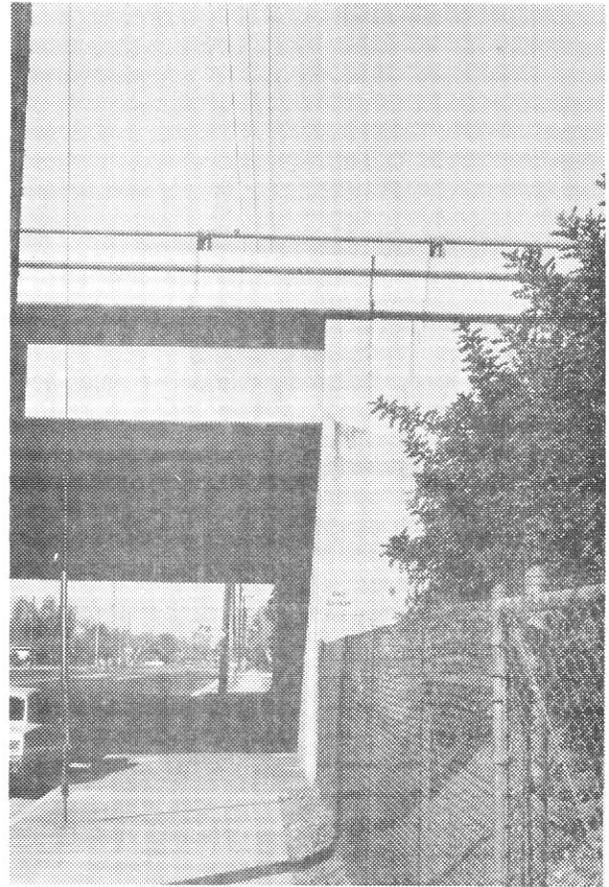
A typical freeway undercrossing structure is shown in Photo No. 2. As may be noted, the entire fill end slope is enclosed by concrete curtain walls. Also, the concrete sidewalk at the surface street level extends full-width between curb and curtain wall. As these structures rotated in response to ground motion, forces were exerted through the sidewalks to the curbs causing shear cracks at numerous locations as illustrated in Photo Nos. 3 and 4.

Photo 2. Typical under-
crossing structure on
Route 405.

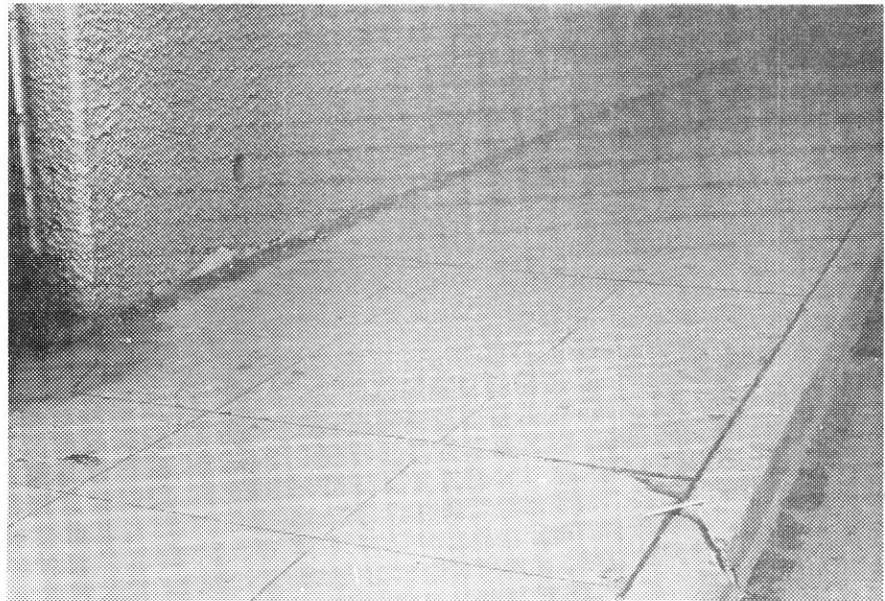
Photo 3. Typical curb crack and displacement
caused by forces from curtain wall movement.
Note cracks in sidewalk adjacent to curtain
wall.

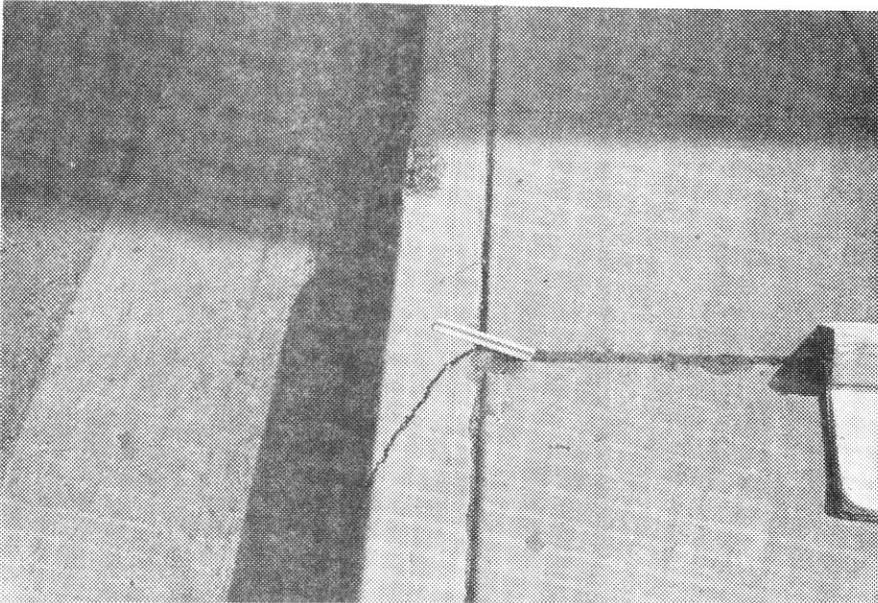
Photo 4. Typical curb crack and displacement caused by forces from curtain wall movement.

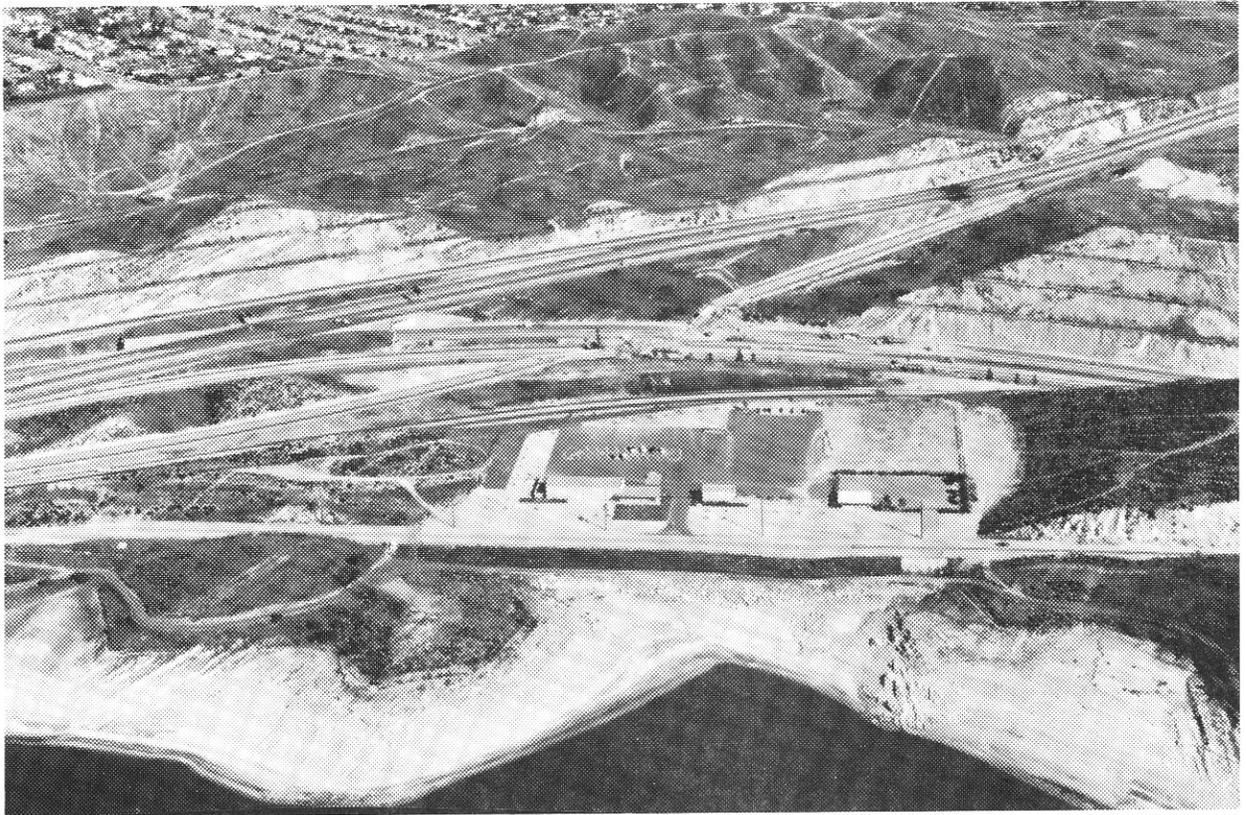
The Route 5/405 Separation, shown in Figure 3, and Photo 6, is constructed in cut section immediately east of the lower San Fernando Reservoir. The terrain is composed of marine siltstone and mudstone (extreme right side of Photo 6) in contact with younger, nonmarine sandstones.

At this location, northbound Route 405 traffic passes through a concrete box tunnel structure, shown in the left center of Photo 6. No visible disturbance of the soils surrounding the structure and the roadway within the structure was detected. Minor cracking in the walls and 1/4- to 1/2-inch separations in some expansion joints were observed. Also, a small amount of wingwall separation from the top deck at the southwest corner of the structure occurred. A report of the structure appears in Reference 5.

Photo 6. Looking easterly at the Route 5/405 Separation Area.

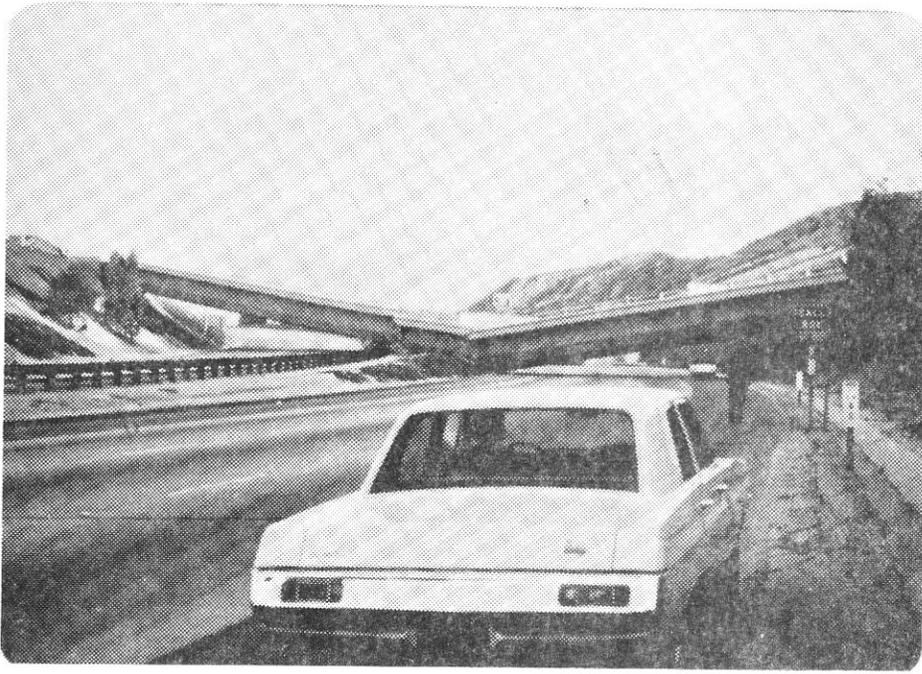
The most notable damage in the separation area was the collapse of the Route 5 southbound truck freeway bridge over Route 405 as shown in Photos 6, 7 and 8. A discussion of bridge damage may be found in Reference 5.

Photo 7. Looking northerly at the collapsed Route 5 southbound truck freeway bridge over Route 405.

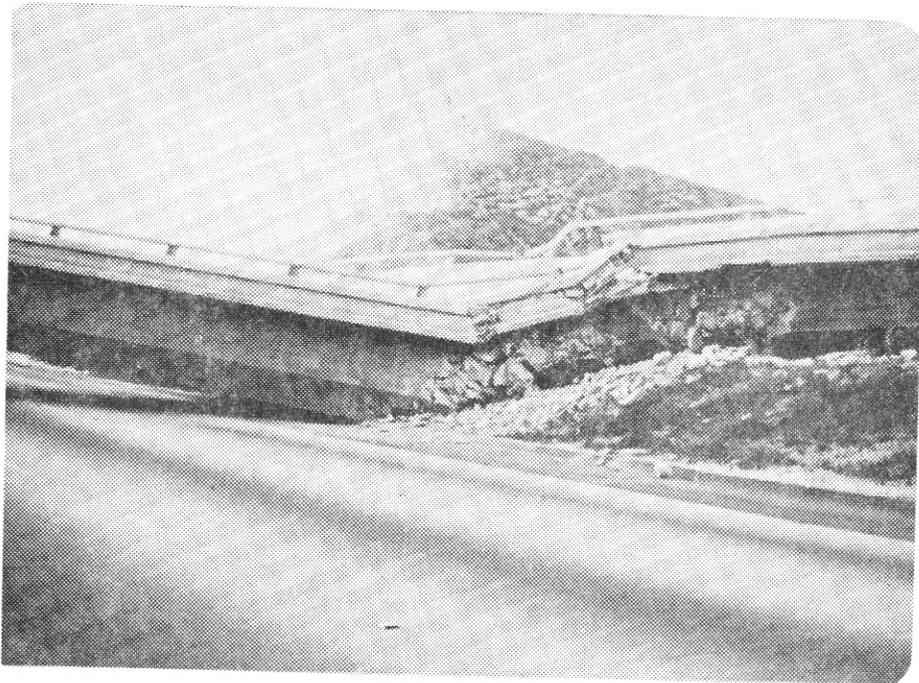
Photo 8. The center portion of the collapsed Route 5 southbound truck freeway bridge.

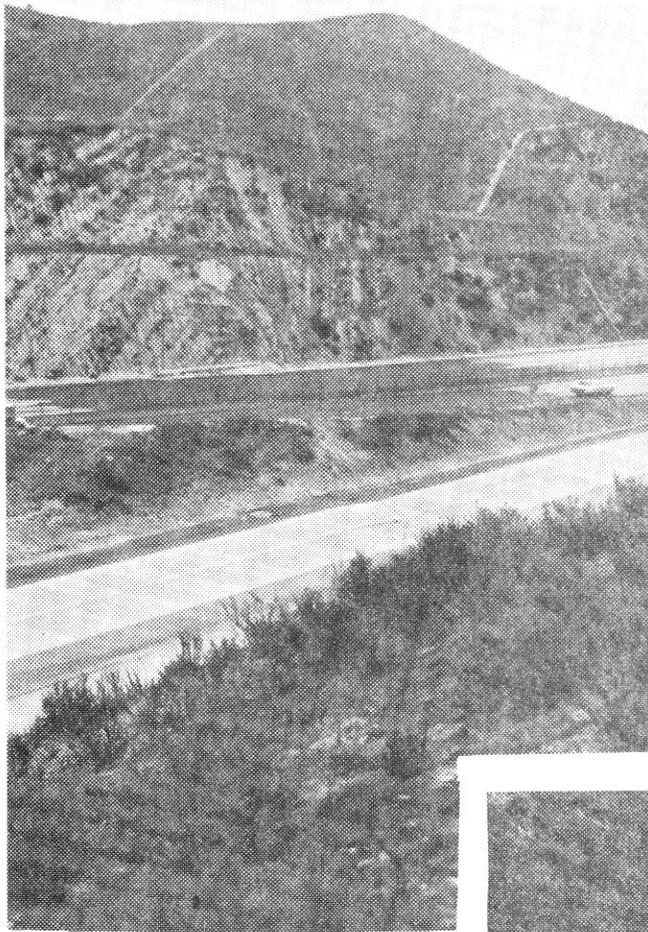
Faulting occurred at this location in an east-west trend through the dark patch across Route 5 shown in Photo 6, upper right. The faulting is shown in more detail in Photos 9, 10, and 11. Two feet of reverse fault displacement, north over south, occurred. The writers believe the faulting continued in a westerly direction across Route 405 in a zone several hundred feet wide (see Ref. 2, p. 19, Item 6).

Photo 9. Looking easterly along discontinuous fault trace. Route 5 (patched) is in background, Route 5 southbound truck lane in center. Note break and disrupted profile in truck lane pavement.

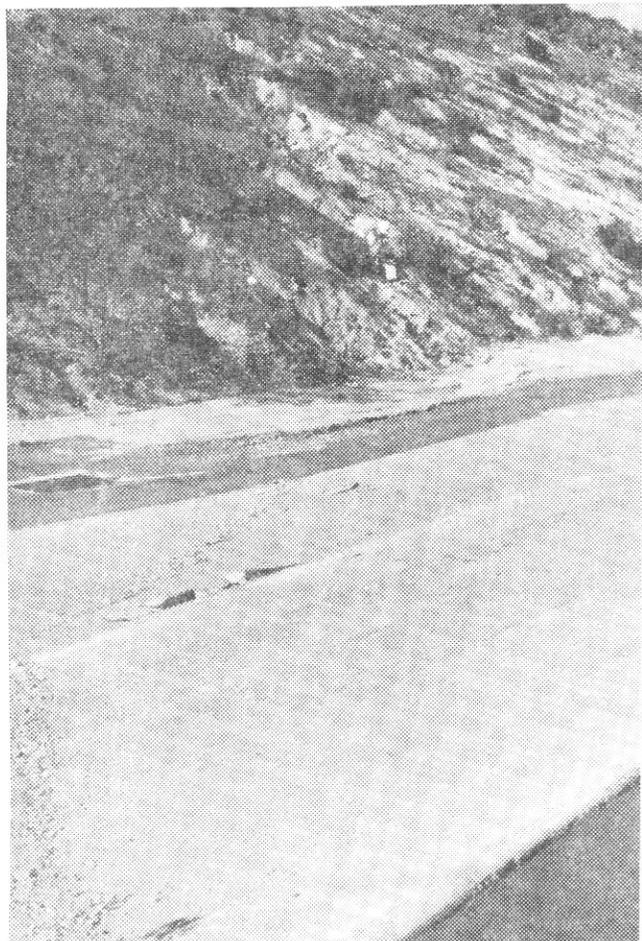
Photo 10. Looking westerly across truck lane pavement. Fault trace extended up cut slope in background.

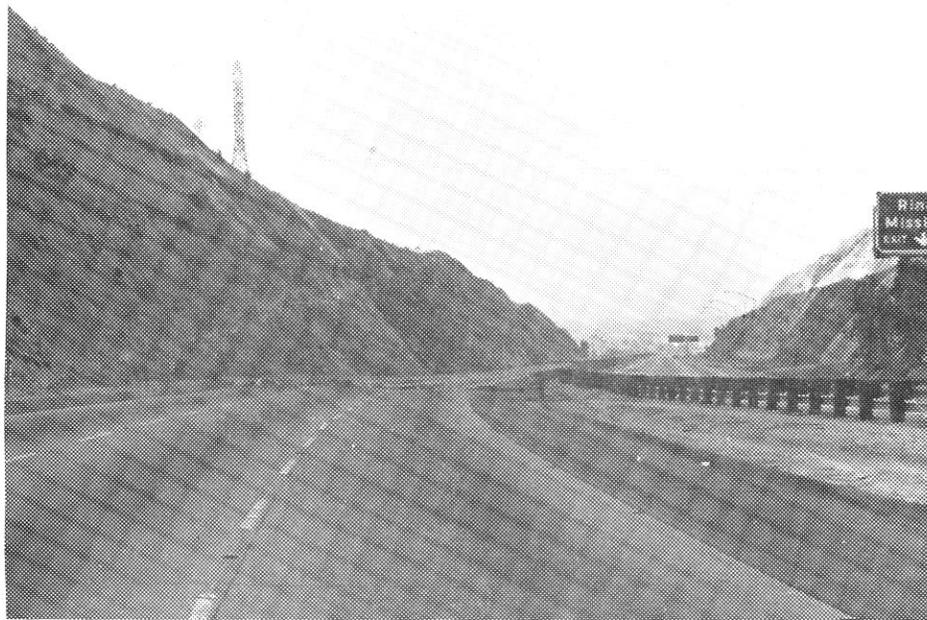
Undulations of the pavement, either visible or detectable when riding over the zone, were noted. Photo 12 is a southerly view of Route 405 across this zone. Immediately to the west of the photo a one-half foot rise in the ground was noted, northside up, but an actual break could not be found. A detail of the pavement buckle in the center of the photo is shown in Photo 13.

Photo 12. Looking southerly at northbound lanes of Route 405. Fault zone is believed to extend across the roadway in the area of broken pavement.

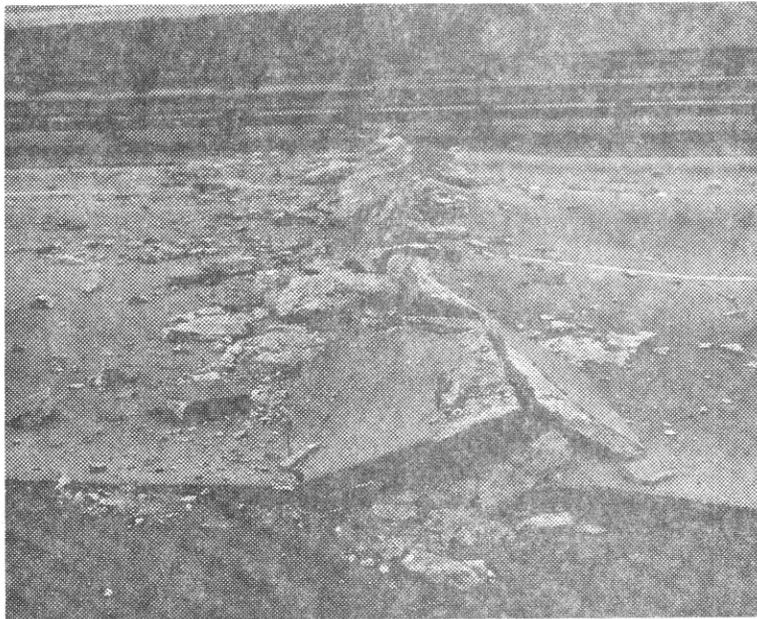
Photo 13. Looking westerly across northbound lanes of Route 405. Pavement break is on a general projection of nearby fault trace mapped by authors.

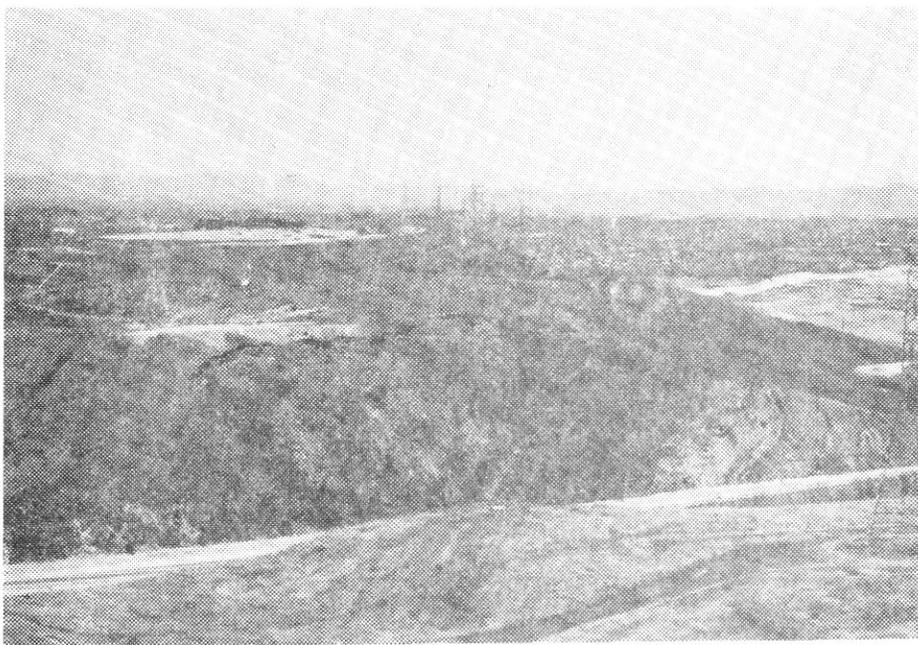
An earthquake-induced slump failure occurred at this location in a cut slope, shown in the center of Photo 14. The failure was confined entirely to the upper three-fourths of the 100-foot high cut.

Photo 14. Looking westerly across Route 5. Note slide in cut slope.

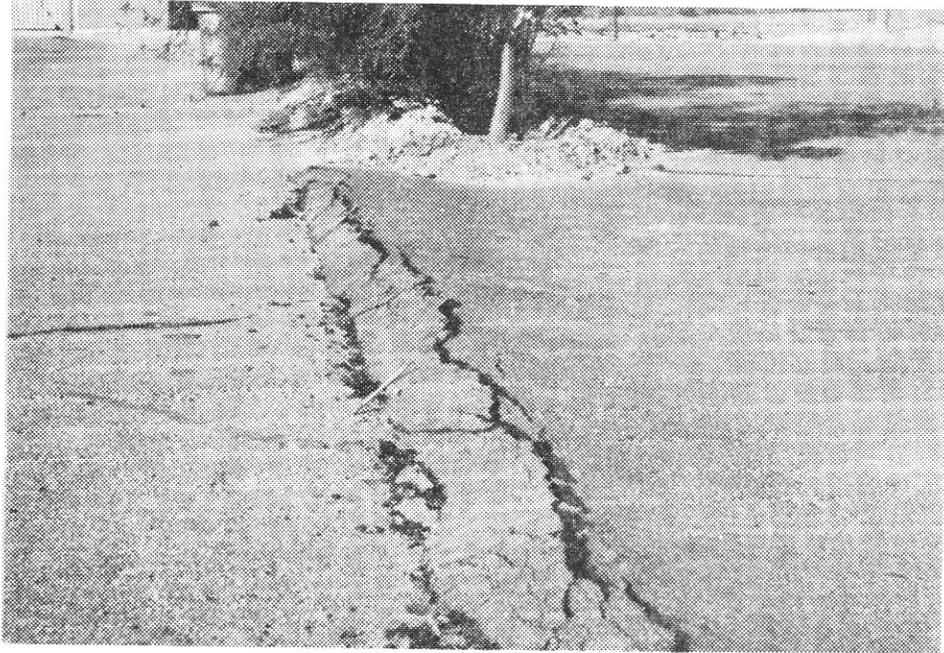
Paved grounds of the Caltrans' maintenance yard immediately east of the slide suffered various amounts of pavement breakage. An example is shown in Photo 16 which illustrates a one-foot thrust of pavement, north over south. Another compressional feature was noted across Blucher Avenue, south of the slide where the roadway enters a cut section (Photo 6); however, details of the feature were not recorded.

Photo 16. Looking westerly at maintenance station parking area. Note pavement breaks and thrusting of north over south.

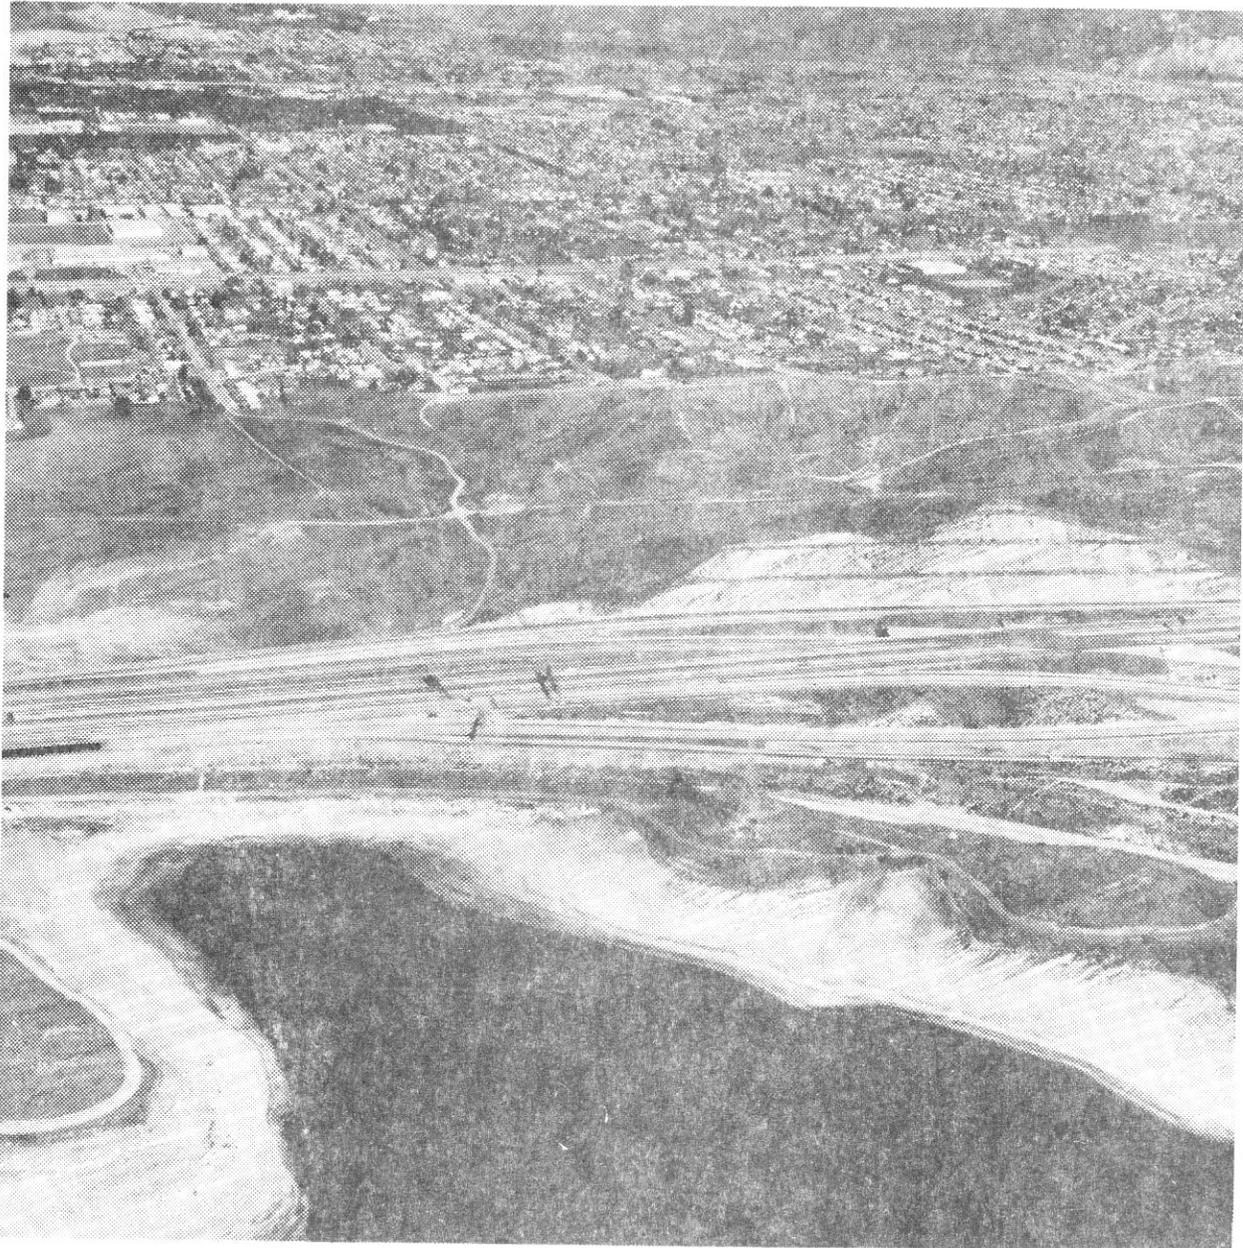
Immediately north of the 5/405 separation, the roadway crosses a canyon on about 45 feet of fill as shown in Photo 17. The embankment, founded on saturated, relatively weak fine-grained alluvial deposits, experienced vertical and lateral movement due to the foundation soil behavior. Cracking in slopes on both sides of the fill (Photos 18 and 19) suggest that much larger movements typical of foundation failures would have occurred had strong motion been of a longer duration. Vertical movement resulted in pavement slab displacements as shown in Photos 20 and 21.

Photo 17. Looking northeasterly at Route 5. Note roadway embankment and pavement patches in left center of photo.

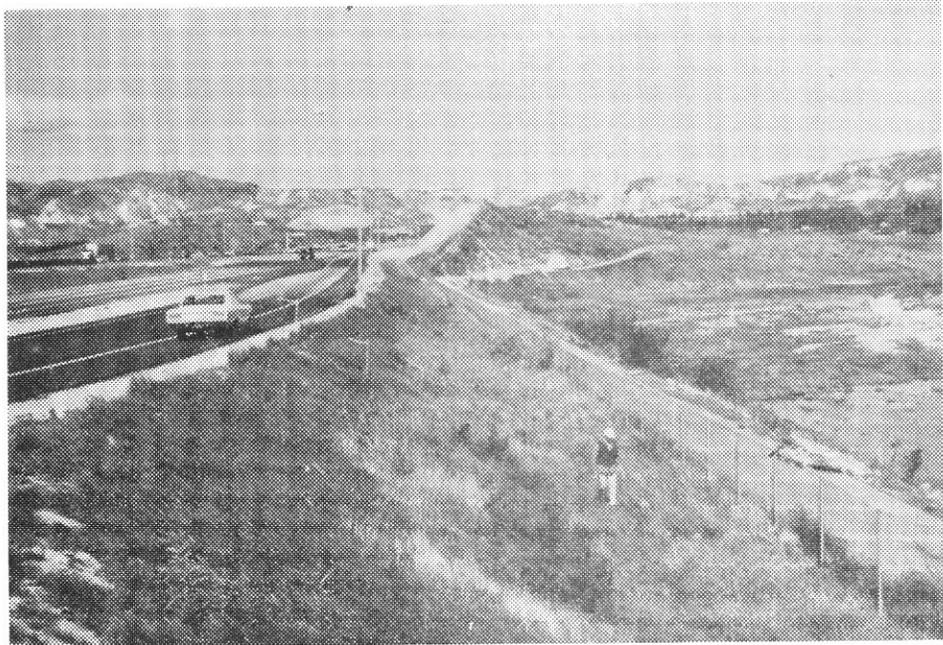
Photo 18. Looking northerly along easterly slope of Route 5 embankment.

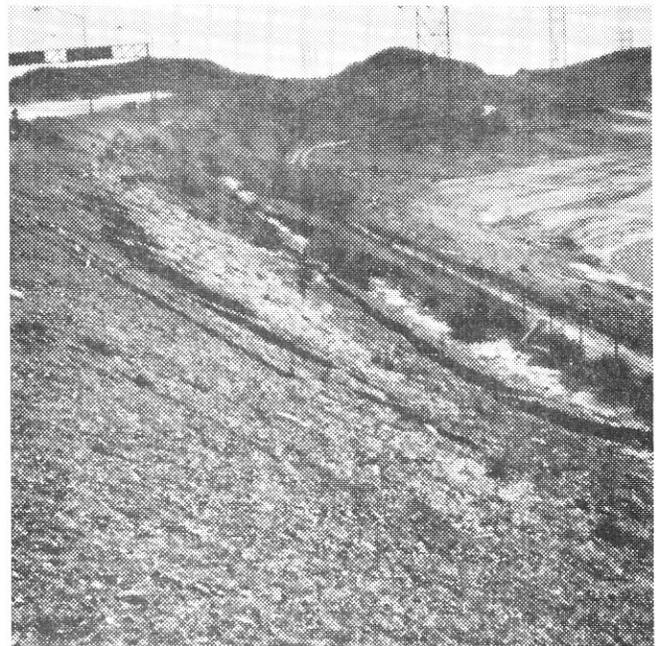
Photo 19. Looking south at westerly slope of embankment. Note cracks and lateral movement in slope.

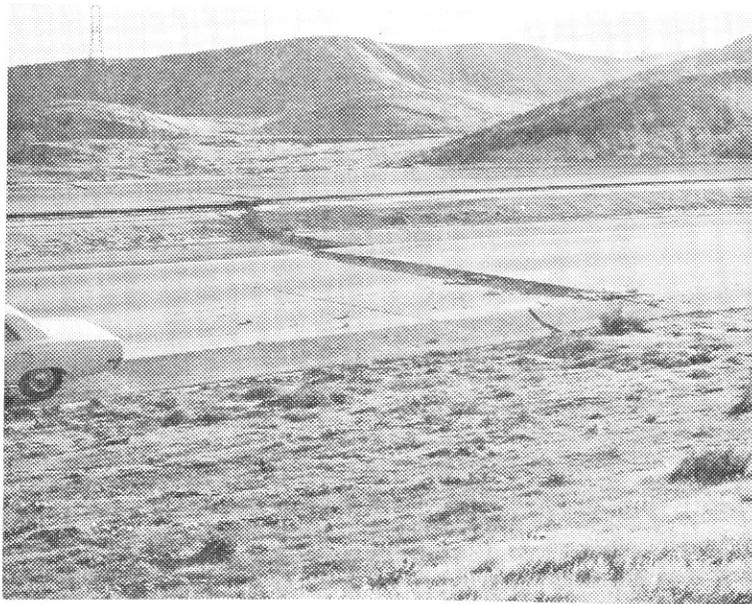
Photo 20. Vertical displacement along pavement slab joints near fill/cut contacts.

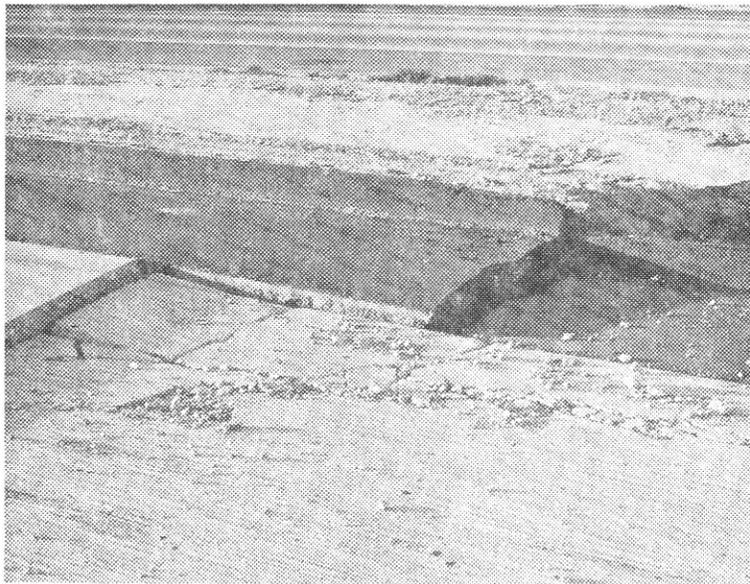
Photo 21. Vertical displacement along pavement slab joints near fill/cut contacts.

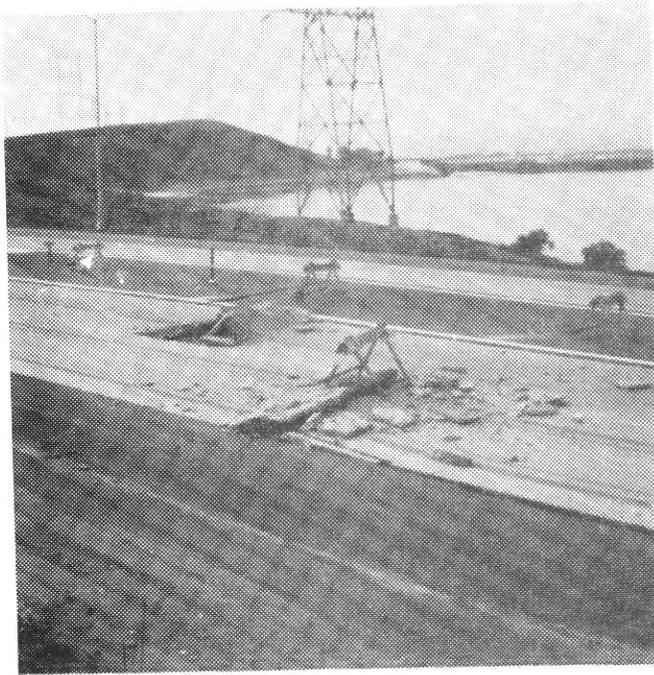
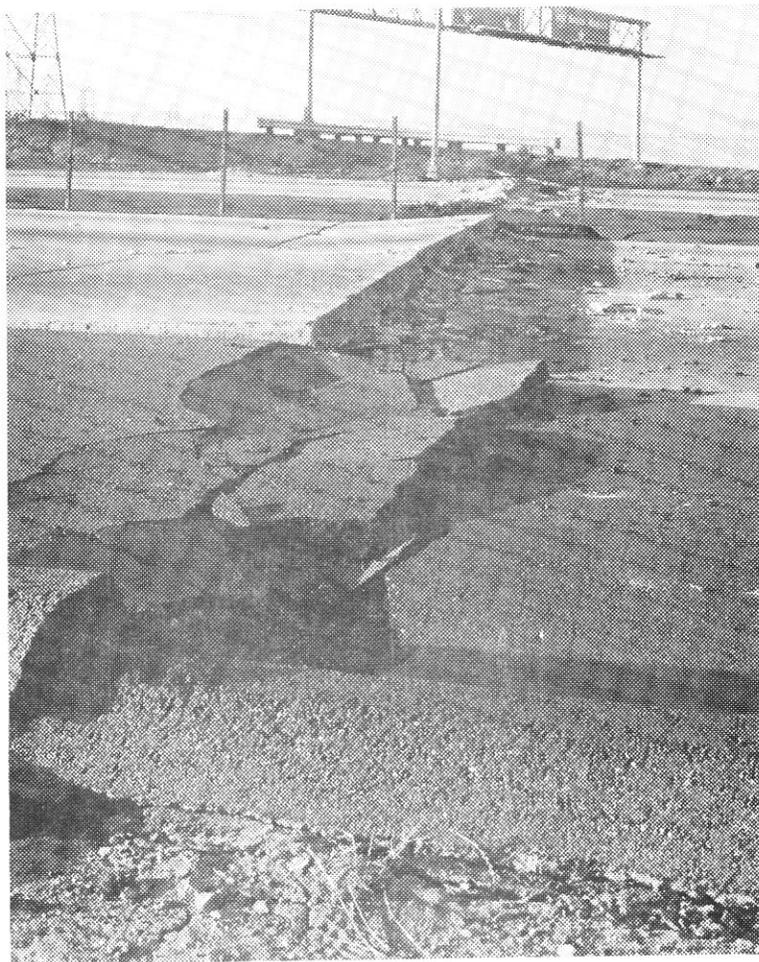
Concrete pavement slabs were thrust together near the south cut-fill contact as shown in Photos 22 and 23, as well as being separated along the same contact shown in Photo 21. Longitudinal separation occurred between pavement slabs due to fill lateral movement as shown in Photo 24.

Photo 22 and 23. Breaking and overriding of pavement slabs at transverse joints due to longitudinal thrusting action.

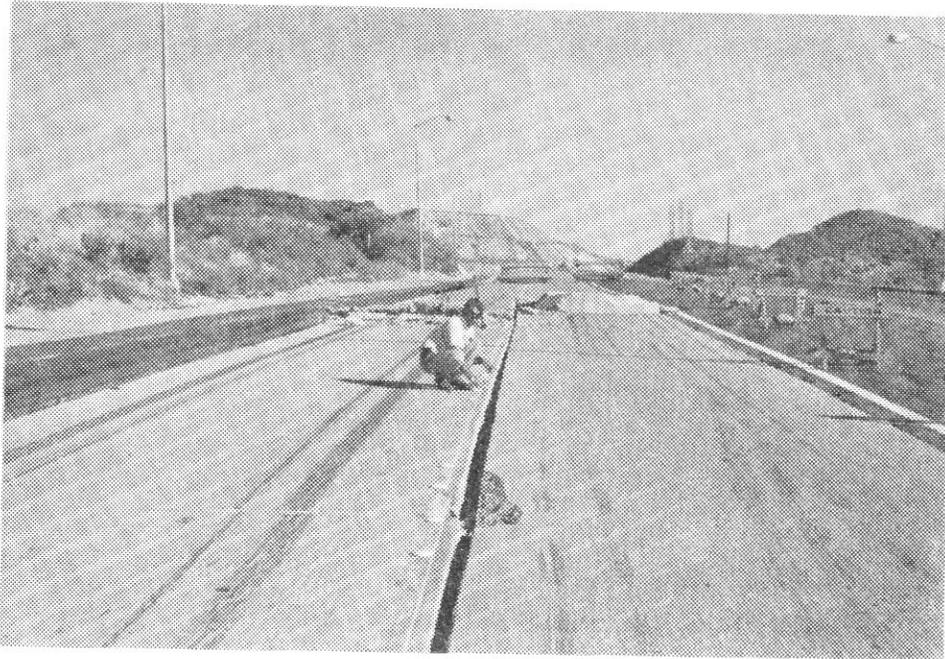
Photo 24. Slab separation along longitudinal joint due to lateral fill movement.

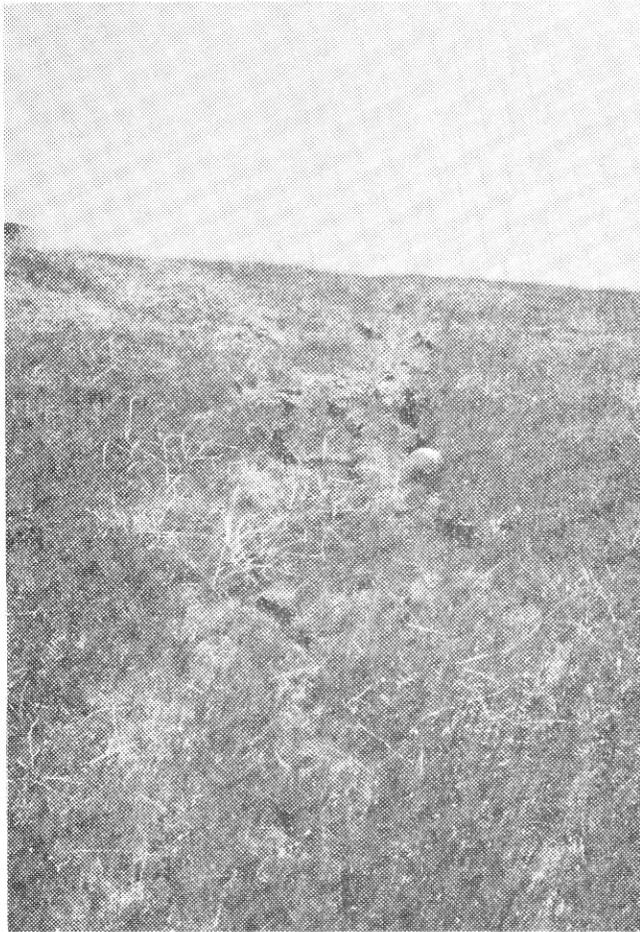
Rotational movement occurred in the cut slope on the west side of the freeway shown in Photo 29. The movement, although small, was sufficient to develop cracks behind the top of cut (Photos 30 and 31) and to upthrust the south-bound roadway surface and cause slab separation, which required patching. Four hundred feet to the south, another upthrust bulge occurred in the roadway but it did not require immediate repairs. It was not obvious upon first observation that slope movements of this nature were the cause of the roadway riding surface damage.

Photo 30. Cracking behind top of cut slope.

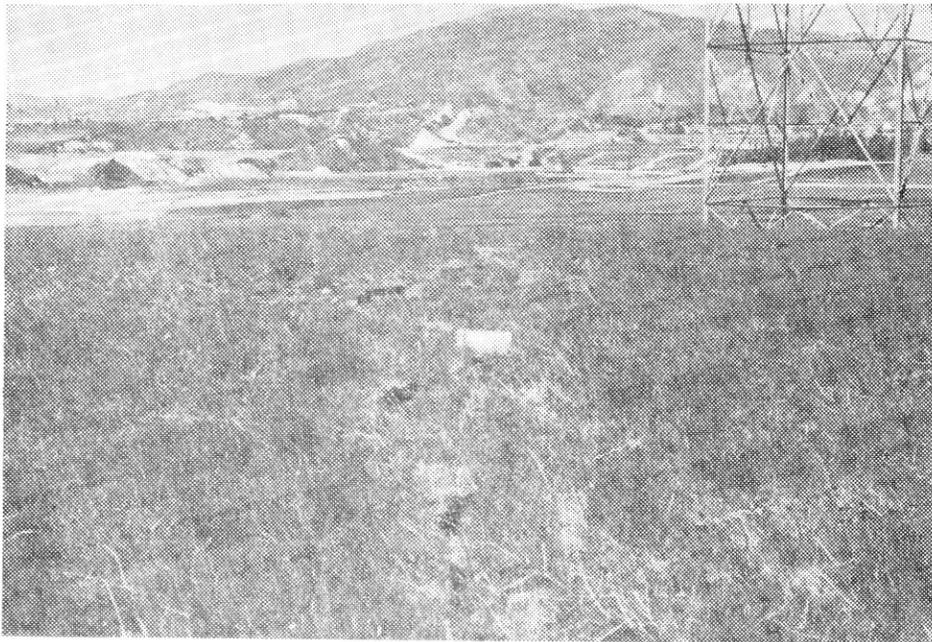
Photo 31. Cracking behind top of cut slope.

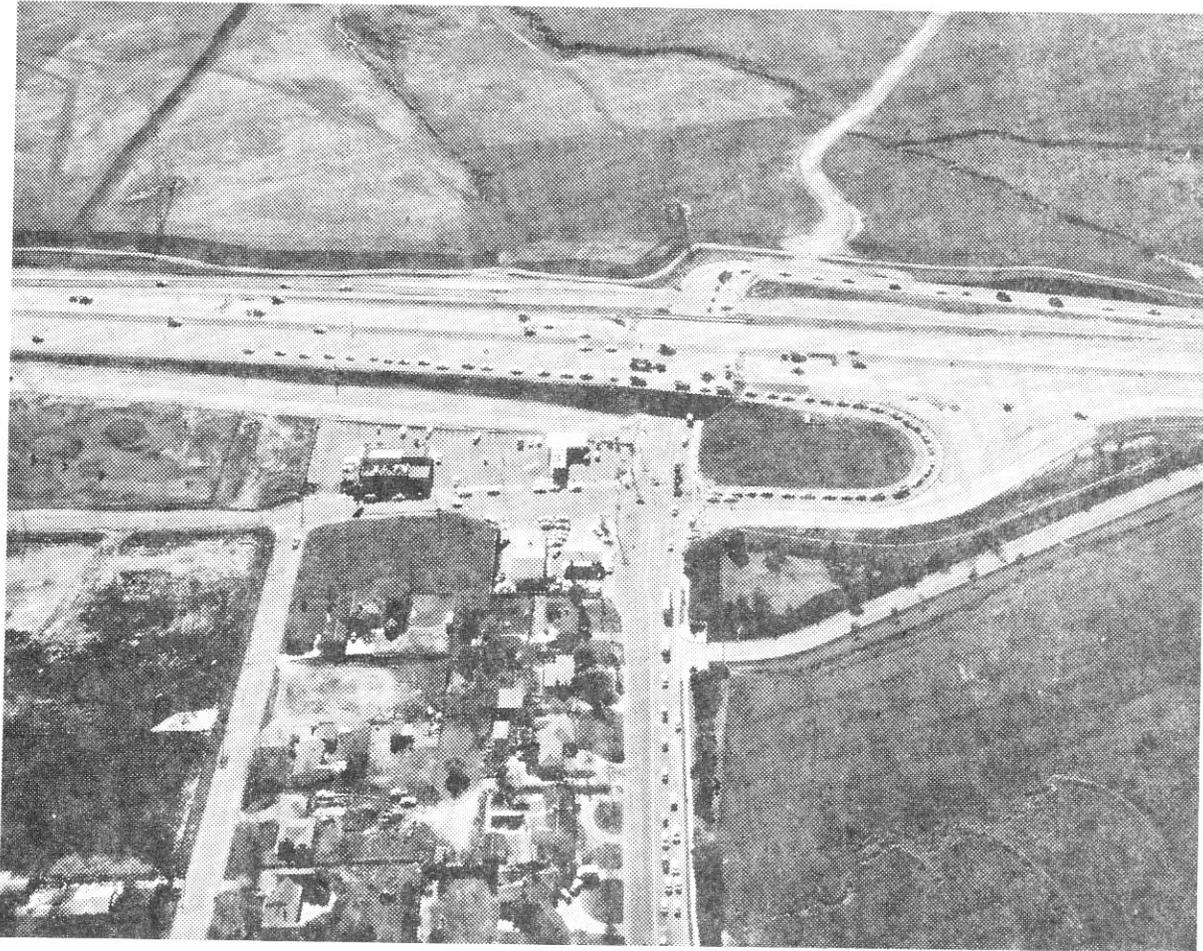
At the time of the earthquake a bridge widening project was under construction at the Roxford Street Interchange, shown in Photo 33. In addition to structural damage shown in Photos 34 and 35, settlement occurred in approach fills and structure backfill shown in Photo 36.

Photo 33. Looking westerly at the Route 5/Roxford Street Interchange.

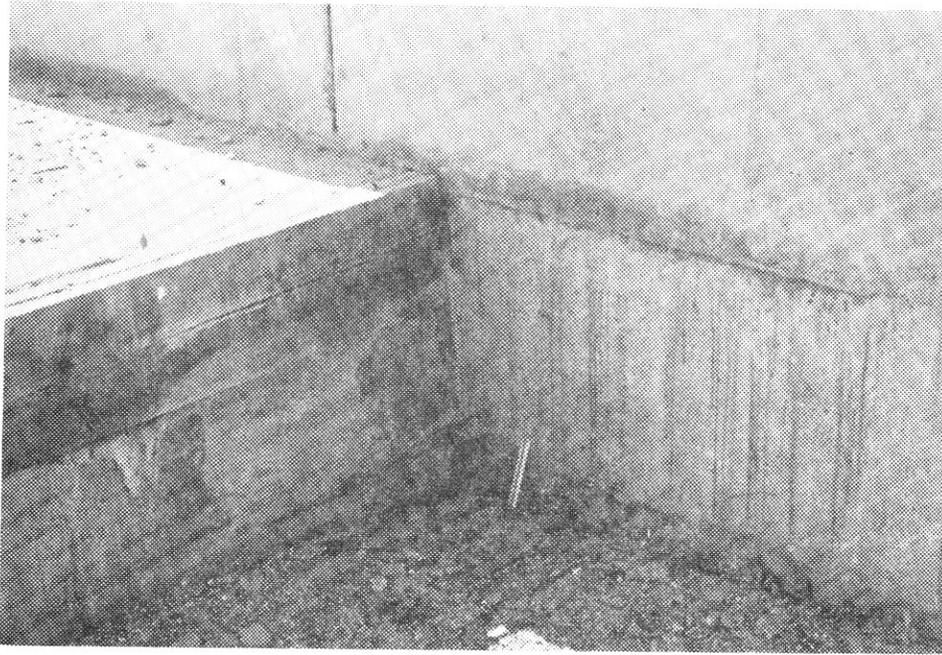
Photo 36. Abutment backfill settlement, north end of Roxford Street Undercrossing.

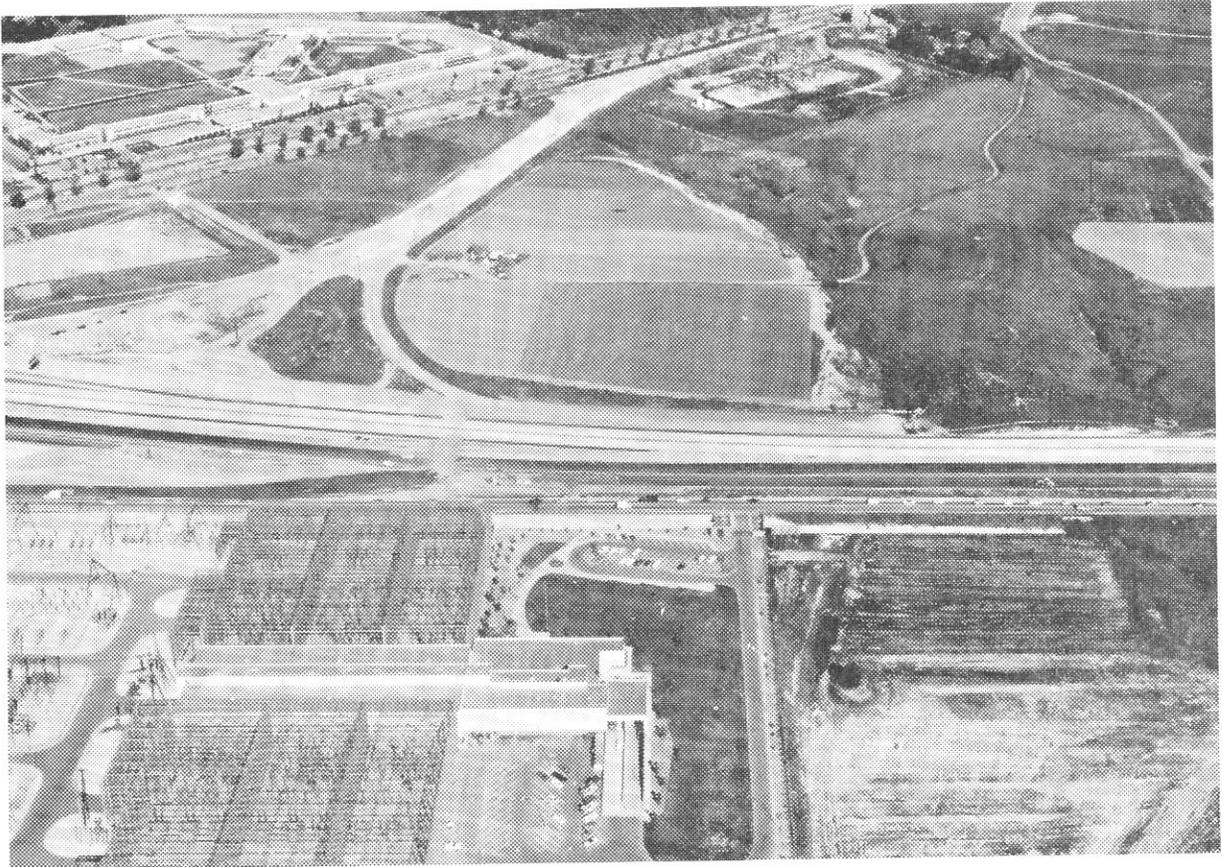
Roadway settlement of a few inches occurred at the cut to fill contact shown in Photo 37, right of center. A low fill crosses the drainage-way that follows the alluvium contact with a slight hill made up of bedded sediments. From this location, the roadway is essentially constructed along the natural ground profile for a 1/4-mile distance, northward.

Photo 37. Looking easterly at Route 5. The Sylmar Converter Station is shown in lower left. Juvenile Hall complex is shown in middle left.

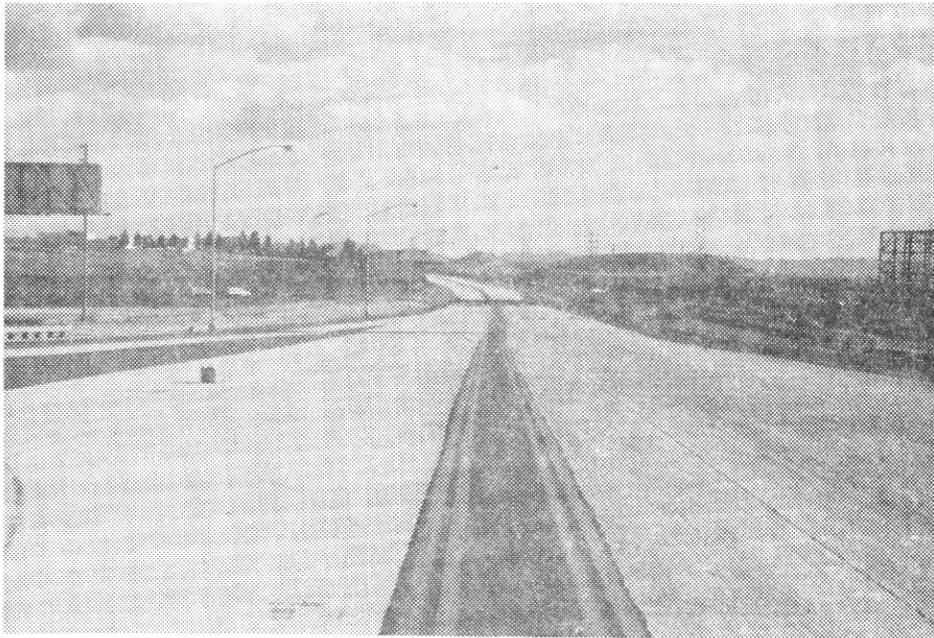
The Juvenile Hall Landslide (Photo 37) displaced Route 5 in excess of 5 feet horizontally, transverse to the roadway (Photos 38 and 39). A compression buckle in the concrete pavement also occurred, as shown in Photo 39.

Photo 38. Looking south along Route 5. Note displacement of striping to right (west) caused by Juvenile Hall slide.

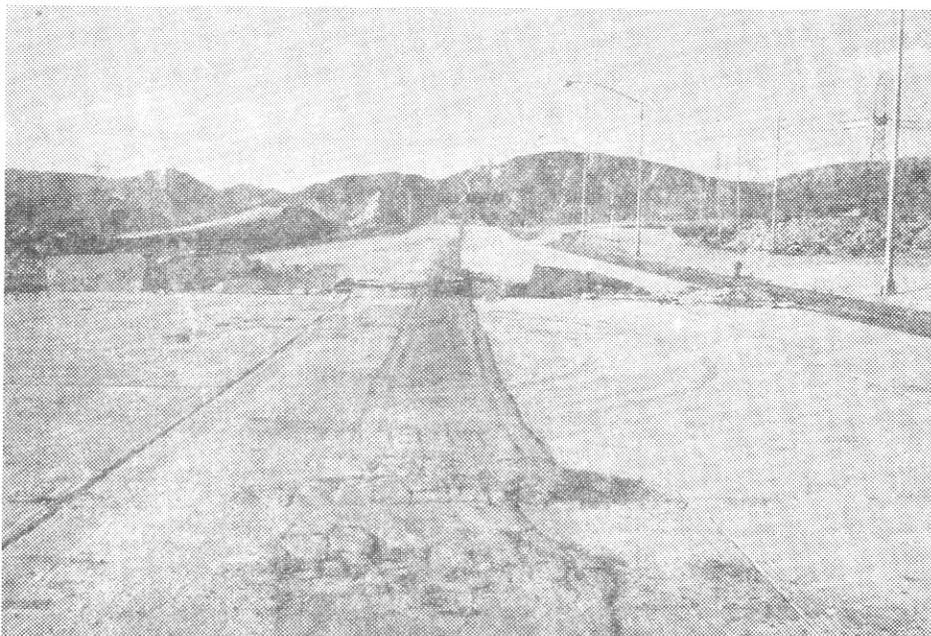
Photo 39. Looking north along Route 5. Note relative lateral slab displacement sharply delineated by striping. Northerly limit of slide displacement is shown by striping in far background. Note pavement buckle caused by extreme thrusting of slabs.

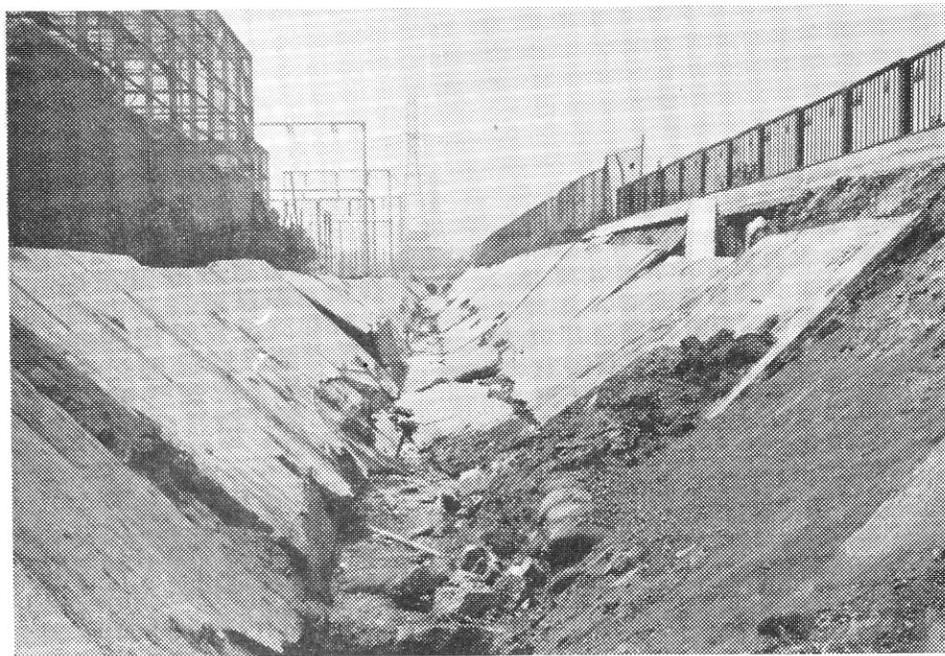
Photo 41. Looking north along concrete lined drainage channel between Route 5 (right) and the Sylmar Converter Station (left). Lateral movement of Juvenile Hall slide (right to left) was largely absorbed by the channel.

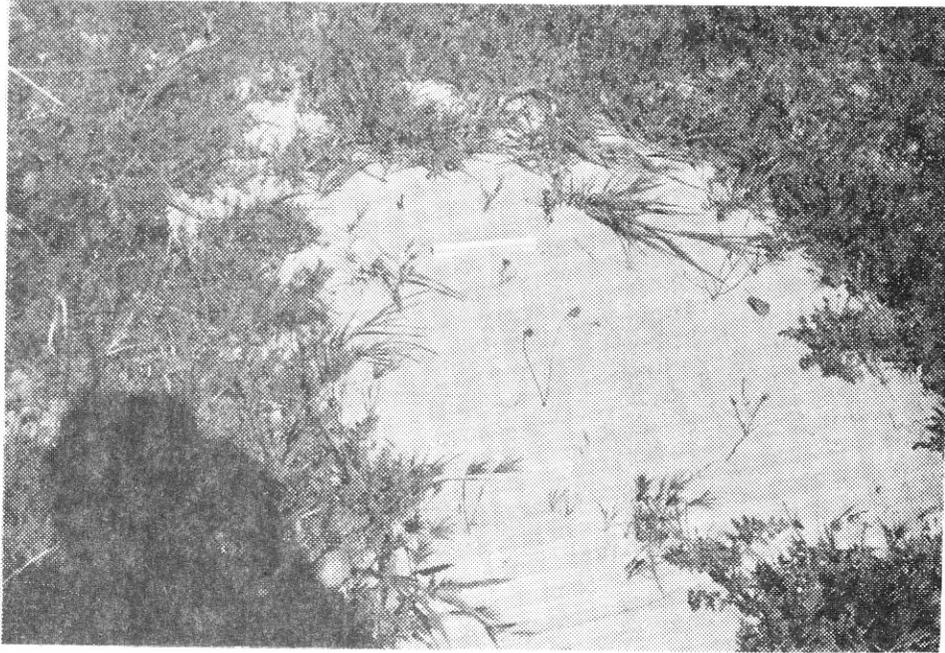
Photo 42. Liquefaction sand boil in central portion of Juvenile Hall slide.

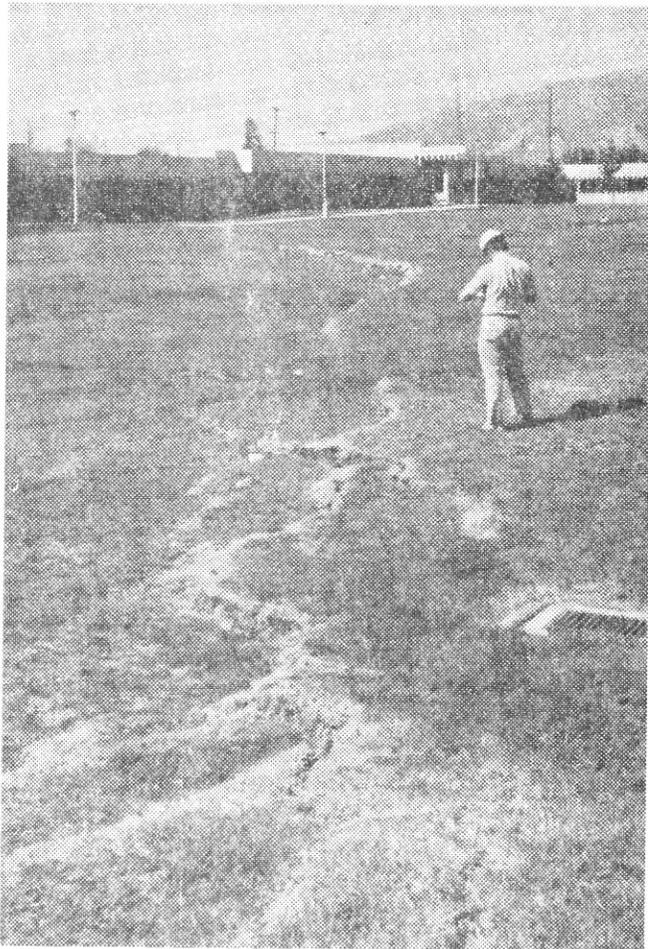
Photo 43. Northern flank of slide, viewed from inside Juvenile Hall complex.
