REPORT NO. FHWA/CA/TL-80/17

ROADWAY DAMAGE DURING THE SAN FERNANDO, CALIFORNIA EARTHQUAKE OF FEB. 9, 1971

FEB., 1981

6. PERFORMING ORGANIZATION CODE		
7. AUTHOR(S) R. H. Prysock and J. P. Egan, Jr.			8. PERFORMING ORGANIZATION REPORT NO. 19305-632119		
9. PERFORMING ORGANIZATION NAME AND ADDRESS Office of Transportation Laboratory California Department of Transportation Sacramento, California 95819			10. WORK UNIT NO.

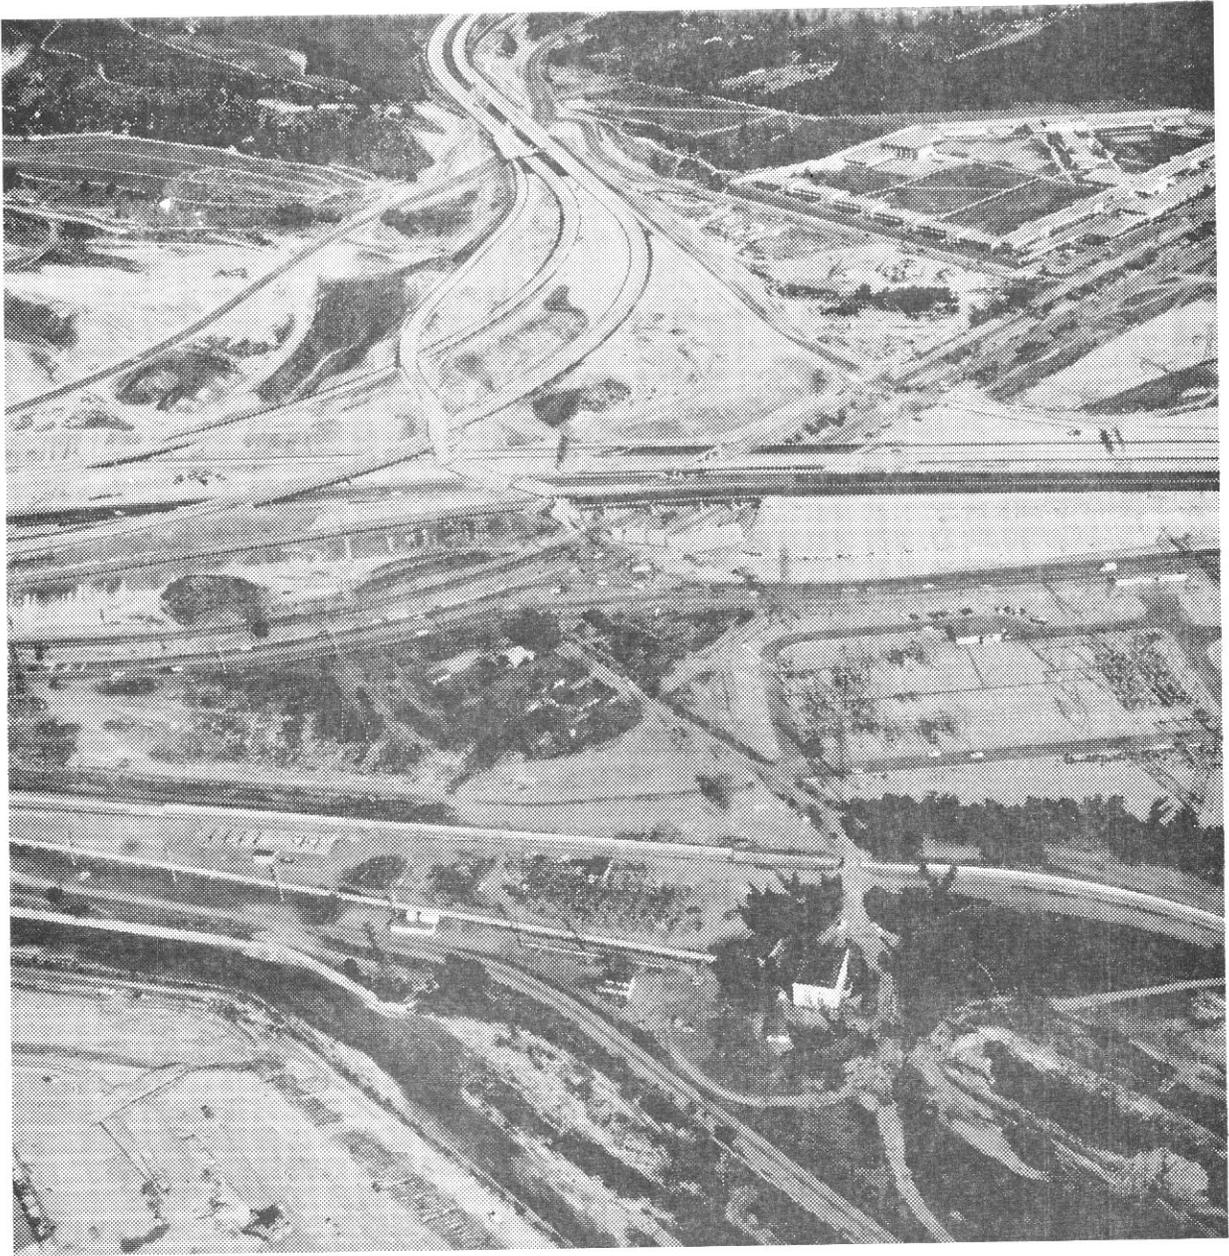
Photo 45. Looking easterly at the Route 5/210 Interchange. Route 5 is shown left to right and Route 210 at the top of the photo. Note the Juvenile Hall complex in upper right and the Sylmar Converter Station in right center.

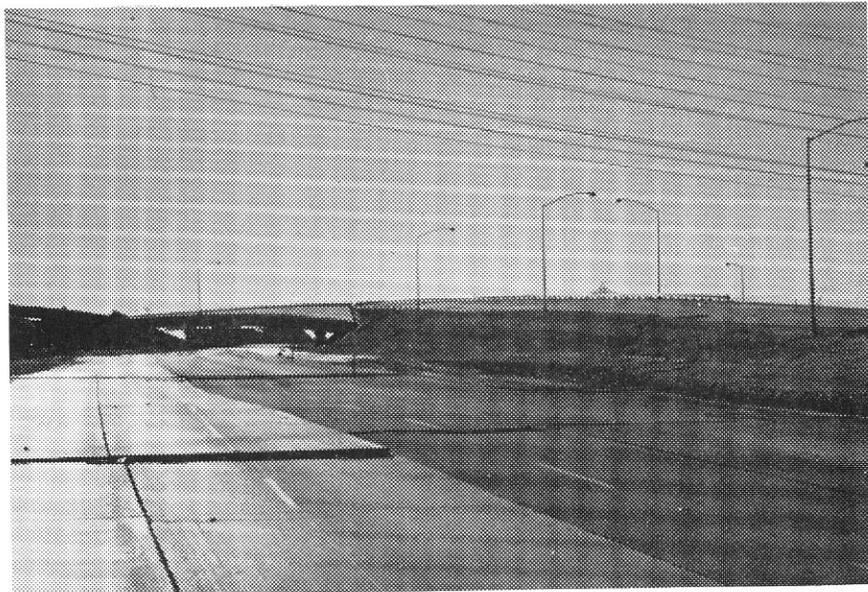
Pavement slabs were faulted badly across the northbound roadbed of Route 5 and Connectors C-Y, D-Y, and M-Y. As may be noted from Photos 46, 47, and 48, typical faulting and slab separation occurred at both longitudinal and transverse joints. The large displacement shown in Photo 47 is the result of a large crack extending up the fill slope. An interesting feature of the pavement distress is that Route 5 at this location is essentially at original ground level (Figure 7) although the slab behavior was typical of pavement on fills.

Photo 46. Looking southeasterly at Route 5 northbound truck lanes. Note slab separation, laterally and vertically, at joints. Damaged D-Y Connector Structure is in background.

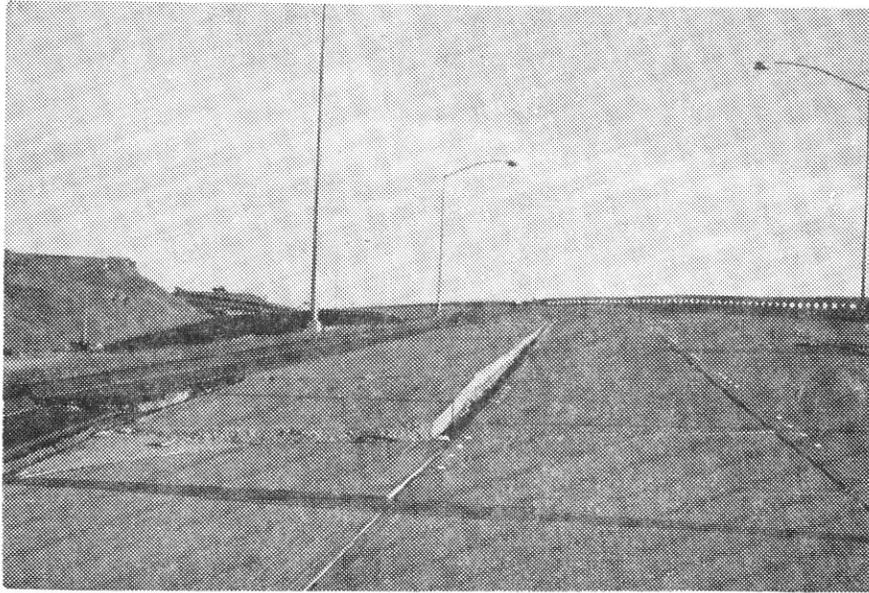
Photo 47. Looking southeasterly along Connector D-Y, at damaged fill-supported pavement.

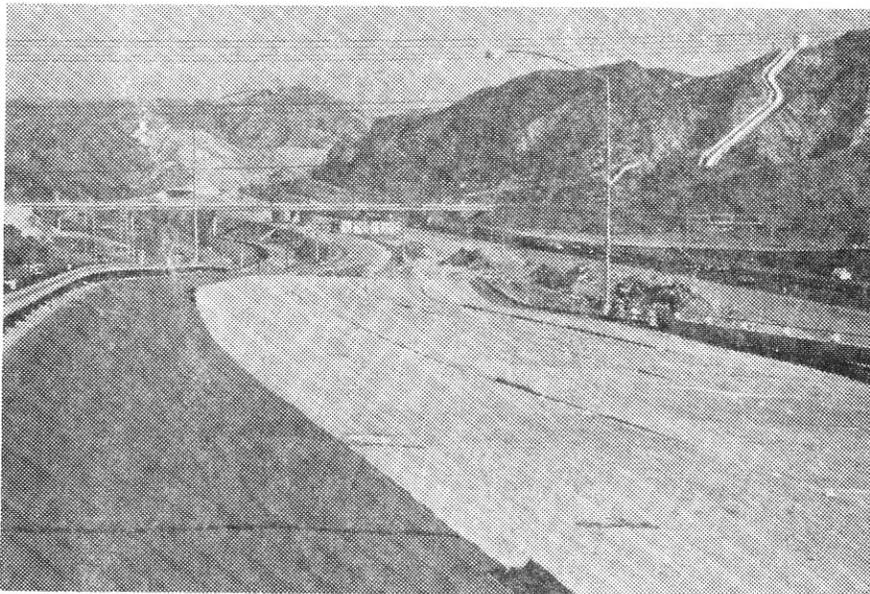
Photo 48. Looking northwesterly along Connector D-Y, at pavement slab faulting, separation, and undulations due to fill movement.

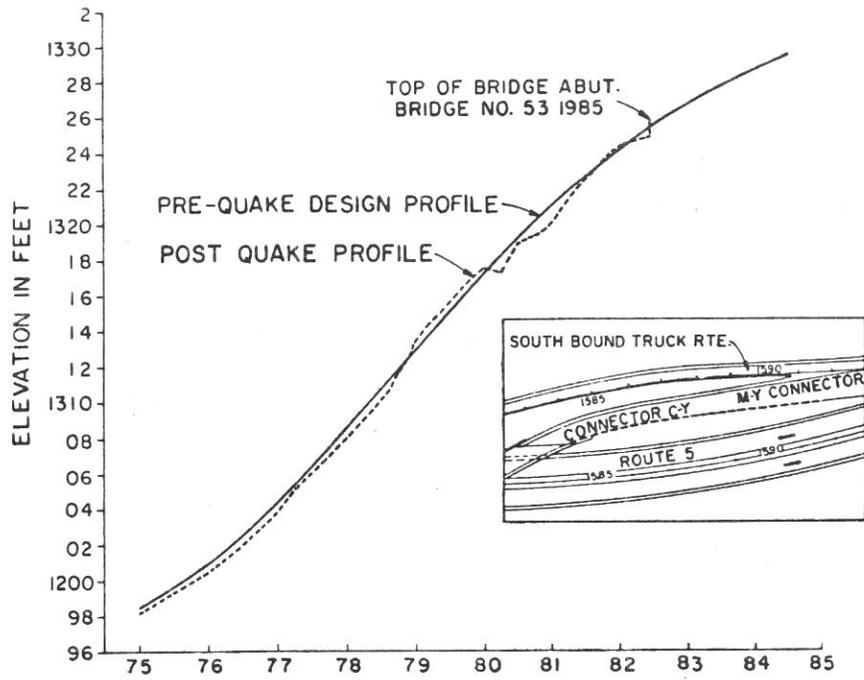
FIGURE 9

Design and post-quake profiles of Connectors C-Y and M-Y are shown in Figures 9 and 10, respectively. The plots show that despite a regional uplift in this area the post-quake profile is lower than the design profile due to fill settlement caused by spreading and densification.

C-Y CONNECTOR PRE-QUAKE AND POST-QUAKE PROFILES

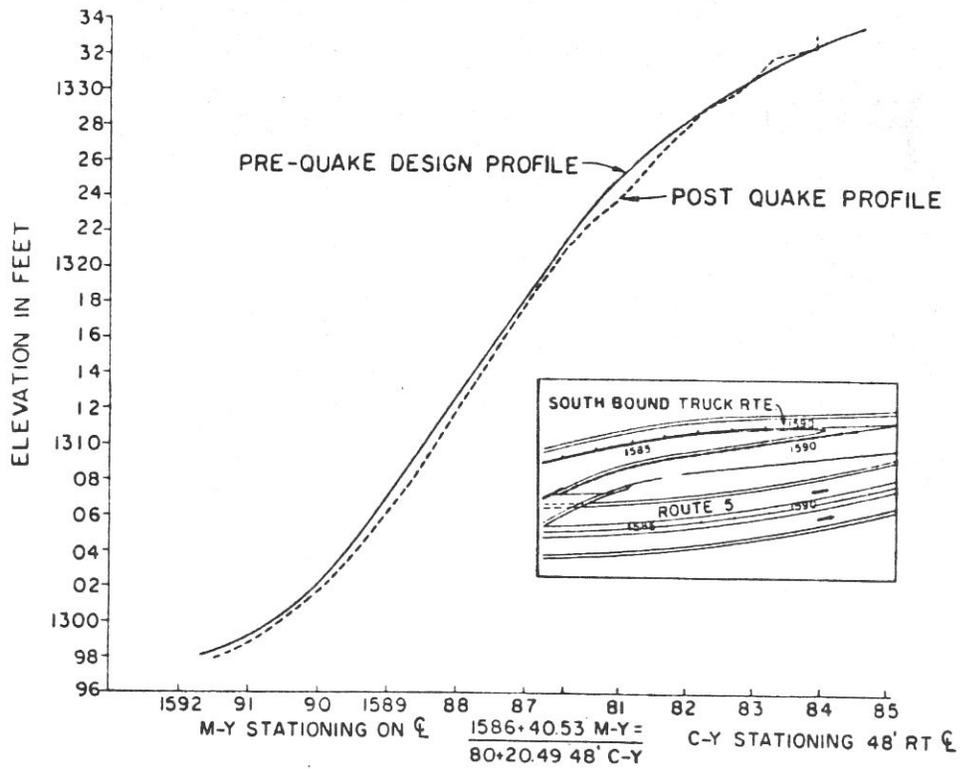
FIGURE 10

M-Y CONNECTOR PRE-QUAKE AND POST-QUAKE PROFILES

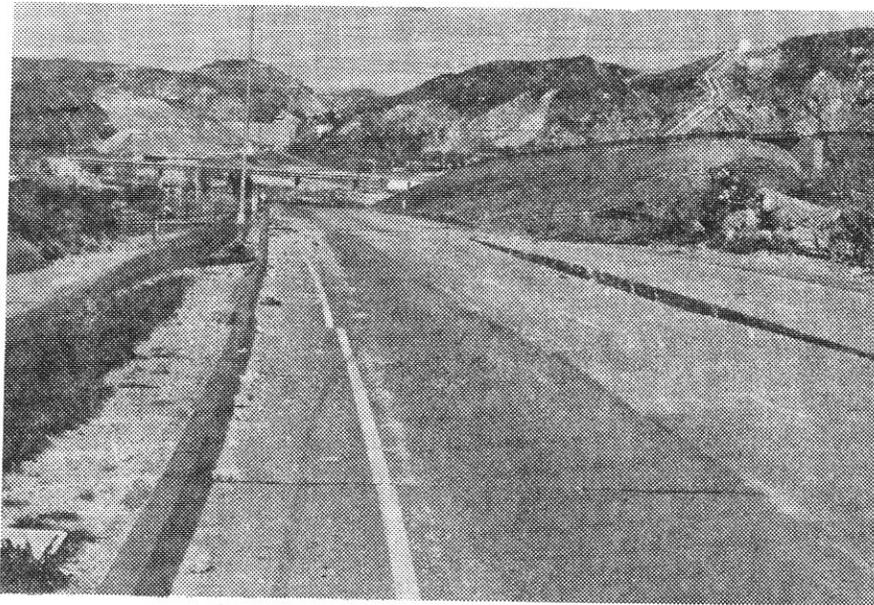
The pavement of the Route 5 Southbound Truck Freeway was faulted and displaced laterally due to shearing action in the fill (Photo 49). The shear pattern, traced diagonally down the fill slope, outlined a complete volume of material that probably would have collapsed had strong motion been of a longer duration. The roadway profile and alignment were deformed as shown in Figures 11 and 12.

Photo 49. Looking northerly at damaged pavement of Route 5 southbound truck freeway caused by fill movement.

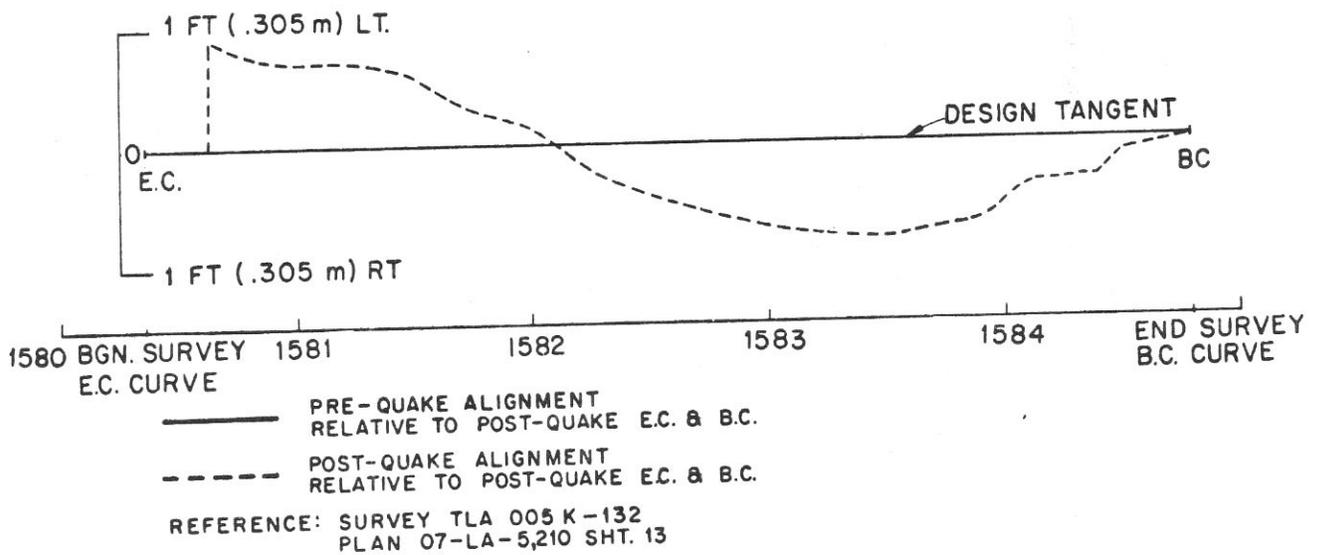
FIGURE 12

HORIZONTAL ALIGNMENT OF A PORTION OF ROUTE 5 SOUTHBOUND TRUCK FREEWAY BEFORE AND AFTER THE QUAKE

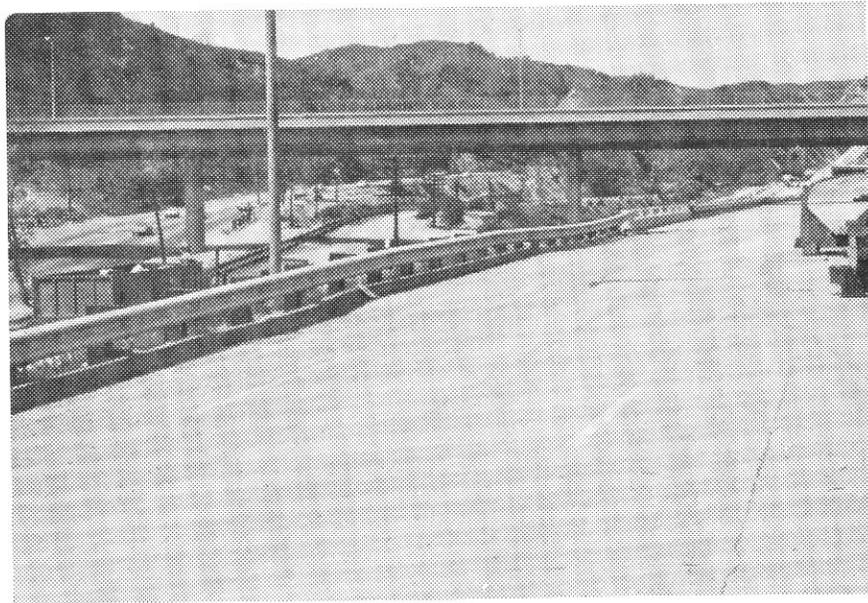
Photo 50. Looking northerly at undulating pavement of Route 5 caused by differential settlement. Balboa Boulevard Overcrossing structure is in background.

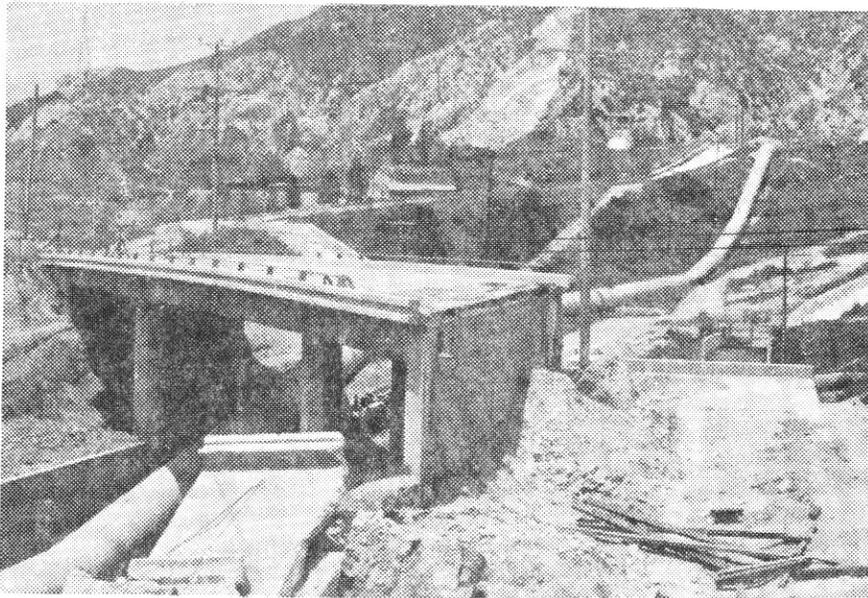
Foothill Boulevard crosses the northerly end of the aqueduct structure (Bridge No. 53-1011) on about 22 feet of fill above the deck, and then, proceeding northwesterly, immediately crosses the penstock on Bridge 53c-316 (extreme left center of Photo 44). A closer view of the two structures is given in Photo 51. Shortly after the earthquake, fill material was removed from the deck of Br. 53-1011 to relieve stress on the sheared deck of the structure. Photo 52 is a view of the deck soffit, the portion that was overlain by about 22 feet of fill.

Photo 51. Looking northeasterly at Bridge 53c-316 which carries Foothill Boulevard over the penstock. Immediately to the right of the bridge, the uncovered deck of the aqueduct structure, Bridge 53-1011, is visible.

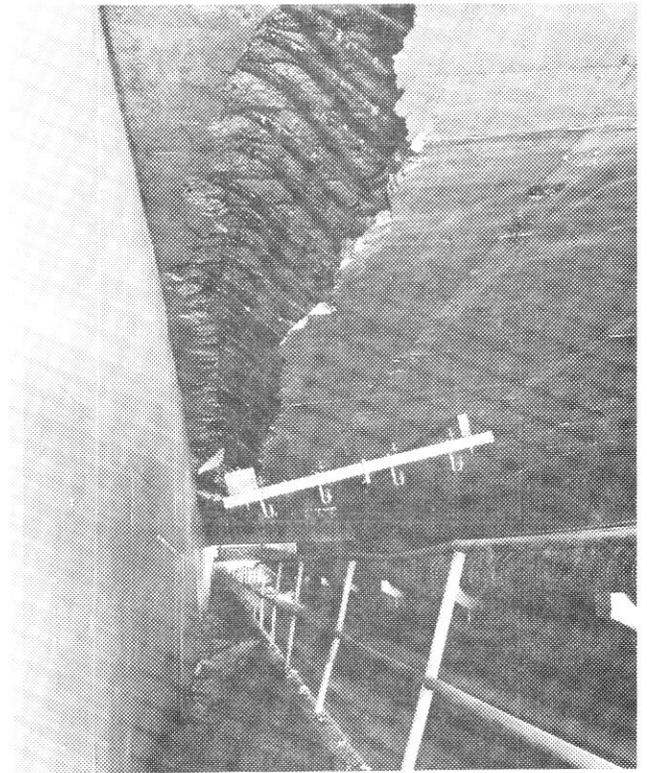
Photo 52. Southwesterly view from inside Bridge 53-1011 showing damage.

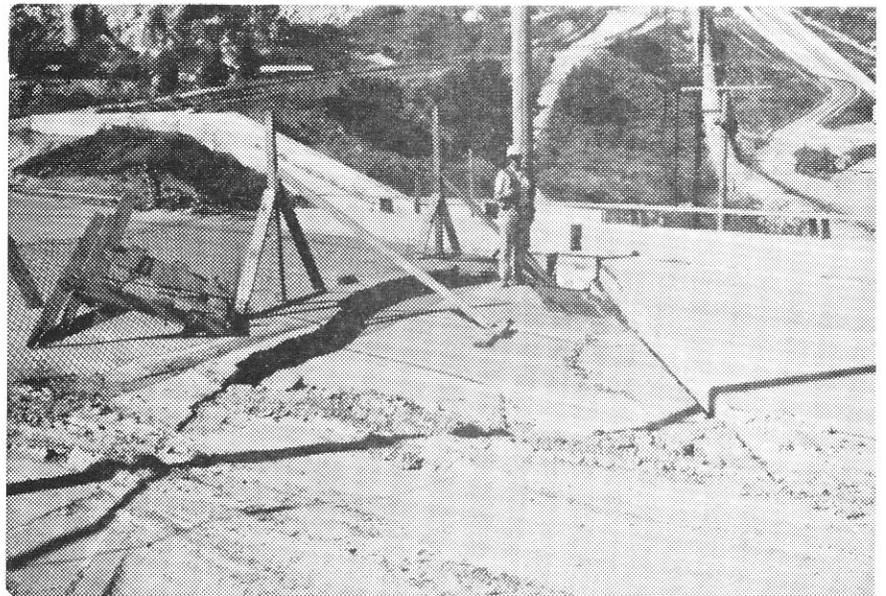
Backfill at the northwesterly abutment of Br. 53c-316 settled about 8 inches as shown in Photo 53. The settlement is clearly defined in the photograph because the pavement was asphalt concrete which does not provide a bridging effect as do the portland cement concrete slabs.

Photo 53. Settlement of abutment backfill at northerly end of Bridge 53c-316.

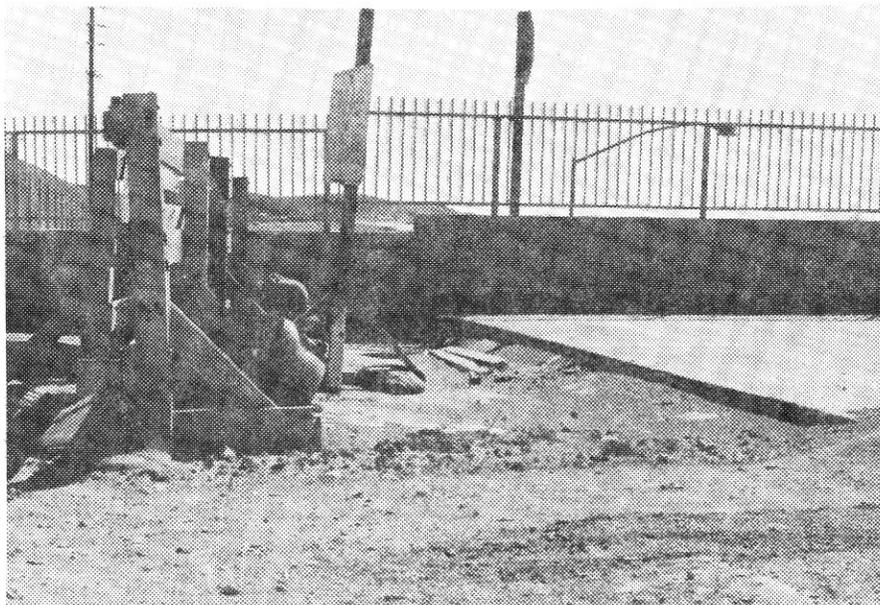
Both approaches to Balboa Boulevard Overcrossing suffered backfill settlement. Photo 54 shows the easterly approach settlement of about 8 inches at the bridgedeck and wingwall joint. The bridge abutment was founded on piles while the wingwalls were on spread footings founded in the embankment. Approximately 25 feet of fill rests over original ground at the easterly bridge approach.

Photo 54. Approach and wingwall settlement at easterly end of Balboa Boulevard Overcrossing.

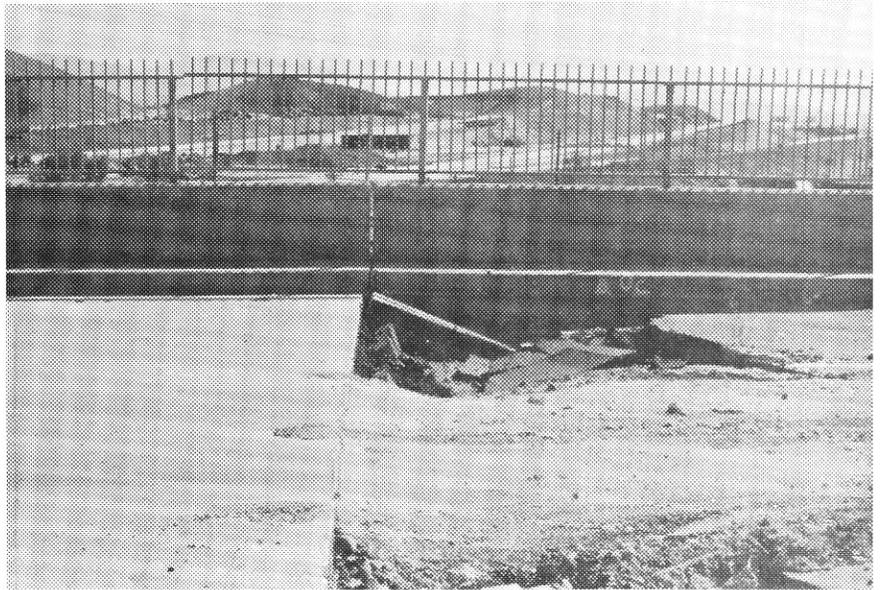
The westerly approach was constructed in cut section with both the bridge abutment and wingwalls founded on spread footings. Backfill at the paving notch settled several inches, while the bridge deck and wingwall remained in essentially the same place, as shown in Photo 55. The abutment failed in shear and rotation about a horizontal axis as shown in Photo 56 and tended to arch the deck as can be seen along the neat line of the concrete guardrail shown in Photo 57.

Photo 55. Westerly approach to Balboa Boulevard Overcrossing. Note abutment backfill settlement but lack of differential settlement between wingwall and abutment.

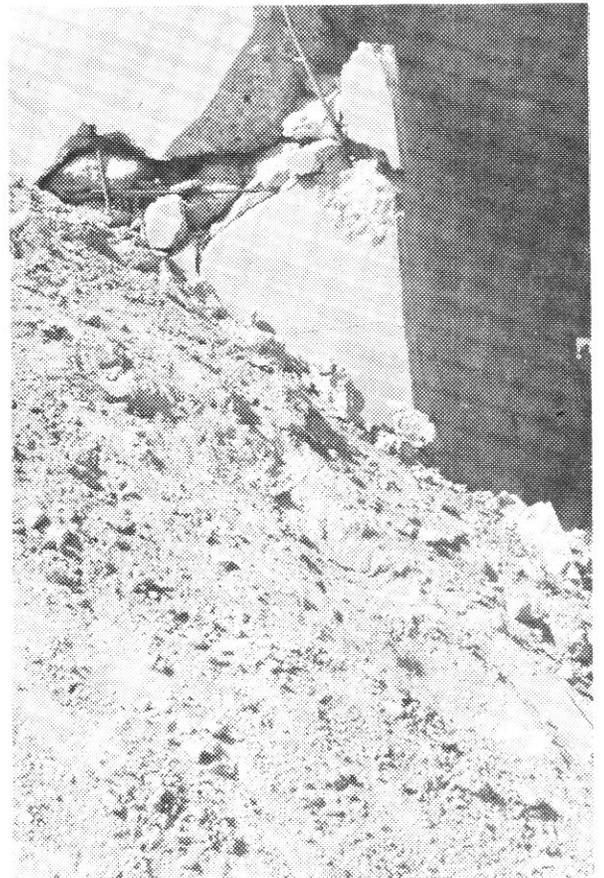
Photo 56. Damaged westerly abutment of Balboa Boulevard Overcrossing.

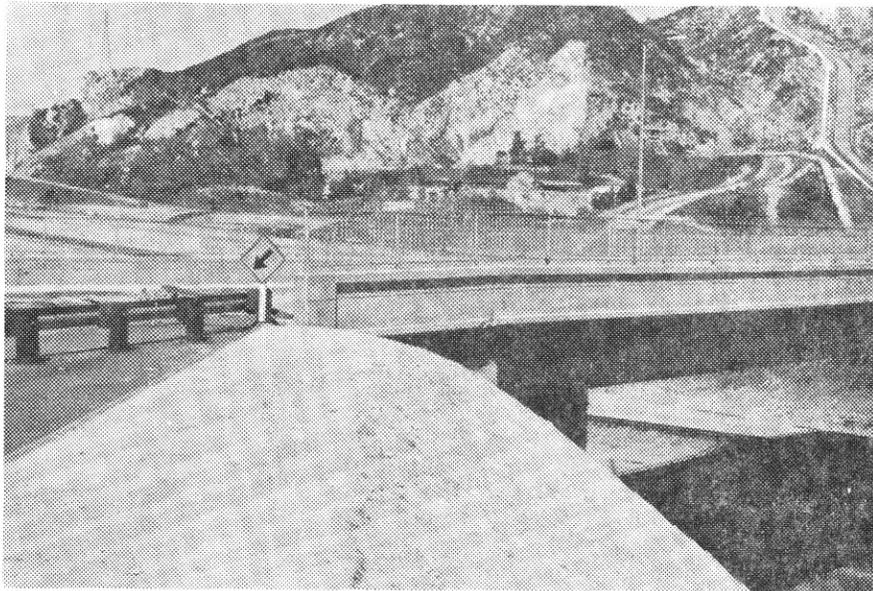
Photo 57. Looking northeasterly at westerly abutment of Balboa Boulevard Overcrossing. Note slight arch in structure caused by abutment movement.

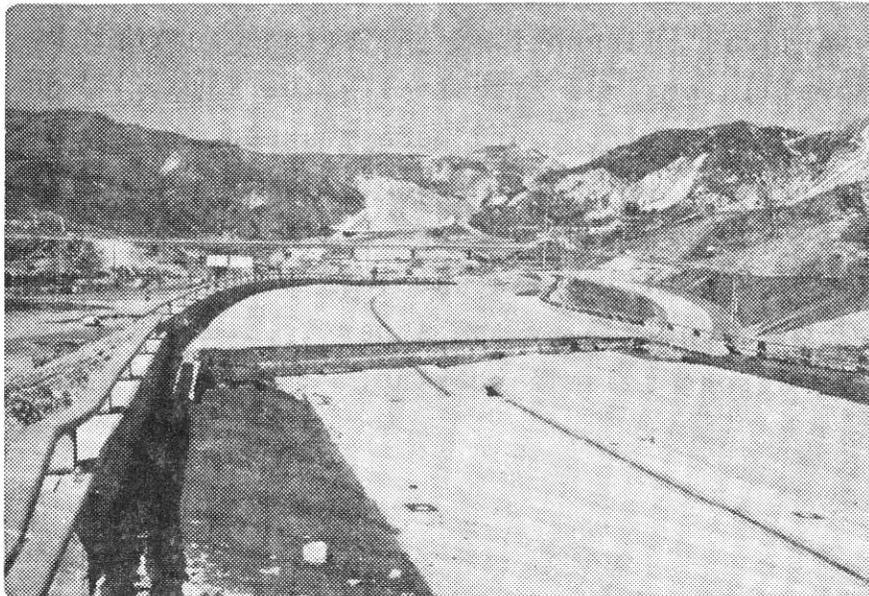
The approaches to this structure (Br. 53-1991R) are a combination of cut and fill. Figure 14 shows the original ground topography with the structure superimposed over it. The entire bridge is founded on spread footings in original ground that is composed of very dense sand, gravelly sand, and sandy gravel with cobbles of the Saugus formation. "Settlement" at the easterly bridge approach, Photos 58 and 59, was about two feet at its maximum. At the westerly abutment, "settlement" was several inches; with a portion of the resulting distress to pavement shown in Photo 60.

Photo 58. Settlement at the easterly approach to Bridge 53-1991R on the D-Y Connector, Route 5/210 Interchange.

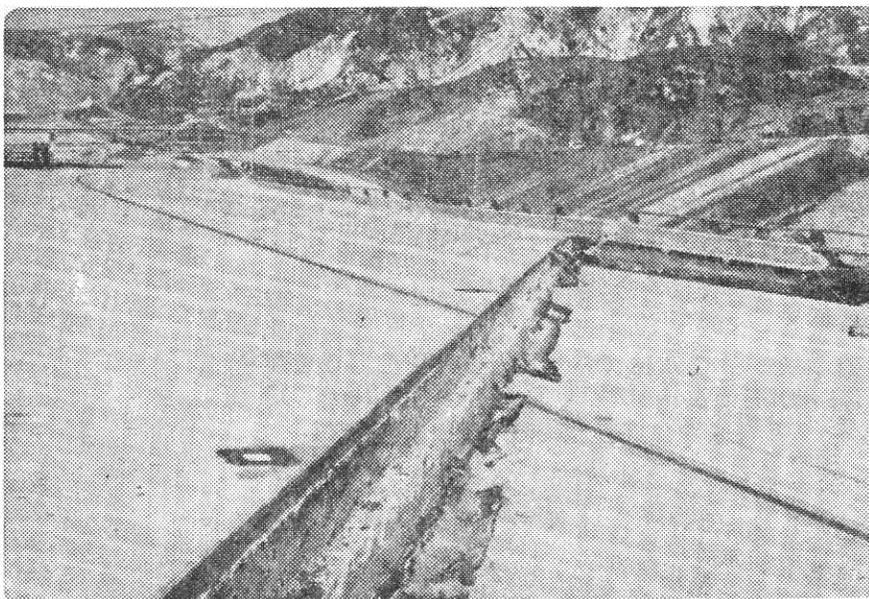
The vertical alignment of the bridge and retaining wall (wingwall) remained essentially the same, as can be seen in Photo 59. Since both were founded on spread footings in very dense original ground, and the vertical alignment remained uniform, the observed settlement is believed to be due to densification and loss of backfill material into voids created by the superstructure displacement during strong seismic shaking.

Photo 59. Settlement at the easterly approach to Bridge 53-1991R on the D-Y Connector, Route 5/210 Interchange.

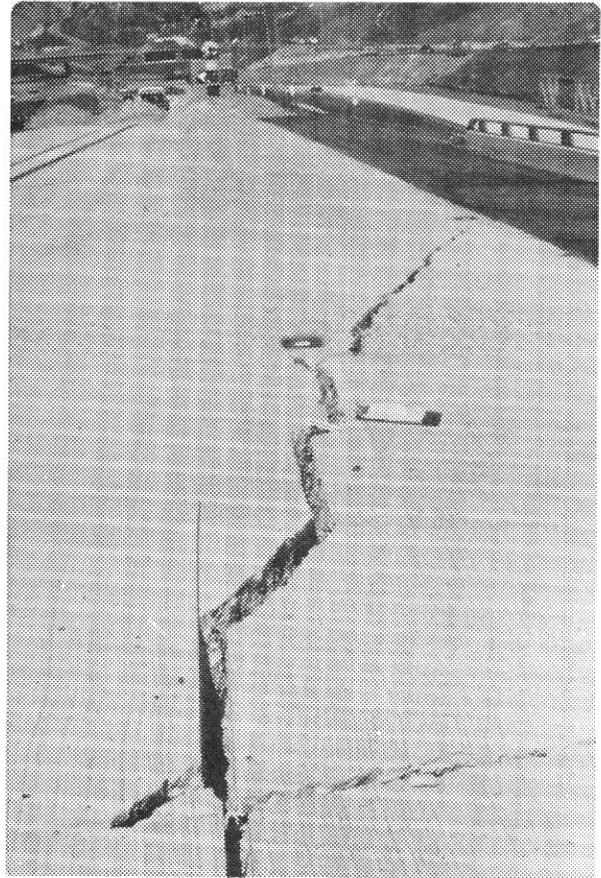
Photo 60. Cracking and movement of D-Y Connector pavement immediately west of Bridge 53-1991R.

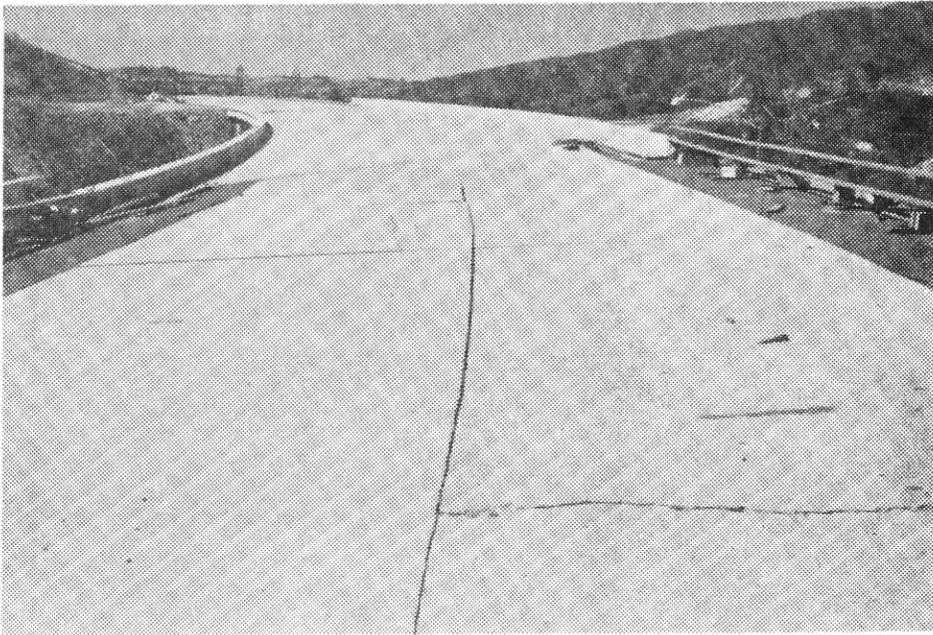
The bridge at this location is founded on spread footings in original ground. The westerly approach is entirely within cut, while the easterly approach is made up of 12 to 30 feet of fill across a narrow steep canyon. The easterly approach pavement slabs cracked, separated, and settled a few inches at the bridge deck, as shown in Photos 61 and 62; whereas little or no pavement distress was noted at the westerly approach. Severe shaking of the bridge did occur as evidenced by the cracked wingwalls and abutment (Ref. 4, p. 207, Index 10), which would allow fill spreading and consequent pavement distress.

Photo 61. Pavement cracks and movement at the easterly approach to Bridge 53-1988L on the A-Y Connector, Route 5/210 Interchange.

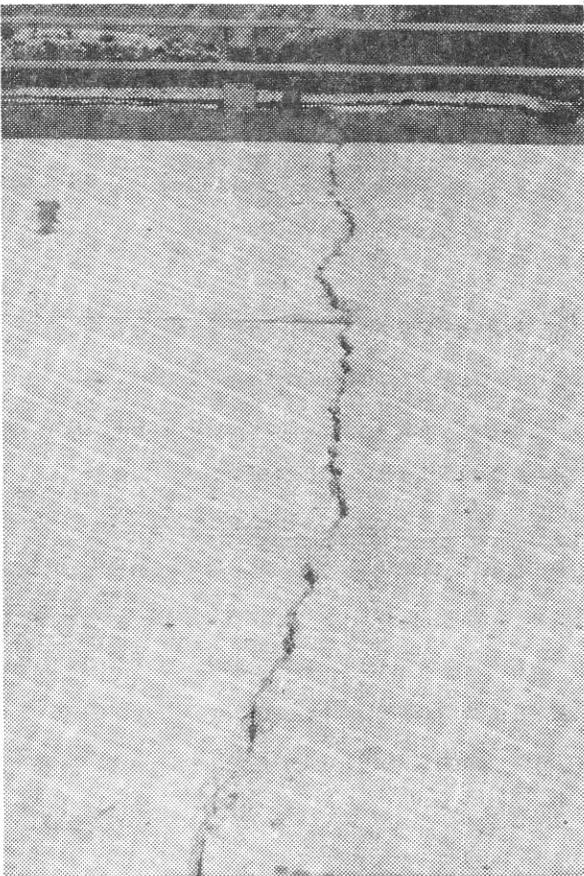
Photo 62. Transverse pavement crack at cut/fill contact near easterly approach to Bridge 53-1988 on the A-Y Connector.

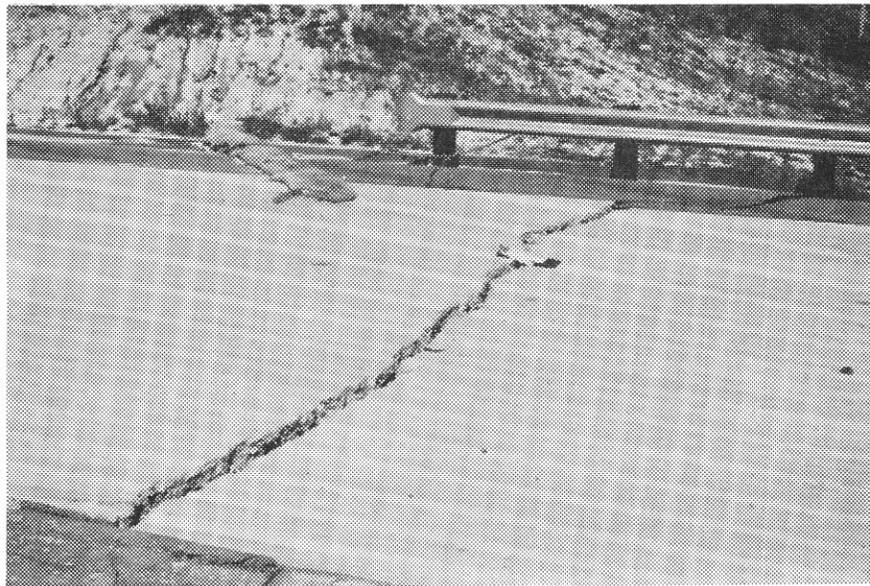
Pavement and soil-cracking occurred in the general area of the cut-fill contact shown in plan on Figure 6. From Connector C-Y the cracking diverged away from the contact in a southerly direction. The cracking progressed from one crack across Connector A-Y, Photo 63, to a zone approximately 200 feet wide south of Connector C-Y. Individual cracks show up to one inch of horizontal separation and generally 1 to 2 inches of vertical separation with the east side down relative to the west. Photo 64 shows the pavement displacement across Connector D-Y and Photos 65 and 66 show the cracking and displacement across Connector C-Y. No cracking on either fill slope was found in this zone. However, south of the toe of fill for a distance of about 70 feet cracking was observed in original ground.

Photo 63. Looking northerly at transverse pavement crack at the cut/fill contact on A-Y Connector. Note horizontal and vertical separation along crack.

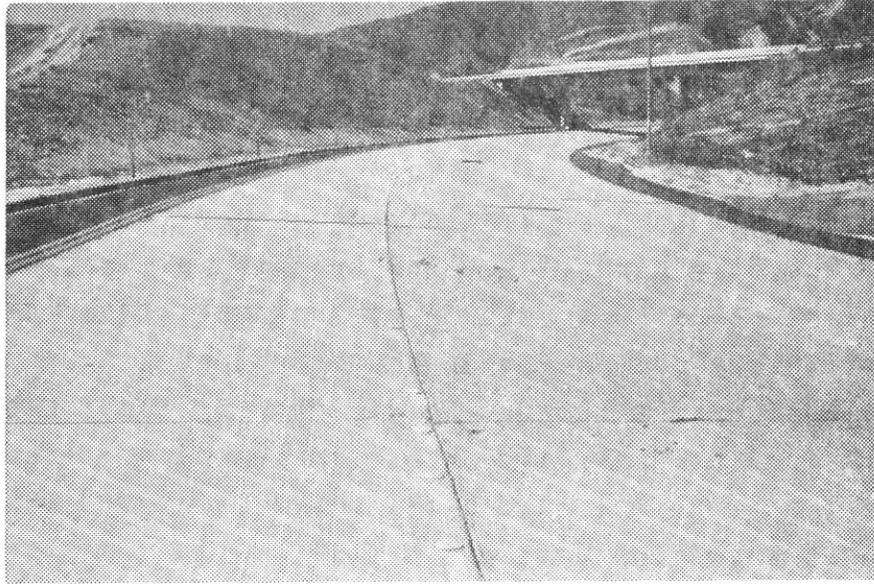
Photo 64. Looking northwesterly at pavement slab displacement through cut/fill zone on Connector D-Y.

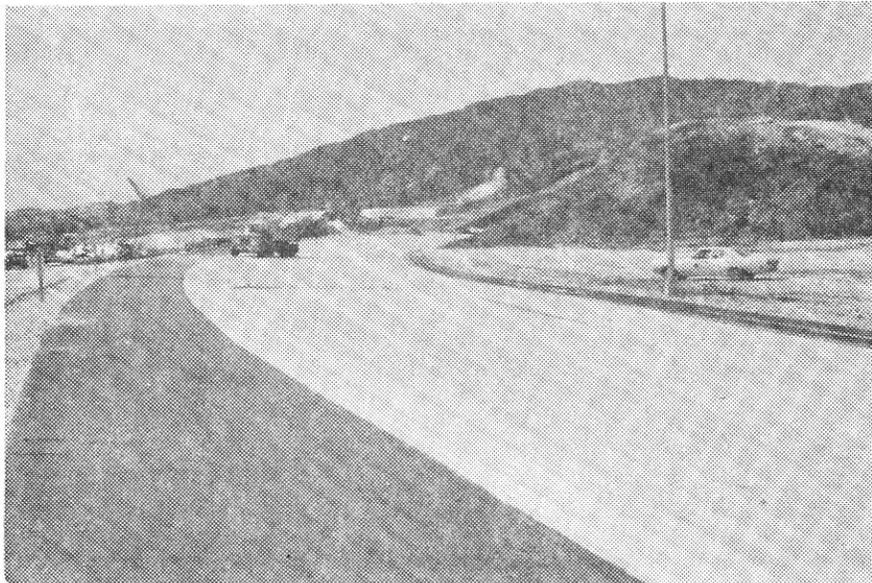
Photo 65. Looking northwesterly at pavement slab displacement through cut/fill zone on Connector C-Y.

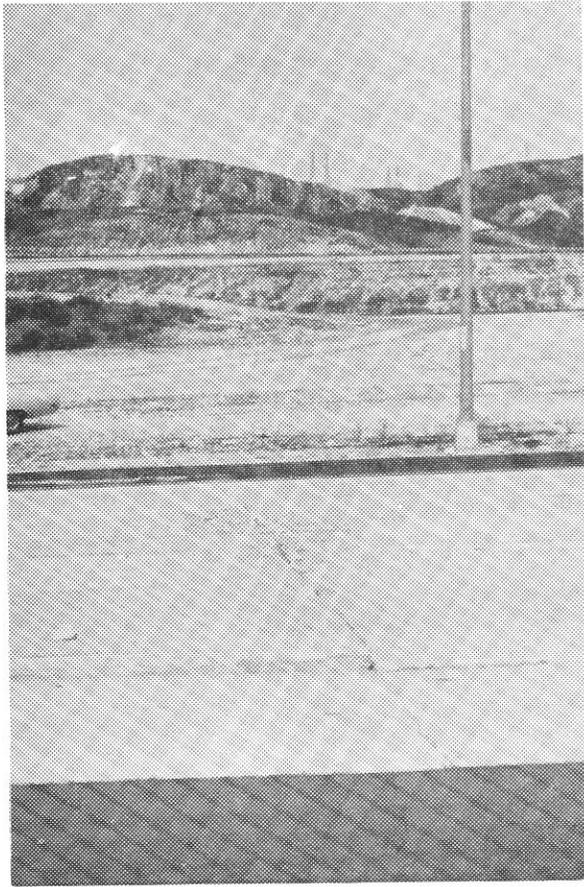
Photo 66. Transverse pavement crack on Connector C-Y. (Light standard is same as shown in Photo 65.)

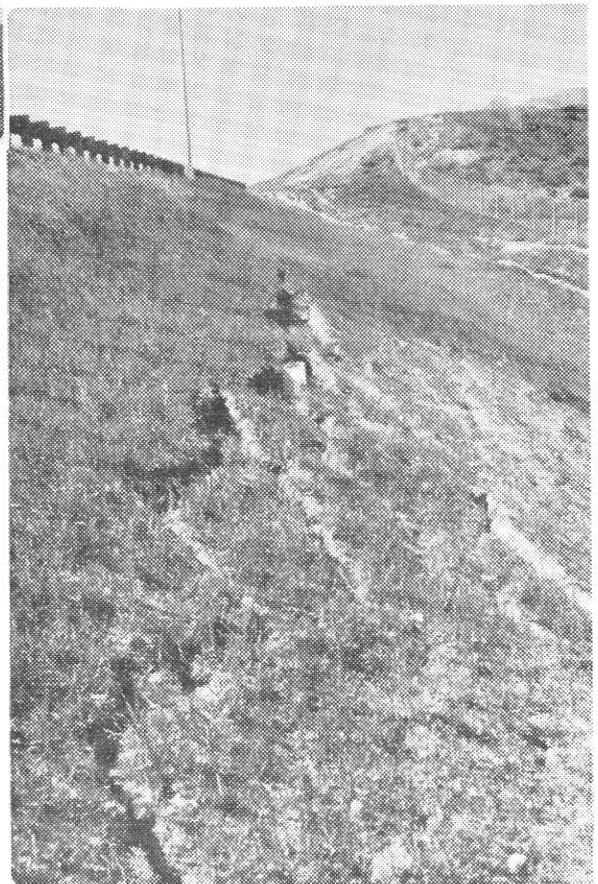
Photo 67. Cracking in north fill slope of Connector A-Y. The pavement crack shown in Photo 63 occurred at cut/fill contact in background.

On the north slope of the fill and about 300 feet east of the cut-fill contact a surficial slide occurred that is shown in Photo 67. This failure extended up into the roadway causing minor pavement distress and a slight dip in profile.

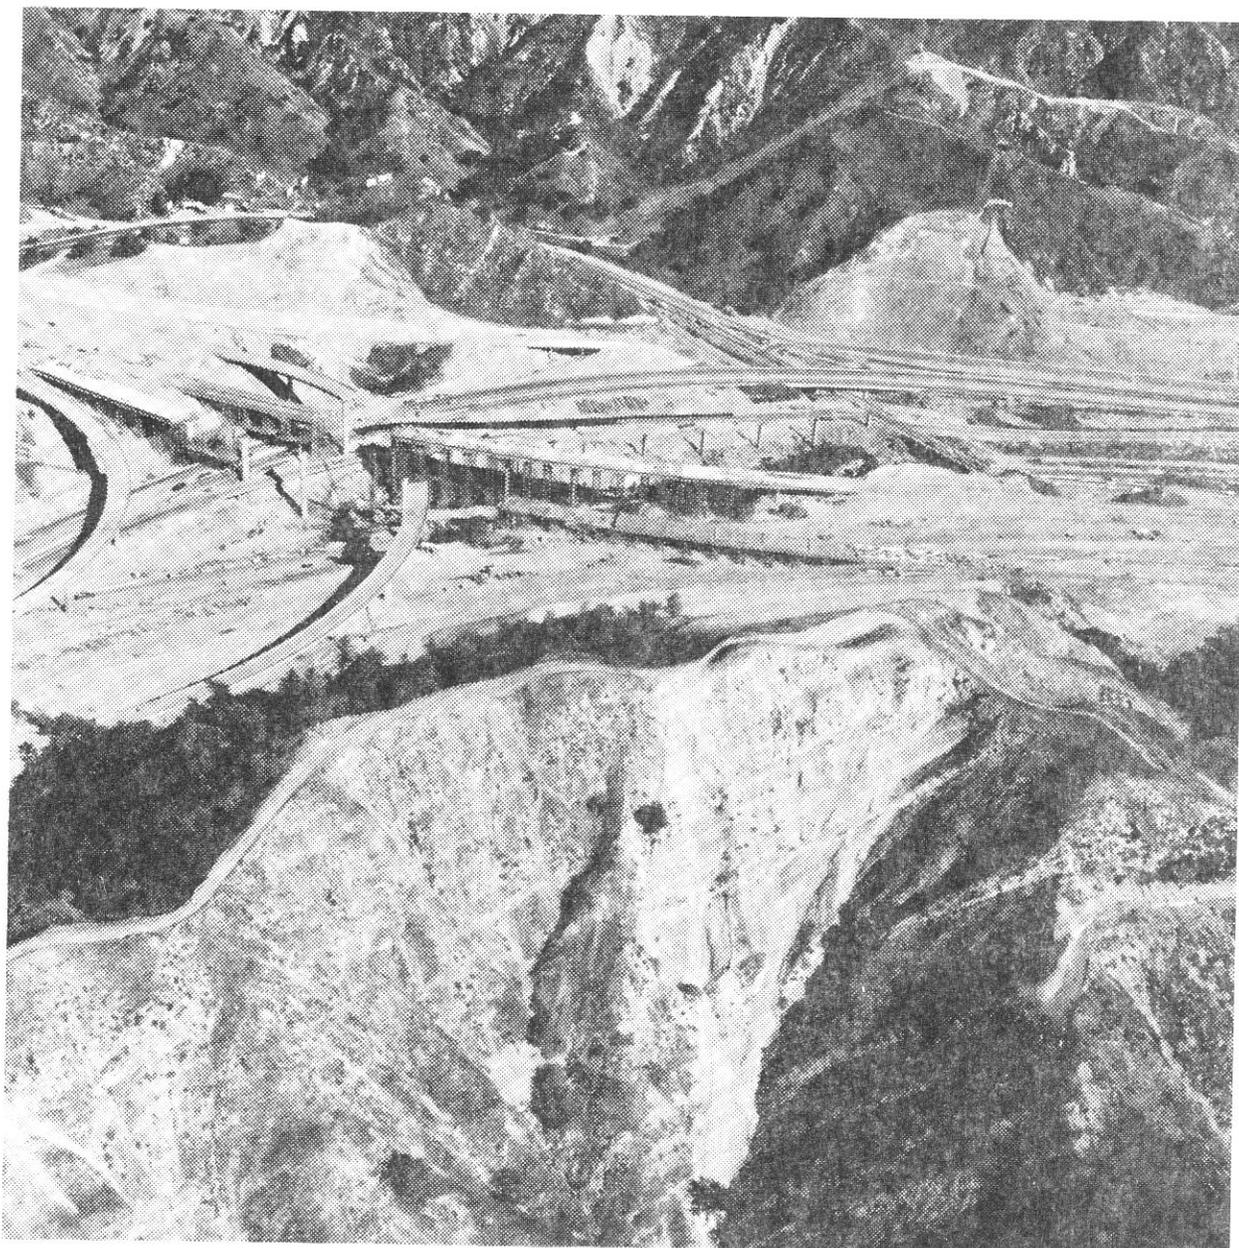
Photo 69. Looking easterly at the Route 5/14 Interchange.

A slump landslide that occurred in a cut slope is shown in Photos 69 (upper right) and 79. The slide, which did not encroach upon the roadway, occurred in a clayey silt with a high moisture content.

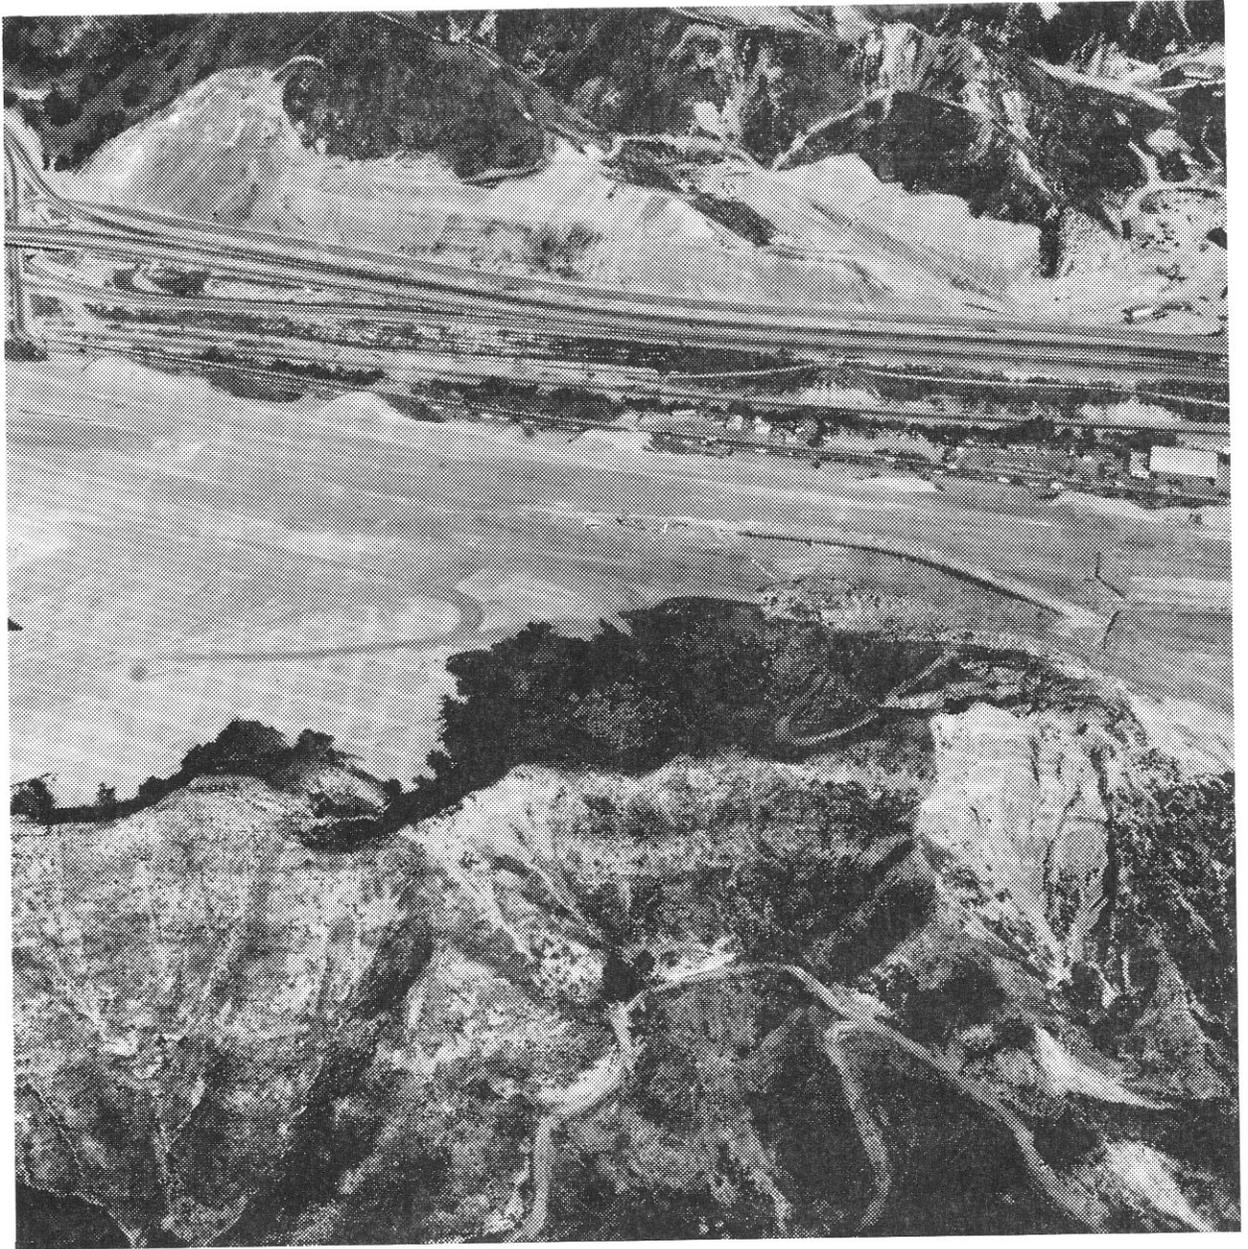
Photo 70. Looking easterly at Route 5, immediately south of the Route 5/14 Interchange.

the cut left a nob with a rather high slenderness ratio. The bedding planes of the friable sediments dipped toward the cut face, and the top of the slide was at the apex of the cut and a very steep natural slope facing west. The top of the slide and west-facing slope may be seen in the lower right of Photo 70.

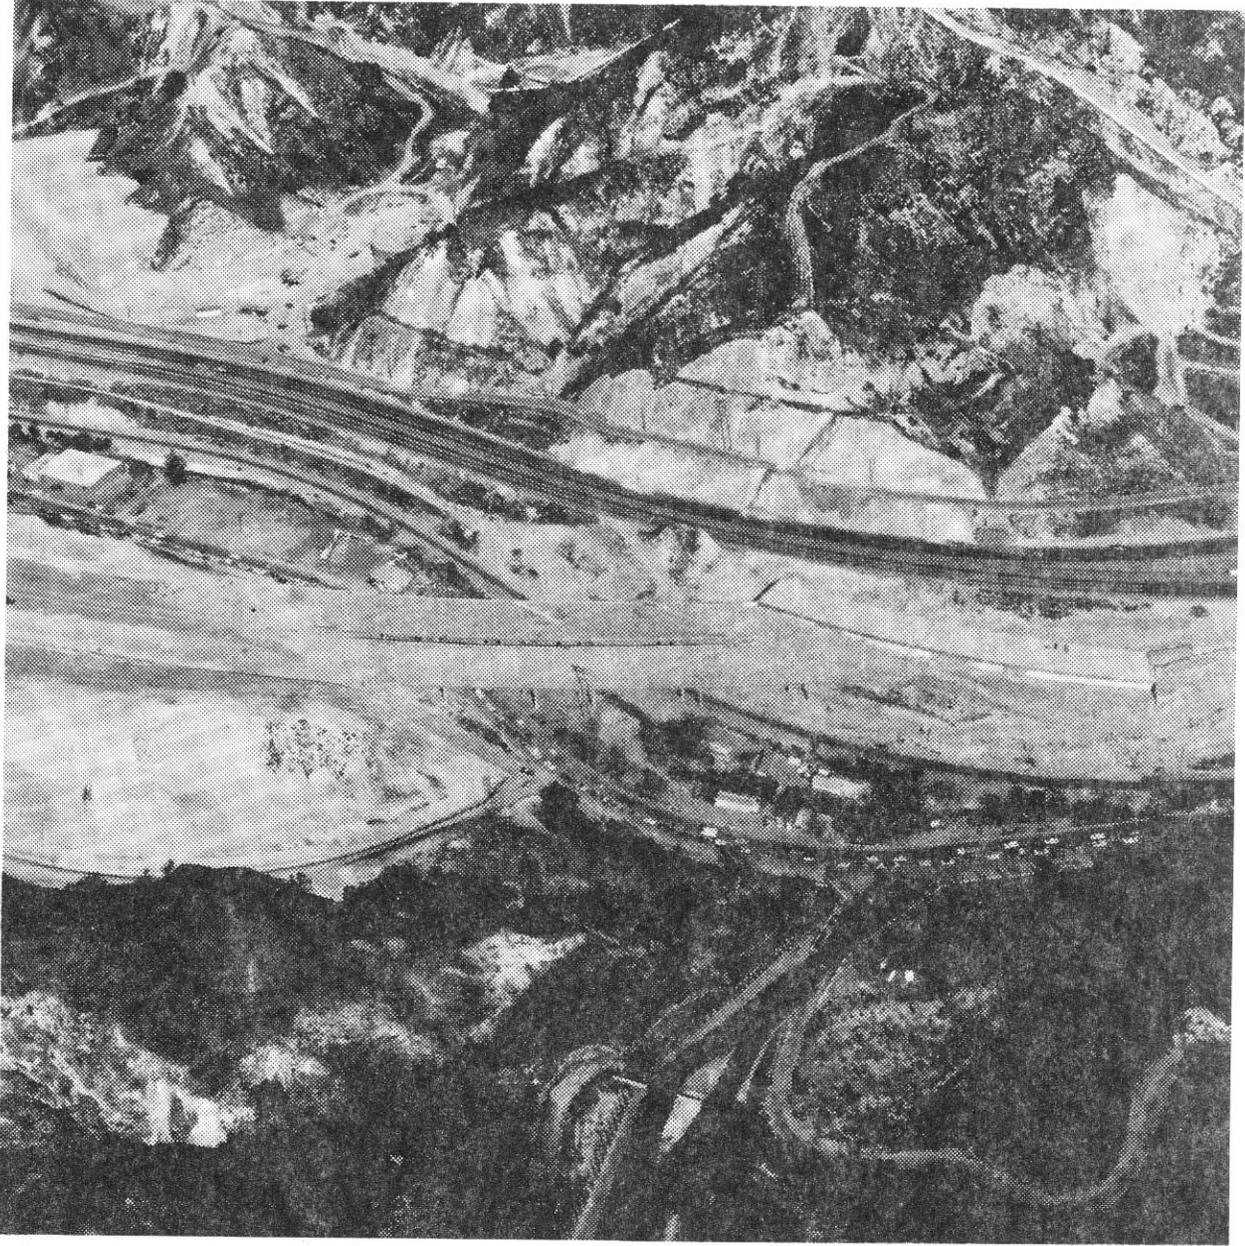
Photo 71. Looking easterly at Route 5.

Cracking of both soil and concrete occurred transverse to the highway at this location. Photo 71 shows roadway concrete broken (right center above the curved reinforced concrete box structure) at what appears to be very near the cut-fill contact. Photos 74 and 75 are close-ups of this break, looking east. Soil cracking occurred through the above concrete box structure and continued westerly into the bridge abutment area (barely visible right of center in Photo 71). The hills to the east of the roadway along the trend of the cracking were shattered in a 100-ft wide zone. The above cracking appears to follow closely the upper Santa Susana thrust fault as mapped by others (Ref. 5, Vol. III, p. 213, Figure 1). East of the shattered slopes a large rockfall occurred, which is visible in Photo 71 (top right).

Rockfalls occurred in the steep, well-indurated sandstone cut face (upper right central portion of Photo 71).
