REPORT NO. FHWA/CA/TL-80/17

ROADWAY DAMAGE DURING THE SAN FERNANDO, CALIFORNIA EARTHQUAKE OF FEB. 9, 1971

FEB., 1981

6. PERFORMING ORGANIZATION CODE		
7. AUTHOR(S) R. H. Prysock and J. P. Egan, Jr.			8. PERFORMING ORGANIZATION REPORT NO. 19305-632119		
9. PERFORMING ORGANIZATION NAME AND ADDRESS Office of Transportation Laboratory California Department of Transportation Sacramento, California 95819			10. WORK UNIT NO.

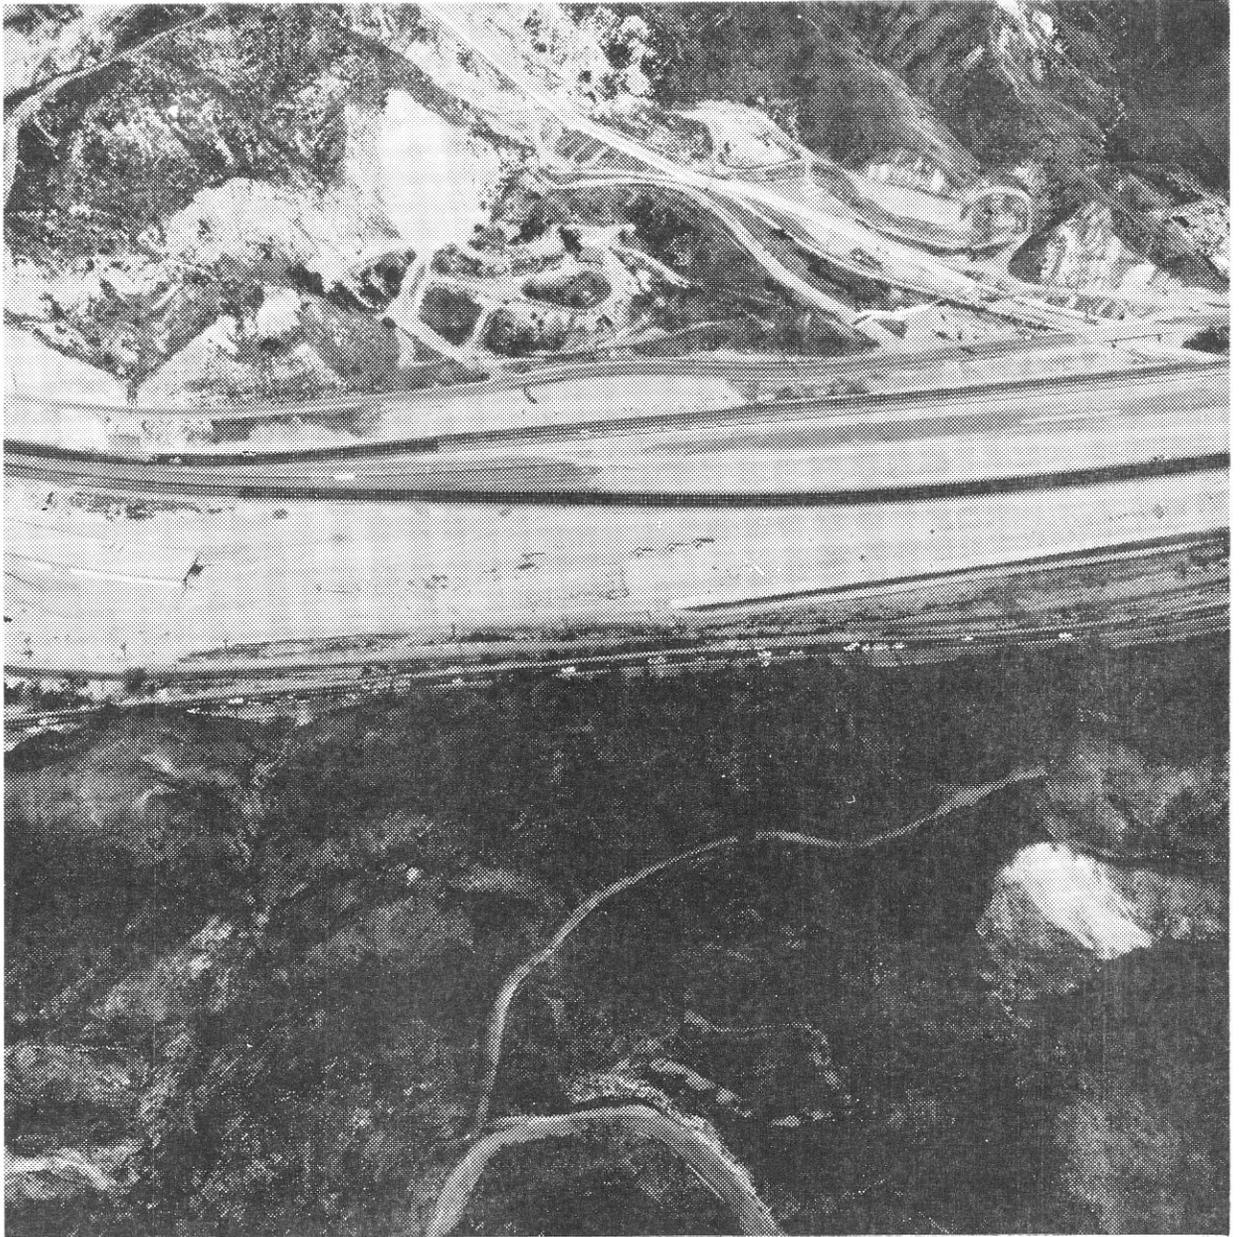
Photo 72. Looking easterly at Route 5 immediately north of Balboa Boulevard Overcrossing.

Very little soil or pavement distress was found in this area. A crack across the asphalt pavement of temporary Route 5 (right central portion of Photo 72) showed 1/2-inch of lateral displacement, south side moved west relative to north side. About 450 feet north of this offset, a tension crack appeared in the pavement with one inch of separation.

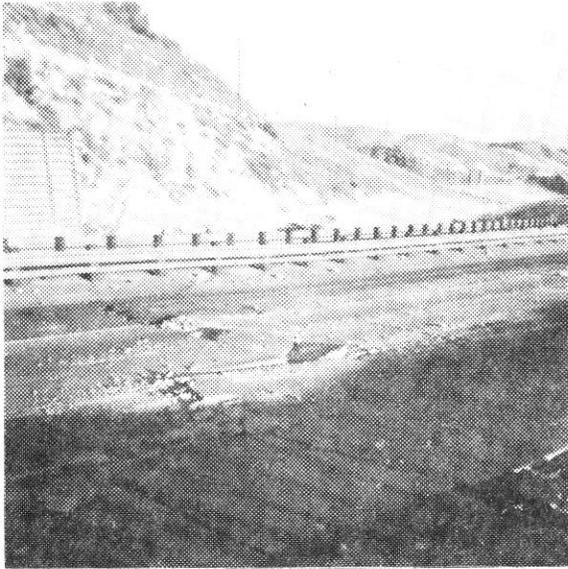
Cracking of both soil and concrete occurred transverse to the highway at this location. Photo 71 shows roadway concrete broken (right center above the curved reinforced concrete box structure) at what appears to be very near the cut-fill contact. Photos 74 and 75 are close-ups of this break, looking east. Soil cracking occurred through the above concrete box structure and continued westerly into the bridge abutment area (barely visible right of center in Photo 71). The hills to the east of the roadway along the trend of the cracking were shattered in a 100-ft wide zone. The above cracking appears to follow closely the upper Santa Susana thrust fault as mapped by others (Ref. 5, Vol. III, p. 213, Figure 1). East of the shattered slopes a large rockfall occurred, which is visible in Photo 71 (top right).

Photo 74. Looking easterly at pavement damage on Route 5 north of Balboa Boulevard.

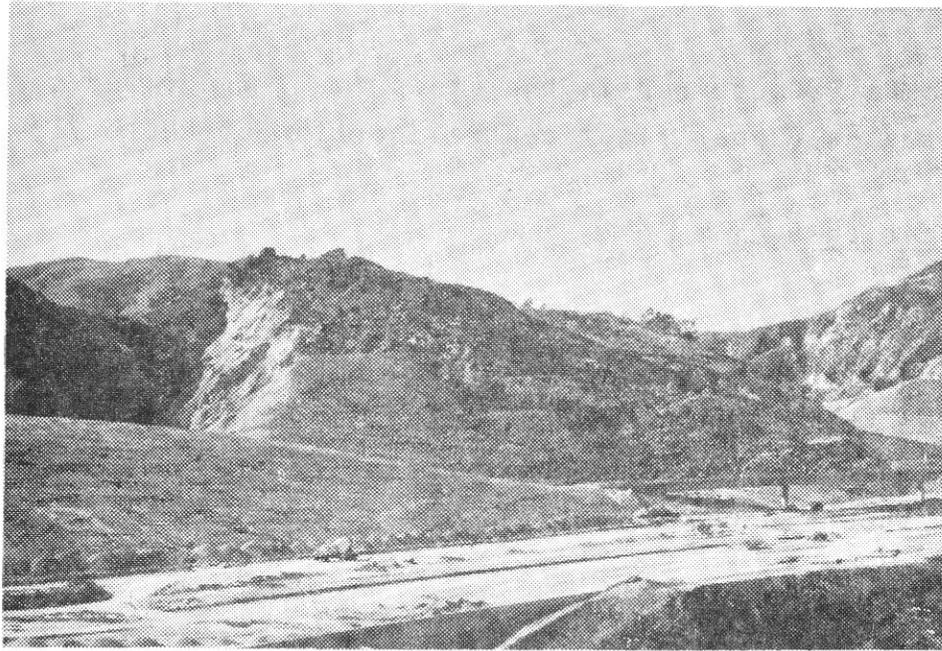
A large landslide occurred in a cut slope at this location (Photos 77 and 78). Had the roadway been completed, front-age road access from one approach would have been blocked by the slide. An interesting aspect of this slope is that

Photo 77. Looking westerly at a cut slope slide immediately south of the Route 5/14 Interchange.

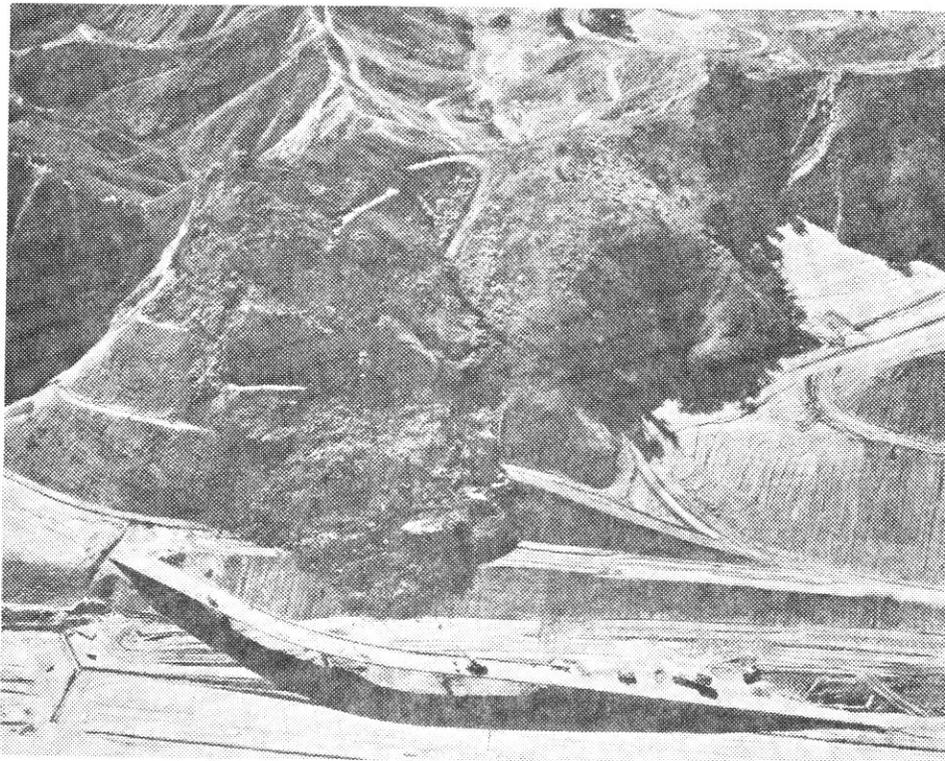
Photo 78. Aerial view of slide shown in Photo 77. Note blockage of unfinished connector by slide debris.

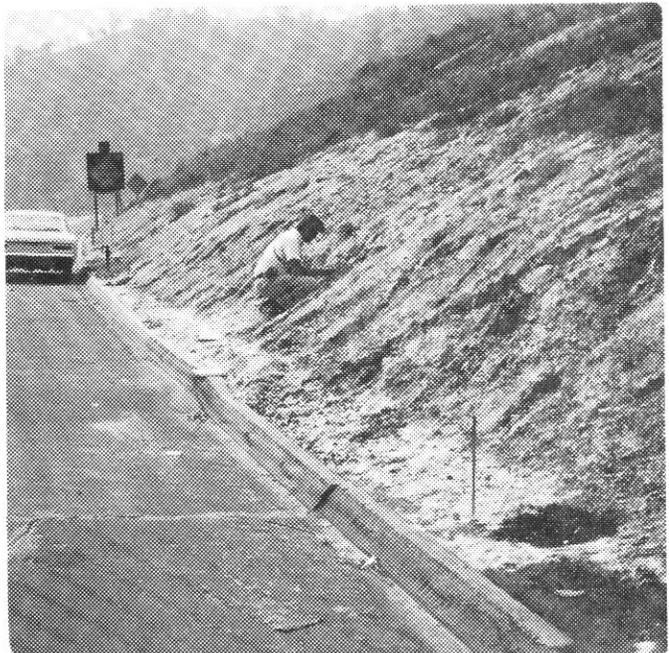
Further north, a cut slope on the east side of the highway had ground breakage behind the top of cut as shown in Photos 82 and 83.

Photo 82. Ground breakage at top of cut slope on east side of Route 5.

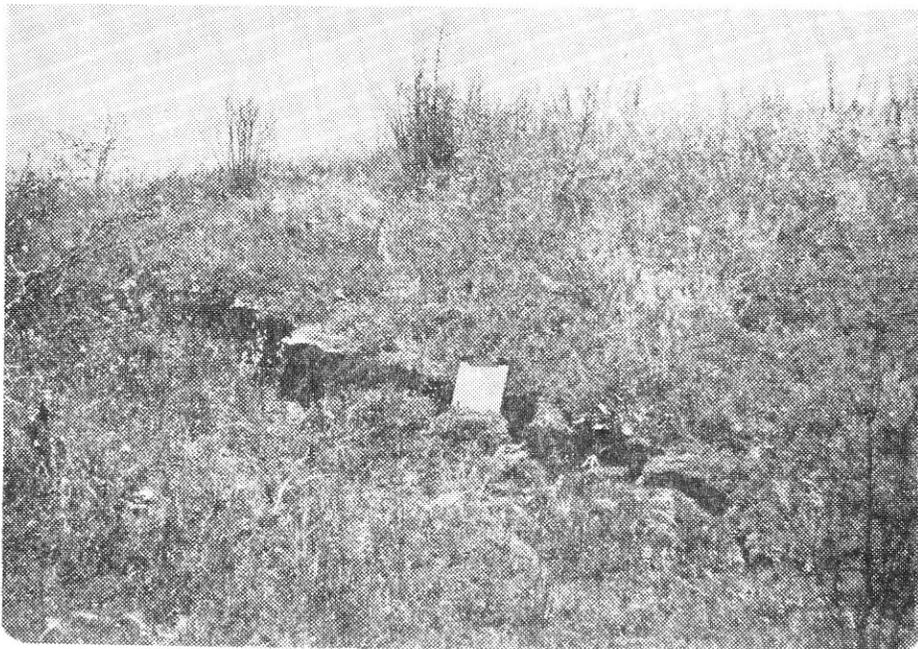
Photo 83. Ground breakage at top of cut slope on east side of Route 5.

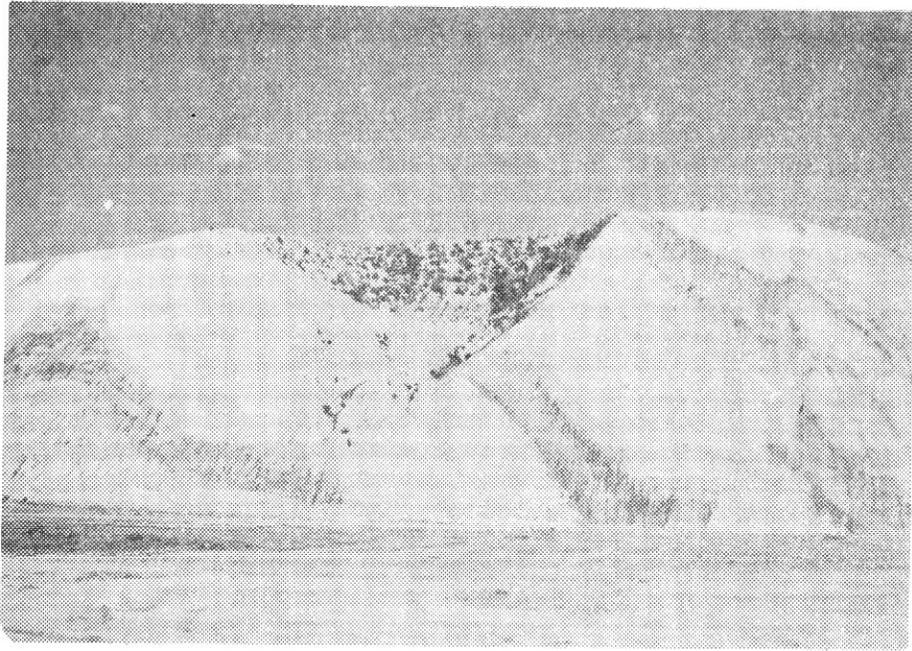
Photo 84. Looking northwesterly at typical contorted geological features east of Placerita Canyon Road.

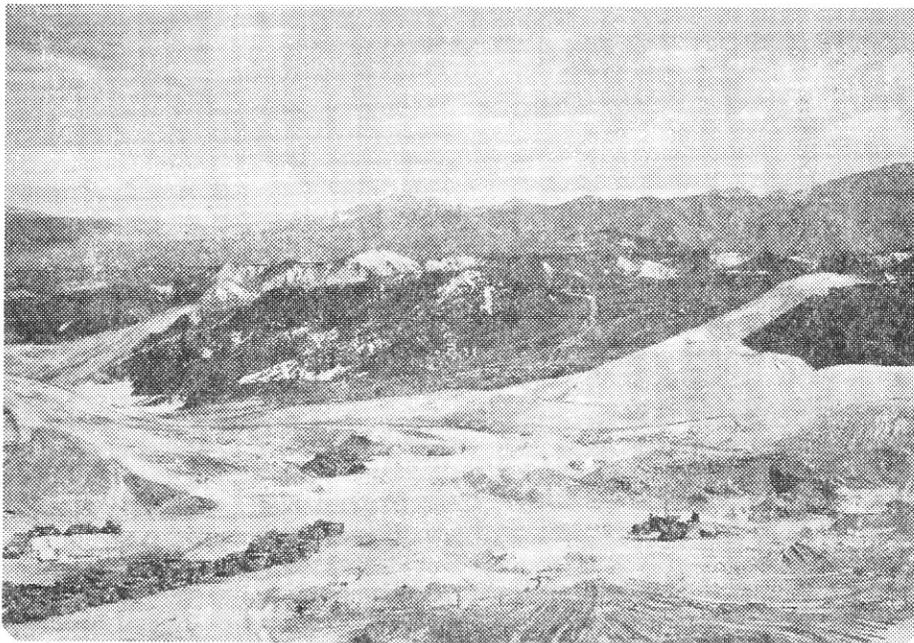
Photo 85. Looking northeasterly at typical scale of earthworks on Route 14.

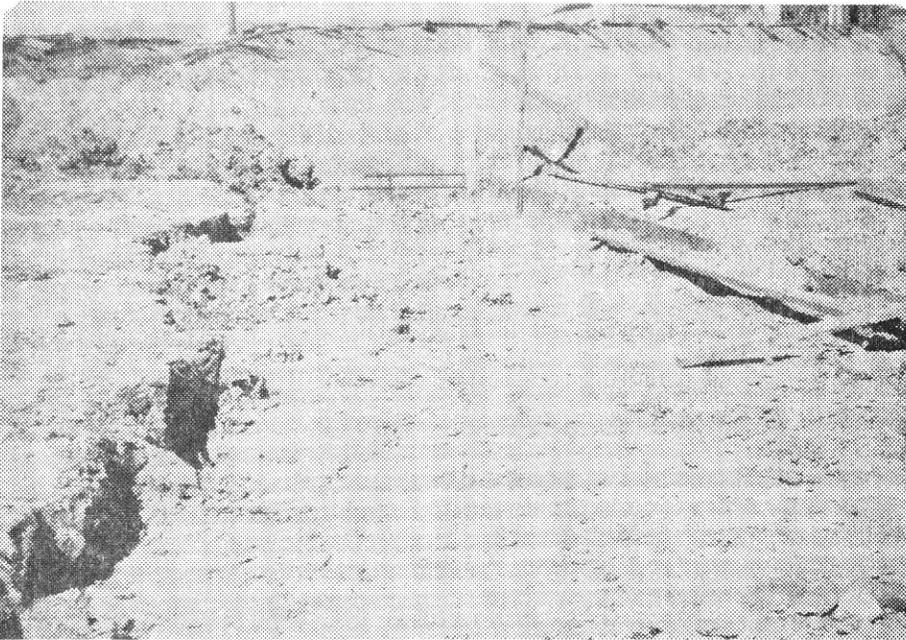
Photo 86 shows 8 to 10 inches of backfill settlement that occurred at the west abutment of the westbound structures for the Via Princessa Undercrossing. Photo 87 shows the area to be backfilled at the west abutment of the eastbound structure. Assuming that construction practices were similar for both structures, a comparison of the two photos show the settlement was confined to the backfilled area. It is probable that the settlement resulted from spreading during seismic shaking as the wingwalls were not yet constructed. The abutments of the structures were either sheared or distressed similar to that shown in Photo 88, with the exception of the west abutment of the eastbound structure.

Photo 86. Abutment backfill settlement at the Via Princessa Undercrossing. Note large crack which delineates limit of backfill.

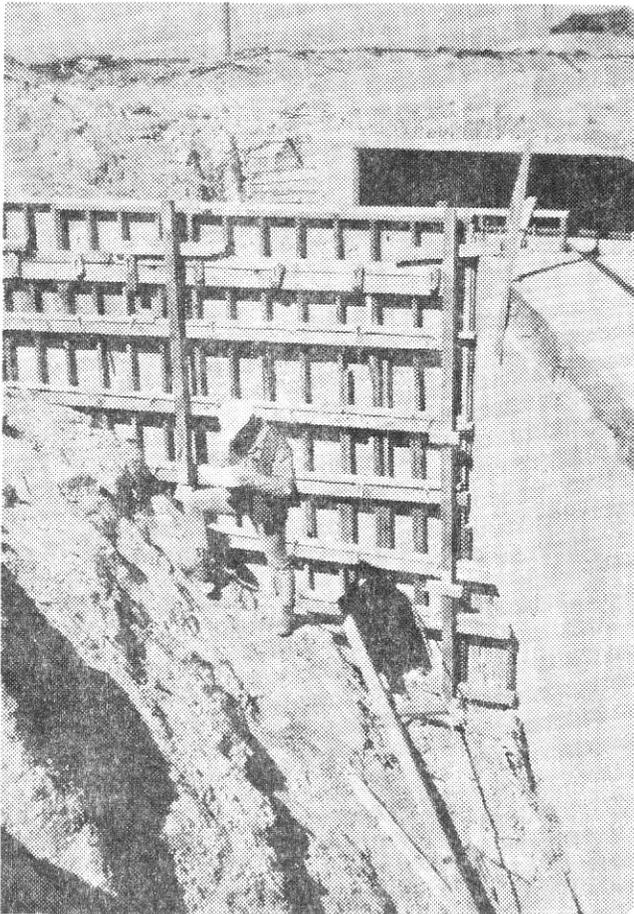
Photo 87. Abutment prior to backfilling at the Via Princessa Undercrossing.

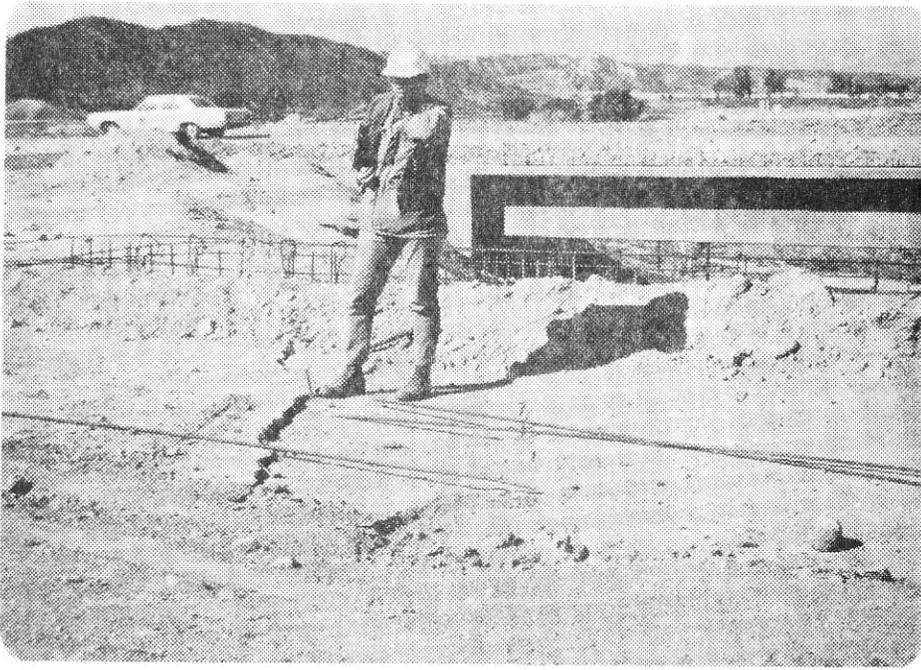
Backfill settlement of 6 to 8 inches at the west abutment of the westbound roadway structure of the Santa Clara River Crossing is shown in Photo 89. The settlement was confined to the backfilled area of the abutment. No displacement of the wingwalls and abutment wall (constructed as a unit) was noted. Photo 90 shows a few inches of backfill settlement at the west abutment of the eastbound structure. The abutment and wingwalls were constructed as a unit and no bridge damage was detected. Again, the settlement appears to be confined to the backfilled area.

Photo 90. Abutment backfill settlement at the Santa Clara River Bridge (west abutment, east-bound structure).

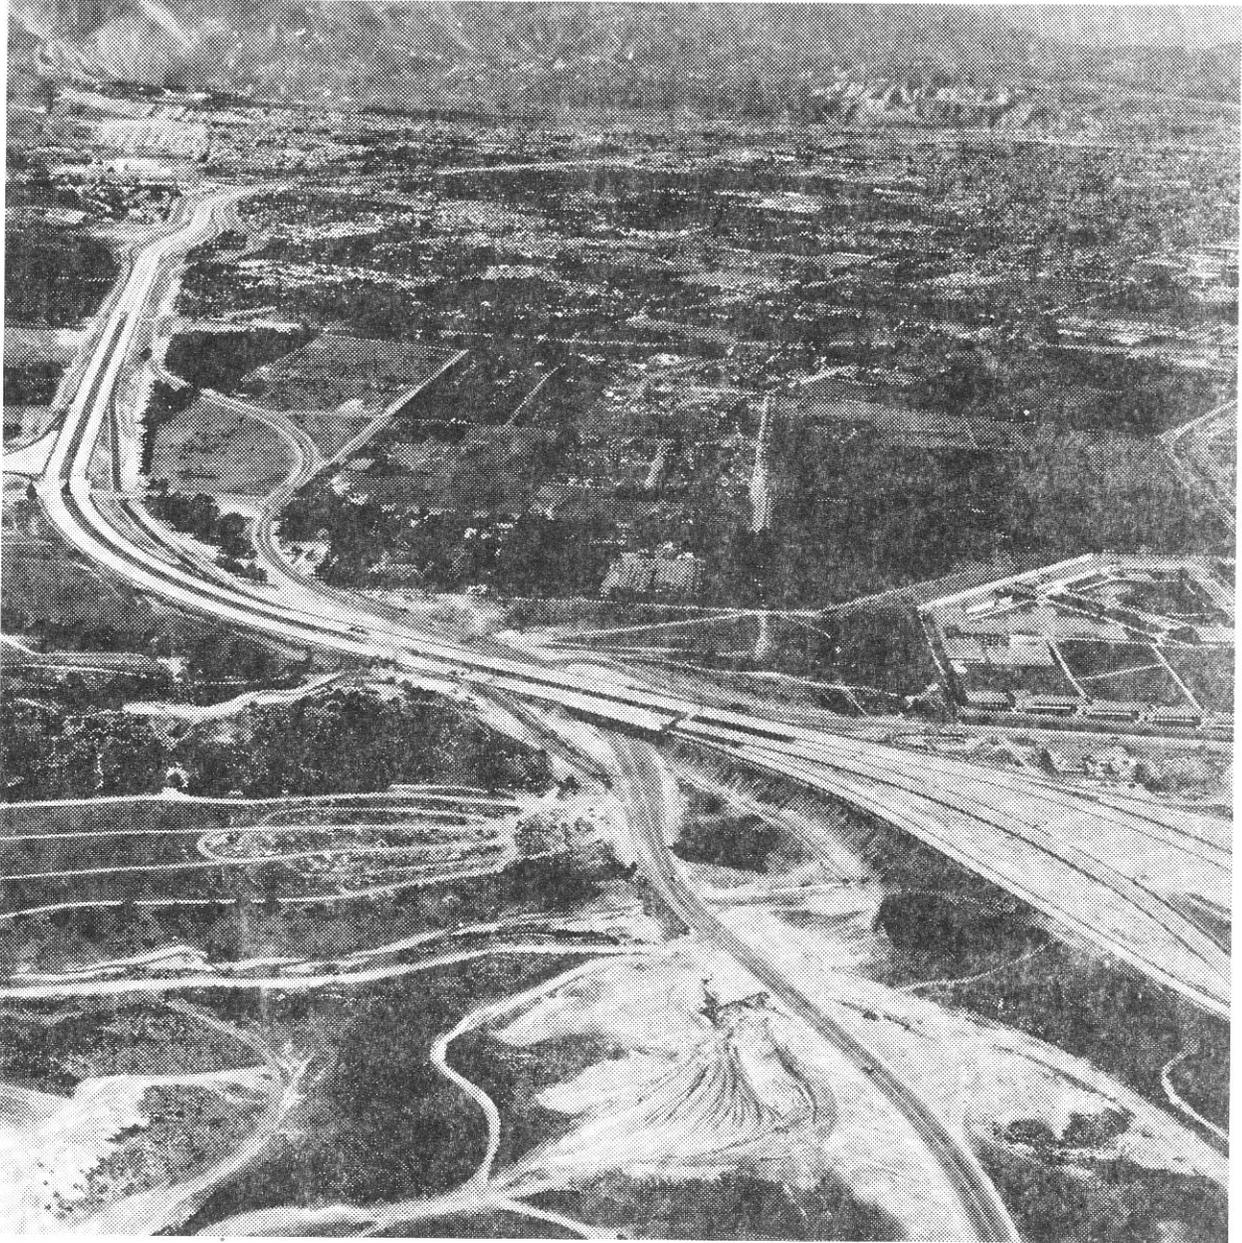
Photo 92. Looking easterly at the completed portion of Route 210. The Juvenile Hall complex is in right center of photo.

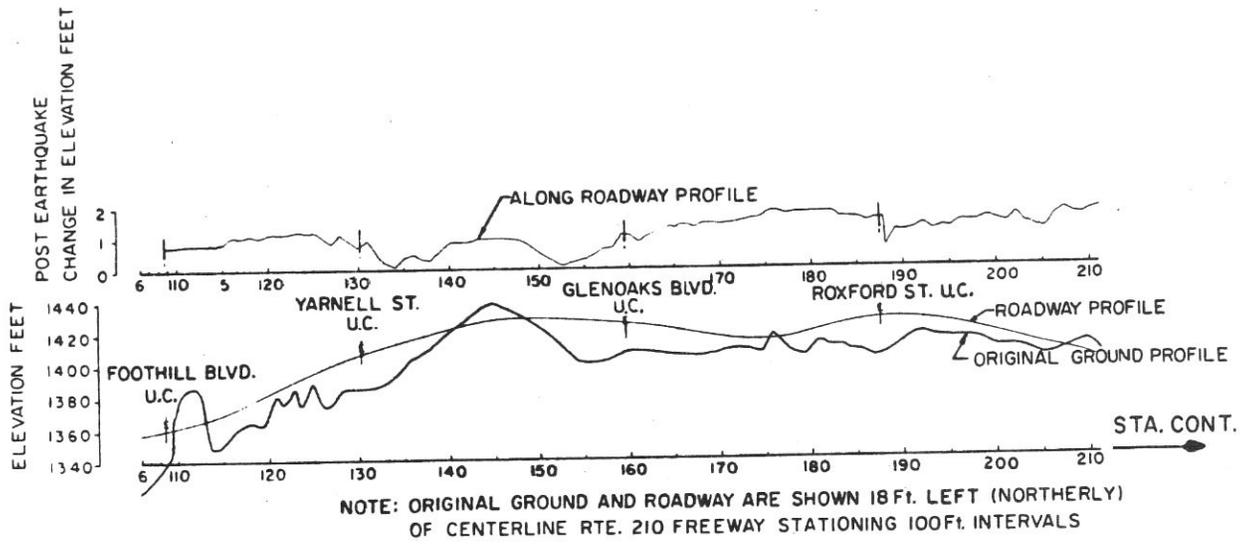
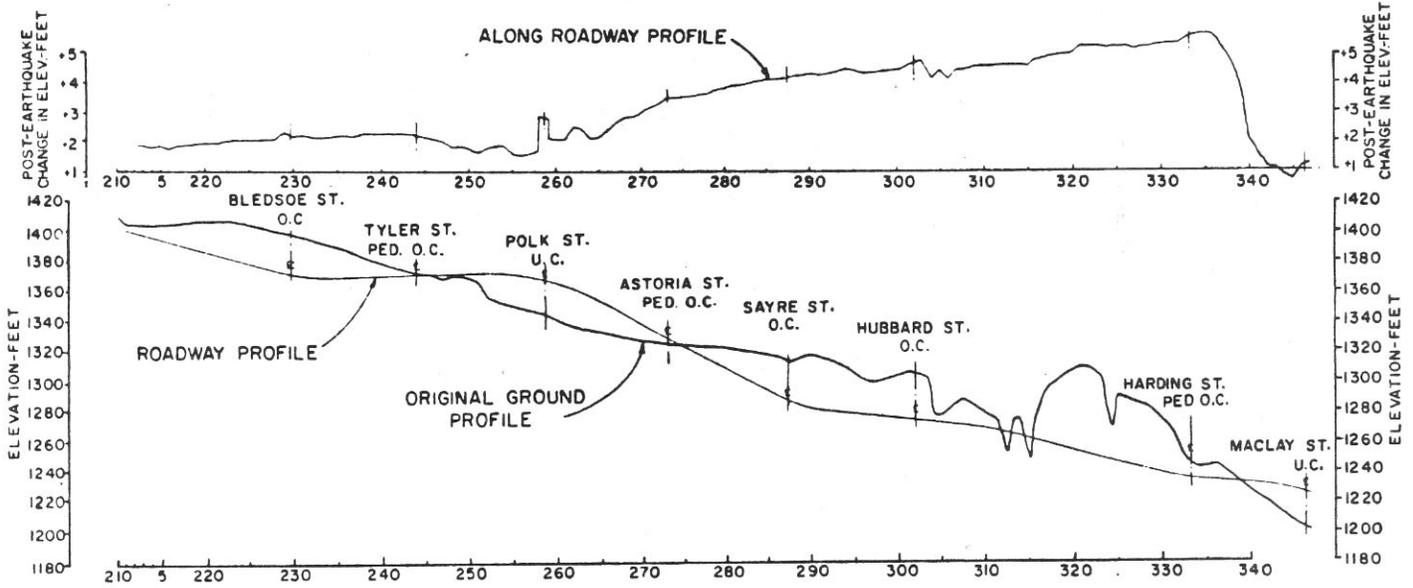
FIGURE 17

ROUTE 210 DESIGN AND ORIGINAL GROUND PROFILE AND POST QUAKE CHANGE IN DESIGN PROFILE

An undulating roadway surface, shown in Figure 17, was the result of tectonic uplift combined with differential settlement in the roadway embankment and underlying gravelly sands.

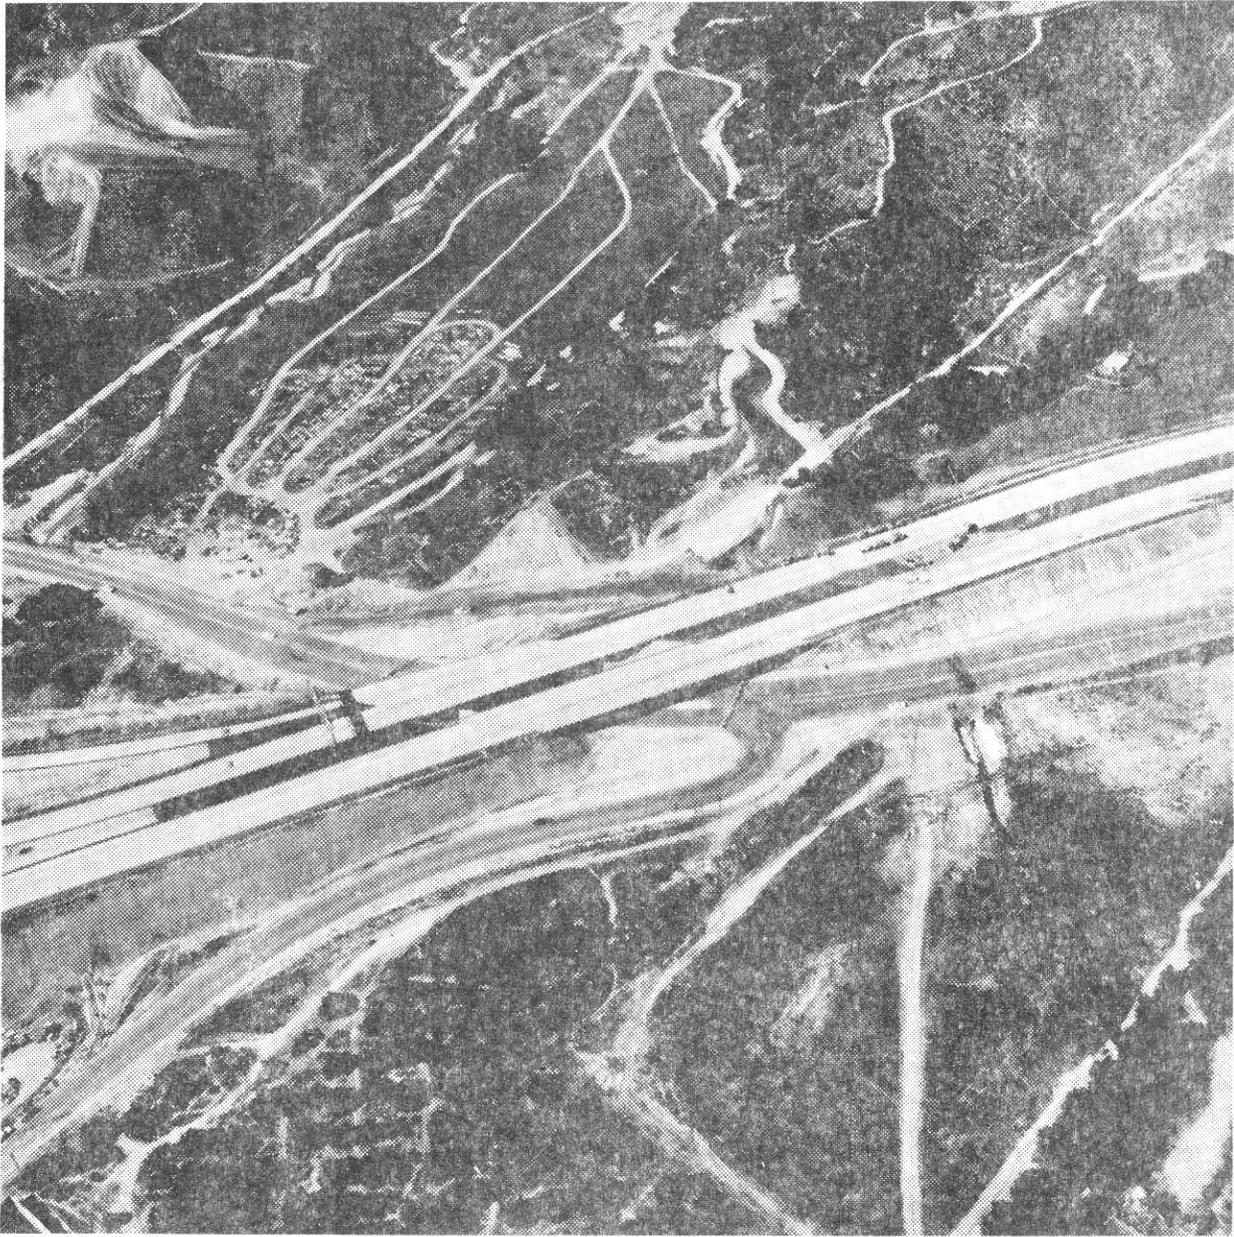
In addition to the structural damage to the Foothill Undercrossing (Photo 93), embankment distress in the form of shear cracks and settlement occurred at the approaches. Backfill settlement measuring up to one foot resulted in approach slab breakage.

Photo 93. Looking northerly at the Foothill Boulevard Undercrossing.

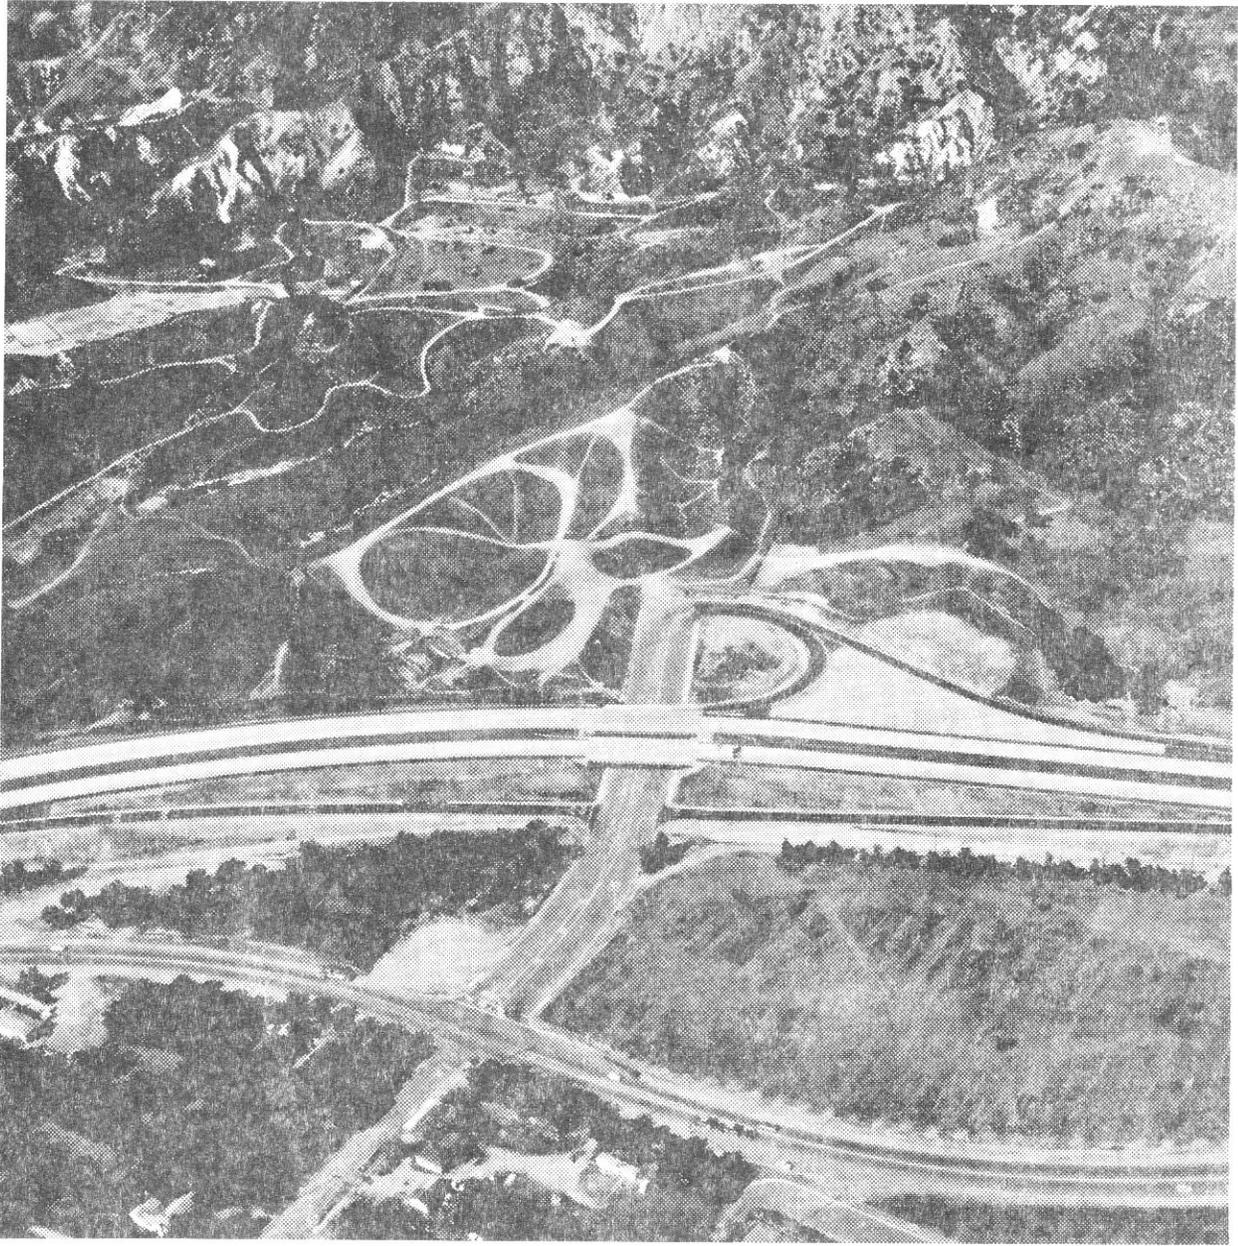
Photo 94. Looking northerly at the Yarnell Street Undercrossing.

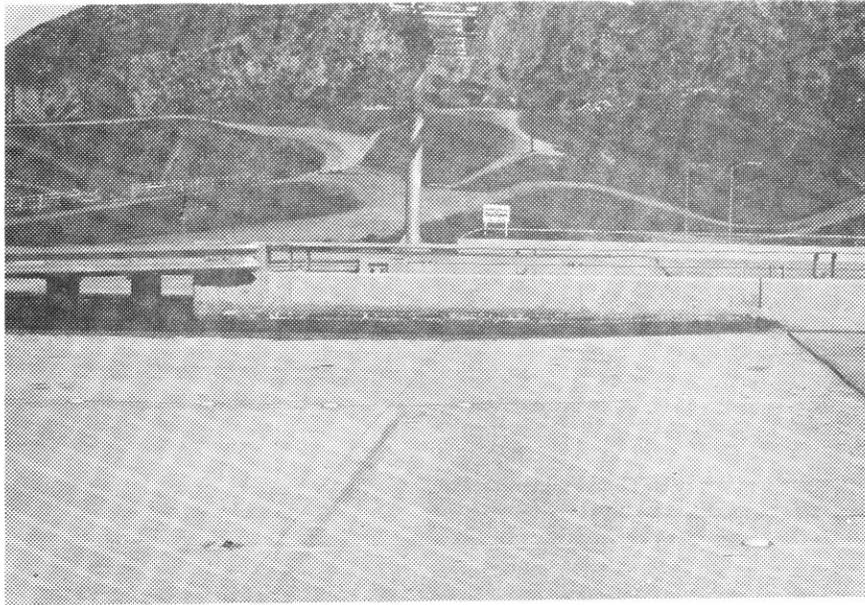
Fills at the Yarnell Street Undercrossing (Photo 94) settled about three inches at the west approach (Photos 95 and 96) and about six inches at the east approach. Photo 97 shows cracking and settlement in the median at the wing wall. Again, settlement appears to be the combined result of densification of fill and underlying alluvium caused by the seismic shaking.

Photo 95. Fill and abutment backfill settlement at the Yarnell Street Undercrossing, eastbound roadway, west approach. Note ramp effect of approach slab to structure deck.

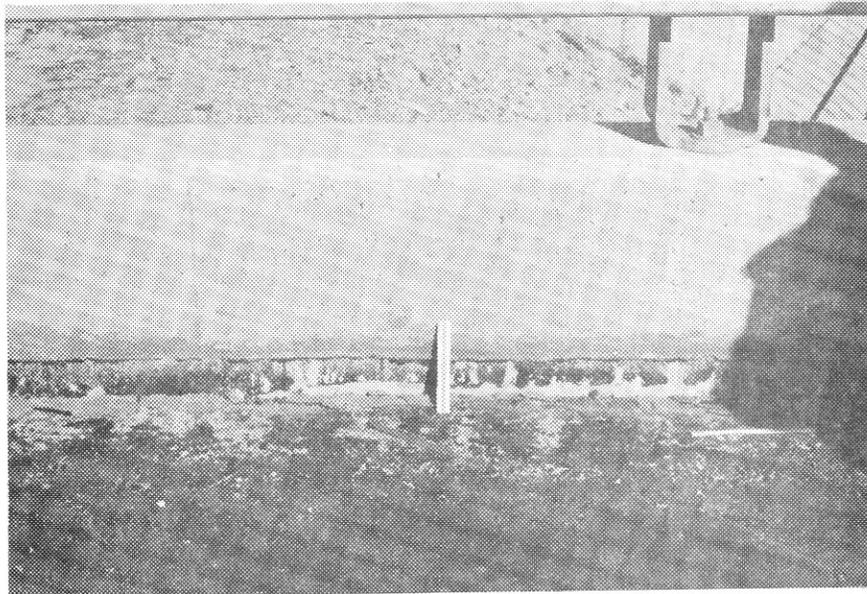
Photo 96. Same location as Photo 95. Note settlement of AC shoulder pavement relative to wingwall.

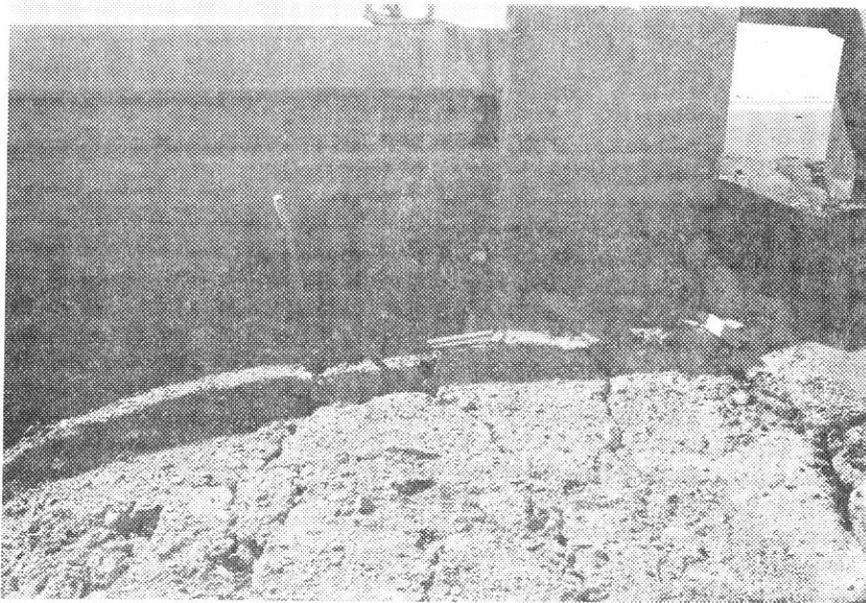
Photo 97. Fill cracking and settlement in median at Yarnell Street Undercrossing.

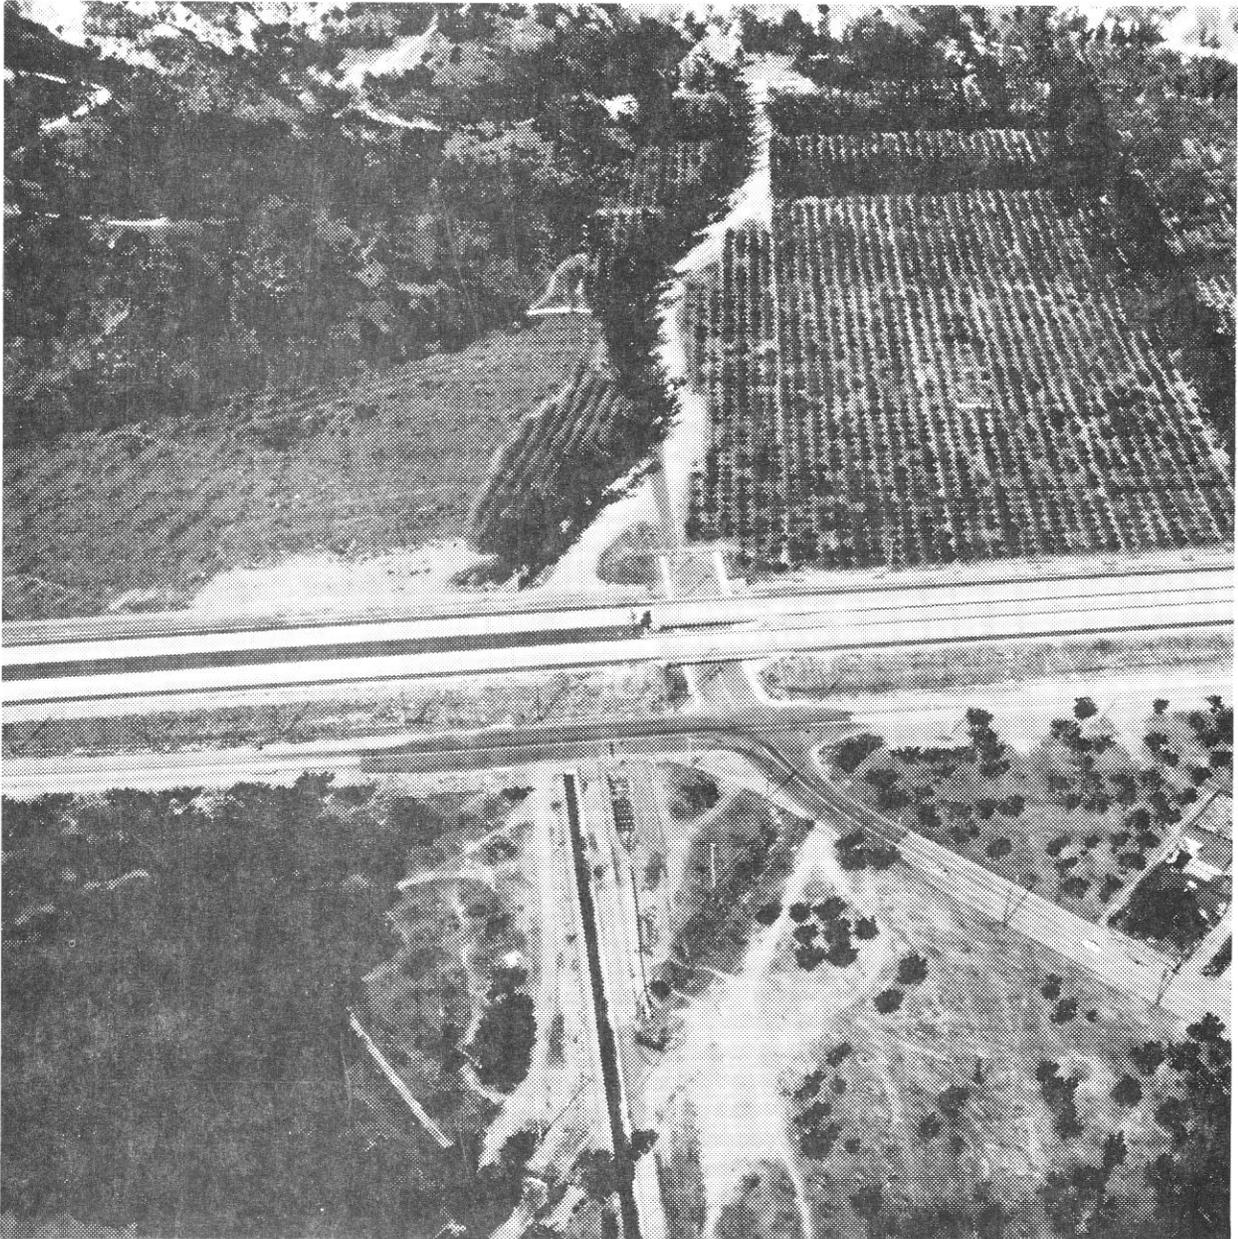
In the Glenoaks Boulevard area (Photo 98), Route 210 is constructed on about 20 feet of fill over alluvium that is made up of gravelly sands. A comparison of the constructed profile vs. the post-earthquake profile (Figure 17) shows that slightly more than three inches of fill settlement occurred at the west bridge approaches and about 4-1/2 inches of fill settlement occurred at the east approaches. Both bridges are set on piles that are founded about 30 feet below original ground.

Photo 98. Looking northerly at the Glenoaks Boulevard Undercrossing.

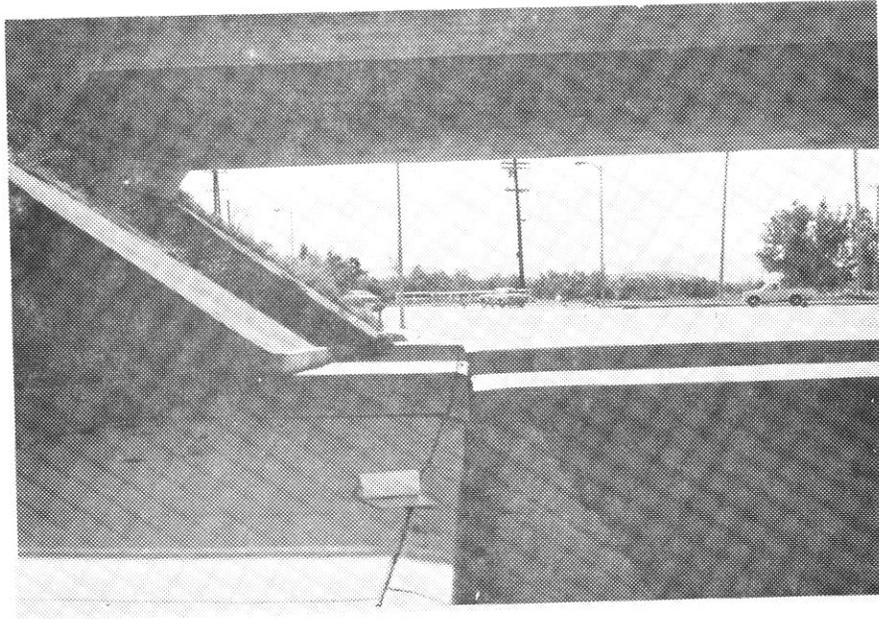
No structural damage to the bridges was found (4), but concrete slope paving beneath the superstructures caused minor damage to the concrete sidewalks and curbs along Glenoaks Boulevard (Photo 99).

The slope paving, which settled about 3 inches at the bridge abutment and about 2 inches at the sidewalk, transmitted forces from the abutments to the sidewalk and curbs.

Photo 99. Looking south along Glenoaks Boulevard. Note rotated and displaced curb due to lateral force of displaced slope paving that was transmitted through sidewalk.

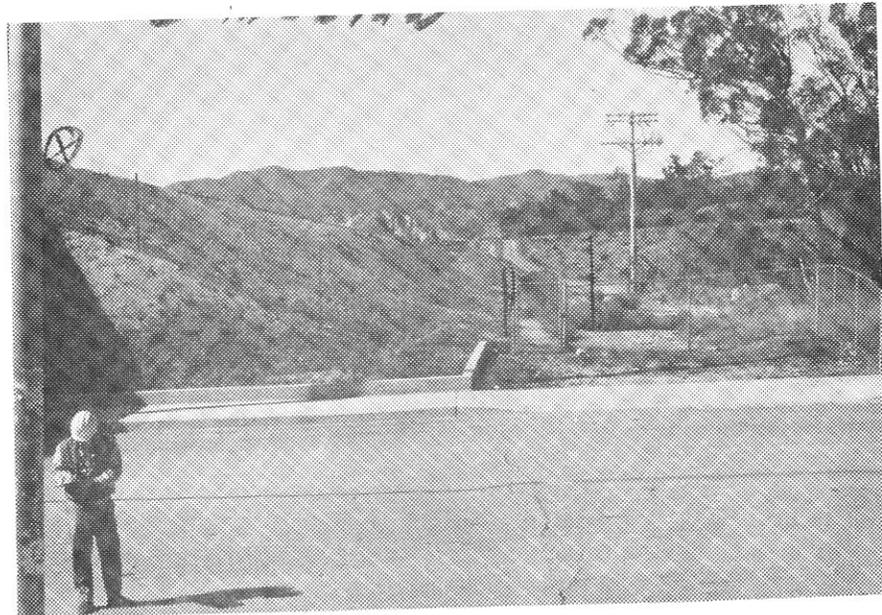
Photo 100. Looking west across Glenoaks Boulevard at tension cracks in AC pavement caused by differential settlement.

The asphalt concrete pavement of Glenoaks Boulevard settled differentially where it crosses beneath the freeway, resulting in transverse tension cracks as shown in Photos 100 and 101. The cracks are nearly coincident with the freeway toe of fill line. The break in pavement profile appears to be nearly over the southerly edge of a buried 11-foot wide by

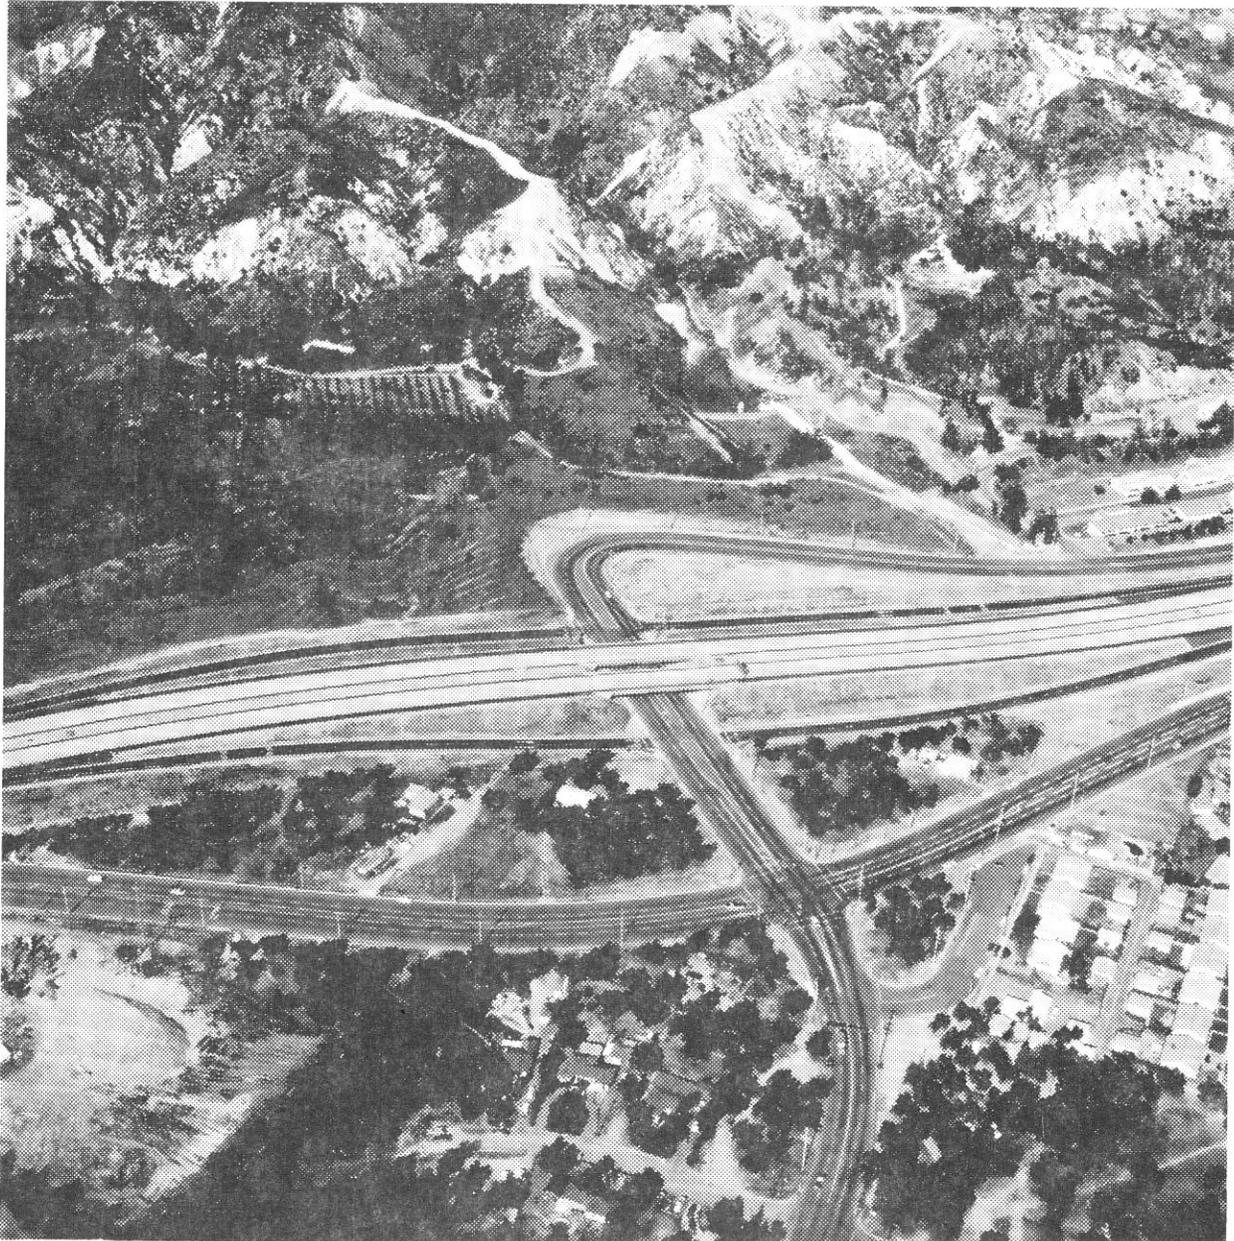
Seismic shaking at the I-210/Roxford Street Interchange (Photo 102) appears to have been much more intense than that to the west for a distance of about one mile along the freeway alignment. The east abutment for the eastbound structure separated from the pilings and the structure shifted about three feet to the south as shown in Photo 103. Fill spreading and settlement disrupted the roadway profile (Photos 104 and 105). Pavement slab separation and longitudinal cracks resulted from fill displacement (Photos 106, 107, 108, and 109). A compression buckle formed in asphalt concrete pavement in the eastbound off-ramp (Photos 105 and 110). Lateral shear displacement of fill is evidenced by bulging and a developed thrust offset near the toe of fill at the west approach to the eastbound bridge. Bulging occurred at the toe of fill along the eastbound off-ramp for a distance of several hundred feet.

Photo 102. Looking northerly at the Roxford Street Undercrossing.

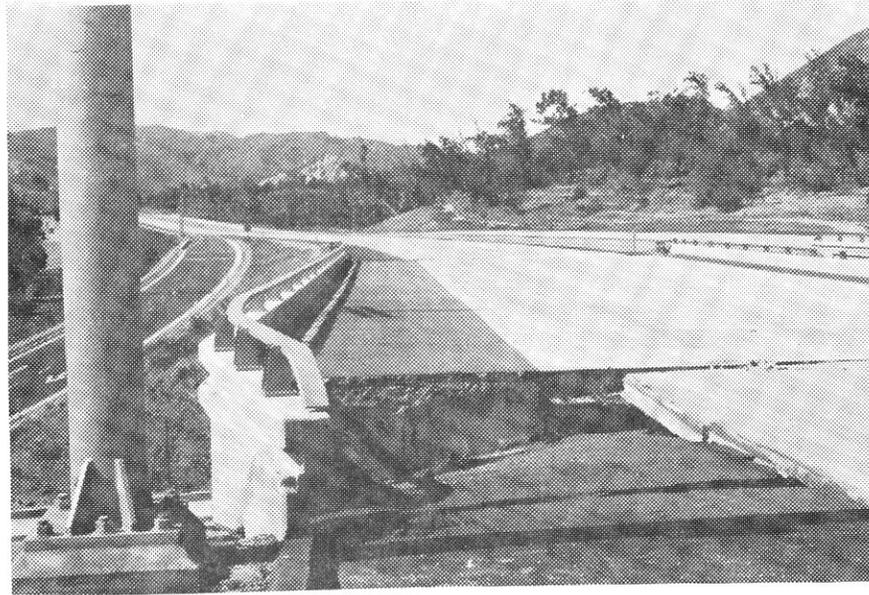
Photo 103. Looking west at the eastbound structure of the Roxford Street Undercrossing. Note rotational movement of structure.

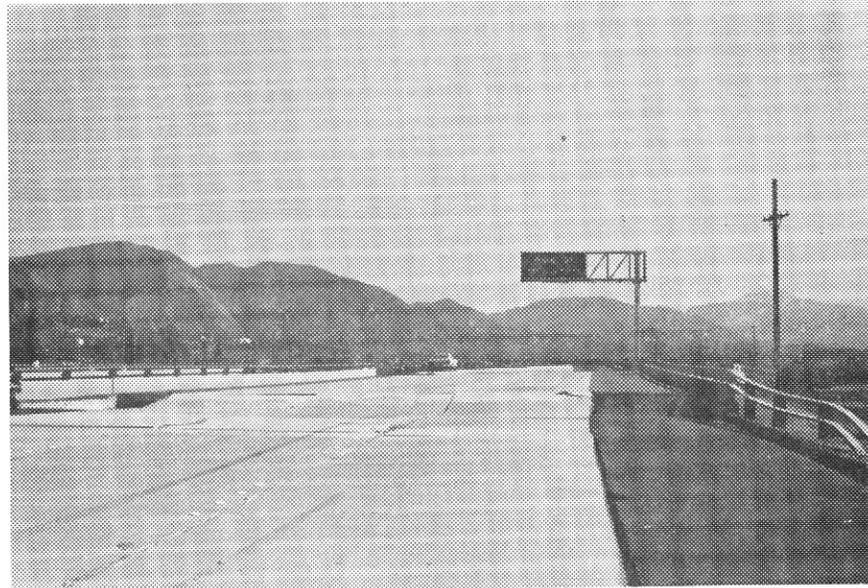
Photo 104. Looking east at the eastbound structure of the Roxford Street Undercrossing. Note settlement of pavement relative to structure deck. Note also separation of pavement slabs and the broken approach slab. The tire skid marks leave little doubt as to the whereabouts of one motorist at the time of the earthquake.

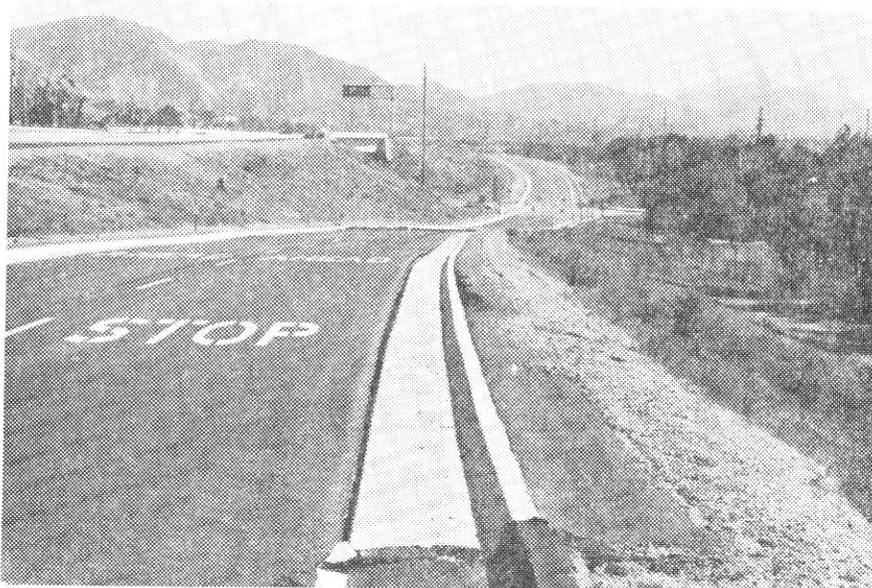
Photo 105. Eastbound off ramp at the Route 210/Roxford Street Interchange. Note disruptions in pavement profile and alignment.
