REPORT NO. FHWA/CA/TL-80/17

ROADWAY DAMAGE DURING THE SAN FERNANDO, CALIFORNIA EARTHQUAKE OF FEB. 9, 1971

FEB., 1981

6. PERFORMING ORGANIZATION CODE		
7. AUTHOR(S) R. H. Prysock and J. P. Egan, Jr.			8. PERFORMING ORGANIZATION REPORT NO. 19305-632119		
9. PERFORMING ORGANIZATION NAME AND ADDRESS Office of Transportation Laboratory California Department of Transportation Sacramento, California 95819			10. WORK UNIT NO.

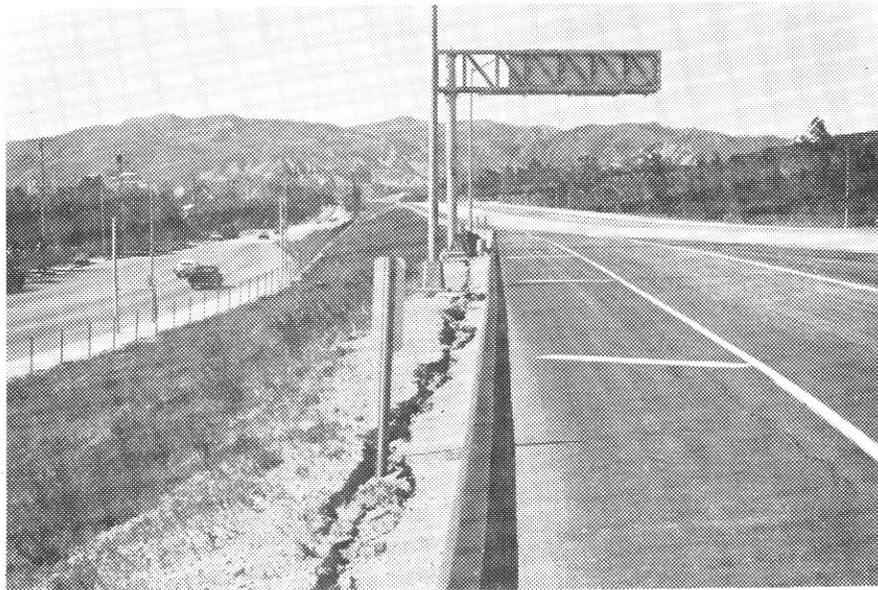
Photo 108. Looking west at eastbound off ramp to Roxford Street. Note transverse pavement cracks and wide longitudinal crack between fill hinge point and AC dike.

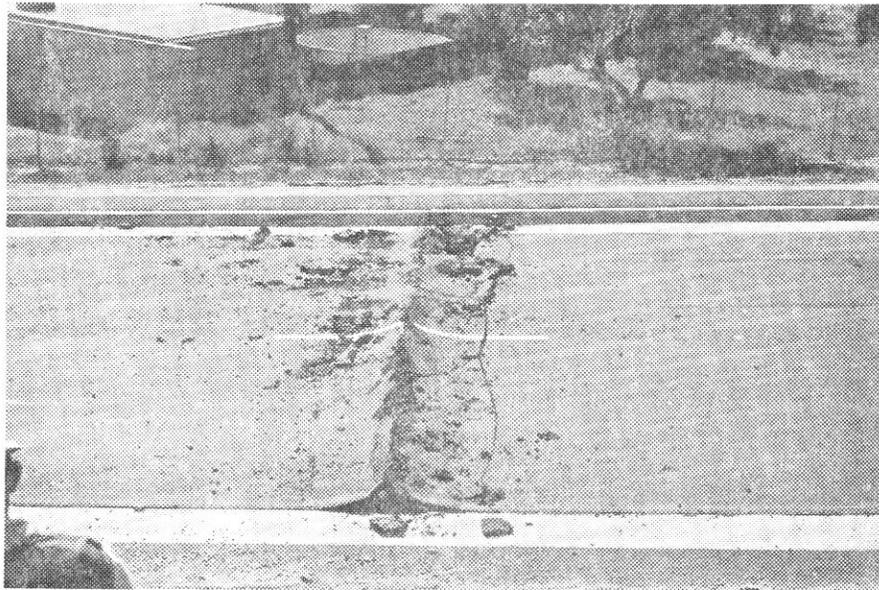
Photo 110. Compression buckle in AC pavement of eastbound off ramp to Roxford Street.

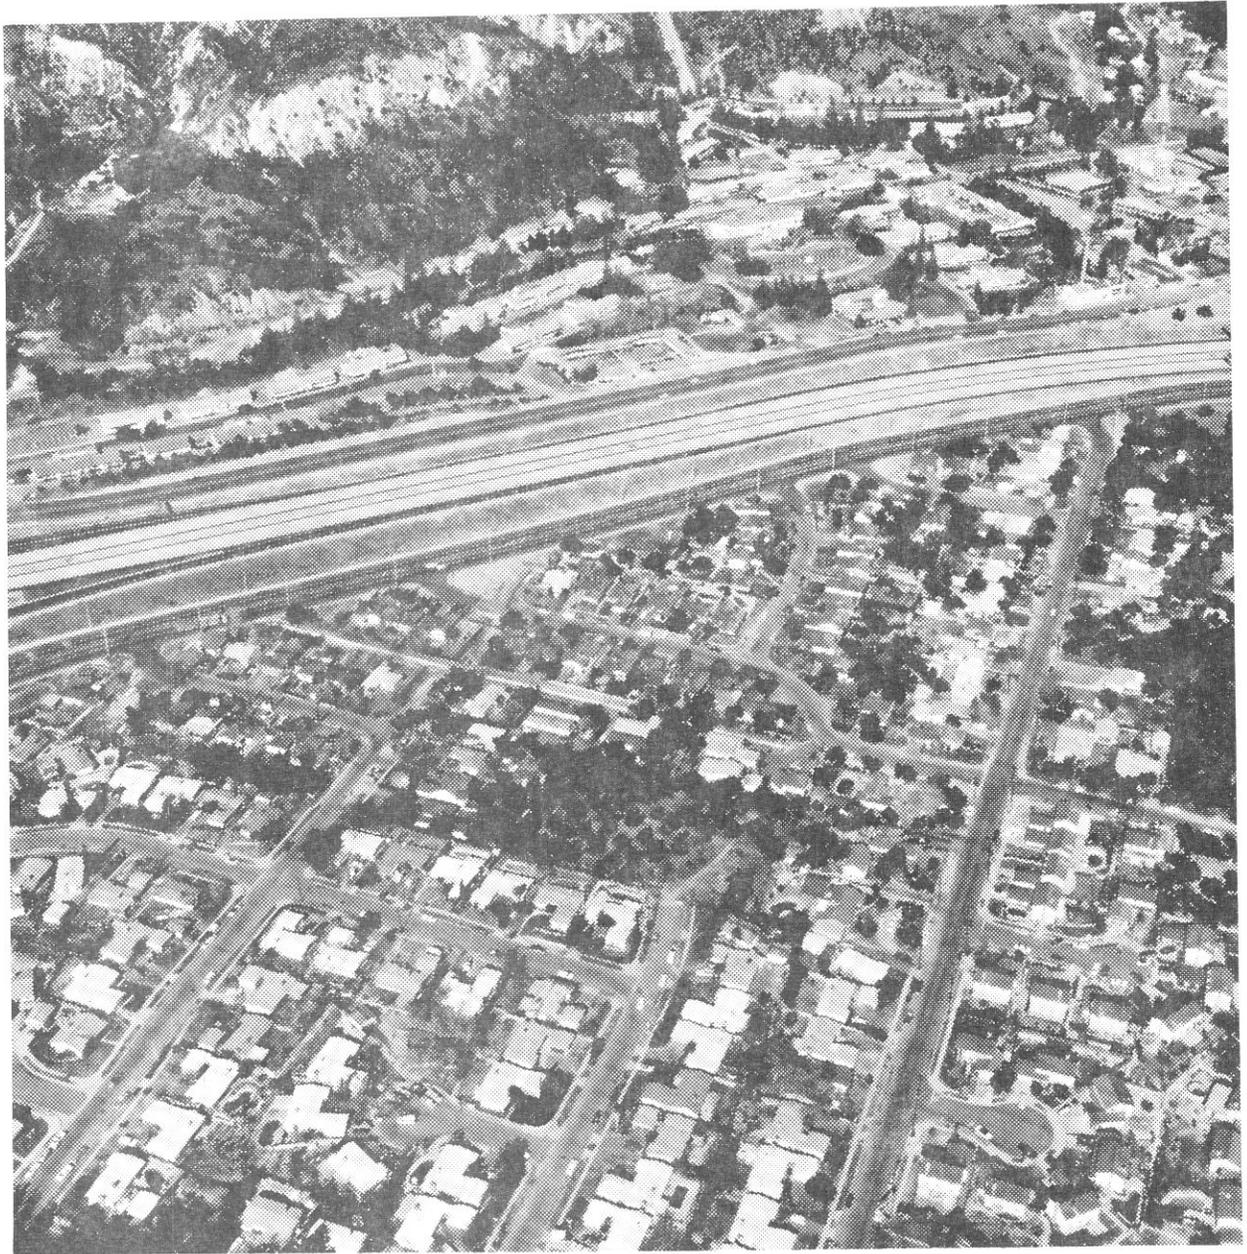
Progressing from west to east (left to right on Photo 112), the freeway is constructed in sidehill cut-fill to a full cut-section (right 1/3 of the photo). A perceptible bulge occurred across the freeway at the transition to full cut-section. The bulge was about 200 feet wide across the roadway with a maximum uplift of 0.4 feet relative to each side of it.

Photo 112. Looking north at that portion of Route 210 immediately east of the Roxford Street Undercrossing.

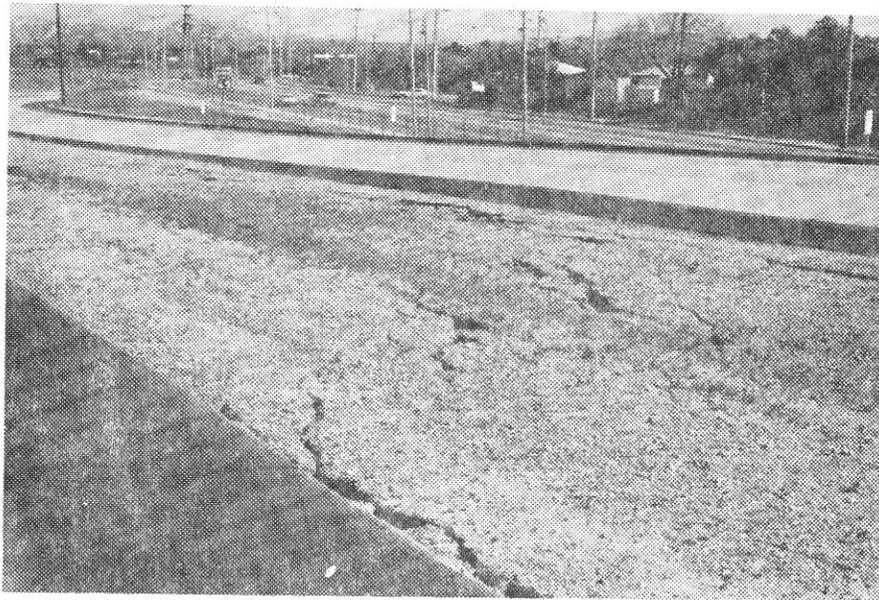
Longitudinal cracking and lateral movement of the sidehill fill resulted in pavement slab separation and faulting as shown in Photos 113, 114, and 115. Fill shear and thrusting at depth created a bulge and shattering slightly above the toe for a distance of about 500 feet as shown in Photo 116. The chainlink fence in Photos 115 and 116 was tilted towards the freeway several degrees as shown in Photo 117. No obvious distress occurred to the sidewalk, curb and gutter, or pavement of Foothill Boulevard adjacent to the above fence. Photo 118 shows typical cracking that occurred along the top of cut on the north side of the freeway.

Photo 113. Sidehill fill cracking in median east of Roxford Street.

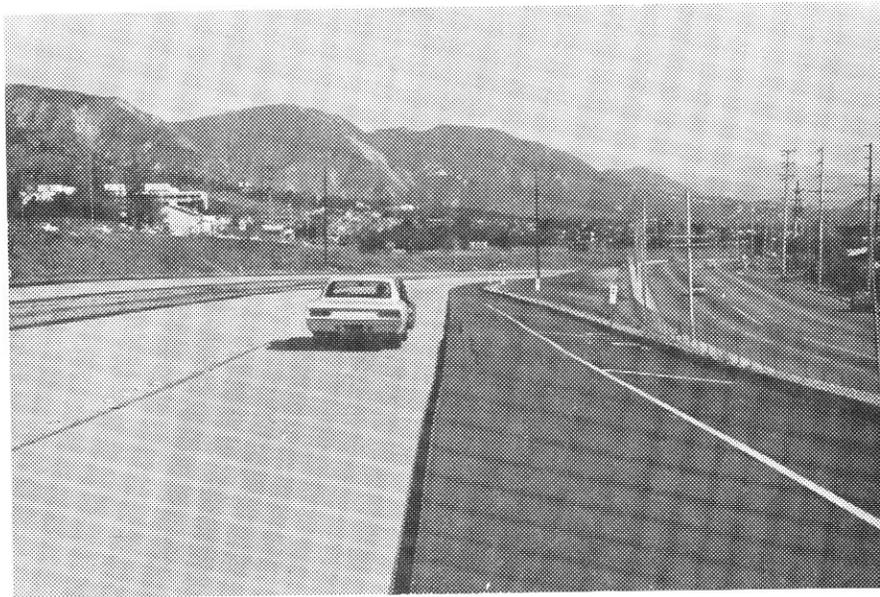
Photo 114. Slab separation and faulting in sidehill fill east of Roxford Street.

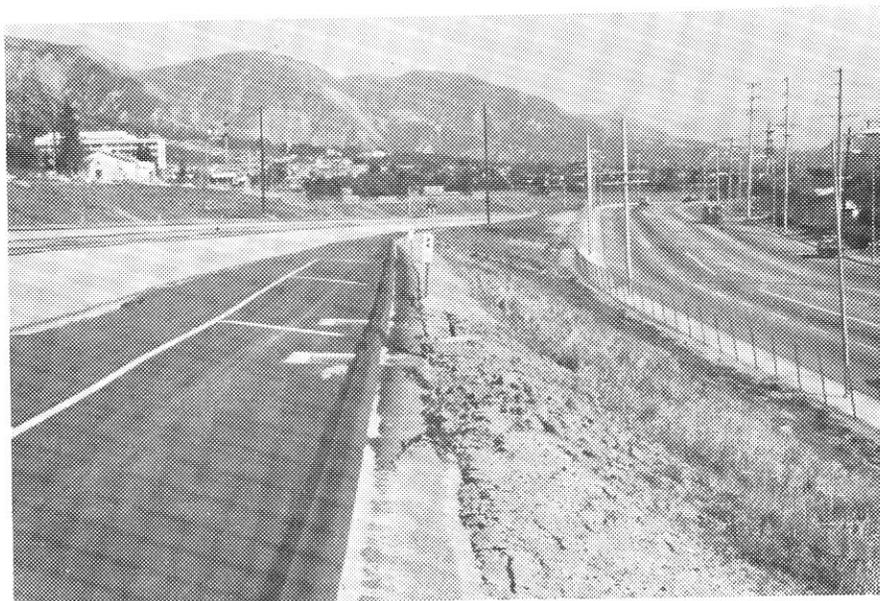
Photo 115. Shattering of outer portion of fill east of Roxford Street.

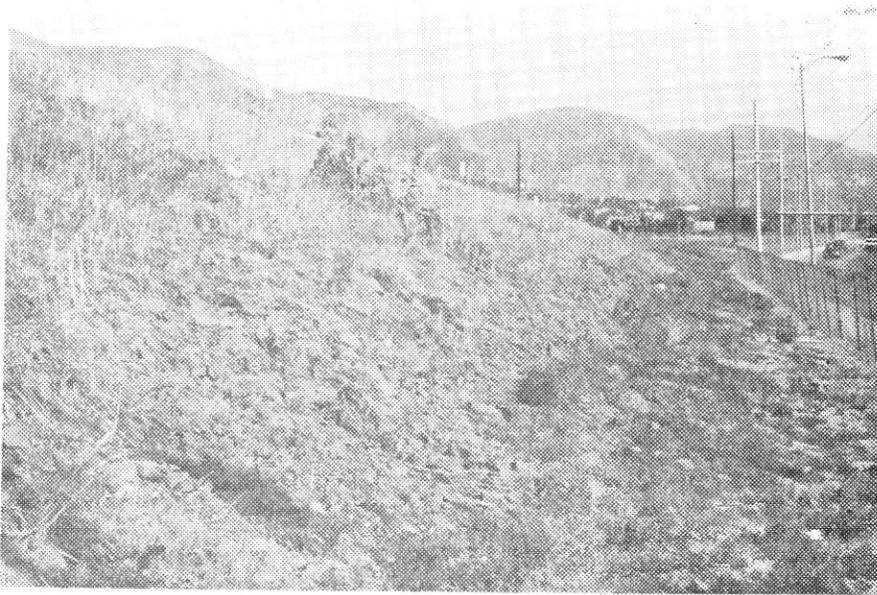
Photo 116. Slope shattering of fill shown in Photo 115.

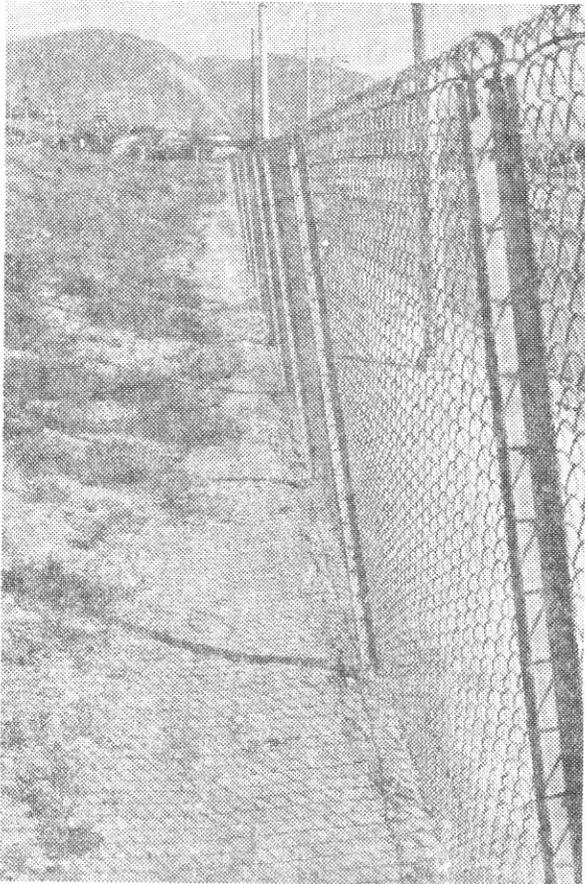
Photo 117. Toe of fill shown in Photos 115 and 116. Note rotation of fence inward, toward fill.

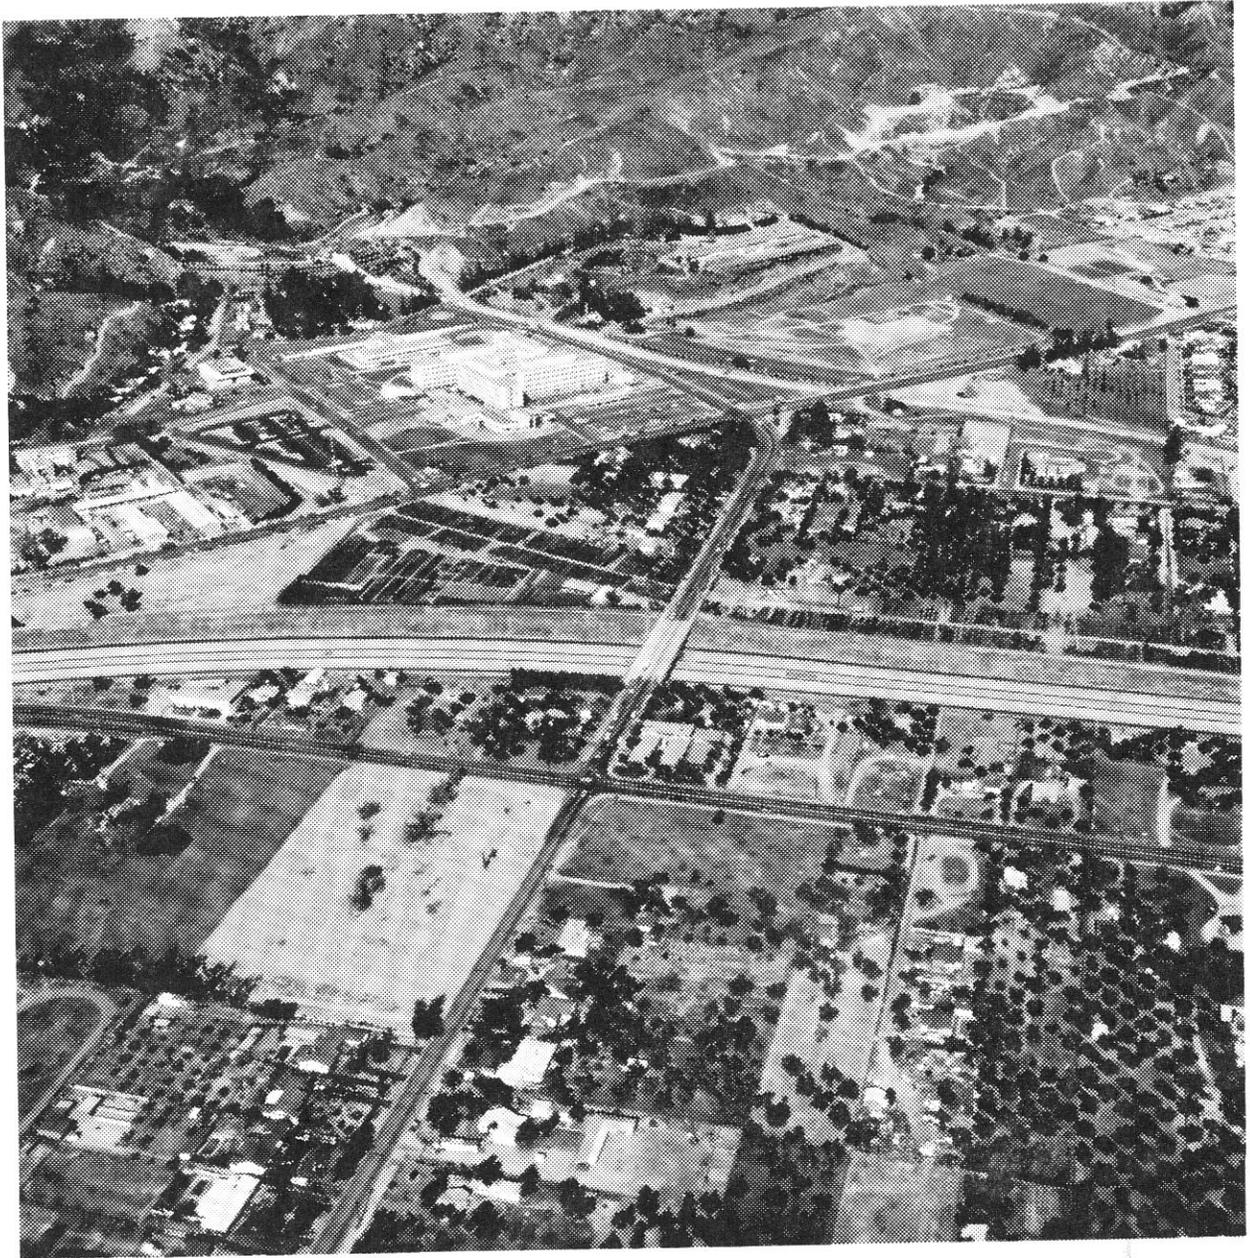
The freeway in this location is a full cut section with about 25 feet of vertical relief (Photo 119). The material consists of gravelly sands, uncemented and poorly consolidated in the upper several feet.

Photo 119. Looking northerly at Route 210. Bledsoe Street Overcrossing is in center, Olive View Hospital in upper left-center.

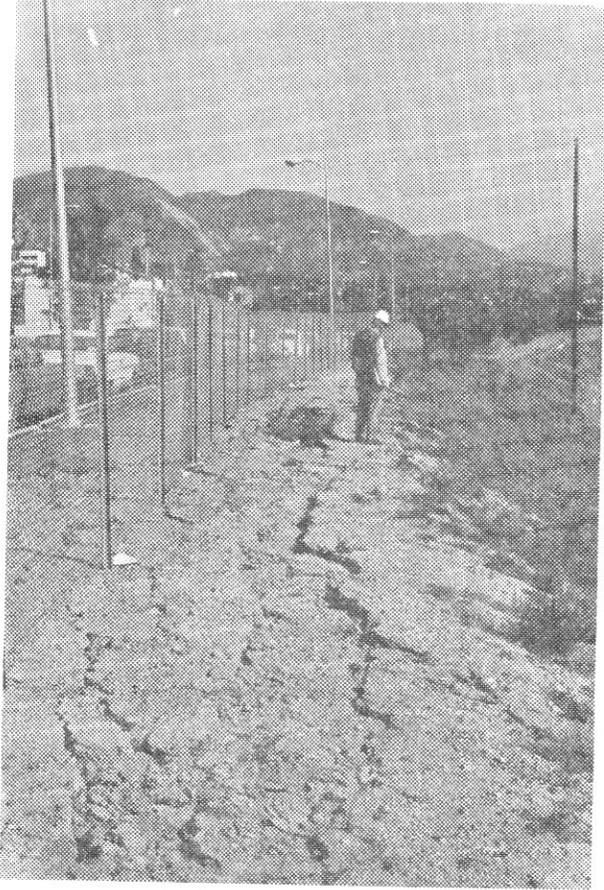
The cut slopes were distressed to various degrees by tension cracking and a minor amount of sliding. Photo 120 shows tension cracks that occurred at the top of cut on the northerly side of the road. The cracking was nearly continuous for the length of the cut and was generally within a 20 foot-wide zone.

Photo 120. Looking easterly at tension cracks along top of cut slope.

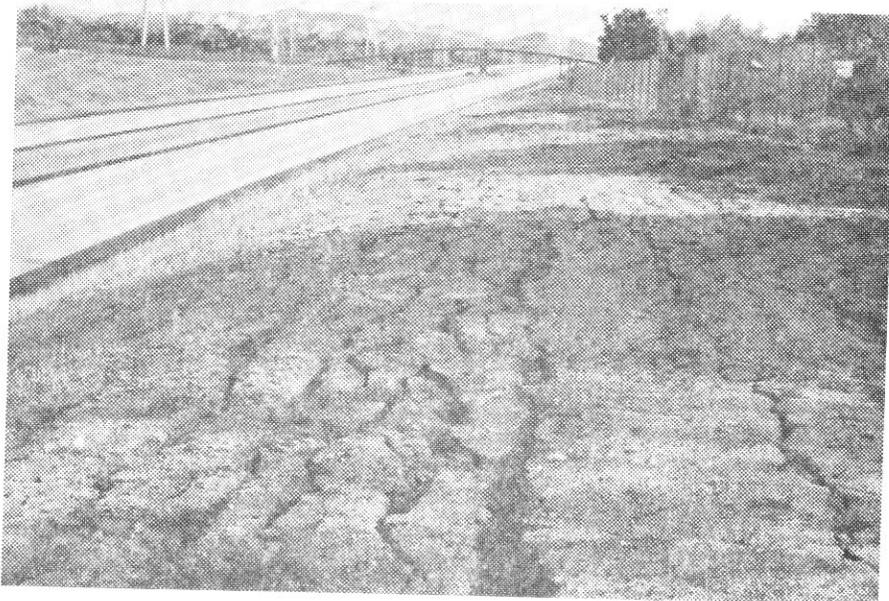
Soil-cracking at top of cut on the southerly side of the road is shown in Photos 121 and 122. Cracks extended along, and parallel to, the top of cut for a distance of about 2,000 feet in a zone that was generally 20-25 feet wide, but which in some cases extended 70-80 feet in back of the cut. The cut face on the south side of the road was distressed more than that on the north side.

Photo 121. Looking east from Bledsoe Street at cracking in cut slope. The Tyler Street Pedestrian Overcrossing structure is in background.

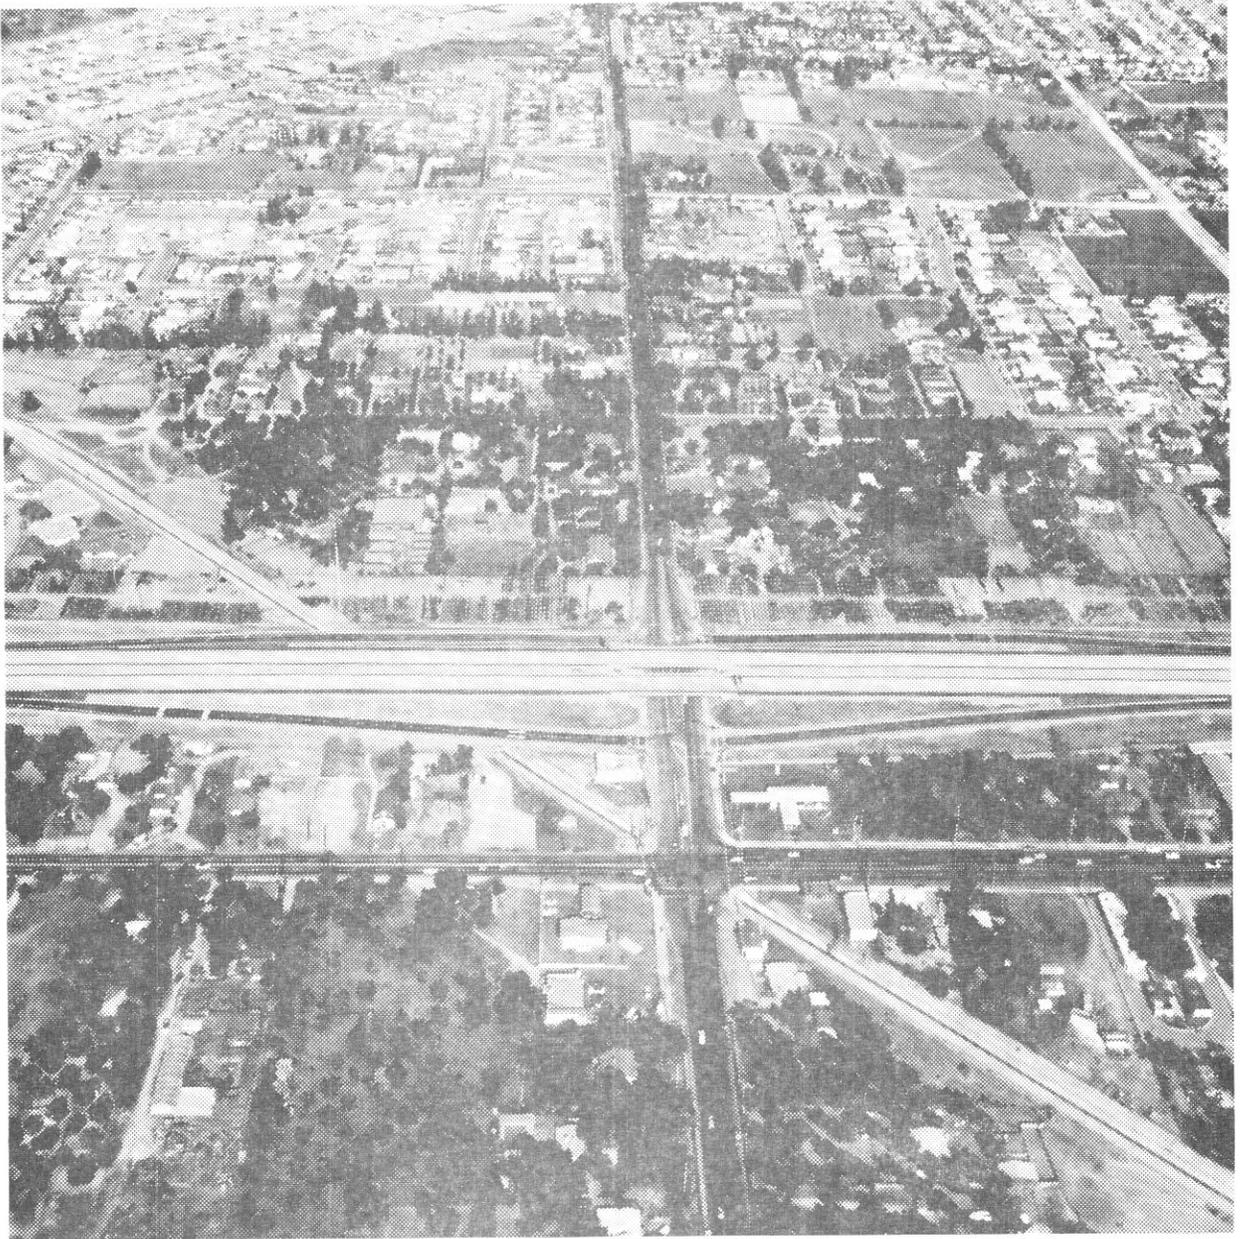
The Polk Street/Route 210 Interchange area is shown in Photo 123. The freeway at this location is constructed on 3000 lineal feet of embankment, with a maximum height of about 23 feet between cut sections. Subsurface drainage facilities both parallel and cross the freeway within the interchange area.

Photo 123. Looking north at the Route 210/Polk Street Interchange.

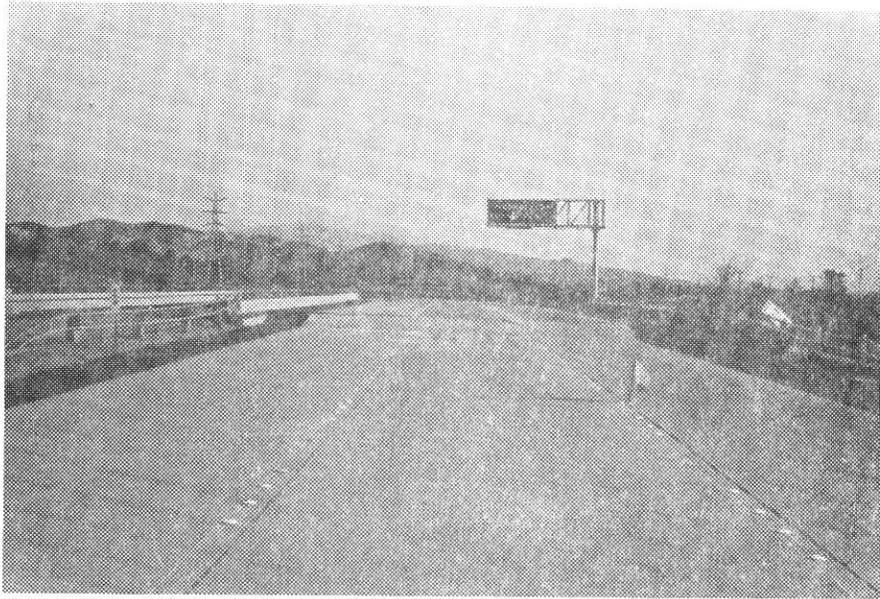
The most obvious roadway damage at this location was the abrupt break in roadway profile at the bridge approaches where differential settlement in excess of one foot occurred, as shown in Photos 124 and 125. Embankment settlement of over one foot relative to abutments, shown in Photos 126 and 127, is typical of all the bridge abutment-embankment relationships. Even with the extreme settlement, the approach slabs remained serviceable to emergency traffic at this particular location as shown in Photo 128. Both bridges were founded on piles that penetrated original ground at least 30 feet with the pile tips in dense, poorly sorted gravelly sand.

Photo 124. Looking east at eastbound structure of Polk Street Undercrossing. Note difference in profile between roadway and structure deck.

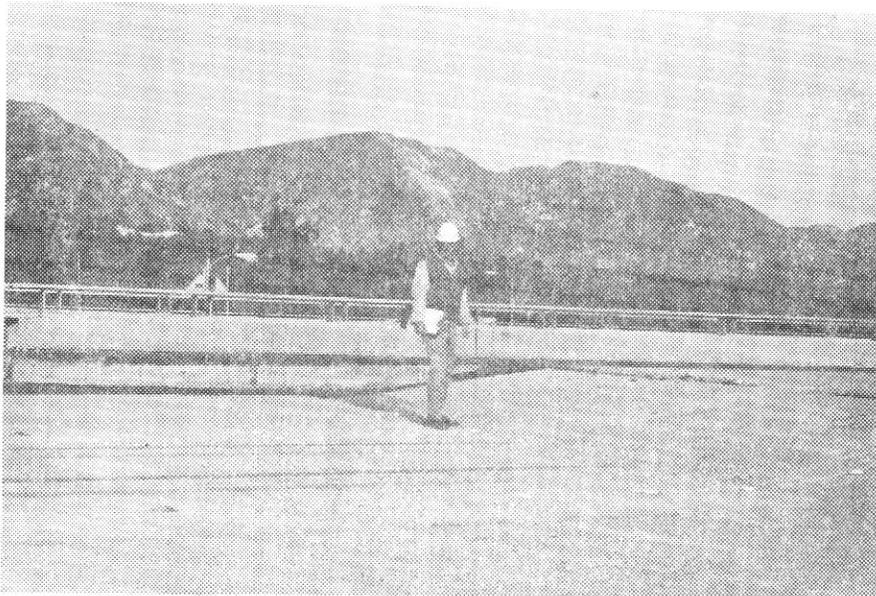
Photo 125. Fill settlement at west approach to eastbound structure at Polk Street Undercrossing. Note approach slab break and resulting ramp effect. The amount of settlement is indicated by the dark (AC) marking along the bridge rail.

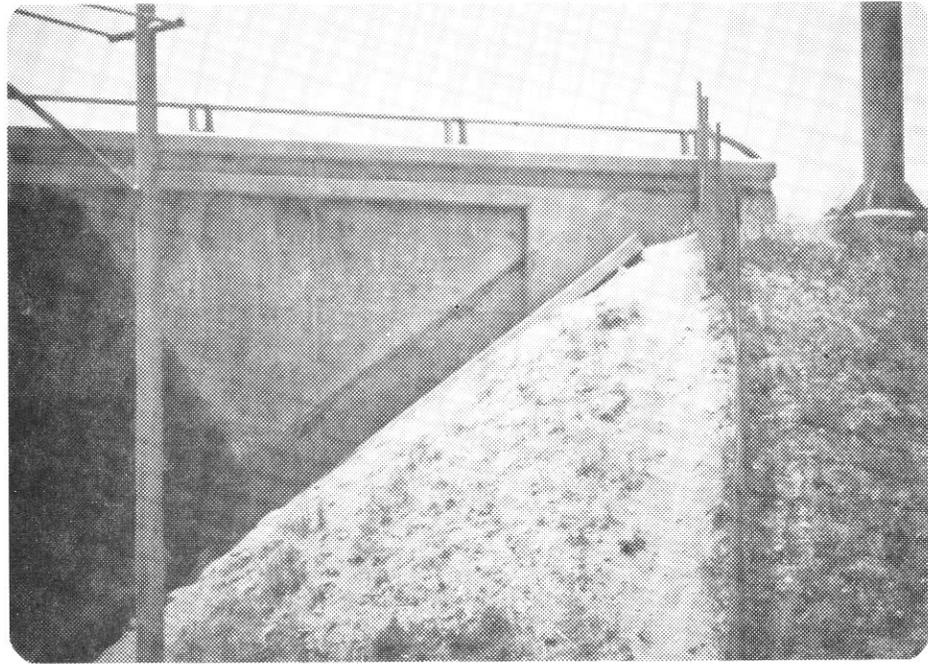
Photo 126. Fill settlement relative to abutment - south side of fill.

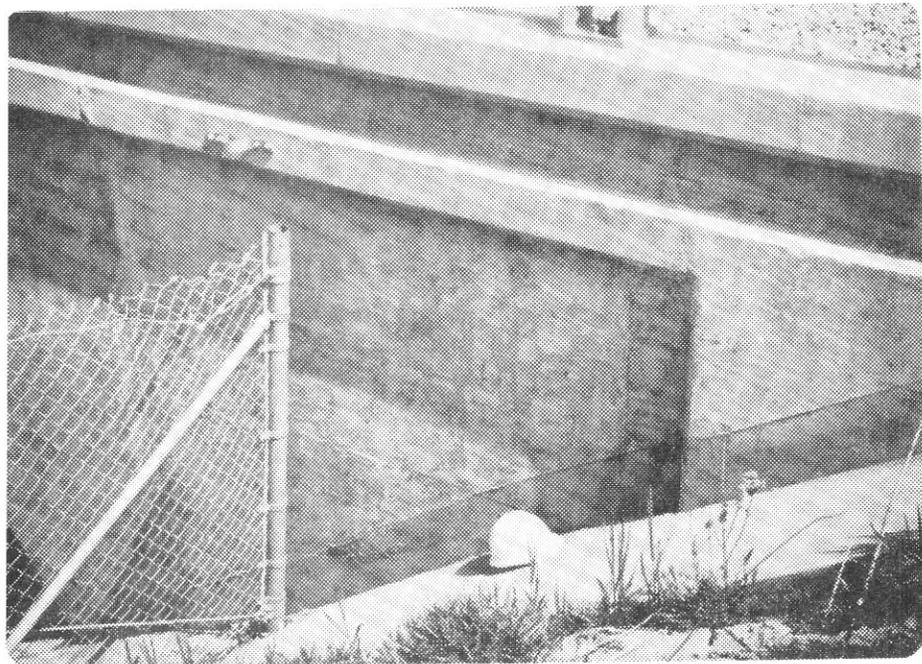
Photo 127. Fill settlement relative to abutment - median area of fill.

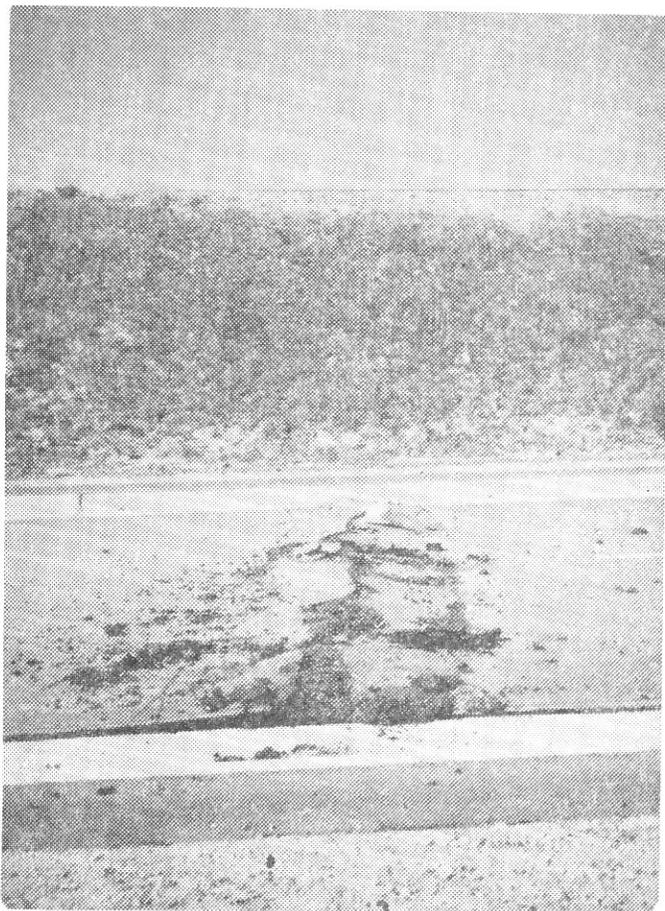
A compression buckle occurred in the westbound on-ramp asphalt concrete pavement as shown in Photo 132. It is interesting to note that the buckle did not continue into the PCC curb and gutter sections on either side of it.

Photo 132. Compression buckle in AC ramp pavement. Note intact PCC curb and gutter on each side of pavement.

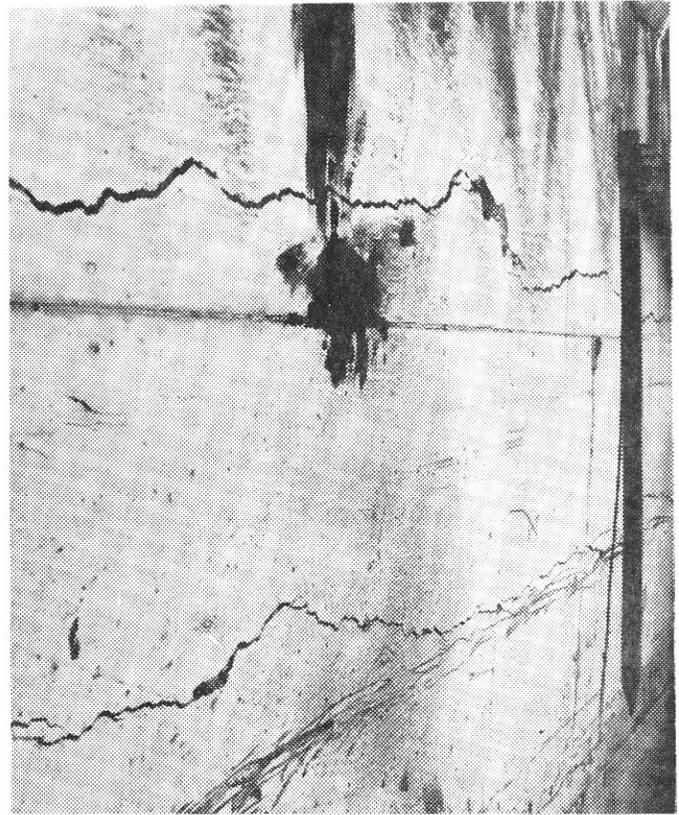
Wilson Canyon Channel crosses diagonally beneath the freeway in an 11 1/2-foot high by minimum 15-foot wide reinforced concrete box. Differential settlement of freeway embankment was observed in the roadway profile of this area, and Photo 133 shows the resulting "hump" over the RCB where it crosses the eastbound off ramp (center of photo). Another buried reinforced concrete box 7 feet high by 8 feet wide branches into Wilson Canyon at the north toe of the freeway embankment. Lateral earth pressures on the freeway embankment side of the box caused cracking in the wall as shown in Photos 134 and 135. These photographs were taken in the segment of the box opposite freeway Stations 250+50 to 252+. The lateral entering the box (right side of Photo 135 is a

Photo 135. Crack in drainage structure of Photo 134.

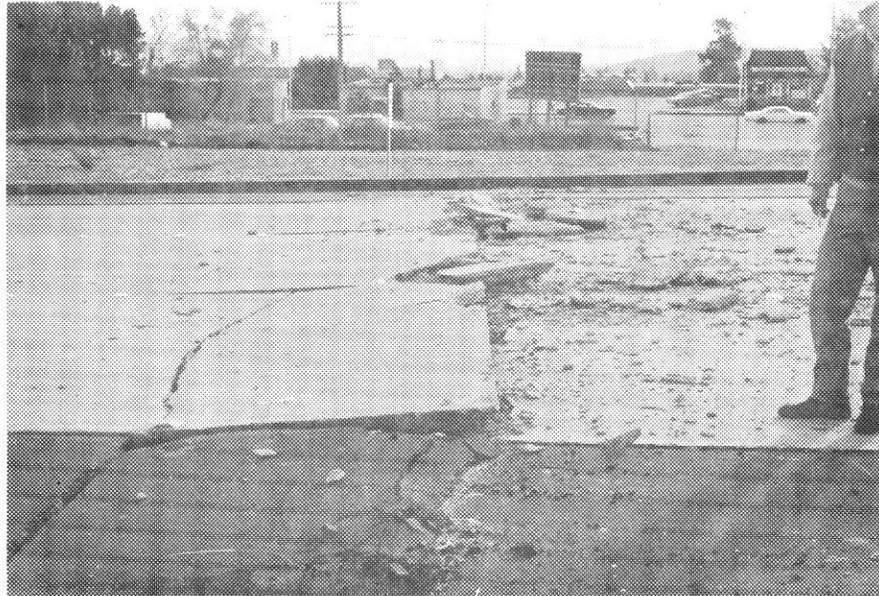
Roadway damage consisted of compression buckles in the concrete pavement that affected all lanes of both roadbeds in a 300-foot long zone as illustrated in Photos 136-139. No evidence of tectonic rupture was observed in the buckled zone. Non-tectonic buckles observed at this location and others tended to occur at cut-to-fill transition zones or fill to essentially original ground transition zones.

Photo 137. Compression at transverse joint in eastbound lanes. Note slab overthrusting east to west.

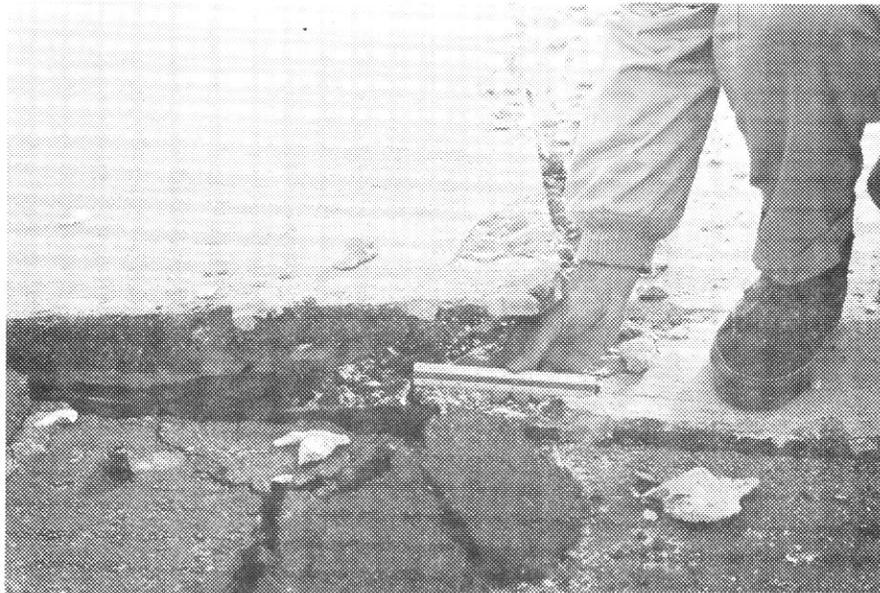
Photo 138. Close view of slab compression. Note lower portion of overthrusting slab sheared off on impact.

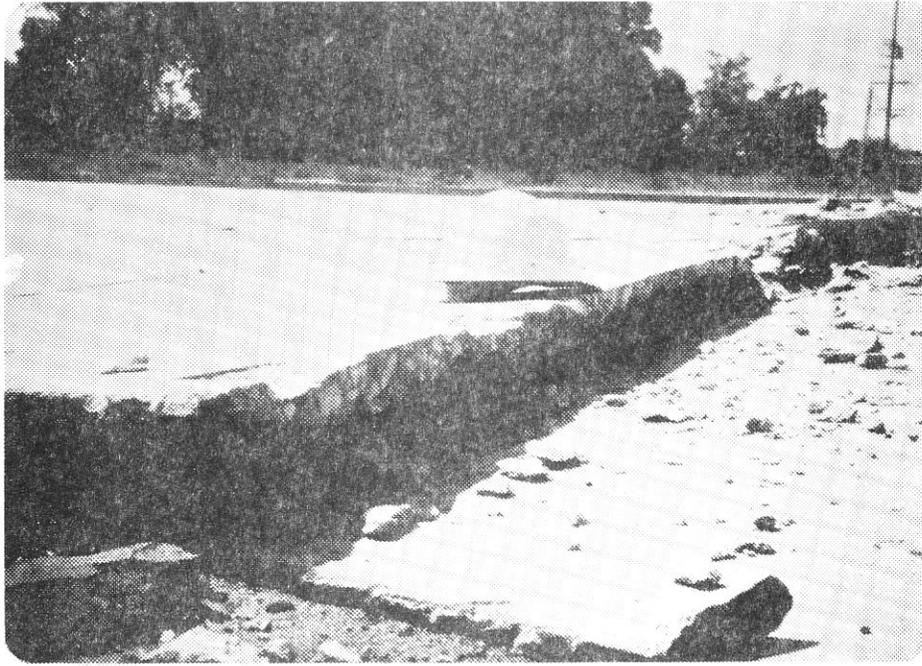
Photo 139. Slab compression and overthrusting in same general area as Photo 137.

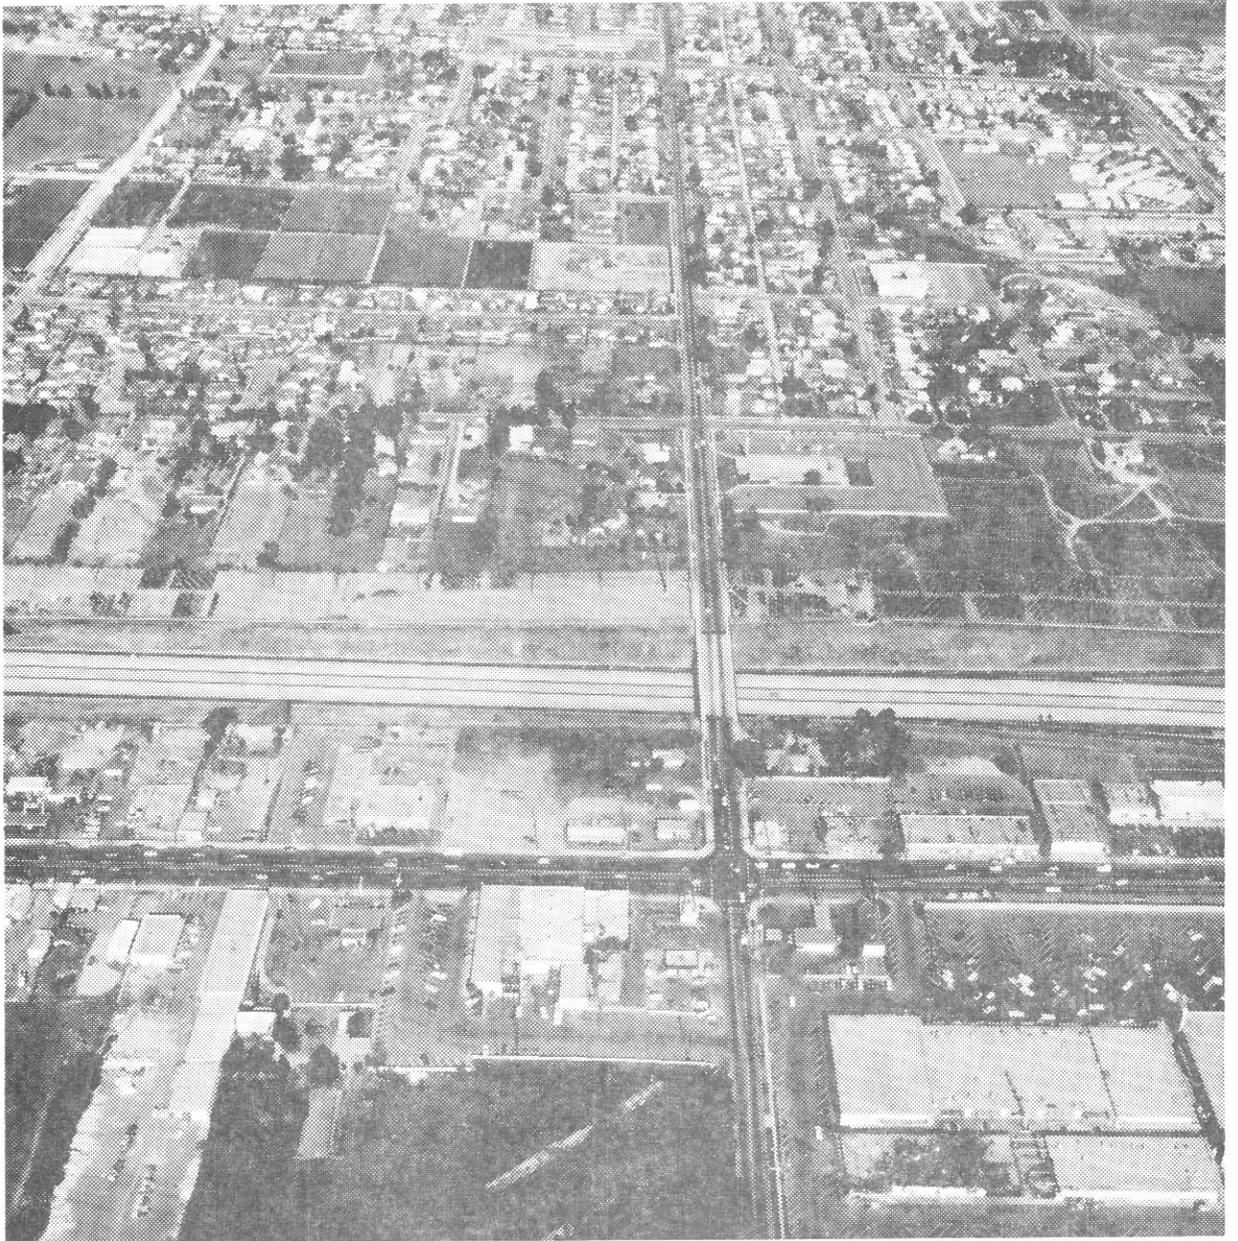
At this location, Sayre Street crosses over the freeway that is in about 25 feet of cut (Photo 140).

Photo 140. Looking northerly at Sayre Street Overcrossing.

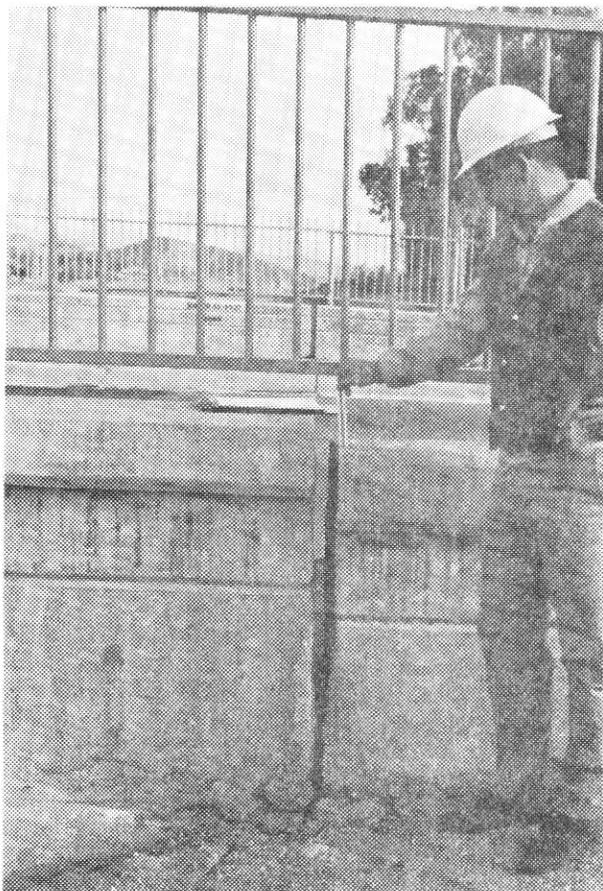
The bridge approaches and wingwalls settled about 2 inches as shown in Photo 141. Tension cracks developed behind the top of cut on the south side and down the cut slope to about mid-height. Some cracks were up to 2 feet deep. Material at this location is composed of dense, slightly silty very fine sand, with a small amount of coarse sand and fine gravel.

Photo 141. Settlement and separation of wingwall at the Sayre Street Overcrossing.

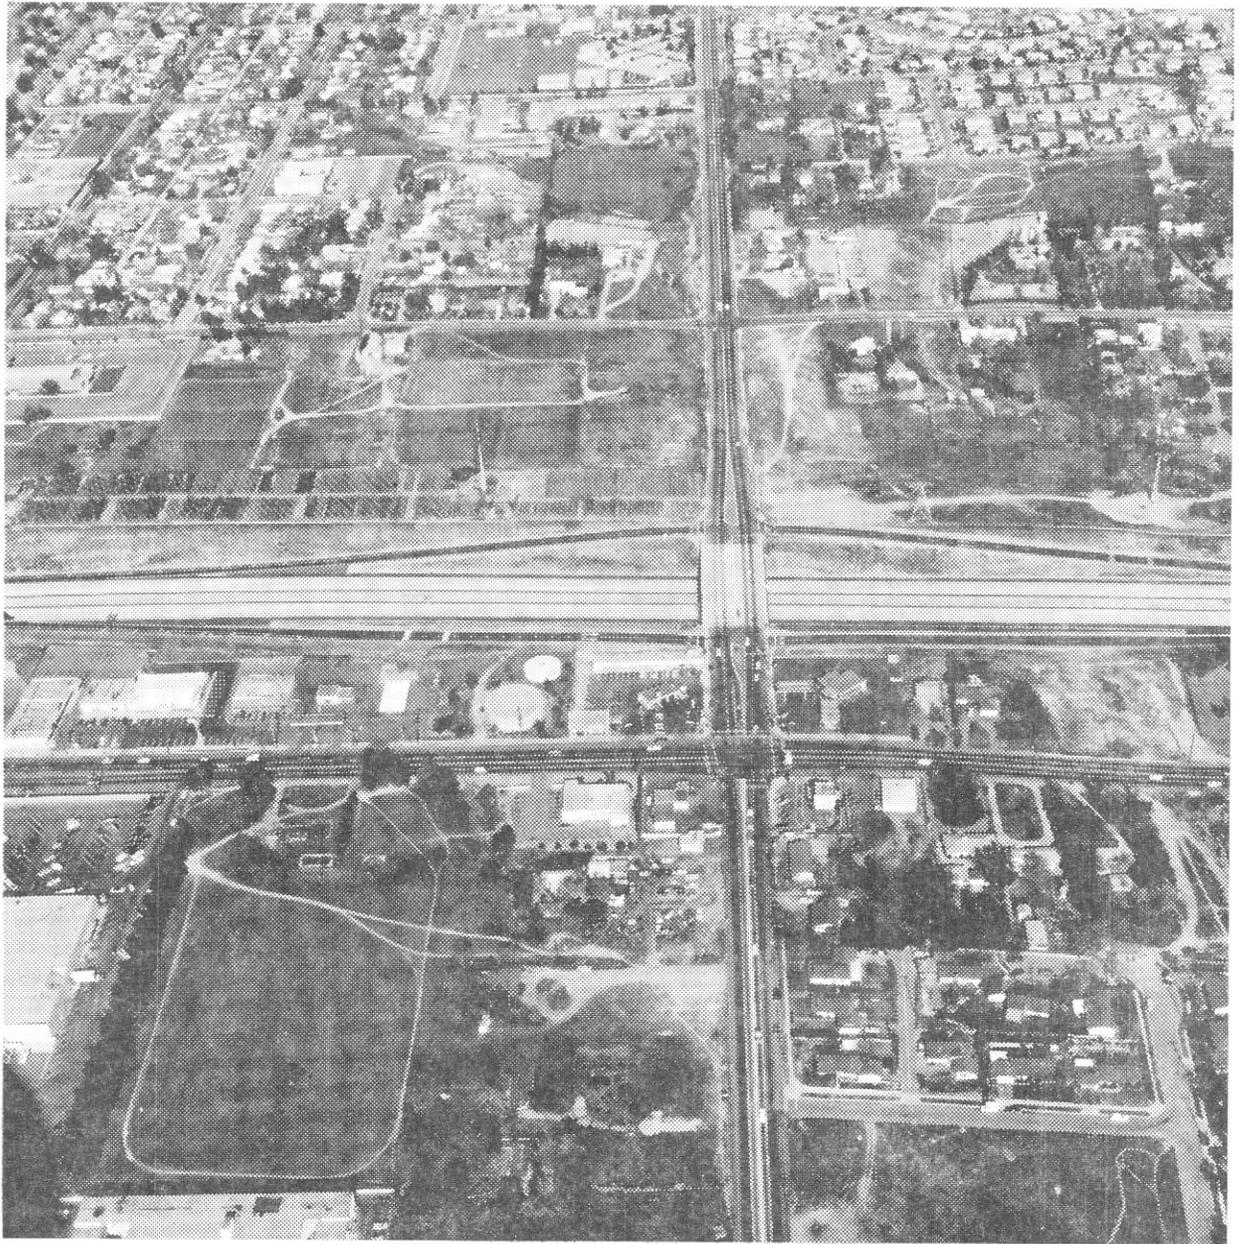
The Hubbard Street Overcrossing and interchange area is shown in Photo 142. The freeway is entirely in cut section, up to 30 feet high. No visible damage occurred to the bridge structure, which is founded on spread footings. At the northwest corner of the bridge, the approach slab settled about two inches. South of the bridge, a slight amount of cracking occurred at the curb-returns of the on and off-ramps.

Photo 142. Looking northerly at the Route 210/
Hubbard Street Interchange.

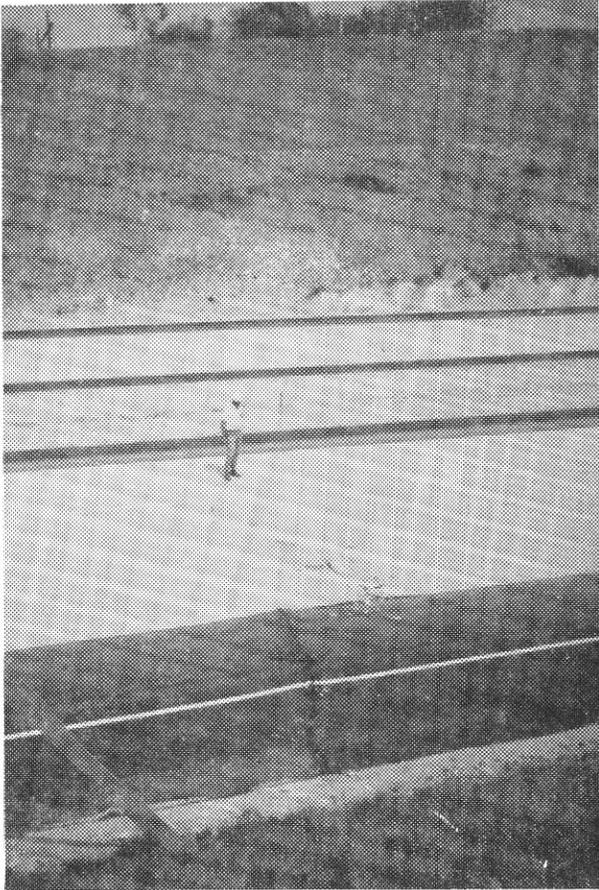
A pavement break in the eastbound roadway (Photo 144) plus undulations in the roadway appeared to be due to faulting. Cracking in the cut slope on the north side of the freeway (Photo 145) lends support to the belief that faulting occurred here.

Photo 144. Looking northerly at pavement break in east-bound lanes.

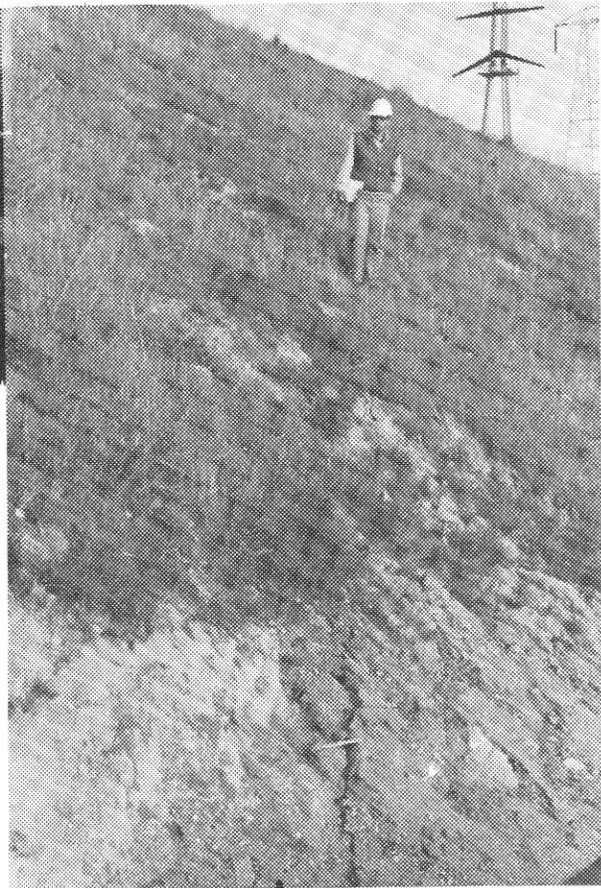
Photo 145. Cracking in north cut slope opposite pavement break shown in Photo 143.
