REPORT NO. FHWA/CA/TL-80/17

ROADWAY DAMAGE DURING THE SAN FERNANDO, CALIFORNIA EARTHQUAKE OF FEB. 9, 1971

FEB., 1981

6. PERFORMING ORGANIZATION CODE		
7. AUTHOR(S) R. H. Prysock and J. P. Egan, Jr.			8. PERFORMING ORGANIZATION REPORT NO. 19305-632119		
9. PERFORMING ORGANIZATION NAME AND ADDRESS Office of Transportation Laboratory California Department of Transportation Sacramento, California 95819			10. WORK UNIT NO.

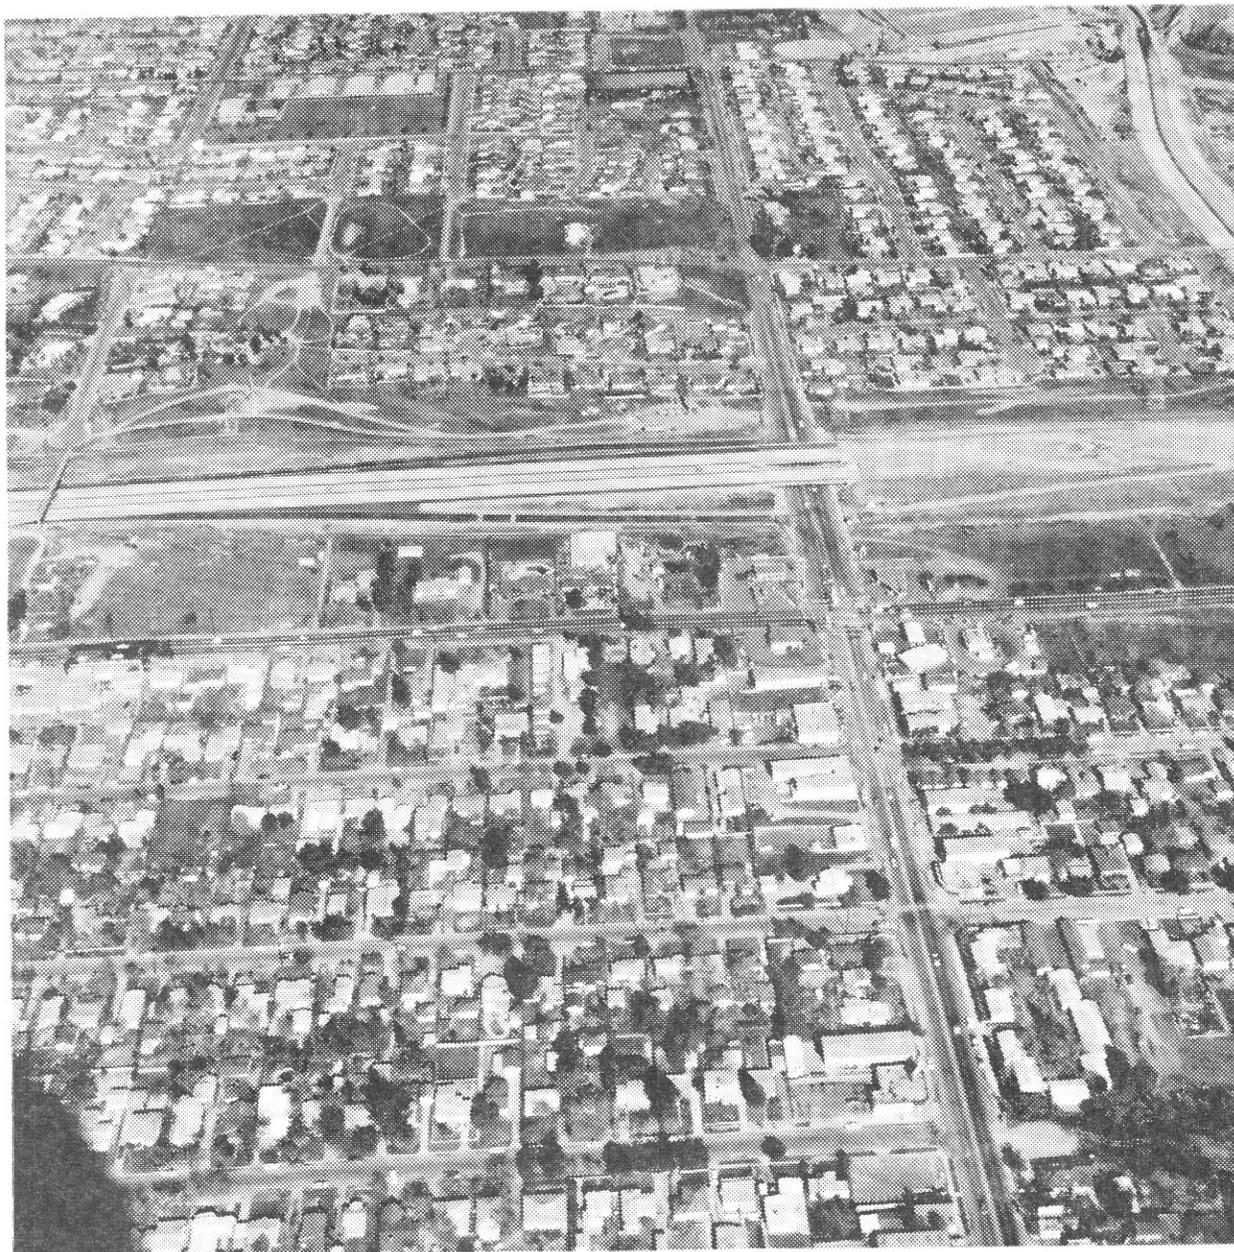
The area between Harding and Maclay Streets, shown in Photo 146, is where the Sylmar Fault trace crossed the freeway and disrupted the roadway across a 600-foot wide zone. Photo 147 is a view, looking east, that shows left lateral displacement across the fault of about 4 feet. Vertical displacement of about 4-1/2 feet occurred across the fault, with the west (foreground) up, relative to the east. Photos 148-151 are views of the faulted area.

Photo 146. Looking northeasterly at end of completed portion of Route 210. Maclay Street Undercrossing is at right-center, Harding Street Pedestrian Overcrossing at left-center.

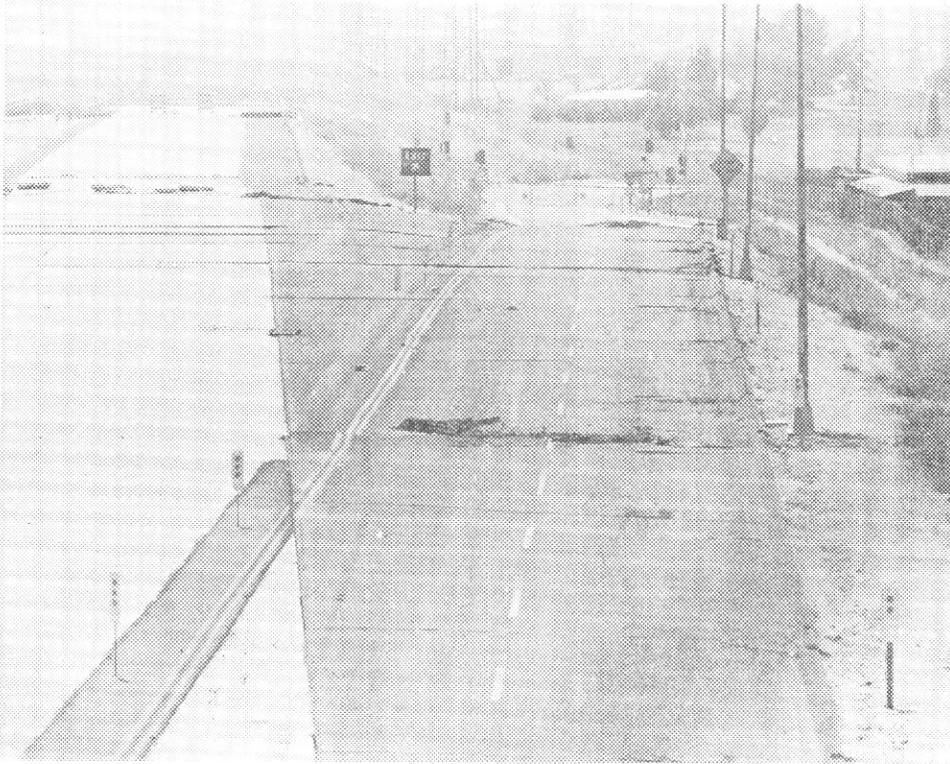
Photo 147. Looking east at fault zone crossing freeway between Harding Street and Maclay Street.

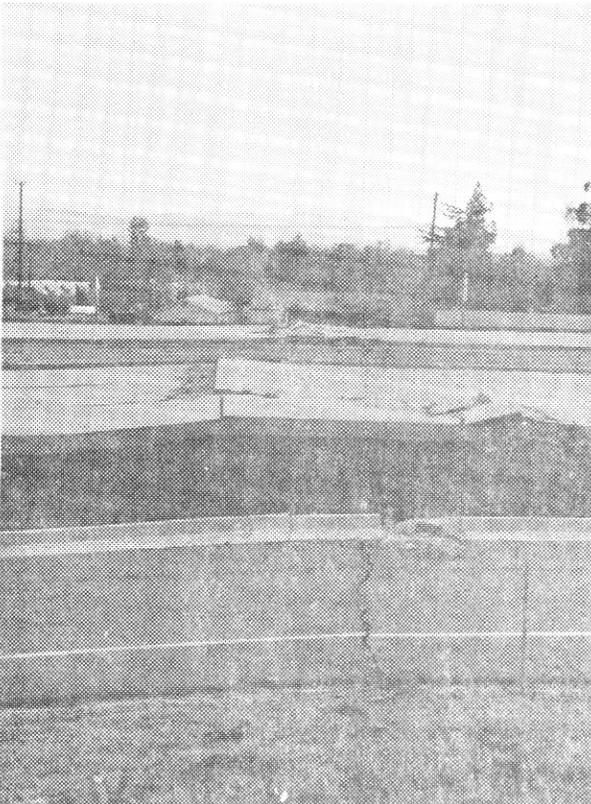
Photo 148. Looking south at fault zone crossing freeway.

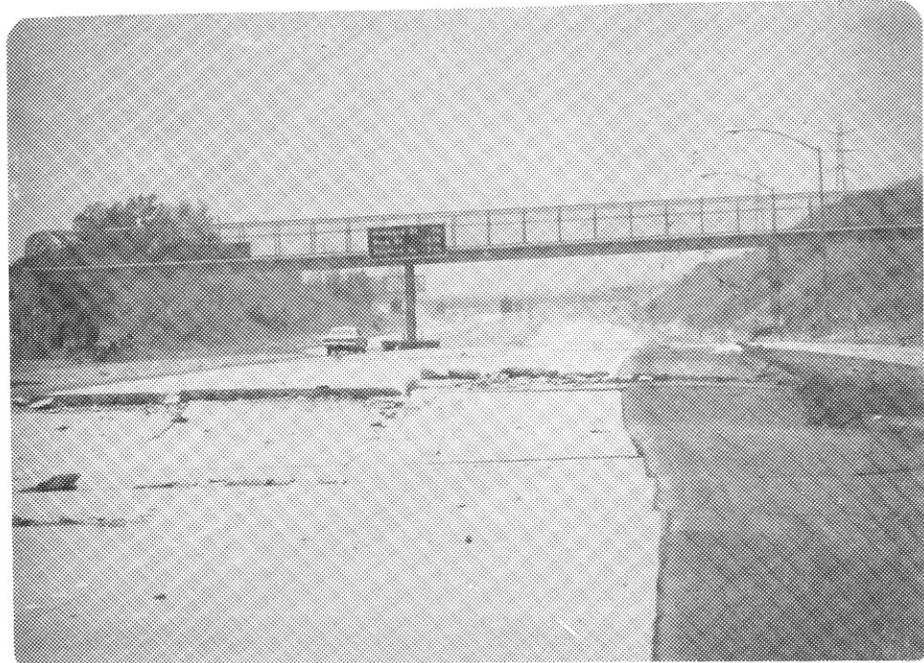
Photo 149. Looking westerly at fault crossing freeway.

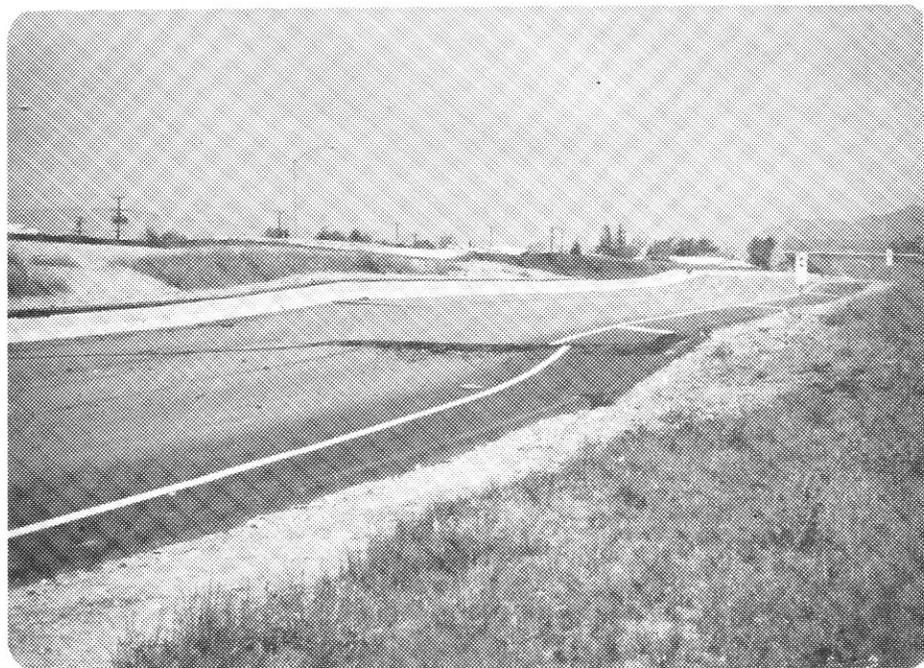
Photo 150. Westbound on-ramp from Maclay Street in fault zone.

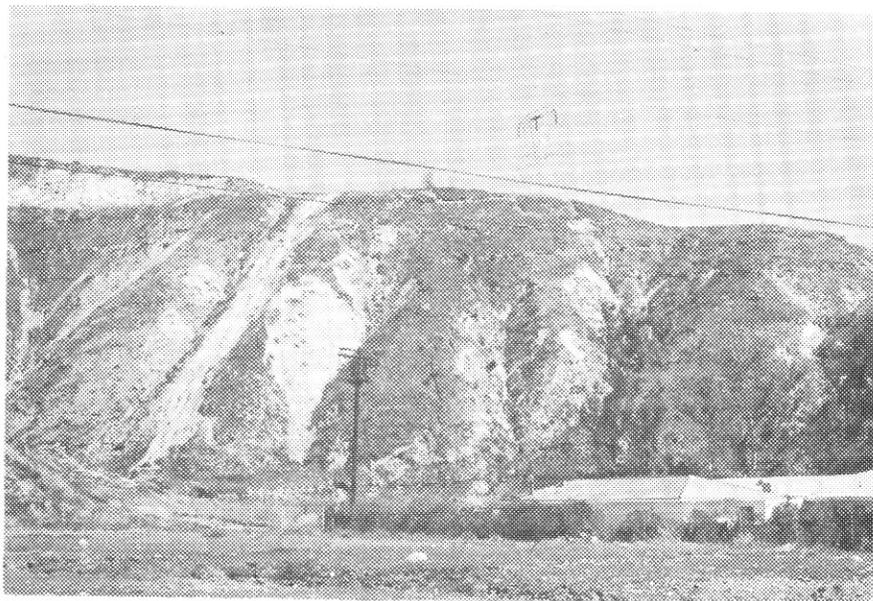
During the earthquake, geologic upheaval occurred within the Route 118/210 Interchange area in the form of faulting, horizontal compression of alluvium, and numerous landslides with attendant soil cracking and displacement. Photos 152-155, present an overall impression of ground disturbance in the area of the interchange.

Photo 153. Looking northeasterly at planned site of Route 210/118 Interchange.

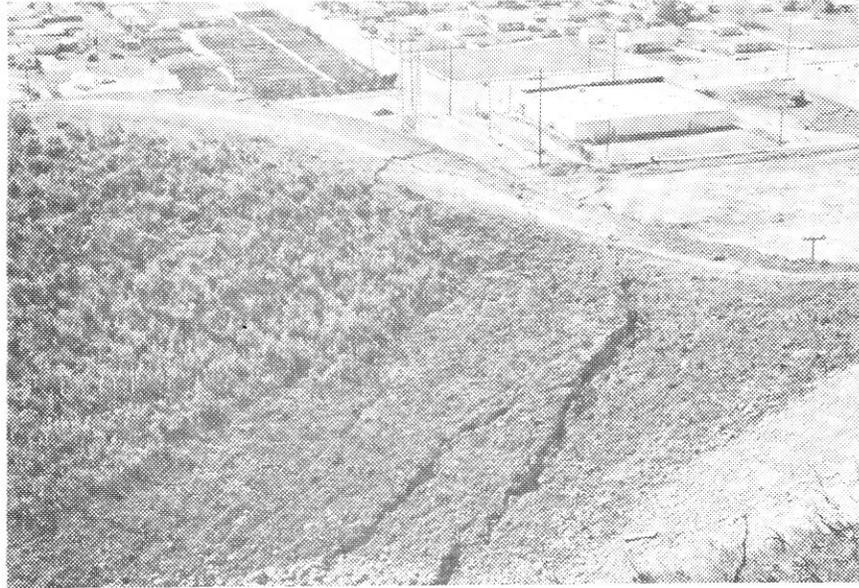
Photo 154. Cracking and displacement in slopes of hills shown in Photo 152.

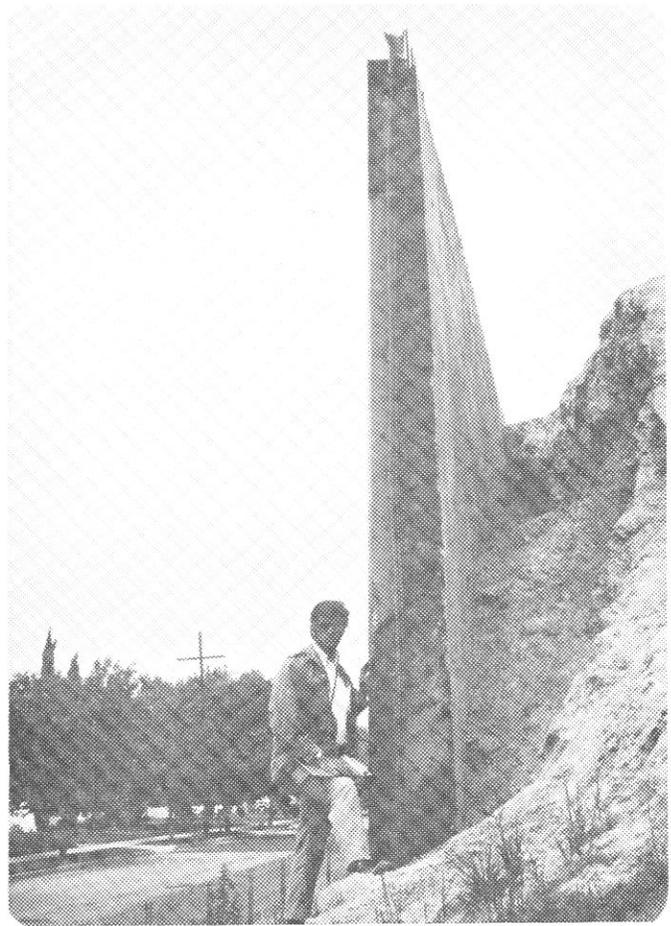
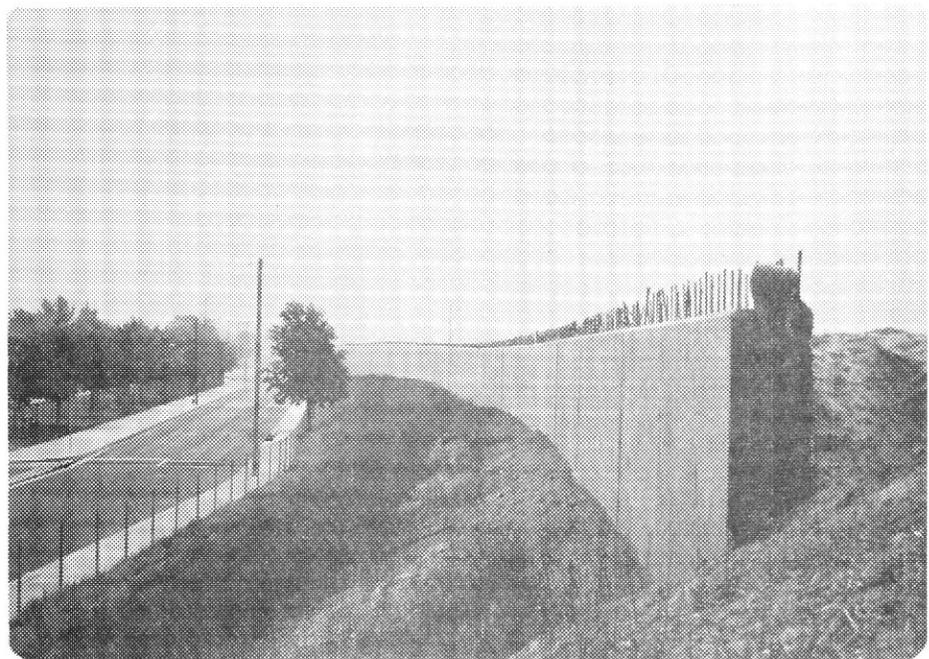
Retaining walls, such as shown in Photos 158-160, had no visible signs of damage.

Photo 158. Completed retaining wall on Route 118 showed no evidence of damage.

Photo 159. Completed retaining wall on Route 118 showed no evidence of damage.
