INFORMATION HANDOUT

CALIFORNIA DEPARTMENT OF TRANSPORTATION (CALTRANS)
PLUMAS SR 70 METAL BEAM GUARDRAIL REPAIR PROJECT

Subject: Foundation Report for Wall Location 15

02-PLU-70 PM 1.67/1.68 (LOCATION 15)
Foundation Report

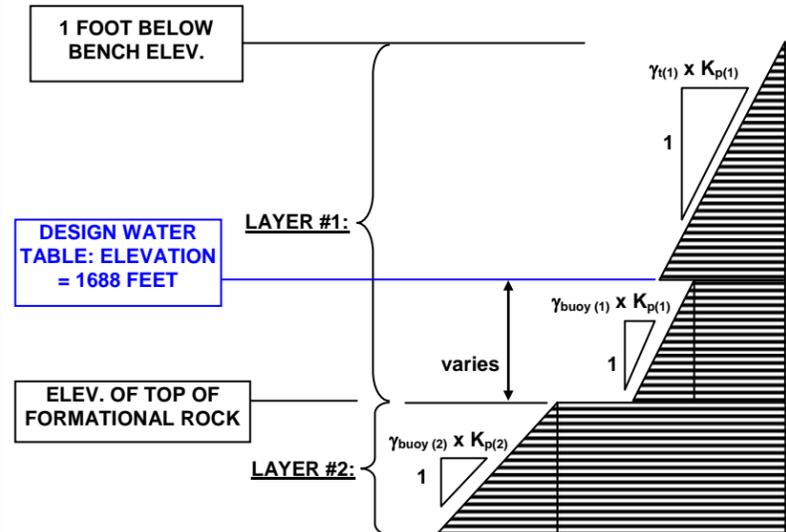
FIGURE 1A. IDEALIZED PASSIVE PRESSURE DISTRIBUTION

LAYER #1 (SOIL, COBBLES AND BOULDERS):	LAYER #2 (FORMATIONAL ROCK):
$\gamma_{t(1)} = 95 \text{ pcf}$	$\gamma_{t(2)} = 165 \text{ pcf}$
$\gamma_{buoyant(1)} = 32.6 \text{ pcf}$	$\gamma_{buoyant(2)} = 102.6 \text{ pcf}$
LOG SPIRAL PARAMETERS:	LOG SPIRAL PARAMETERS:
$\phi_{(1)} = 44^\circ$	$\phi_{(2)} = 38^\circ$
$\beta_{(1)} = -40^\circ$	$\beta_{effective(2)} = -18^\circ$
$B/\phi = -0.909$	$B/\phi = -0.474$
$\delta/\phi \approx 1$	$\delta/\phi \approx 1$
$K_{p(1)} = 1.613$	$K_{p(2)} = 5.752$

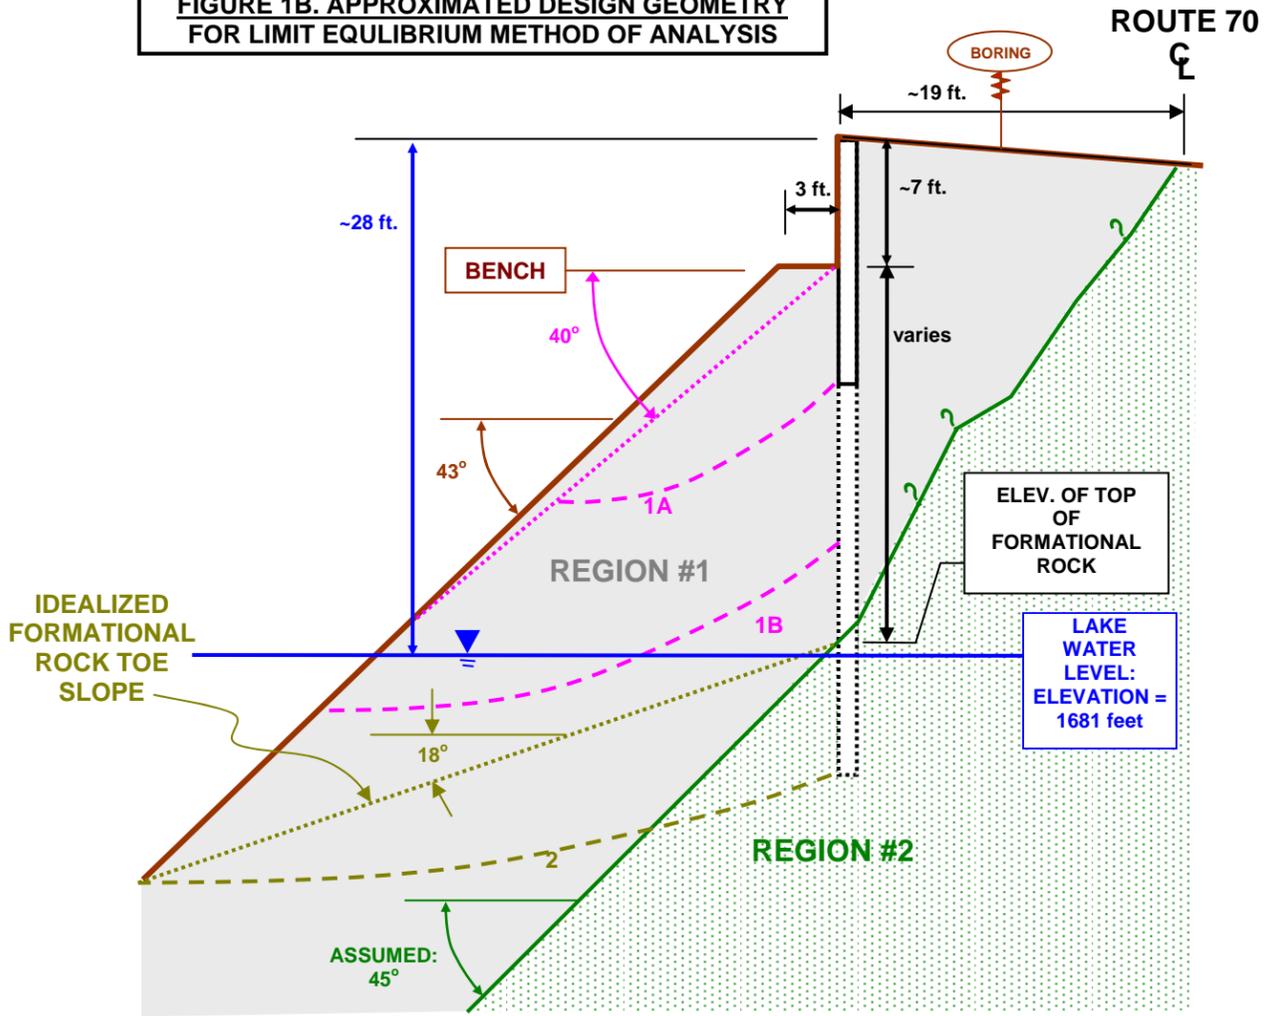
FIGURE 1B. APPROXIMATED DESIGN GEOMETRY FOR LIMIT EQUILIBRIUM METHOD OF ANALYSIS

LIMIT EQUILIBRIUM ANALYSIS PARAMETERS
FS of slope = 1.1 (with 240 psf traffic surcharge)

REGION #1: (SOIL, COBBLES & BOULDERS)	REGION #2 (FORMATIONAL ROCK):
$\phi = 44^\circ, c = 25 \text{ psf}$	$\phi = 38^\circ, c = 3,500 \text{ psf}$
$\gamma_t = 125 \text{ pcf} \quad \gamma_{sat} = 130 \text{ pcf}$	$\gamma_t = \gamma_{sat} = 165 \text{ pcf}$

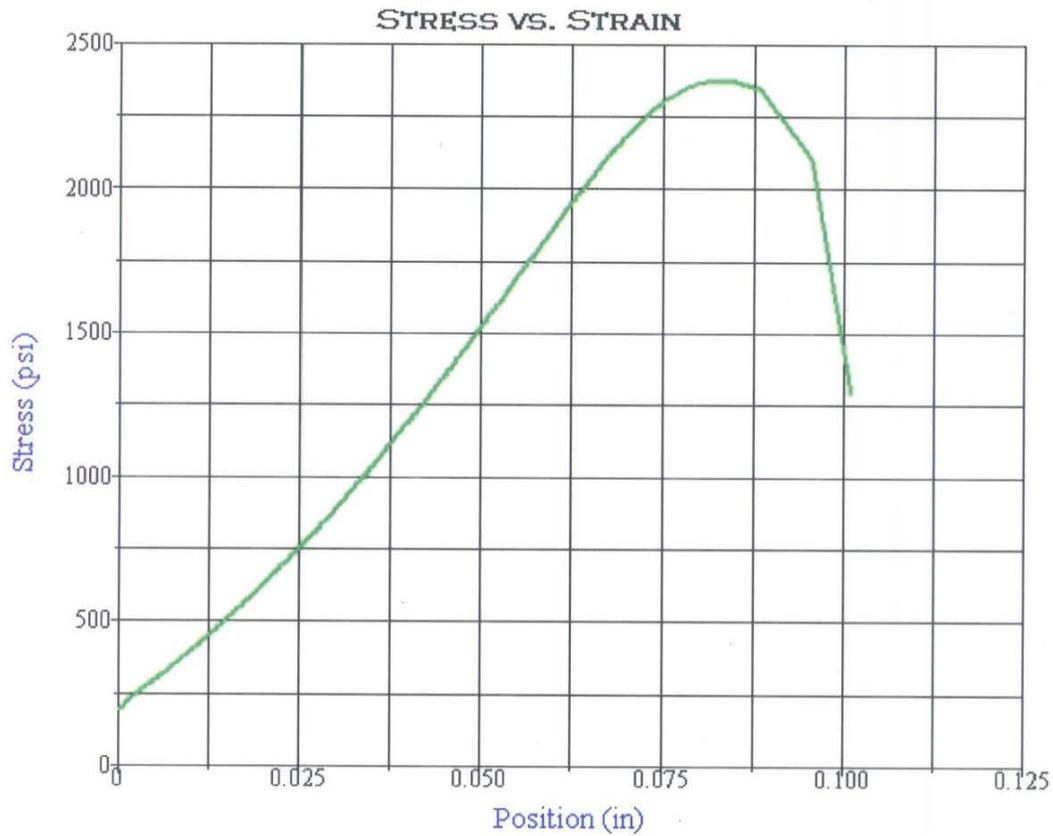
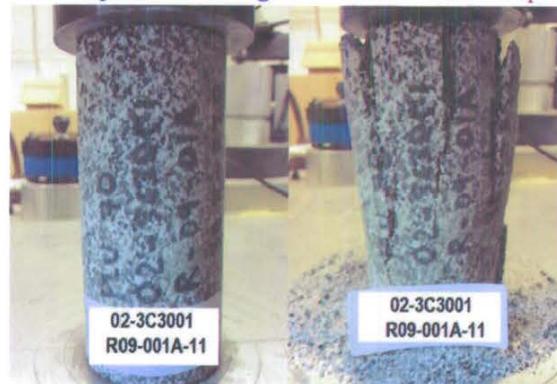
CALTRANS Division of Engineering Services Geotechnical Services Office of Geotechnical Design - North	EA: 02-3C3001	SUMMARY OF UNCONFINED COMPRESSION TEST RESULTS
	Date: March 2011	
	02-PLU-70; PM 1.67-1.68 FOUNDATION REPORT	Plate No. B-1

Specimen Gage Length: 5.1300 in
 Diameter: 2.3800 in
 Area: 4.4488 in²
 Maximum Load: 10548 lbf
 Compressive Strength: 2371 psi

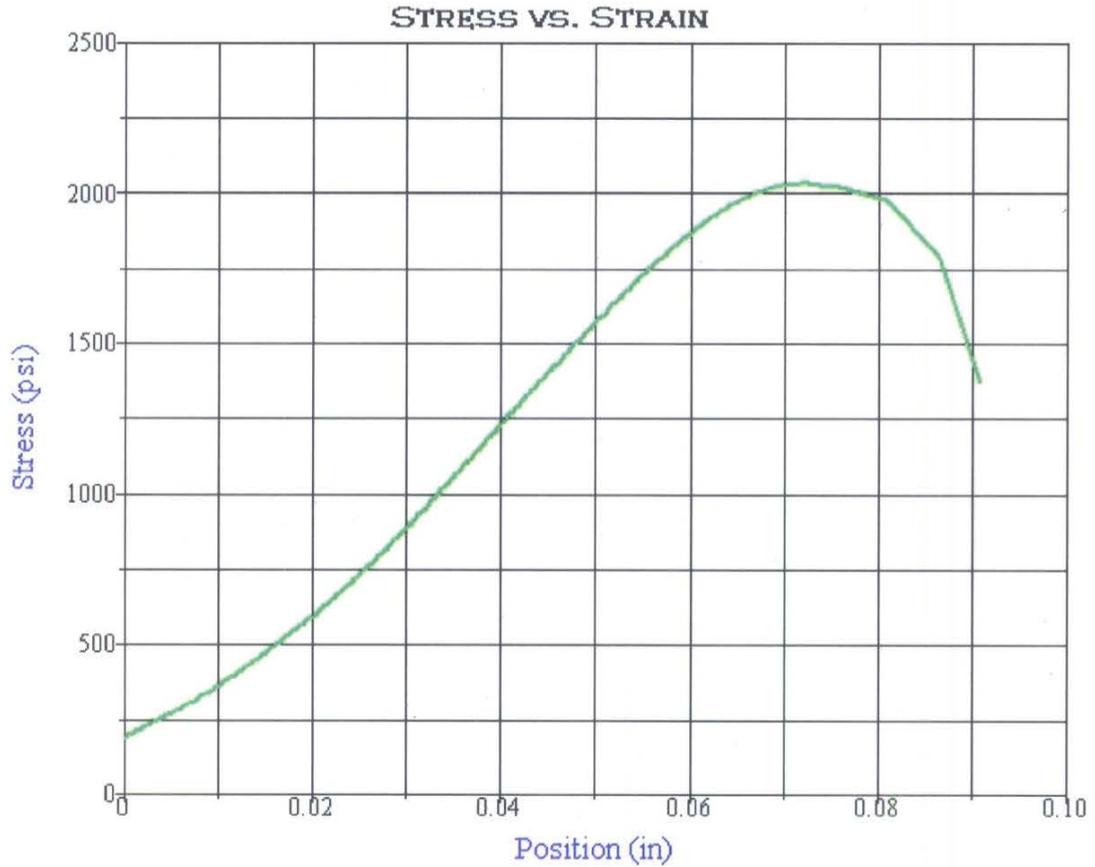
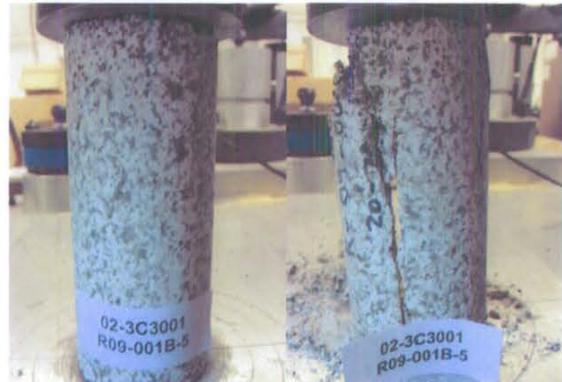
Plate No.
 B-2

Specimen Gage Length: 5.4500 in
 Diameter: 2.4000 in
 Area: 4.5239 in²
 Maximum Load: 9186 lbf
 Compressive Strength: 2031 psi

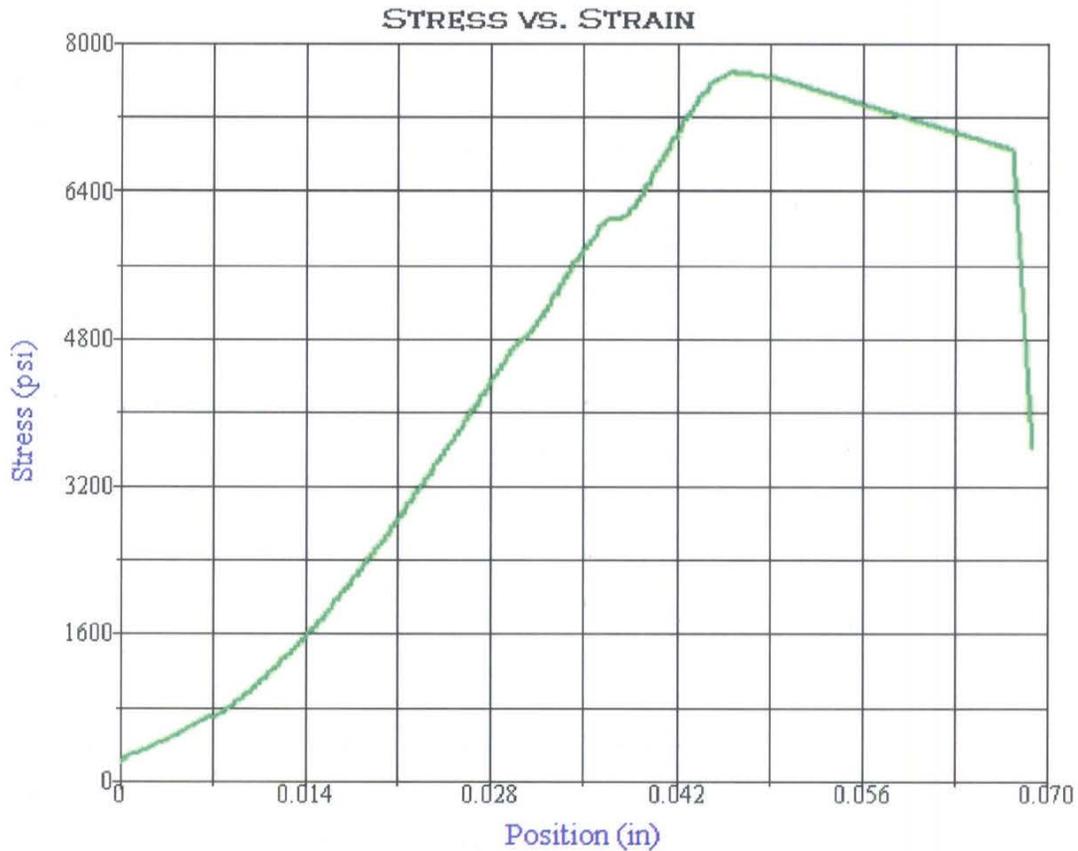
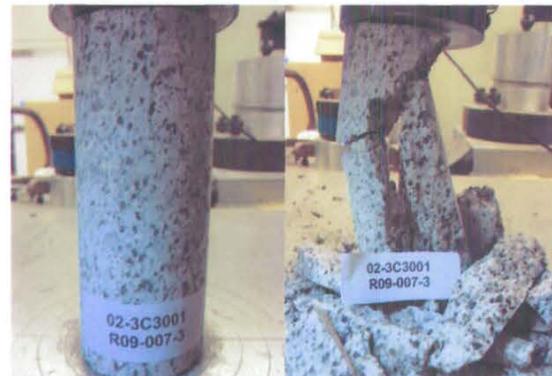
Plate No.
B-1

Specimen Gage Length: 5.7200 in
 Diameter: 2.4000 in
 Area: 4.5239 in²
 Maximum Load: 34691 lbf
 Compressive Strength: 7668 psi

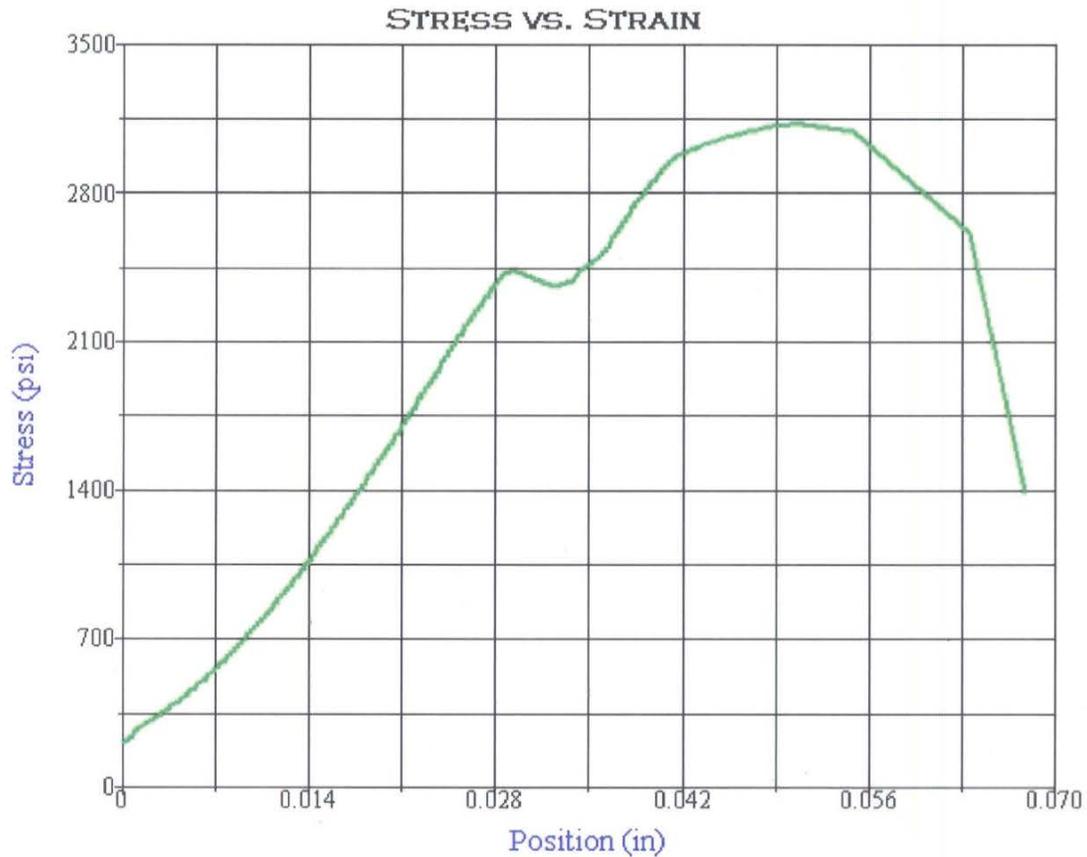
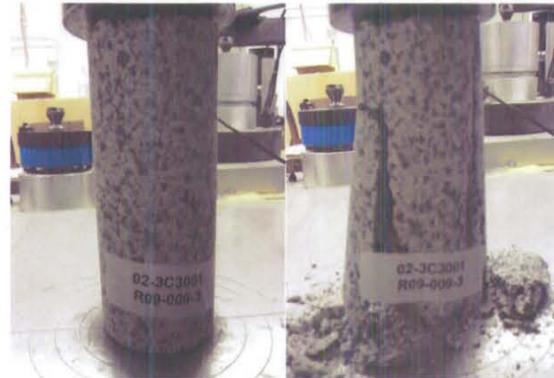
Plate No.
 B-2

Specimen Gage Length: 5.7900 in
 Diameter: 2.3900 in
 Area: 4.4863 in²
 Maximum Load: 14018 lbf
 Compressive Strength: 3125 psi

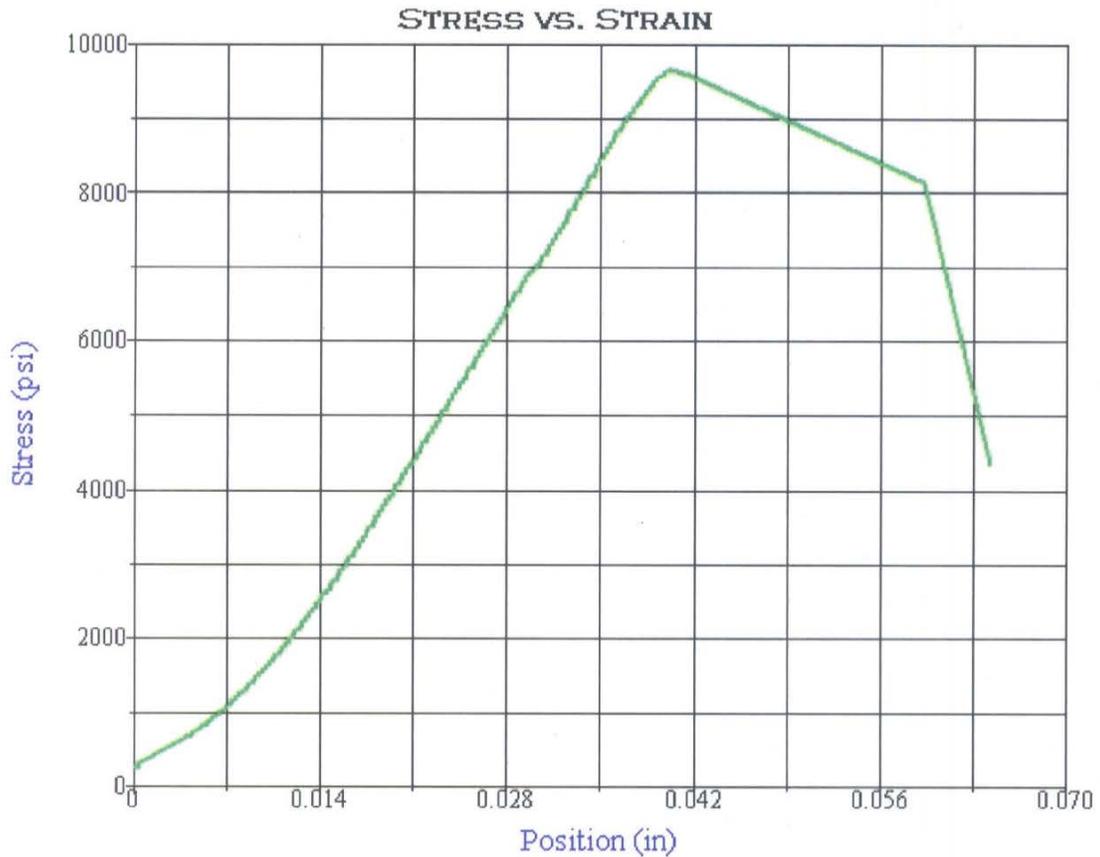
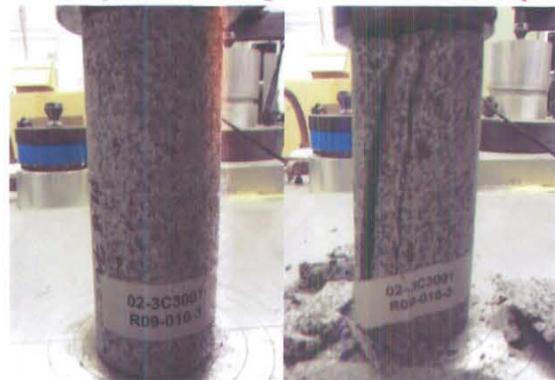
Plate No.
 B-3

Specimen Gage Length: 5.7900 in
 Diameter: 2.3900 in
 Area: 4.4863 in²
 Maximum Load: 43297 lbf
 Compressive Strength: 9651 psi

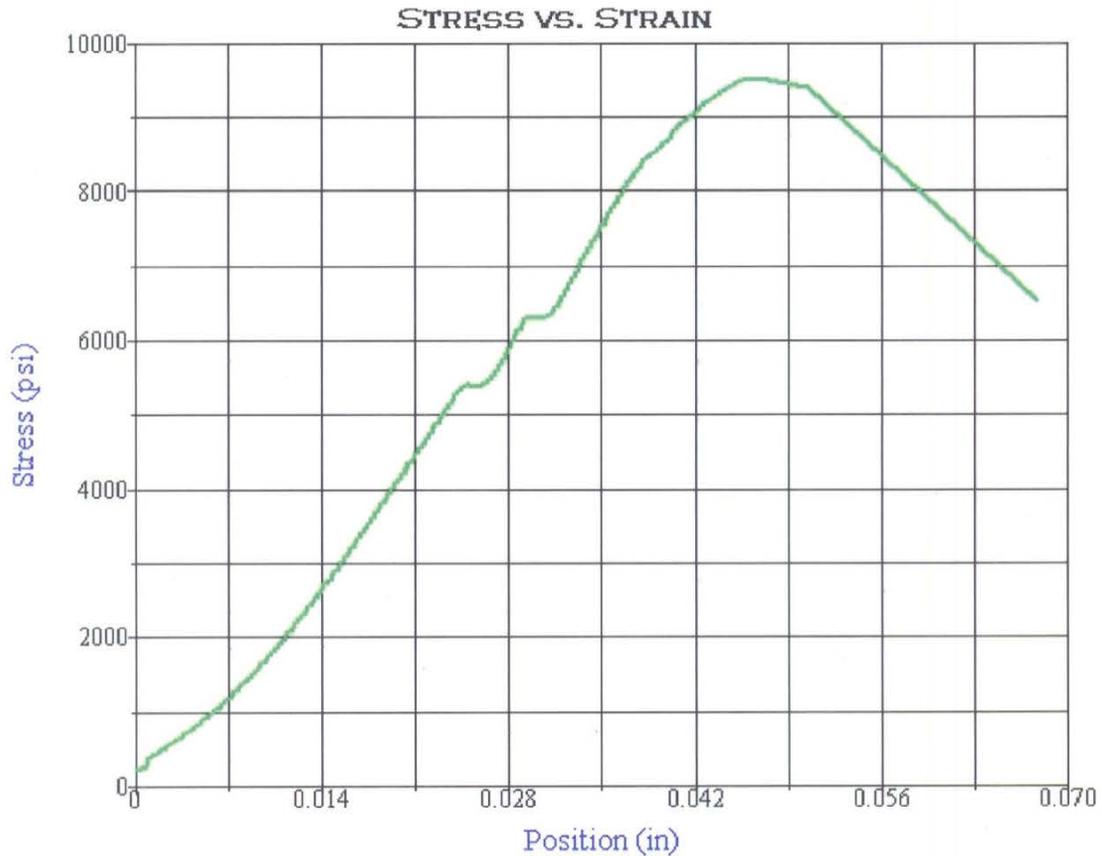
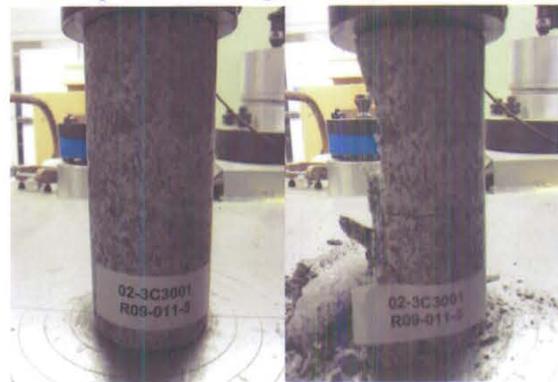
Plate No.
 B-4

Specimen Gage Length: 5.5000 in
 Diameter: 2.3900 in
 Area: 4.4863 in²
 Maximum Load: 42648 lbf
 Compressive Strength: 9506 psi

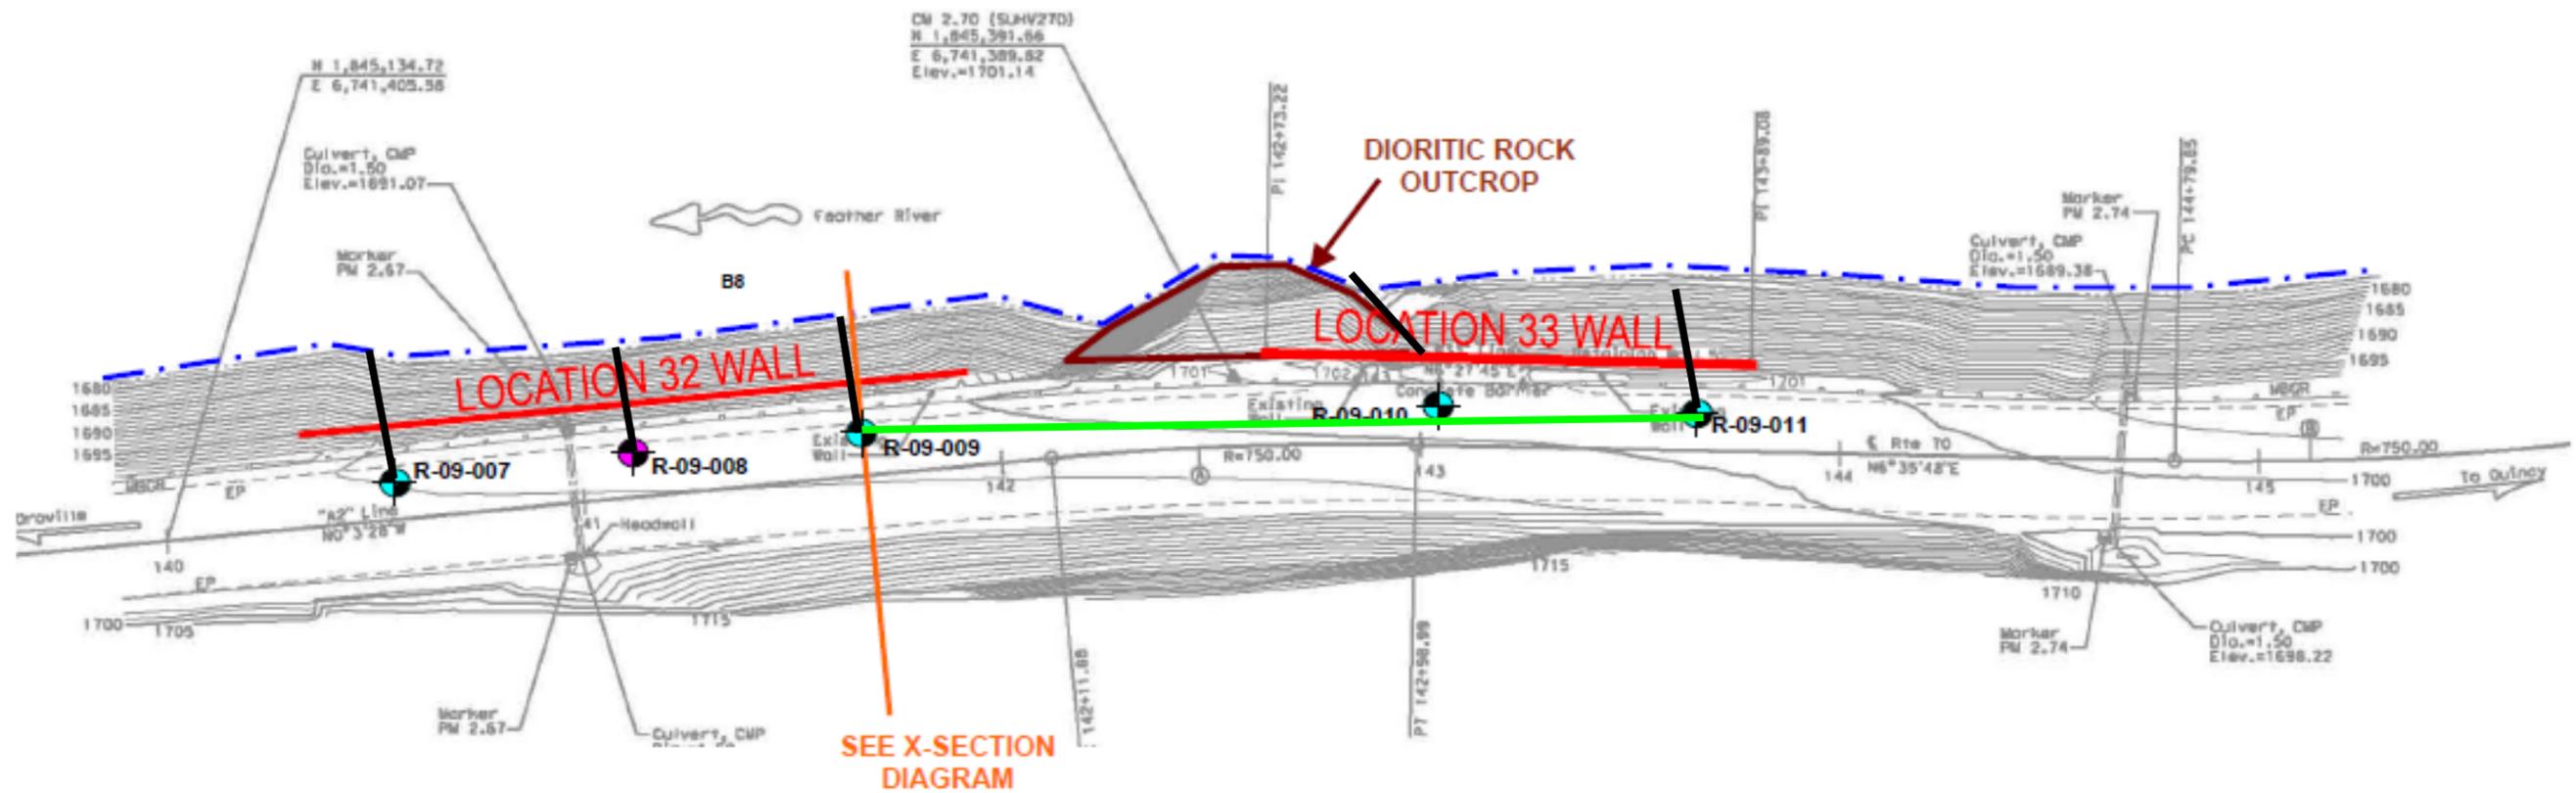
Figure 1. Site map showing the locations of the seismic investigation. Green line is location of the refraction profile acquired for velocity data, black lines are the borehole to surface tomographic sections. Stationing line provides scale.
