MATERIALS INFORMATION

Asbestos Survey Report

Alternative-in-Line Terminal System

Subject: ASBESTOS SURVEY REPORT
HANFORD-ARMONA ROAD UNDERCROSSING (45-0078)
KINGS COUNTY, CALIFORNIA
CONTRACT NO. 06A1895, E-FIS 06-1400-0172-1 (EA 06-462211)
TASK ORDER NO. 35

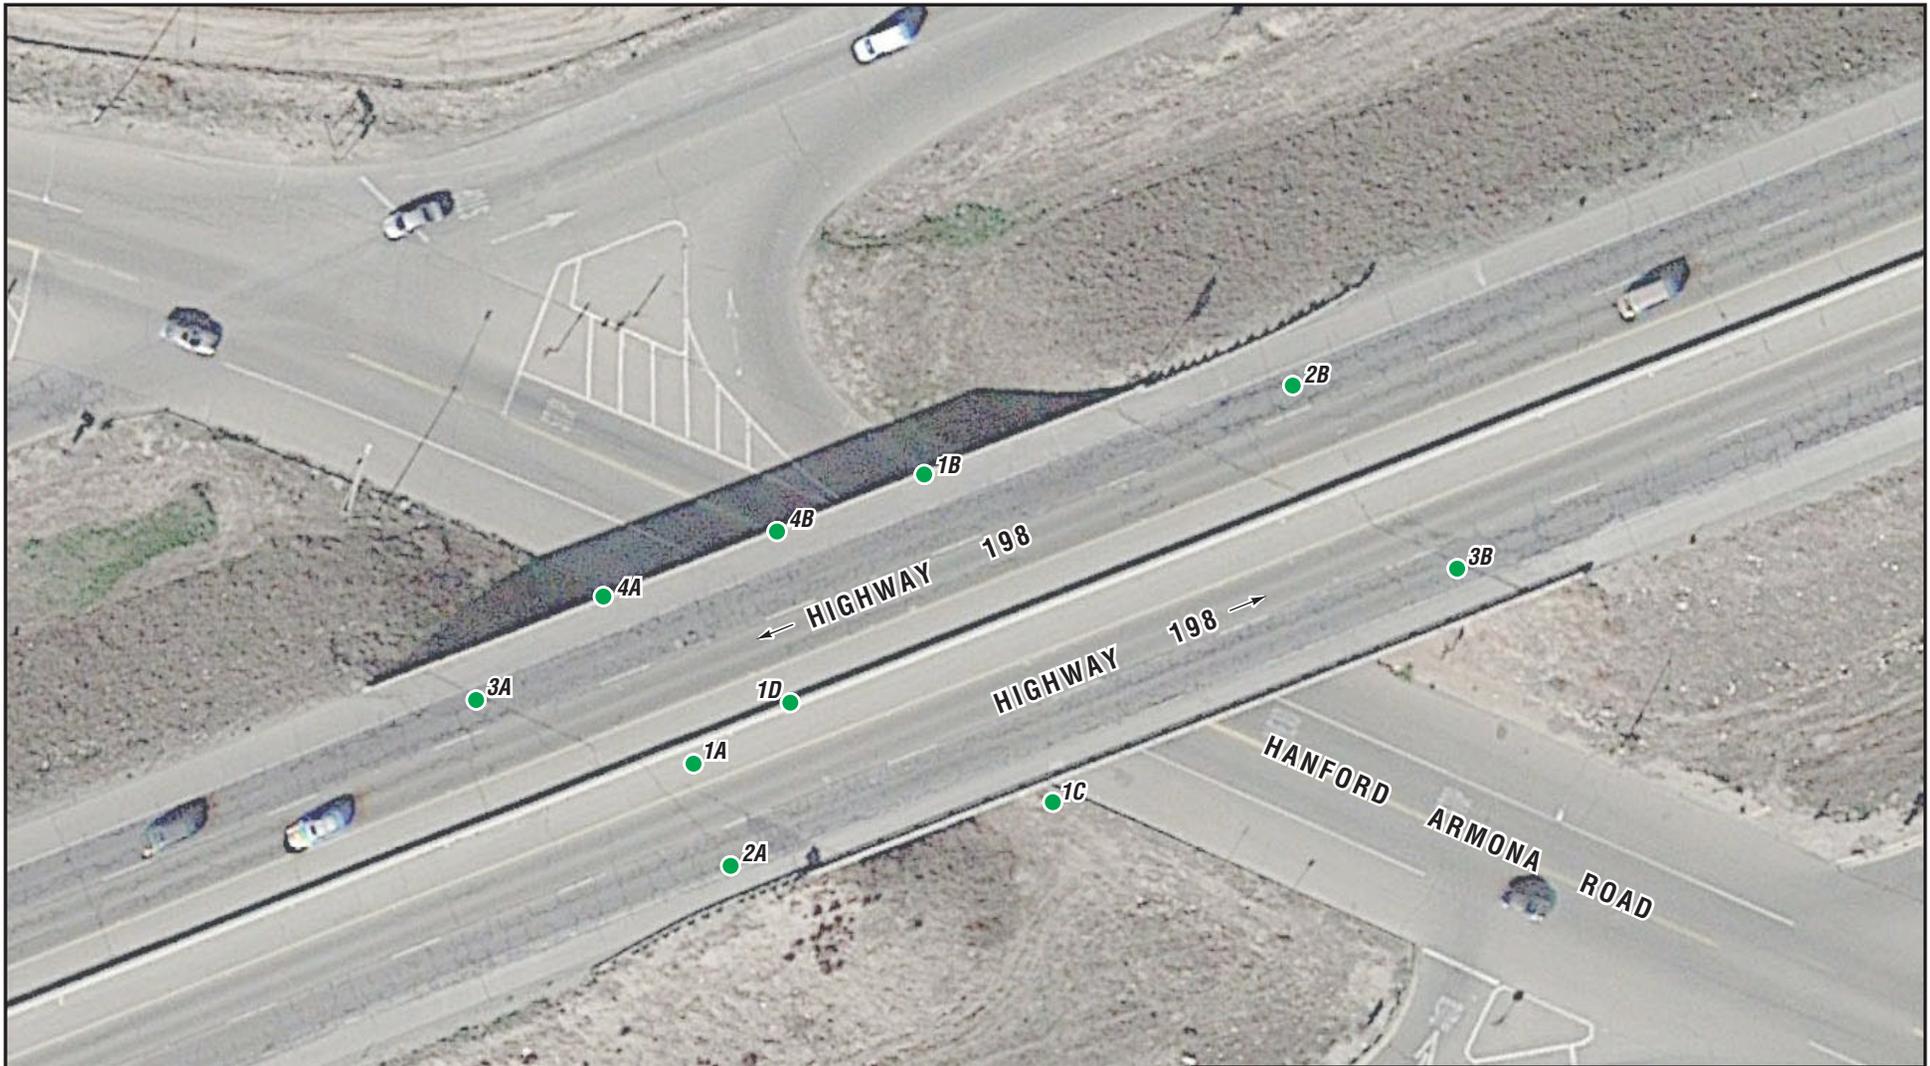
Figure 2

Sample group identification numbers, material descriptions, approximate quantities, friability assessments, and photo references are summarized on Table 1. Approximate sample locations are presented on Figure 2. Materials represented by the samples collected are shown in the attached photographs.

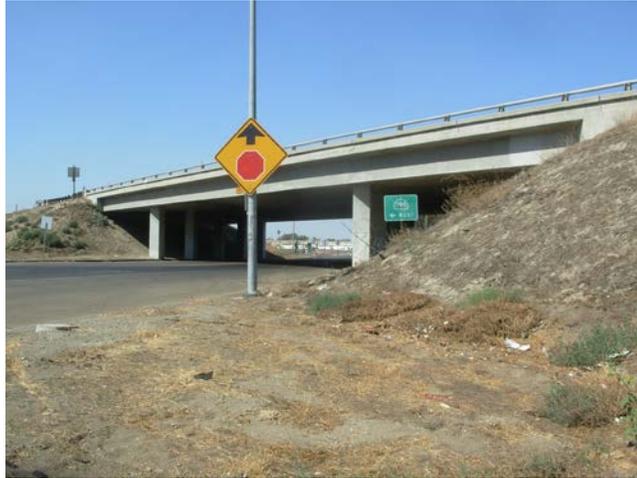
Photo 1 – Hanford-Armona Road UC (45-0078) at PM 15.75 on Highway 198 in Kings County, California
